**Performance of Precast Concrete Pavement Repairs
on an Urban Freeway in Toronto**

Paper prepared for presentation

of the 2011 Annual Conference of the
Transportation Association of Canada
Edmonton, Alberta

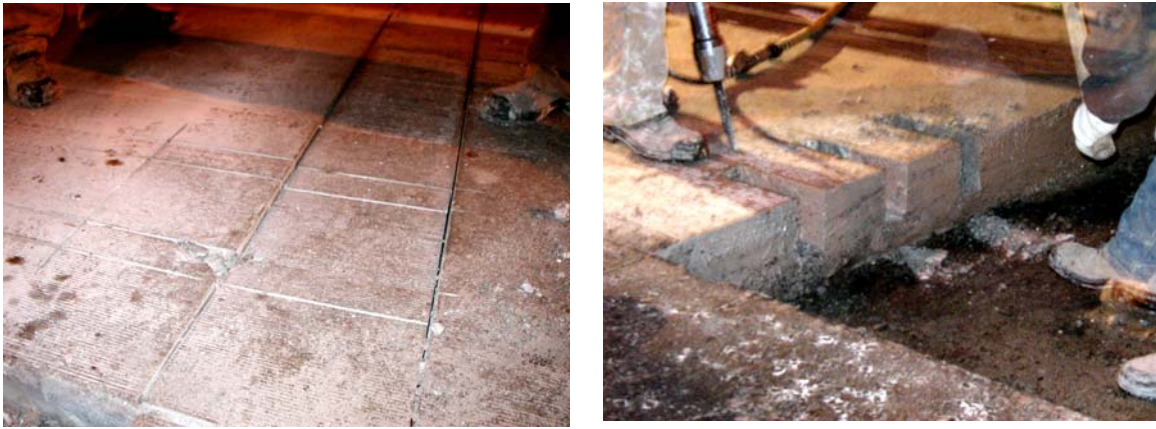
Dowel bar slots were also sawcut the previous night. Triple cuts were made at each dowel bar location, providing for three dowel bars in each wheel path. These were over-cut significantly (Figure 2a). Contract documents specified that hand held chipping hammers be used to excavate the slots, to reduce damage to the adjacent concrete. Unfortunately, heavier jackhammers were used, resulting in spalling and cracking around the dowel slots (Figure 2b). The dowel bar slots were rapidly excavated using jackhammers. Since removal of the dowel slots was not a controlling operation, more time should have been taken to carefully excavate the slots with chipping hammers and more thoroughly clean out the slots. Dowel bar slots were blown out with compressed air but it was still possible to remove dried slurry from the slots, which may have had a detrimental effect on bonding.

Excavation of the dowel bar slots was not carried out with a desirable level of care. After placement, it was observed that dowel bars were not centered in the dowel slots and were sometimes resting against the walls or base of the dowel slots, meaning it would be difficult to get full encasement with grout. Some of the dowel bar slots were spalled down to the CTB and there were also cracks extending from some dowel slot removal areas into the existing concrete. It was clear that the Michigan Method requires good workmanship to ensure that the dowel bars slots are carefully excavated without damaging the existing concrete.

Figure 2 a) Sawcutting and b) Excavation of Dowel Bar Slots for Michigan Method

- When chipping out the dowel bar slots for the Michigan Method, spalling and cracking occurred. The contract specified the use of light-weight chipping hammers, but jack-hammers were used. Since the dowel bar slots are crucial to performance of the slabs, more time should have been taken to carefully excavate the slots with chipping hammers and thoroughly clean the slots.

- Gang saws, like those used for dowel bar retrofit, are recommended for sawing dowel bar slots in the Michigan Method. A template is also required to mark out the dowel bar slots to ensure that dowel bars fit and are centered in dowel bar slots.

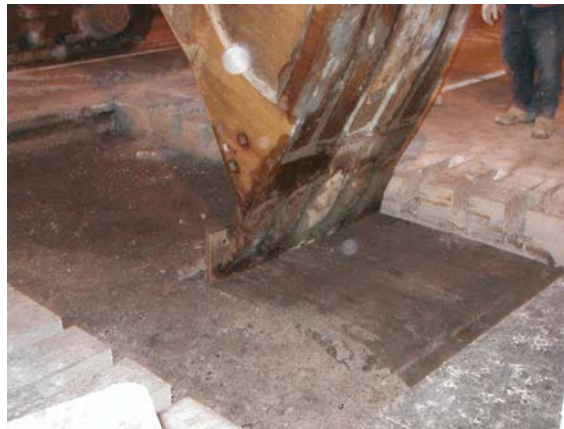
The precast design concept does not require excavation of the underlying cement treated base (CTB). Once the concrete pavement is removed, a leveling course is placed directly on the undisturbed CTB prior to placing the precast slab. This concept only works if the precast slabs are cast thinner than the existing concrete. On this trial project, the precast slabs were cast to the exact dimensions 2 m x 3.65 m x 230 mm. Coring later revealed that the existing concrete pavement, which had been diamond ground the previous year, ranged in thickness from 200 – 230 mm. It became evident that the CTB would need to be partially excavated to allow for placement of the leveling material and the precast slab. The Contractor used a large backhoe with a welded plate to scrape the CTB to the required depth (Figure 3).

Figure 3. Use of backhoe to partially excavate cement treated base.

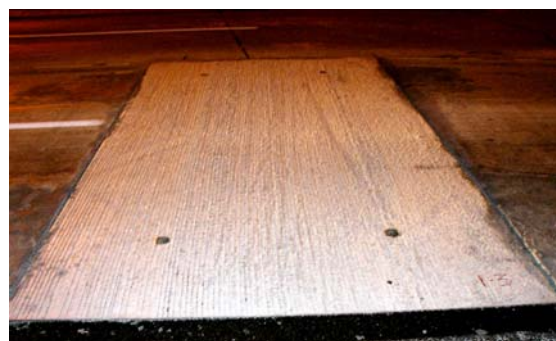
The Michigan slabs were lowered by crane onto the flowable fill with the 12 cast-in dowel bars fitting into the sawcut slots. The first slab was placed slightly high. The contractor attempted to drive heavy equipment over the slab to settle it deeper in the flowable fill, but the slab was set. All three Michigan Method slabs were placed between 10:00 pm and 3:00 am. The second slab was the best of the three slabs, being flush with the existing concrete pavement. The other two slabs sat slightly higher than the existing concrete. These slabs should have been diamond ground to meet surface tolerances.

Figure 5. Completed Michigan Method slab repair

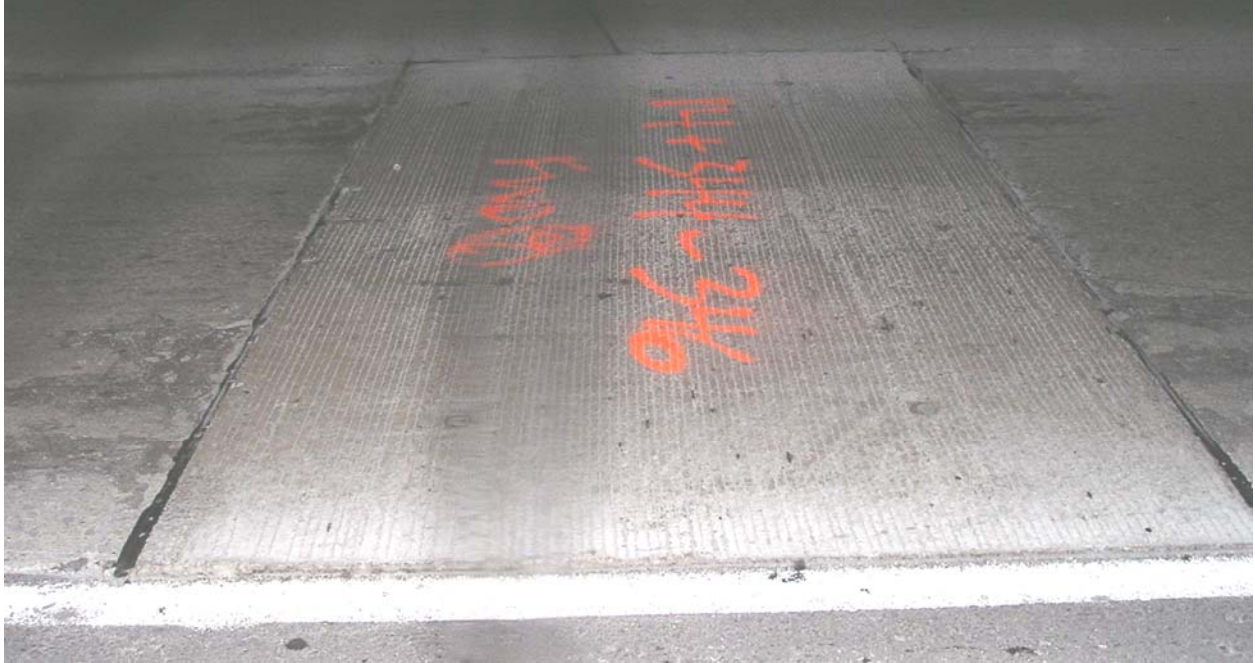
Initially, the Michigan Method slabs were found to be in excellent condition (Figure 9), however progressive deterioration was observed in some areas of the grouted dowel bars slots, likely the result of damage to older, existing concrete during sawcutting and removal of dowel slots.

Figure 9. Michigan Method precast slab, June 2005.

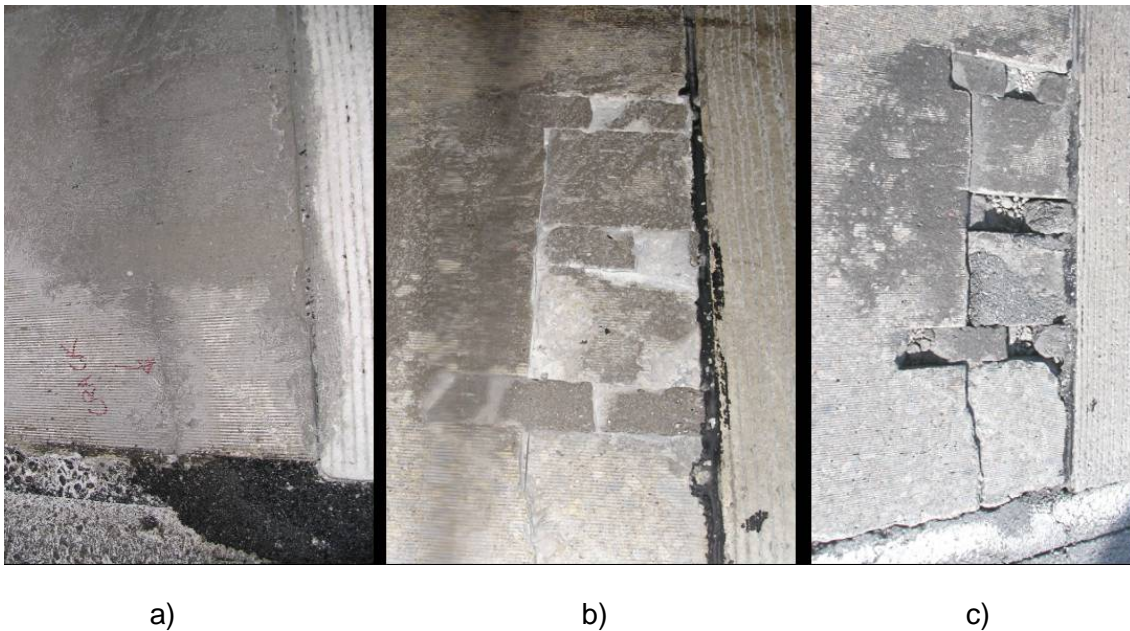
Figure 10. Michigan Method Slab 2 a) after construction in November 2004 b) June 2005 at one-year field review c) May 2006 in second year field review.

Dowel slots showed some cracking and spalling and in some instances the dowel bars were exposed. Figure 10 a,b,c shows a crack, which appeared during construction near a dowel bar slot in slab 2. By June 2005, the crack had progressed to block cracking in the dowel slot, with spalling of the dowel slot observed in May 2006.

It is likely that cracking and spalling at the dowel bar slots is the direct result of the removal method, which included over-cutting the slots and jack-hammering to remove concrete from the slots. The Ministry is confident that an improved method of excavating the slots, such as use of gang-saws, light-weight chipping hammers and sand-blasting to clean the slots will improve performance of the Michigan Method.

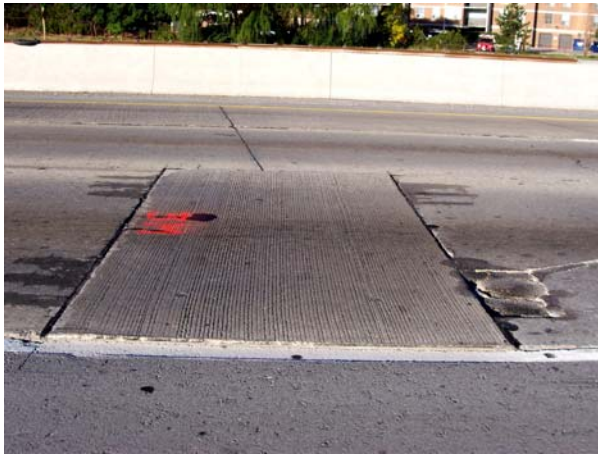
Figure 11 a) September 2008, some Michigan Method slabs are failing at the dowel bar slots b) October 2009, one of the Michigan slabs shows no deterioration after 5 years.

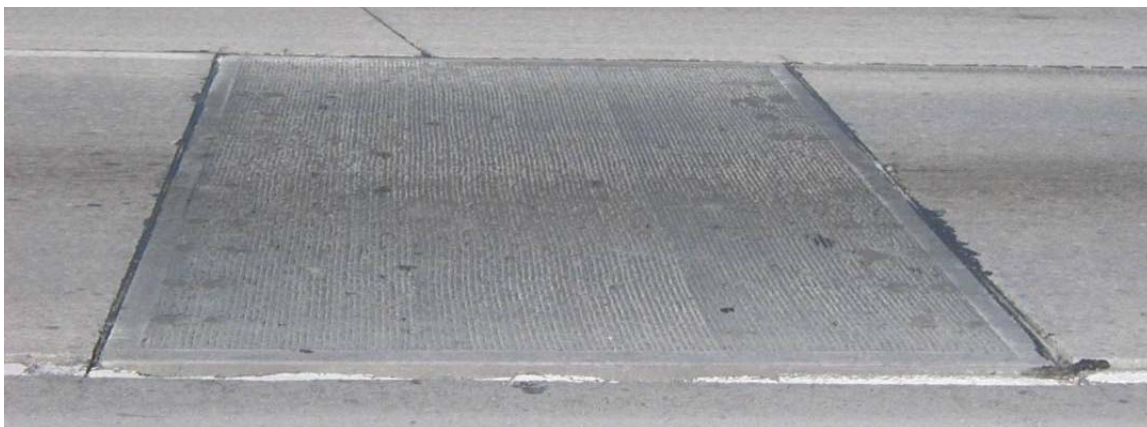
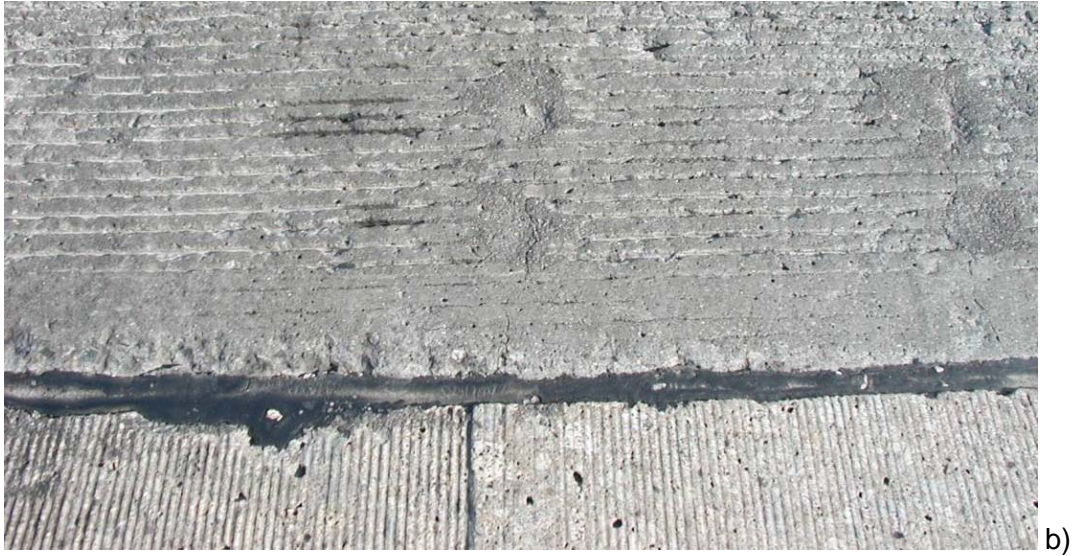
a)

The Fort Miller Intermittent Method slabs are performing very well. In the June 2005 field review no defects were observed in any of the intermittent slabs. In the May 2006 field review, the only distress that could be detected was very slight cracking at a few locations over the dowel bars (Figure 12 a & b, below).

Figure 12 a & b) May 2006 observed slight cracking over dowel bars Fort Miller Intermittent slab.

It is likely that the very slight cracking at a few dowel bar locations in the Fort Miller Intermittent slab repairs was caused by non-uniform support beneath the slab. In the cracked areas, the slabs may be resting on the dowel bars due to poor base excavation and levelling practices during construction.

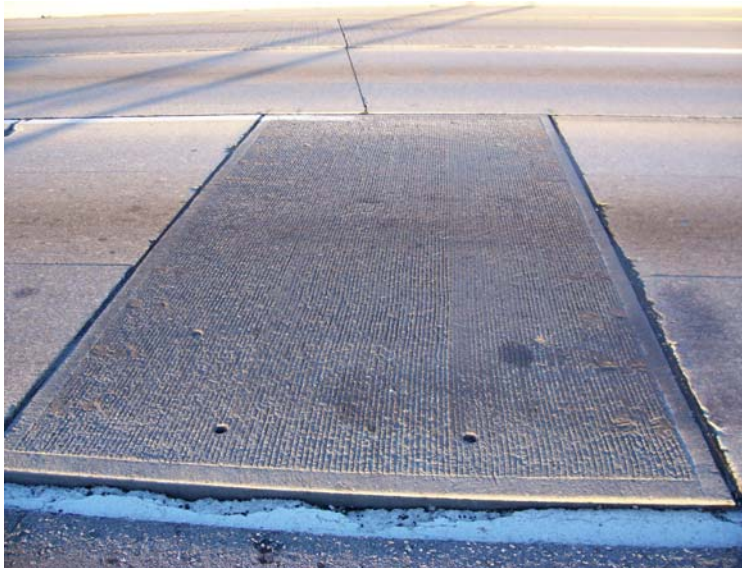
Figure 13 a) September 2007 and b) November 2009, Fort Miller Intermittent slabs performing well.

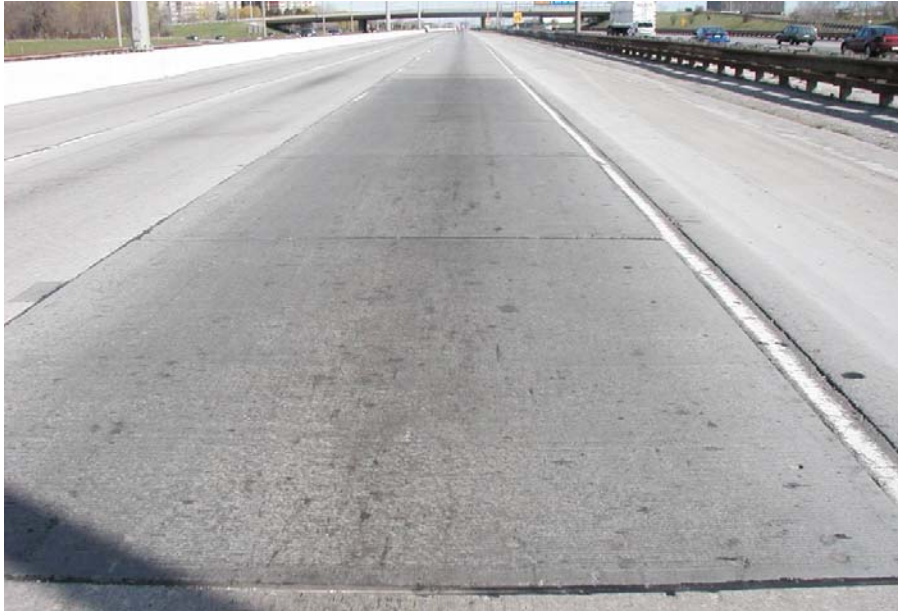
The Fort Miller Continuous Method slabs are also performing very well (Figure 14). No cracking or spalling was observed in any of the six continuous slabs during the June 2005 and May 2006 field reviews. In September 2007 hairline cracking was observed of the dowel bar locations (Figure 15) and in November 2009 very slight transverse cracking was noted in one of the slabs.

Figure 14. Performance of Fort Miller Continuous Slab repairs, May 2006.

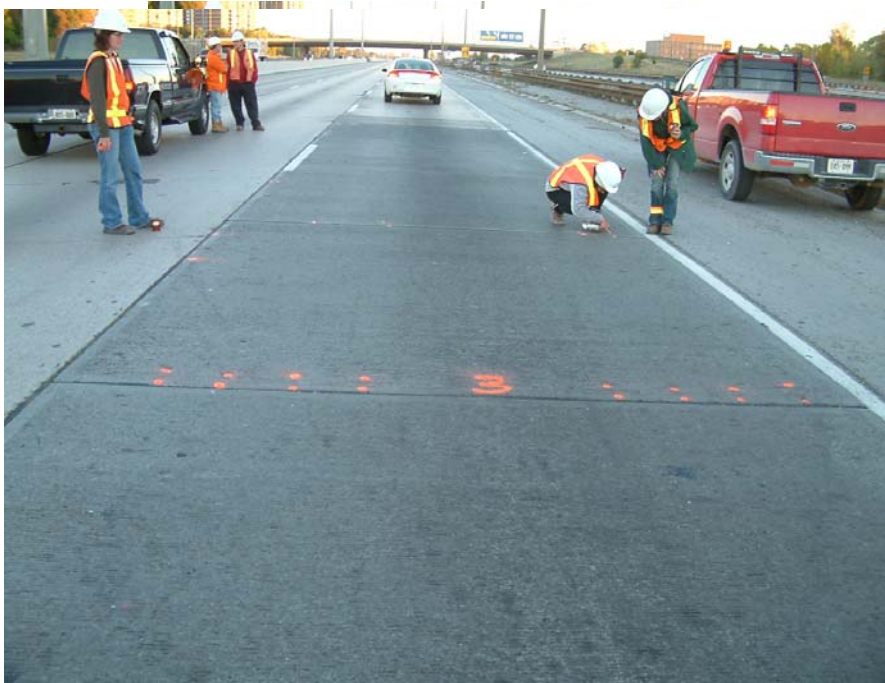
Figure 15. Performance of Fort Miller Continuous Slab repairs, September 2007.
