**REHABILITATION DESIGN METHODOLOGY FOR HAUL ROADS
ASSOCIATED WITH A WIND FARM DEVELOPMENT IN
SOUTHWESTERN ONTARIO**

Ludomir Uzarowski, Ph.D., P.Eng., Principal, Golder Associates Ltd.
Rabiah Rizvi, B.A.Sc., Pavement and Materials Engineering, Golder Associates Ltd.
James D. Rodger, P.Eng., Principal, Golder Associates Ltd.

Paper prepared for presentation at the
Effects of Specialty Vehicles on
Pavement Network Operation Session
of the 2012 conference of the
Transportation Association of Canada
Fredericton, New Brunswick

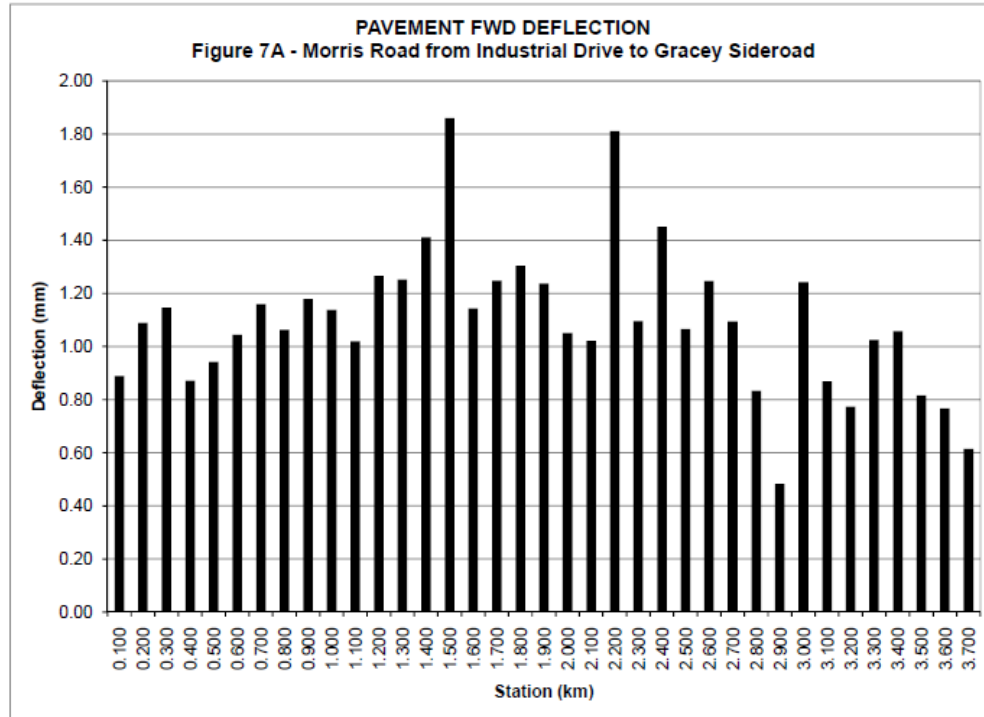
Figure 5 – Example of Graphical Representation of Normalized Deflection for Individual Pavement Sections

The normalized deflections and pavement surface modulus for each of the road sections was plotted against the station to present the overall structural condition of the road section and to identify particularly weak locations. Figure 5 shows a typical normalized deflection plot that was generated for each road section. From the figure it can be seen that at least two points (Stations 1+500 and 2+200) have significantly higher deflections and may require more rehabilitation to restore its load bearing capacity.
