Progressive Investigation and Void Detection of Post-Tensioned Slab Bridge Tendons

Paper prepared for presentation
at the Bridge Session

of the 2012 Conference of the
Transportation Association of Canada
Fredericton, New Brunswick

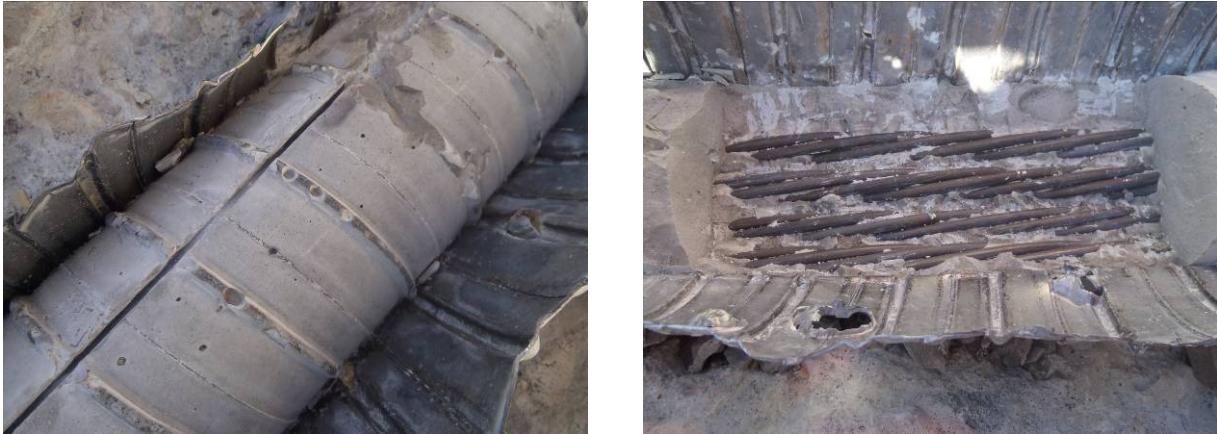
Strands were exposed in four locations (two per structure). One of the exposures for each structure was carried out in an area of high corrosion potential, as this was thought to be the most likely location of corrosion in the strands. The duct was opened up and grout removed to expose the strands. A sample of the grout was obtained for chloride content testing. The average chloride content in the grout was measured to be 0.008%, with the highest single chloride content being 0.016%. The exposed strands were visually inspected for signs of corrosion. Figure 3 illustrates the typical condition of the PT grout and strands. No corrosion of the strands was observed.

Figure 3: Typical condition of a) grout and b) exposed strands after grout removal

Once the necessary inspections were completed, the exposed strands were covered in a thick coating of two-part epoxy, which was allowed to cure. Grout was then used to replace excavated concrete.

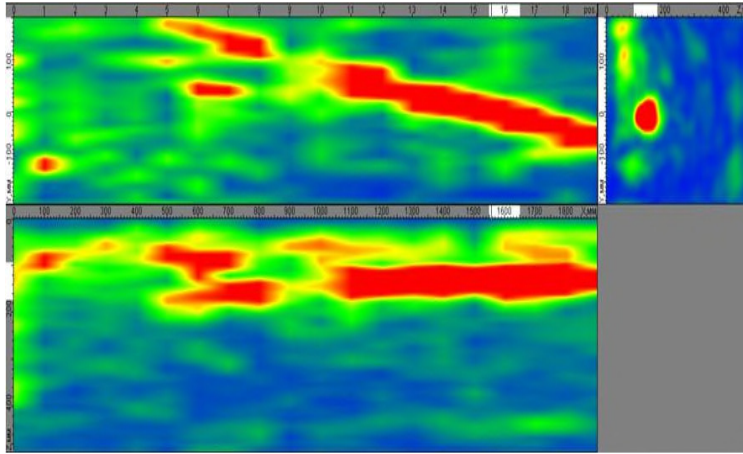
Figure 5: Tomograph representative of a high probability of voids

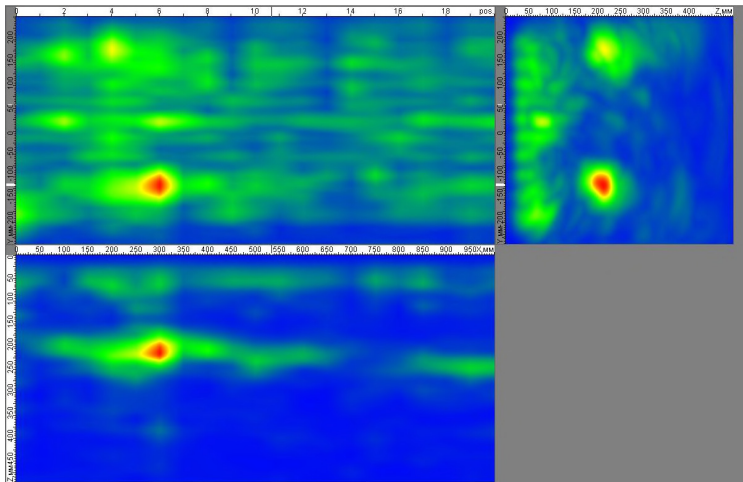
Figure 6: Tomograph representative of a medium probability of voids

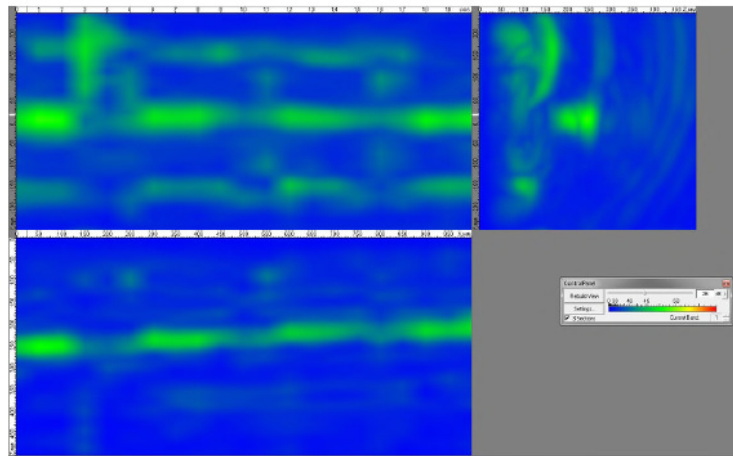
Figure 7: Tomograph representative of a low probability of voids
