BCT Pilot Project for Culvert Integrity Analysis in the City of Toronto

Brian Anderson, OGRA
Contact: brian@ogra.org

John Bowles, M.Sc.E. P.Eng, Inversa Systems
Contact: john.bowles@inversasystems.com

During the summer of 2011, OGRA supported an integrity analysis pilot project on selected roadway culverts using recently-developed inspection equipment capable of quantifying undermining. This new modality, Backscatter Computed Tomography (BCT), is a practical *in-situ* form of Computed Tomography also known as a CAT Scan. The purpose of the pilot was to evaluate the technology’s potential to measure undermining, thereby facilitating the planning of major roadway culvert replacements or rehabilitation. Three culverts in the City of Toronto were inspected to determine the culverts’ structural condition using BCT equipment provided by Inversa Systems Ltd.

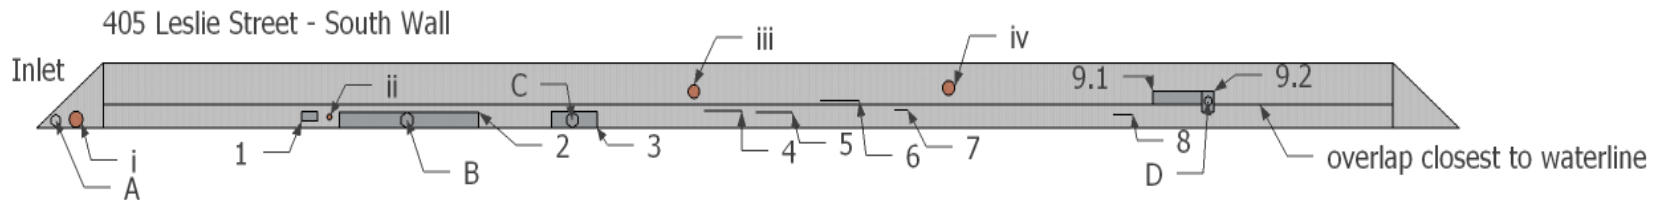
Acoustic Inspection Maps – 405 Leslie Street South Wall

The visual inspection general appraisal for culvert 405 indicated overall poor condition – advanced section loss at inlet and outlet. Deterioration throughout the pipe with through wall holes on the upper 45 of arch at mid span was observed.

A - BCT Image A - Verification image taken of known void at inlet

B - BCT Image B, C, D and E taken at this location

C - BCT Image F and G taken from this location

D - BCT Image H and I taken at this location

i - Through wall corrosion noted on invert at inlet

ii - Corrosion

iii - Through wall corrosion noted on upper 45 of culvert barrel

iv - Corrosion

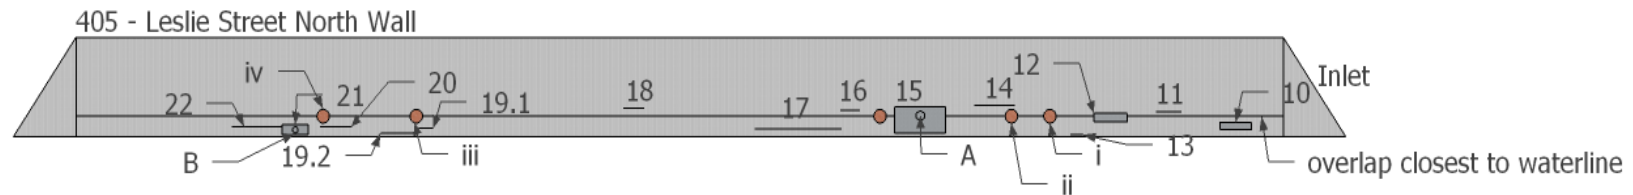
Acoustic Inspection Maps – 405 Leslie Street North Wall

A - BCT Image J and K taken at this location

B - BCT Image L taken at this location

i - Repair work noted at this location

ii - Repair work noted at this location

iii - Repair work and corrosion noted at this location

iv - Repair work and corrosion noted at this location

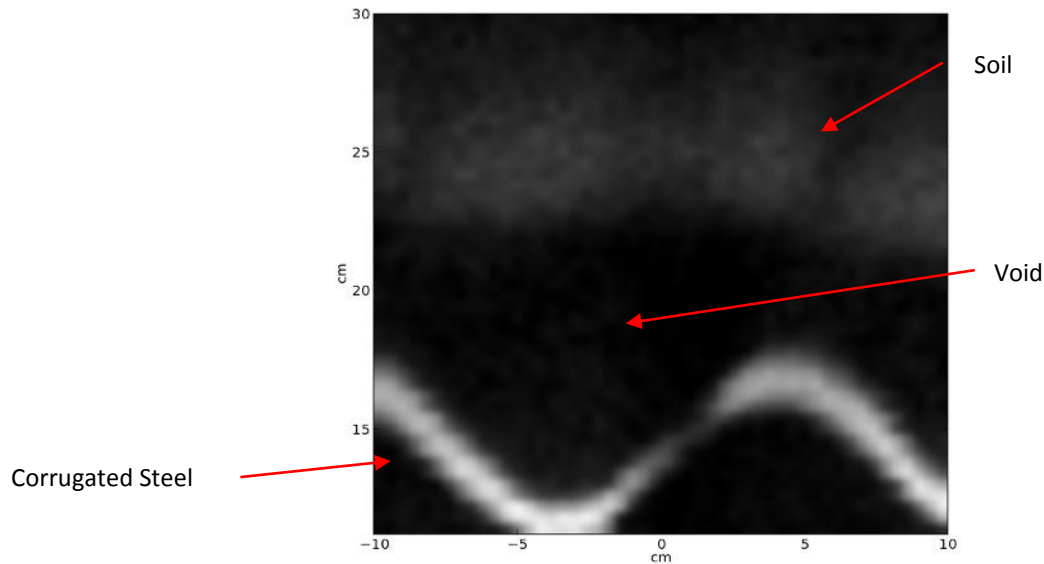
Image A – This image was taken for verification. The image was taken of a clearly visible void section at the inlet end of the culvert on the south wall. The corrugated steel wall is visible at the bottom of the image. The dark black from approximately 12 cm to 22cm on the vertical axis indicates void. The grey that appears from approximately 22cm to 30cm on the vertical axis indicates soil.

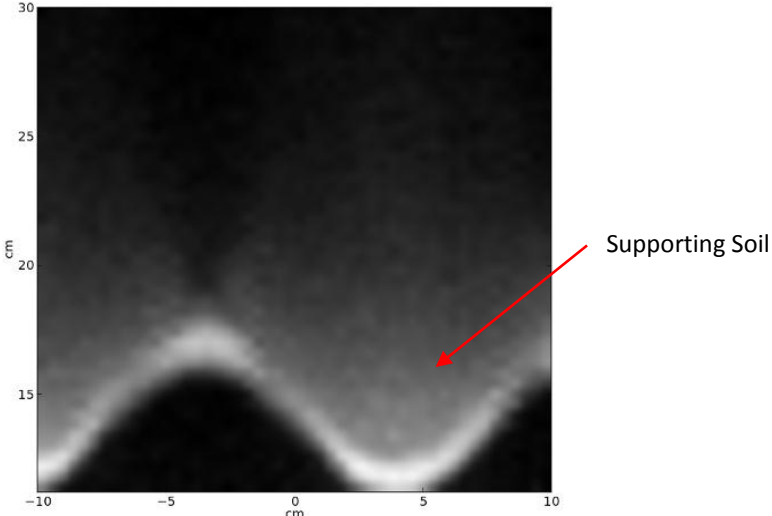
Location: Acoustic Anomaly #2 (X = 1149cm – 1169cm, Y = -44.5cm)

Image B – The acoustic inspection indicated audible void at Acoustic Anomaly #2, however, a follow-up BCT inspection shows supporting soil behind the culvert wall. Three images were taken along the length of Acoustic Anomaly #2 and all revealed supporting soil directly behind the culvert wall. This demonstrates the potential misinformation provided by acoustic inspections without follow up verification. Likely the acoustic variability can be attributed to a thin area along the steel wall in which soil compaction is less, therefore giving a different acoustic signal than surrounding areas.

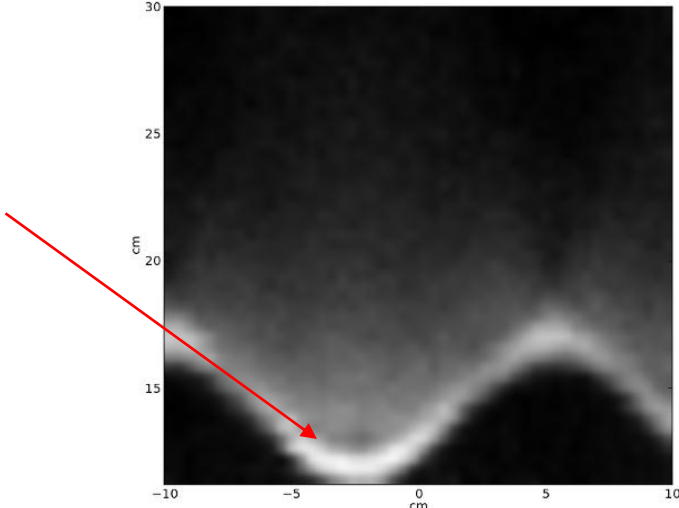
Location: Acoustic Anomaly #3 (X = 2128cm – 2148cm, Y = -52.5cm)

Image C – The BCT inspection of Acoustic Anomaly #3 shows a small void pocket or possibly loosely compacted material behind the culvert wall between X = -5 and X = 0.

Small void pocket,
magnified in Image E

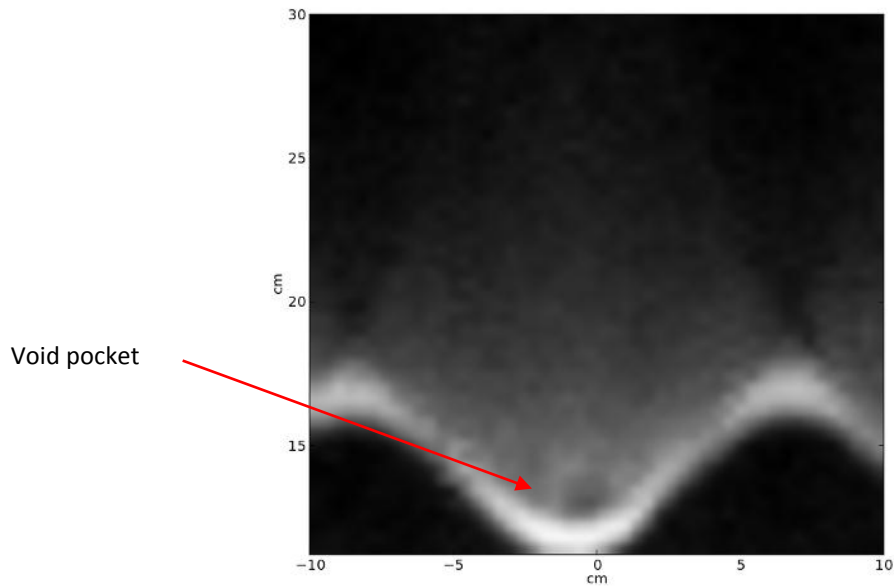
Location: Acoustic Anomaly #15 (X = 2145cm – 2165cm, Y = -28cm)

Image D – The BCT inspection of Acoustic Anomaly #15 indicates a void pocket in the valley of the corrugation.

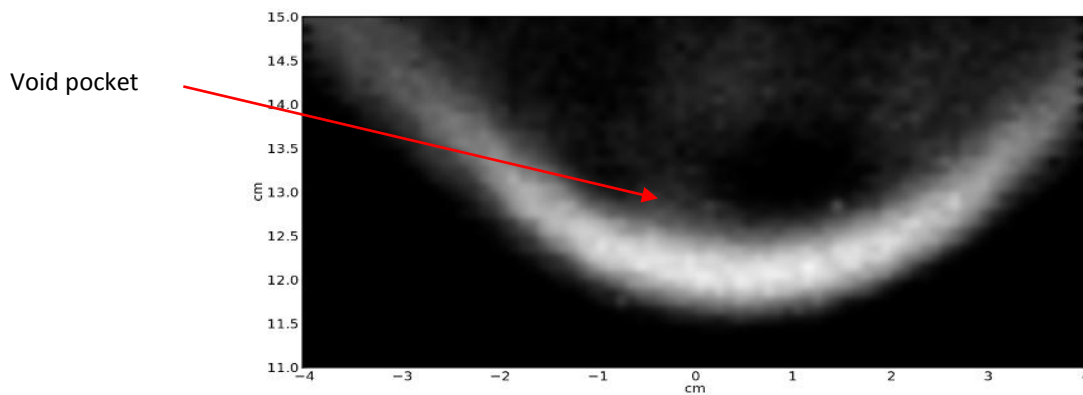
Location: Close up of above – Acoustic Anomaly #15 (X = 2151cm – 2159cm, Y = -28cm)

Image E – A magnified image of Acoustic Anomaly #15 in the area of concern indicates a small amount of void beginning to form in the valley of the corrugation.

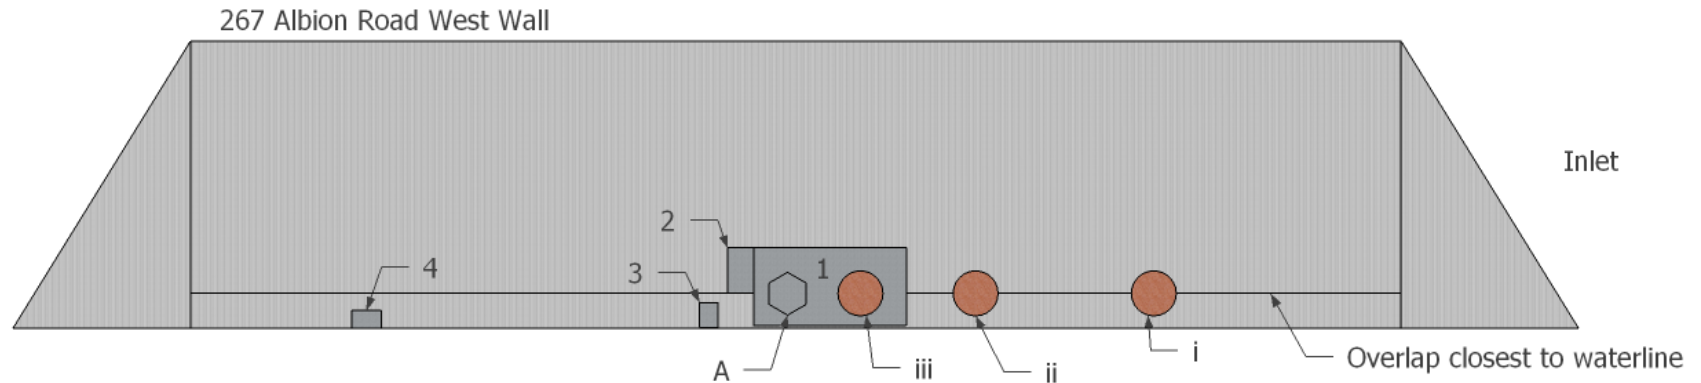
Acoustic Inspection Maps – 267 Albion Road West Wall

A - BCT Image A taken at this location

i - Corrosion on roof

ii - Heavy corrosion at drain

iii - Through wall corrosion

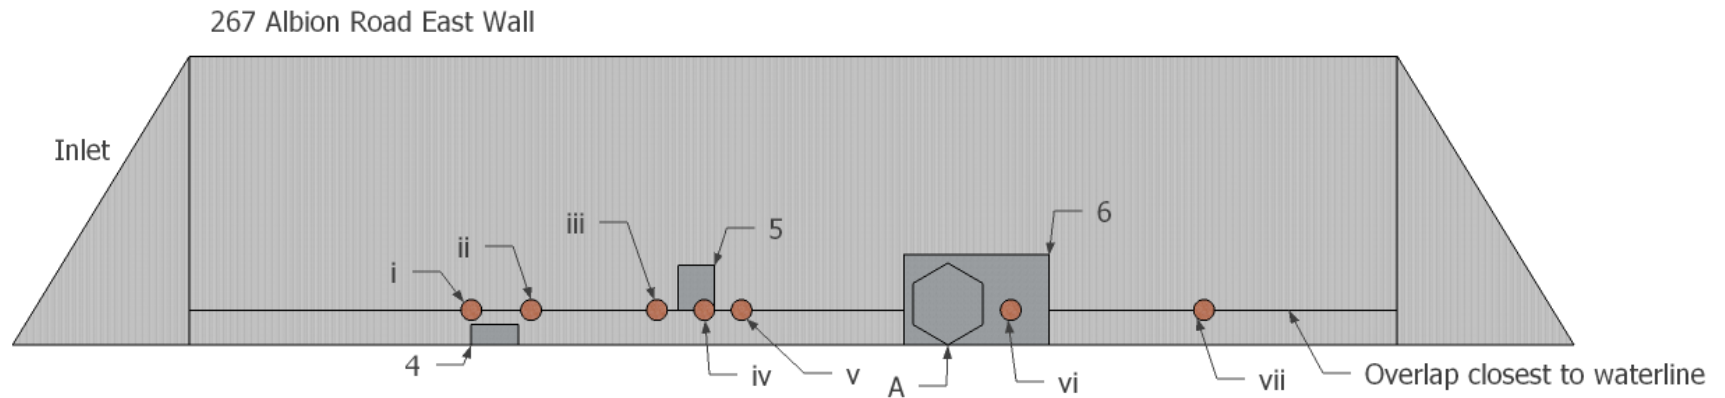
Acoustic Inspection Maps – 267 Albion Road East Wall

A - BCT Image location for images D, E and F

- i - Missing nut
- ii - Missing nut
- iii - Missing bolt
- iv - Missing nut
- v - Heavy corrosion and missing nut and bolt
- vi - Heavy corrosion around drain
- vii - Missing nut

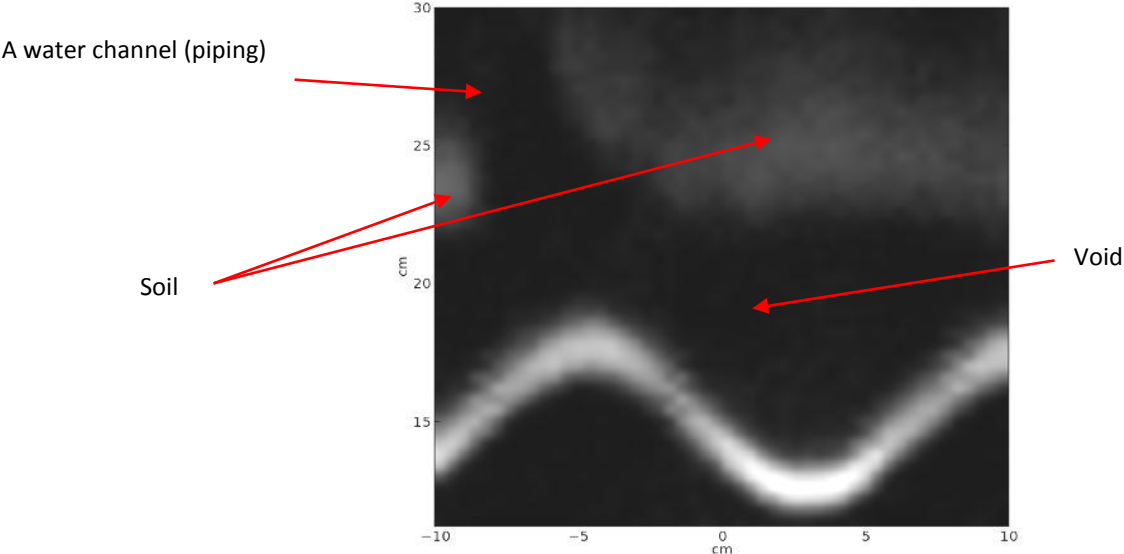
Location: Acoustic Anomaly #1 (X = 1655cm – 1675cm, Y = 25cm)

Image A – BCT inspection of Acoustic Anomaly #1 shows significant void behind the culvert wall.

Insight was also gained in using modern diagnostic imaging tools to understand anomalies. In particular, the piping visible in Image A on the west wall of Albion Road is enlightening. The location and direction give indications of the possible cause of undermining to assist with preventive repairs. A storm drain is near this location and is likely the culprit. Much like in medicine, CT imaging provides meaning that enables diagnostic analysis. With clear visualization of the piping, rehabilitation can be more effectively planned. For example, repair work can be conducted to fill the undermining, as well as repair the adjacent storm drain. Follow-up BCT images can be taken over time to test if the rehabilitation is successful. Again analogous to medicine, with the proper “diagnosis”, one can “save the patient”; the culvert can be repaired avoiding the much

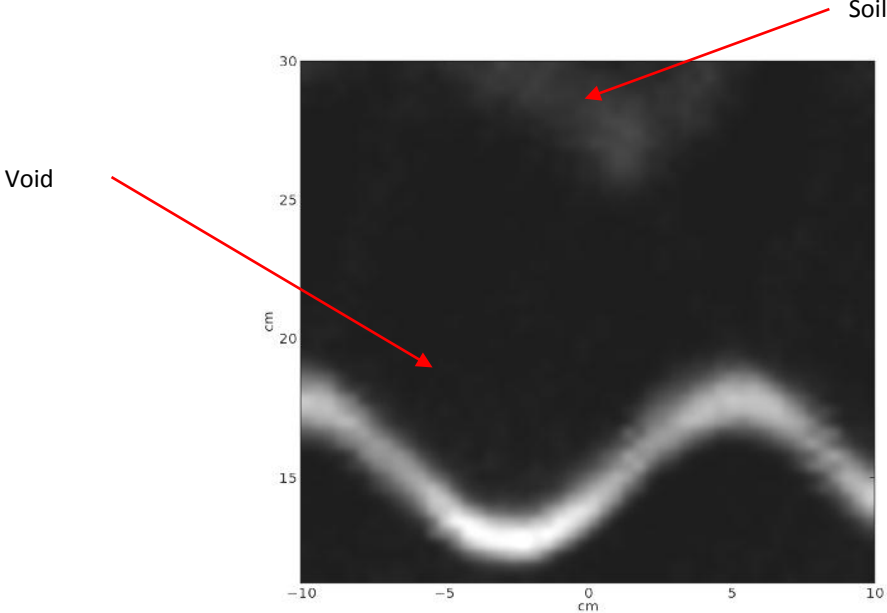
Location: Acoustic Anomaly #1 (X = 1539cm – 1559cm, Y = 17cm)

Image B – A follow up BCT image of Acoustic Anomaly #1 indicates significant (up to 15cm) voiding behind the culvert wall.

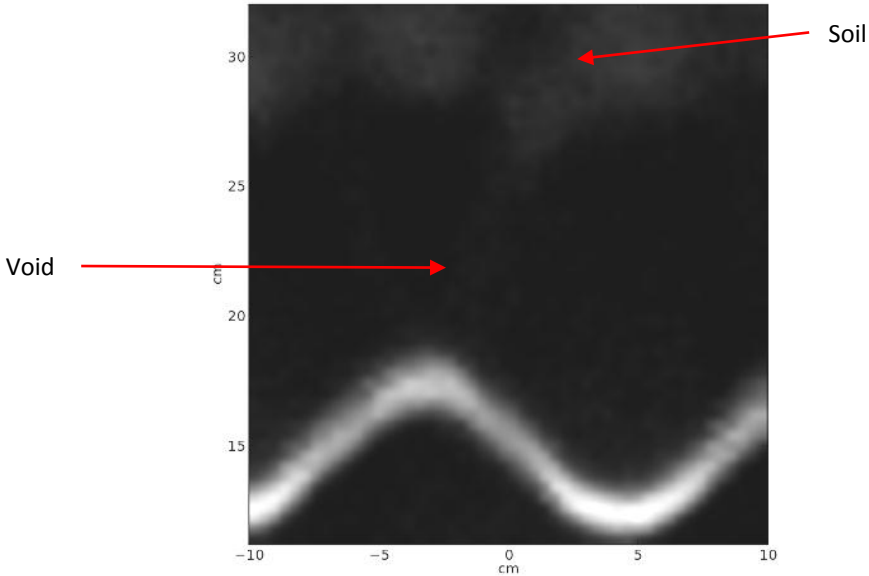
Location: Acoustic Anomaly #1 (X = 1456cm – 1476cm, Y = 84.5cm)

Image C - A follow up BCT image of Acoustic Anomaly #1 indicates significant (up to 15cm) voiding behind the culvert wall. Although difficult to see soil begins to appear at approximately 27cm on the vertical axis.

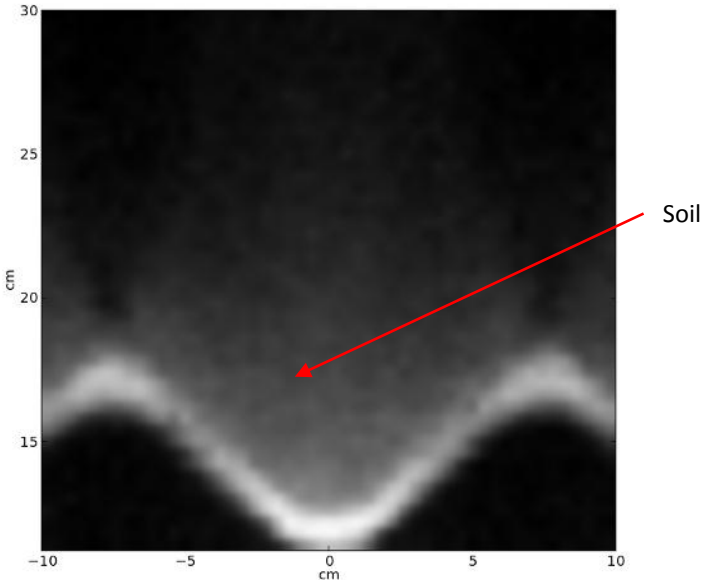
Location: Acoustic Anomaly #4 (X = 1632cm – 1652cm, Y = -63.5cm)

Image D – The BCT inspection of Acoustic Anomaly #6 indicates the presence of soil directly behind the culvert wall.

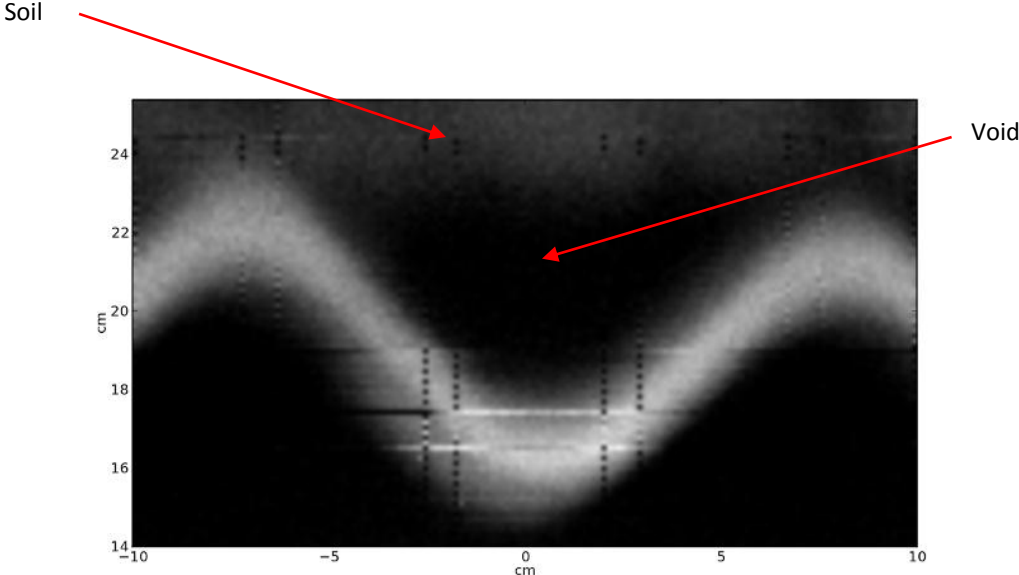
Location: Acoustic Anomaly #4 (X = 1712cm – 1732cm, Y = 37cm)

Image E – Further BCT imaging of Acoustic Anomaly #6 indicates some void in the valley of the corrugation.

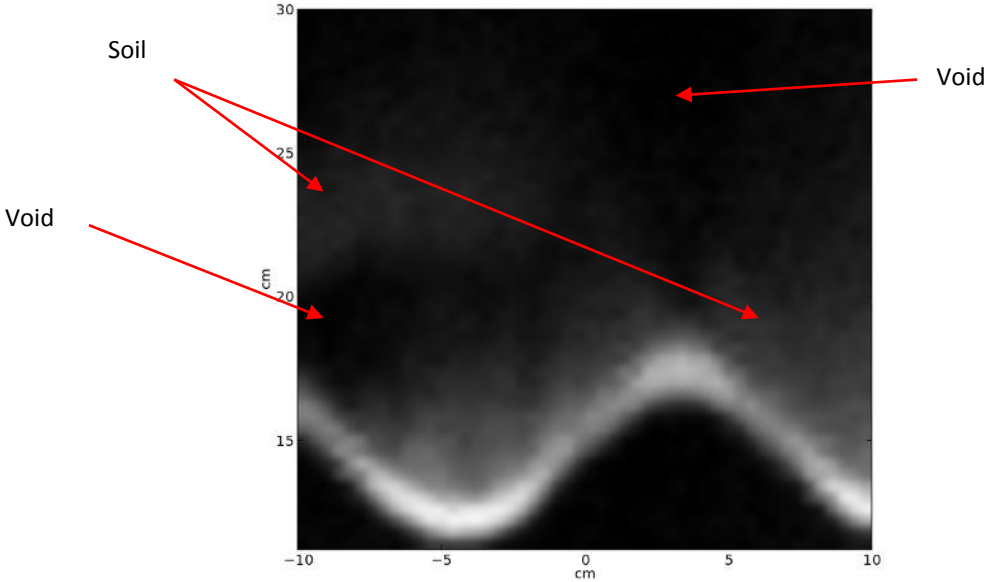
Location: Acoustic Anomaly #4 (X = 1897cm – 1917cm, Y = 31.5cm)

Image F – An additional BCT image of Acoustic Anomaly #6 indicates void pockets behind the culvert wall.

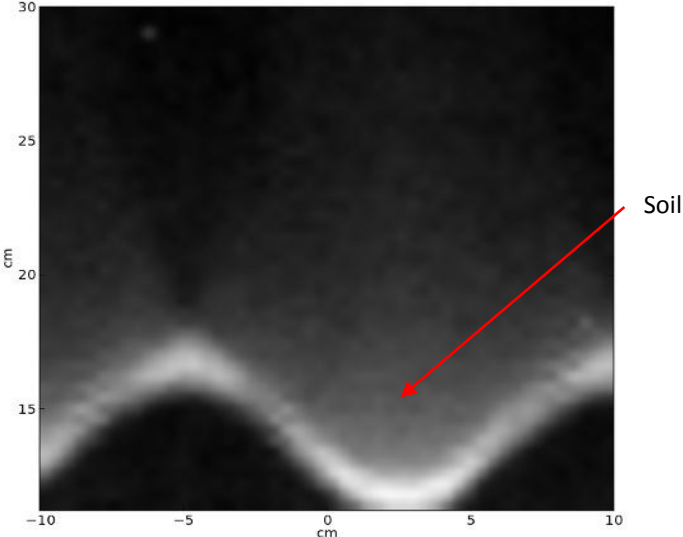
Location: Acoustic Anomaly #1 Shot_2 (X = 922cm – 942cm, Y = -99.5cm)

Image A – A BCT image of Acoustic Anomaly #1 confirms the presence of soil directly behind the culvert wall.

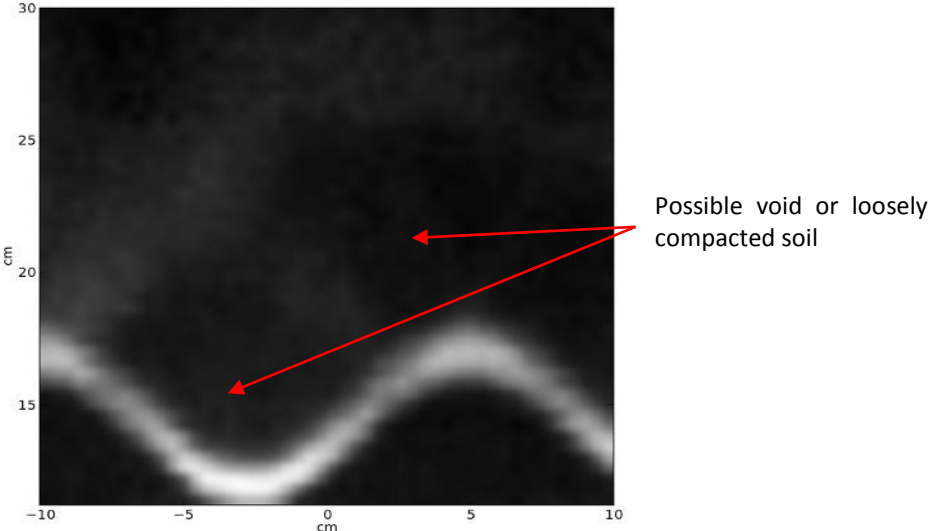
Location: Acoustic Anomaly #5 (X = 6502cm – 6522cm, Y = -88.5cm)

Image B – The BCT inspection of Acoustic Anomaly #5 indicates possible void or loosely compacted soil behind the culvert wall.
