# **Operating and Maintaining Median High Tension Cable Barrier on Highway 2 in Alberta**

Anthony (Tony) Churchill, M.Sc., P.Eng., Transportation Engineer (Presenter)  
Masood Hassan, Ph.D., P.Eng., Senior Transportation Engineer  
Bryan Ngo, P.Eng, Project Engineer  
EBA - A Tetra Tech Company

## **WARRANTY INSPECTION**

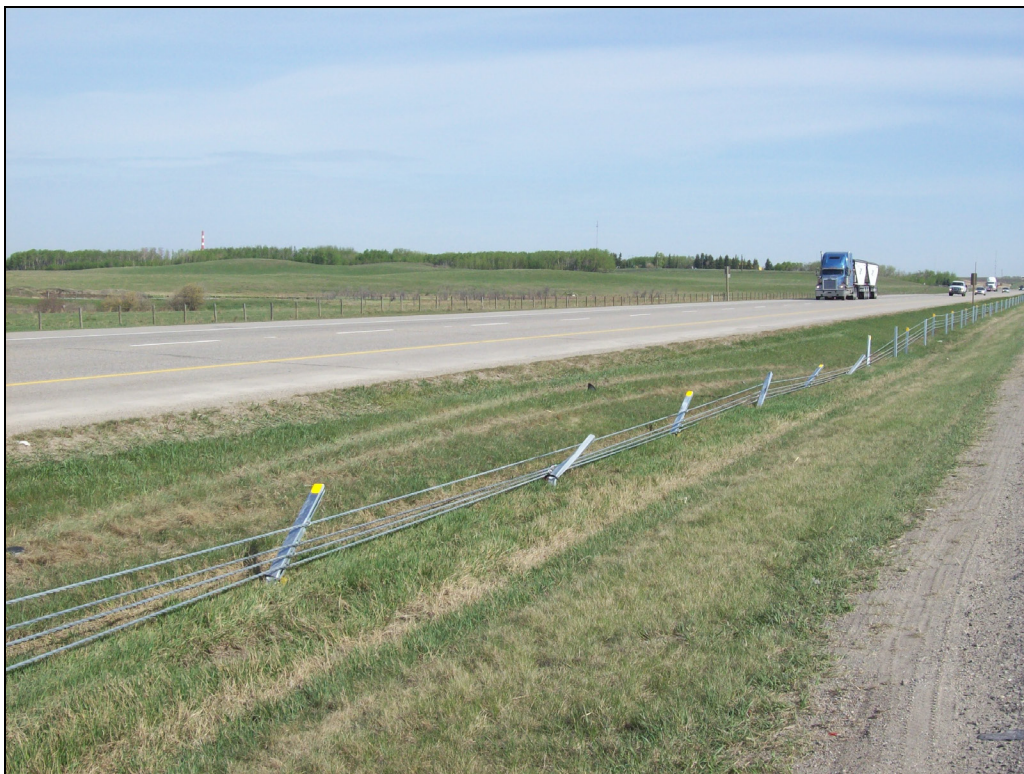
PHOTO 2. Typical HTCB hit in the median of Highway 2 looking downstream (vehicle travelling in direction of photo). Note wheel path in grass.

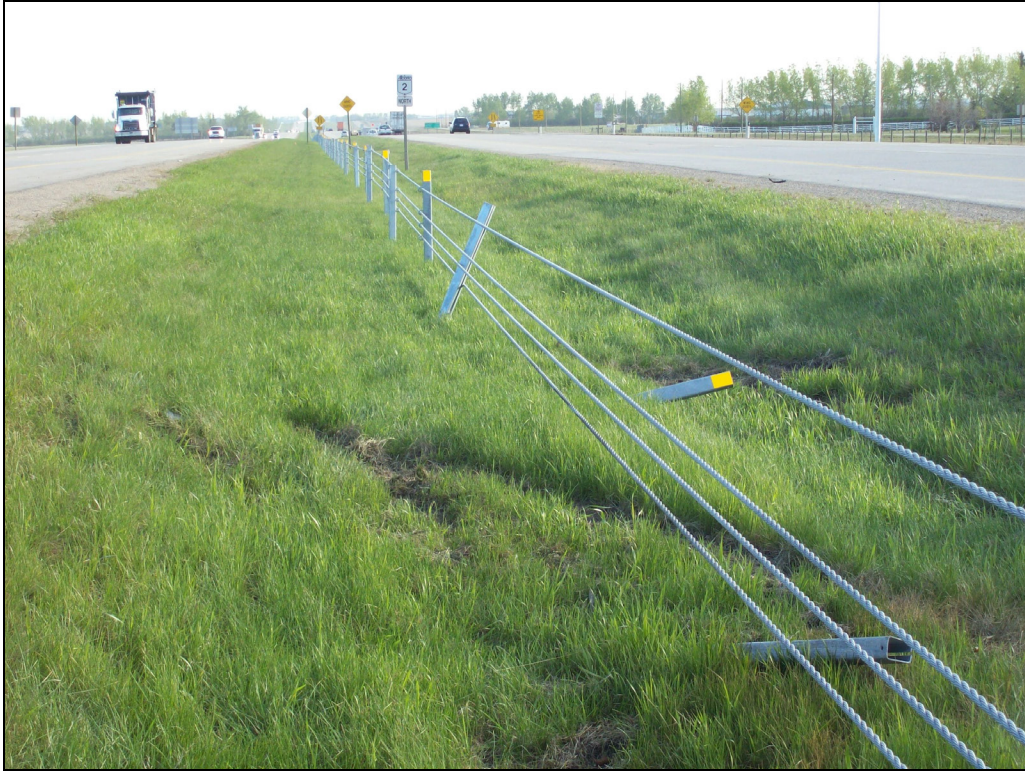
PHOTO 3. Typical HTCB hit in the median of Highway 2 looking upstream (vehicle was traveling toward photo on left side of the median). Note direction of posts.

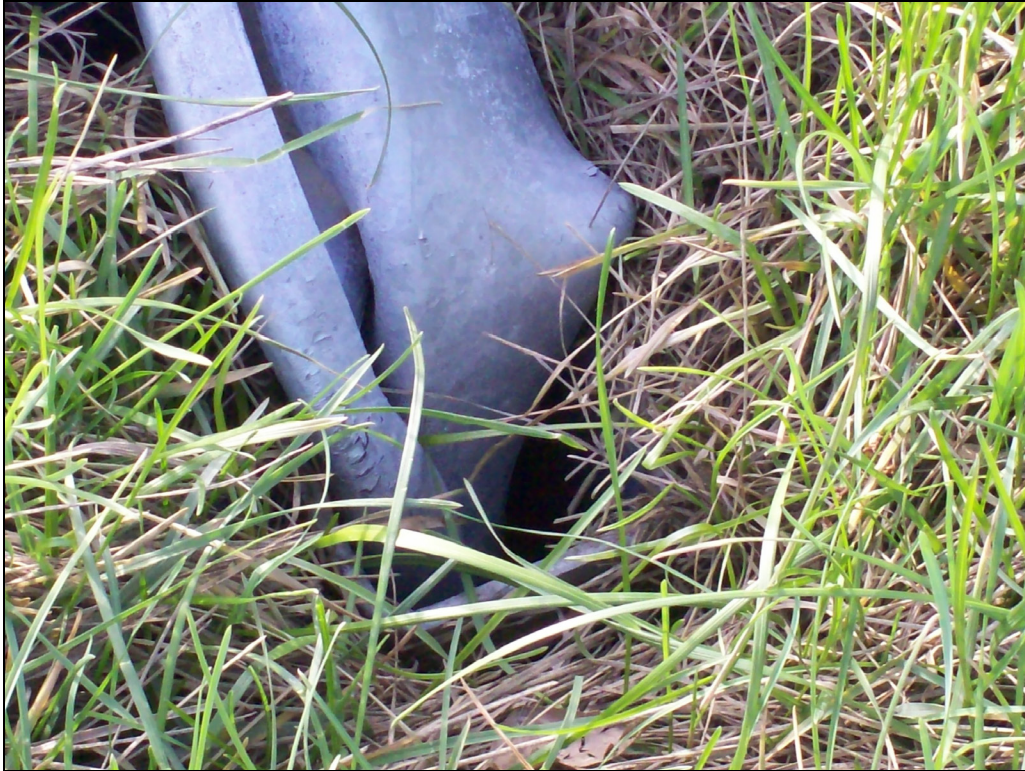
- in most cases post replacement can be completed a lot quicker than conventional W-Beam rail, bent posts are pulled out the socket and a new post inserted (Photo 4);

PHOTO 4. Bent post with un-damaged socket can be extracted and a new post fitted.

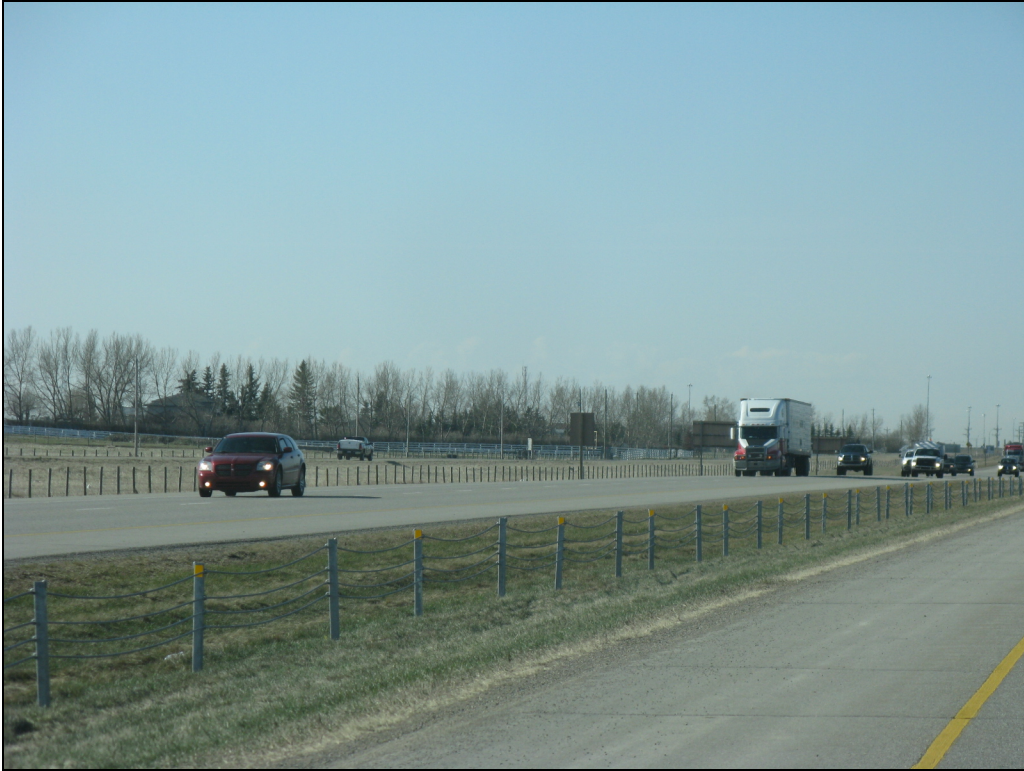
PHOTO 5. Sagging cables due to release of end terminal.

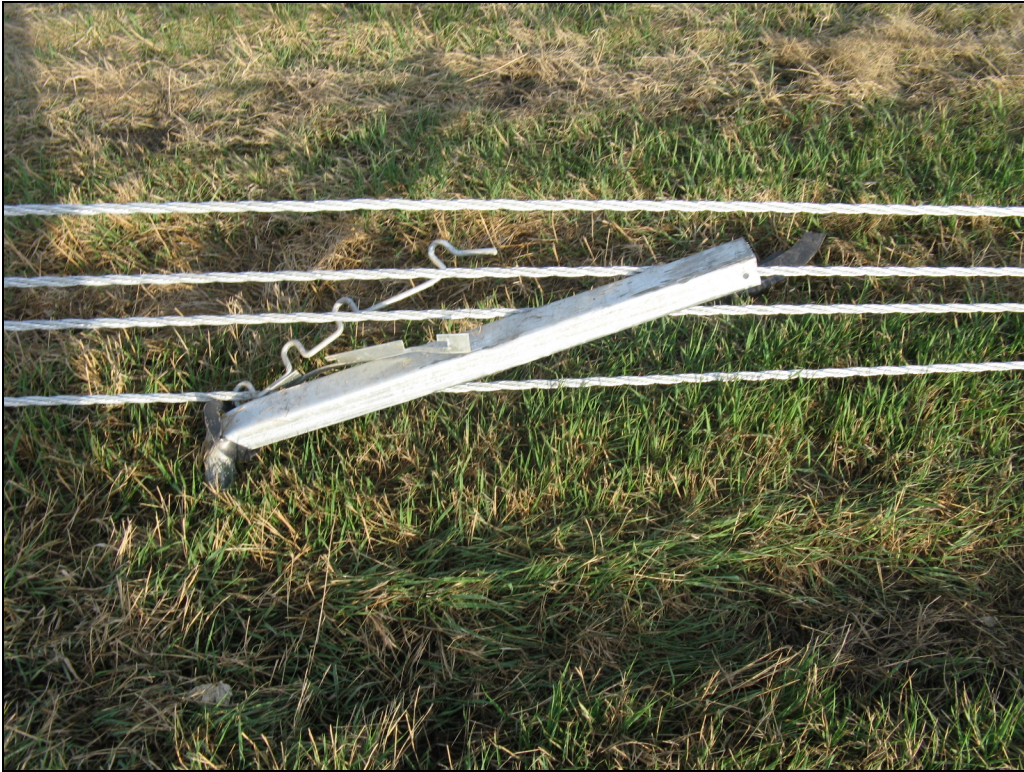
PHOTO 6. Bent line post, hairpin, and lockplate.

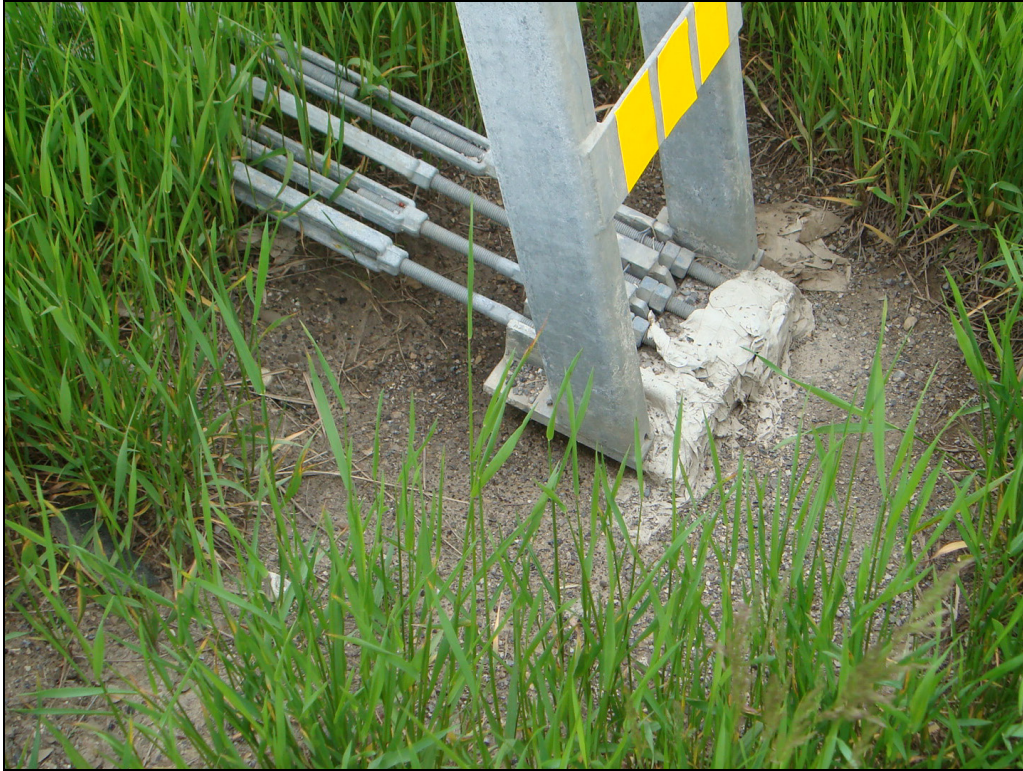
PHOTO 7. Cast in place concrete end terminal anchor with no movement.

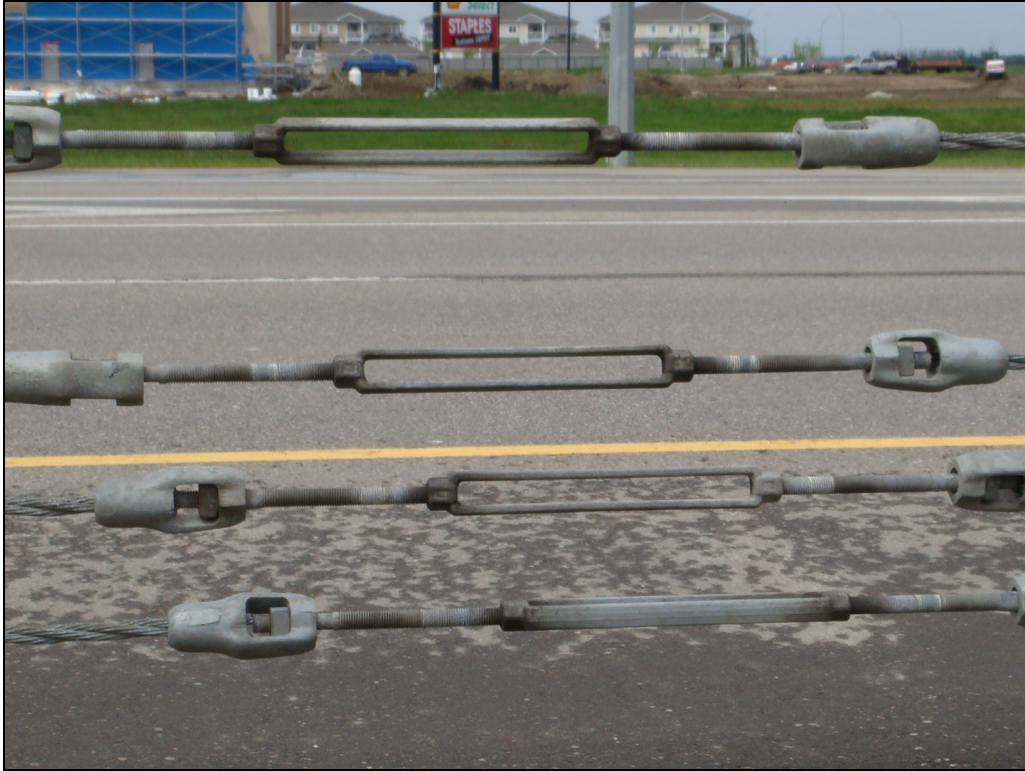
- It was mentioned during the inspection that the threading of any type of turnbuckle should extend a minimum of ¾" to 1" into the turnbuckle to prevent the bolt threads from pulling out during tensioning. (Photo 9)

PHOTO 9. Turnbuckles connecting cables with insufficient thread following tension release.
