## **Investigation and Repair of the Diefenbaker Bridge Fracture**

Paper prepared for presentation  
at the \_\_\_\_\_ Session  
of the 2013 Conference of the  
Transportation Association of Canada  
Winnipeg, Manitoba

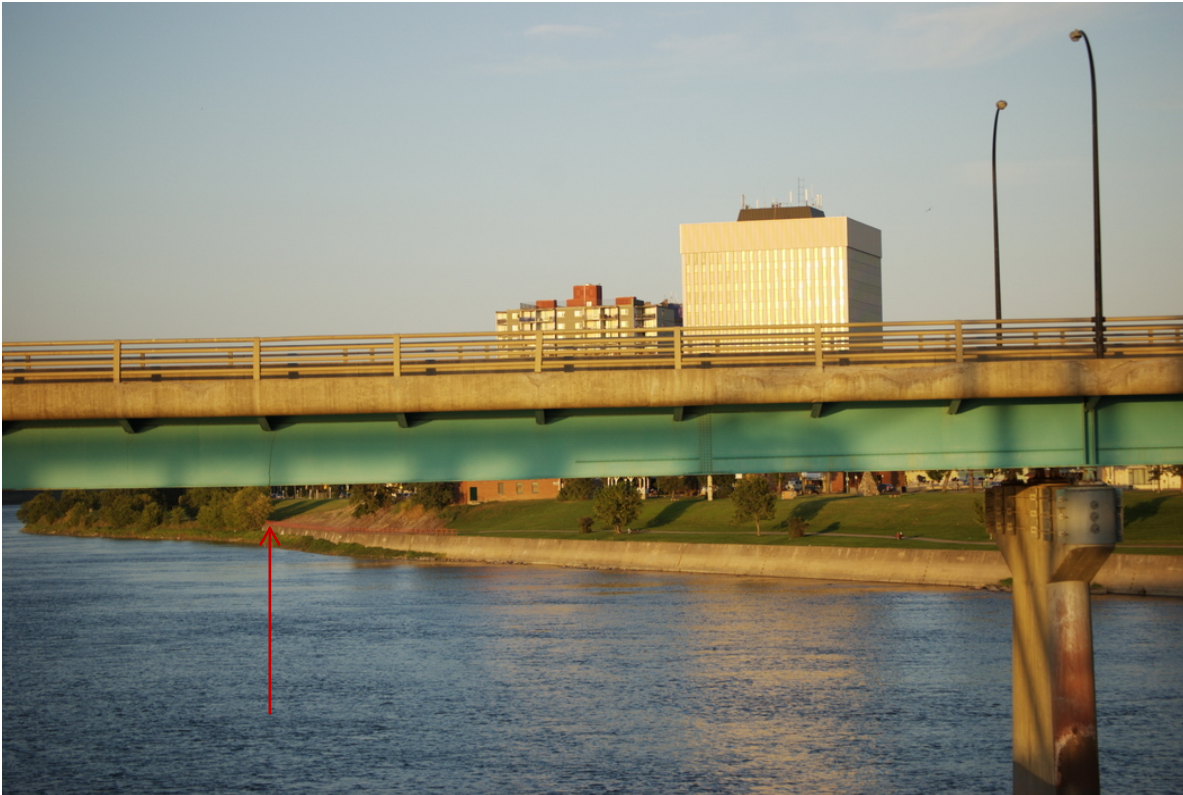
The fracture occurred in the exterior girder of span 4, near mid-span and about mid-length of the structure (Figure 3). The crack extended thru the bottom flange and the web to near the top of the web (approximately 60mm below the top flange).

**Figure 3 Location of Fracture**

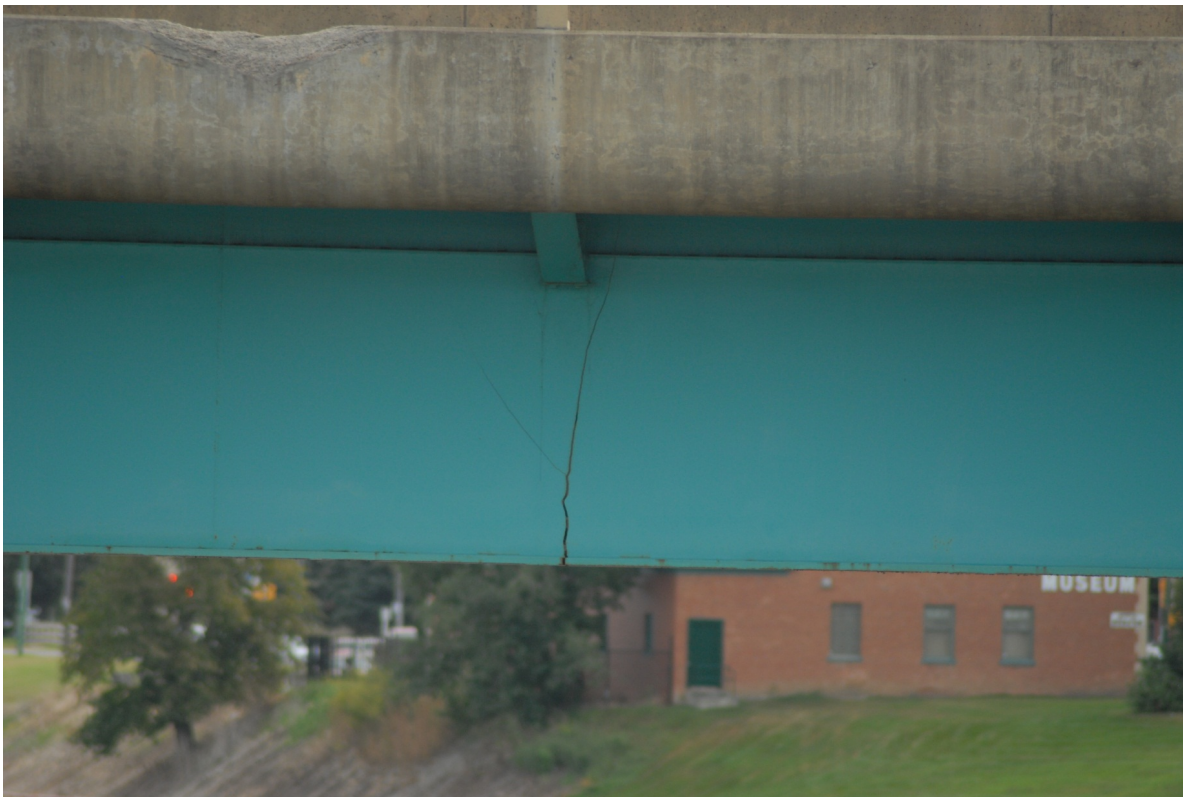
Photographs were taken from an adjacent railway structure and from the police helicopter as it was unknown whether the structure was safe under its own load having lost one of the two girders supporting the structure. Even from some distance, the crack was seen to be large and was observed to have a bifurcation into a second crack extending from the main crack at about a third of the height (Figures 4 and 5).

**Figure 4 Crack showing bi-furcation**

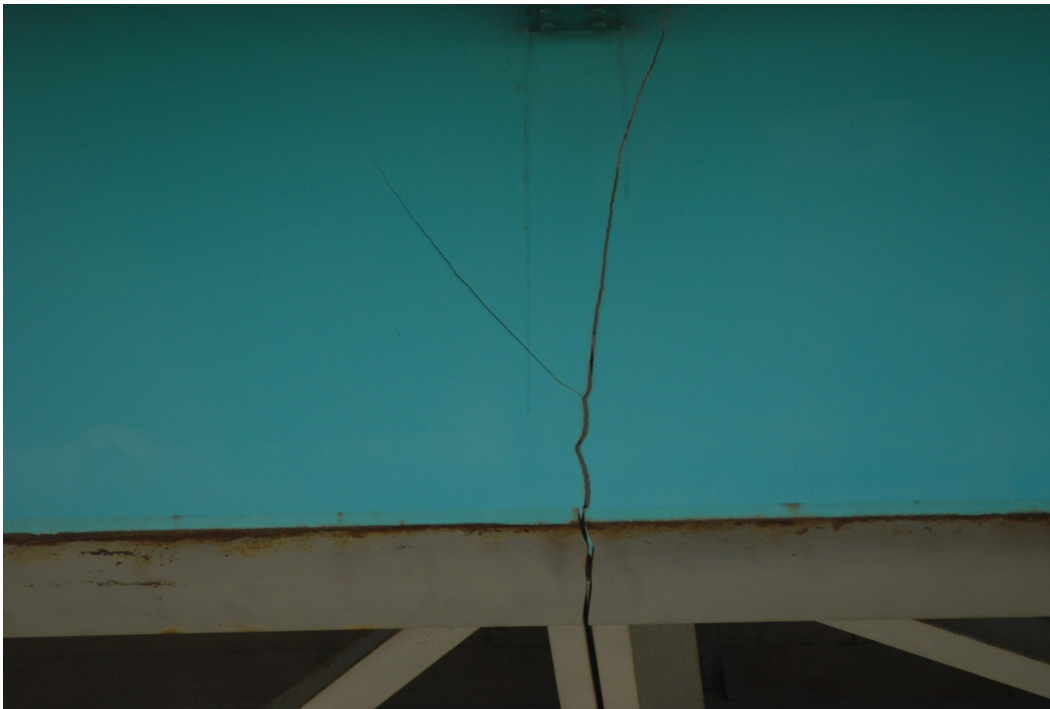
**Figure 5 Closer view of crack bi-furcation**

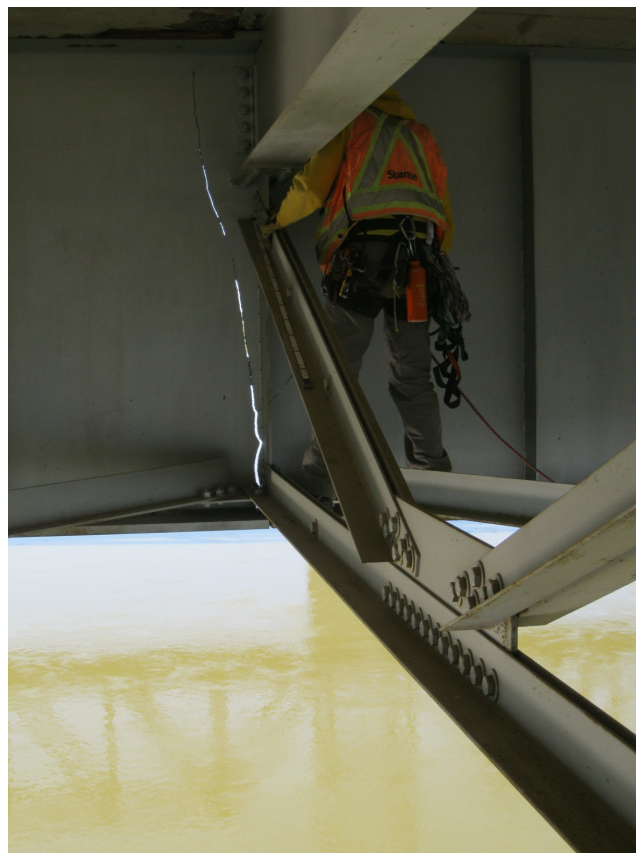
The crack passed vertically through a connection between web, vertical stiffener, horizontal gusset plate, and horizontal cross bracing (Figure 6). The horizontal gusset plate was welded to the girder web on each side of the vertical stiffener and to the vertical stiffener. The horizontal gusset-to-web welds intersected the stiffener-to-web welds.

**Figure 6 Crack location at connection**

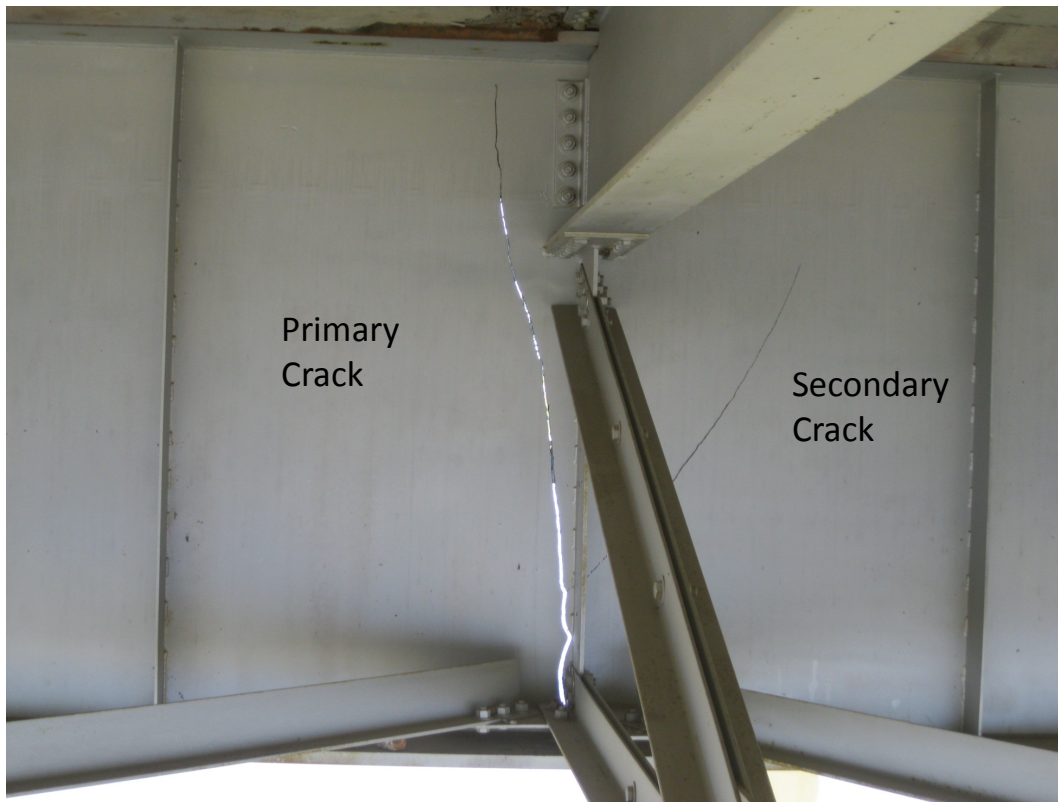
The fracture was mapped and photographed along the fracture surface of two cracks identified as 'primary' and 'secondary' cracks (Figure 7).

Initially it was postulated that the crack formed in the lower area i.e. either at the bottom flange or at the gusset connection and as the fracture progressed it then bi-furcated into a secondary crack due to the large amount of energy release associated with the primary crack propagation.

**Figure 7 Primary and Secondary Cracks**

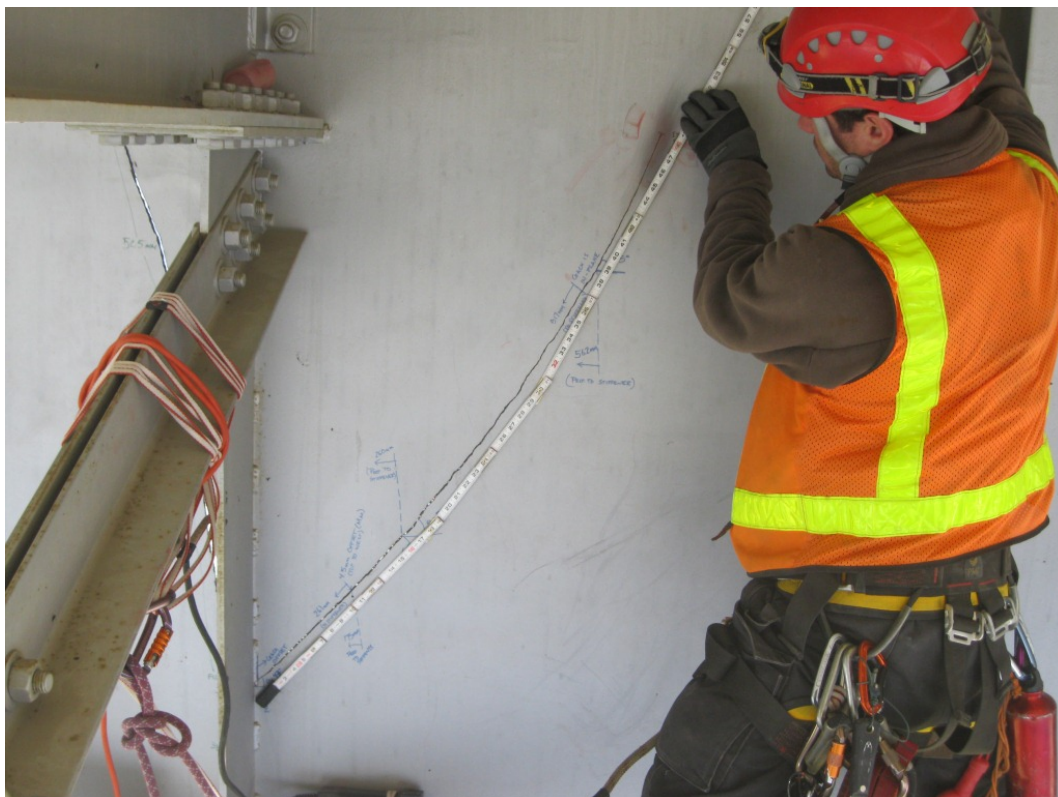
The dimensions of the crack was measured and photographed including width, length, and angle (Figure 8). The terminus of the crack tip was confirmed by magnetic particle examination so that this could be monitored. The fracture surface was photographed in detail (Figure 9).

**Figure 8 Crack dimensions**

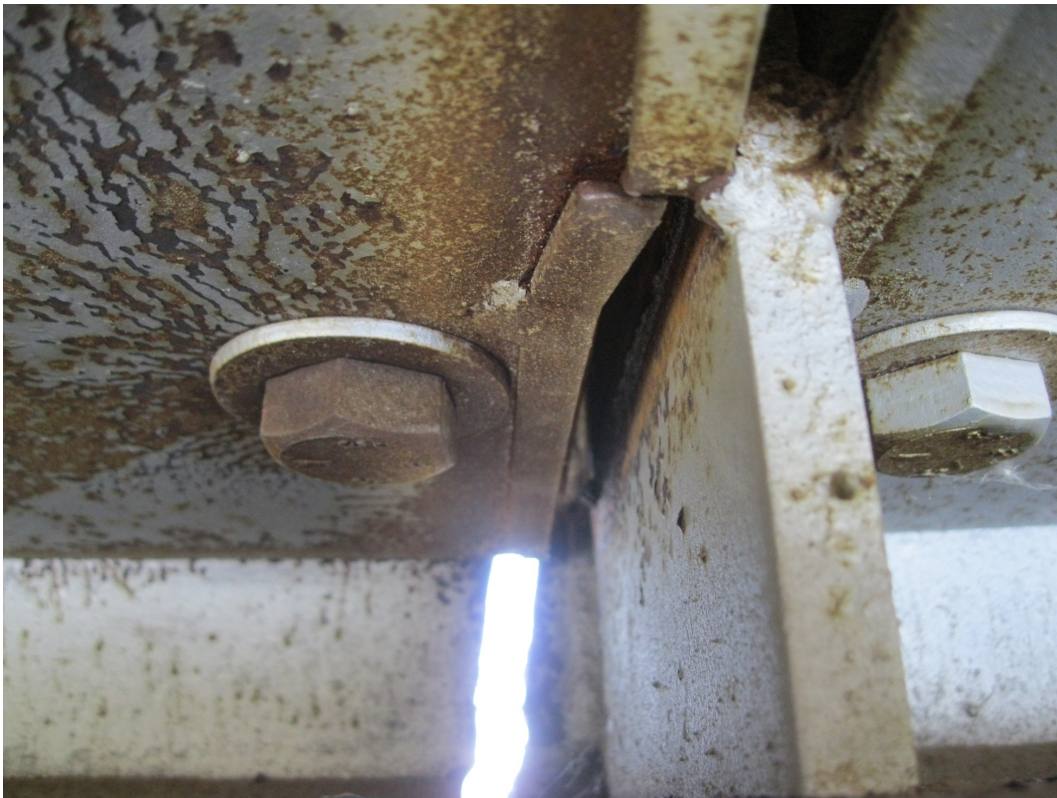
A close up inspection of the crack surface revealed no signs of fatigue cracking as the crack surface was clean, bare steel without patterns consistent with working cracks (Fisher, 1984). The gusset-to-stiffener weld had failed as the energy and stress from the fracture led to the gusset pulling away from the vertical stiffener.

**Figure 9 Crack surface and weld fracture (underside of gusset shown)**

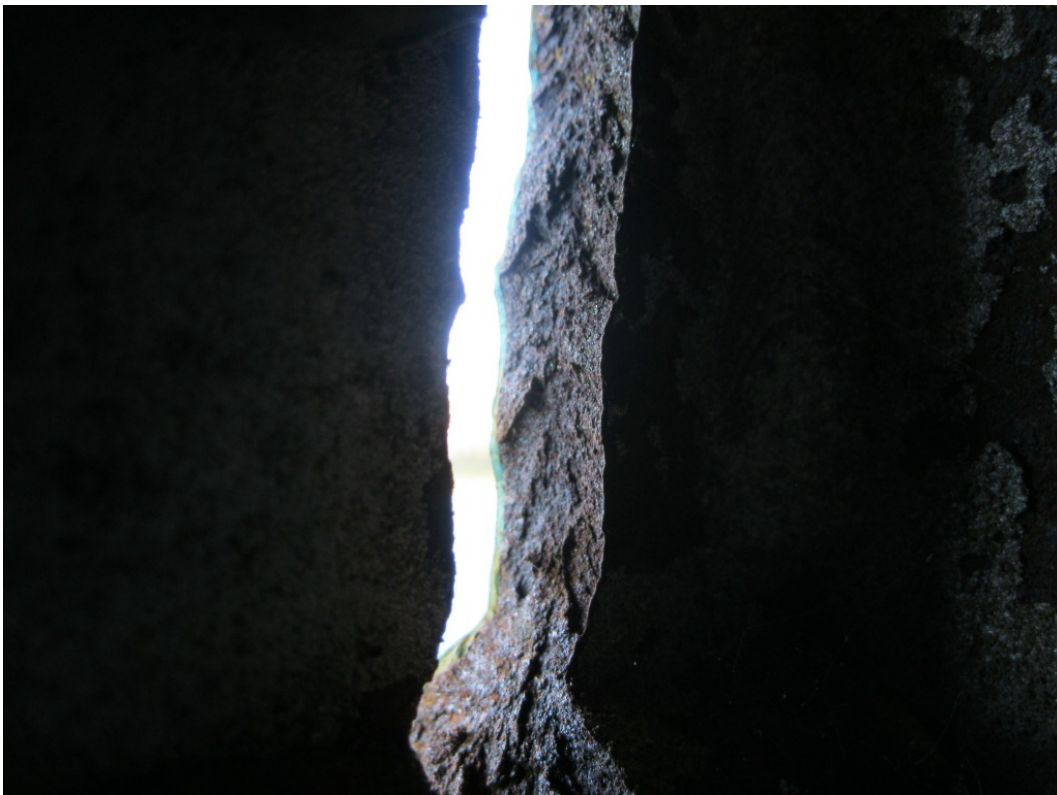
Indications of the failure surface suggested that the fracture had started at the gusset and propagated towards the bottom flange and upwards into the web and had failed in manner consistent with brittle fracture. The rupture surface chevrons in the web were pointing upwards towards the gusset below the gusset (Figure 10) and downward above the gusset.

**Figure 10 Crack surface and weld fracture**

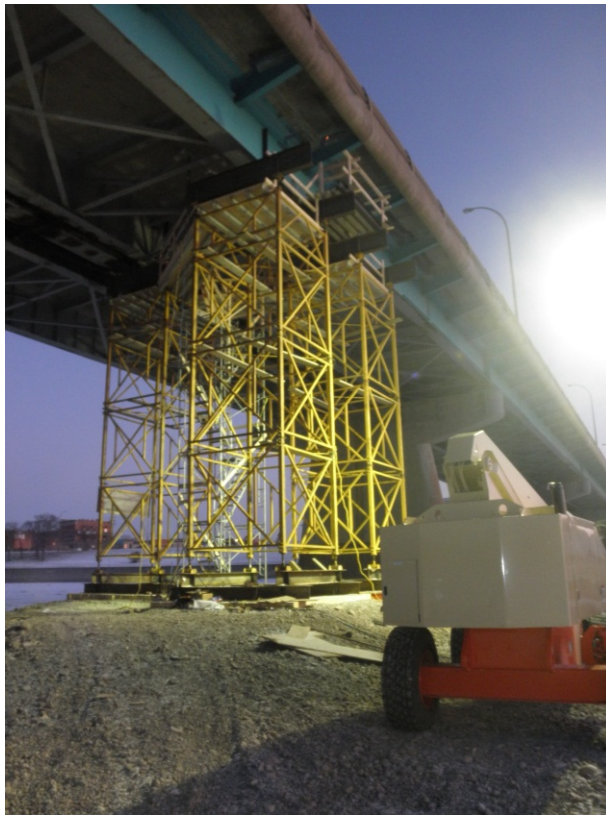
**Figure 11 Steel towers on river berm**

The entire procedure was studied using the FEA model in load steps and determined to be feasible. It was decided that a river berm was the most cost effective way to provide a platform for supporting jacking towers. In early winter 2011, a berm was constructed in the North Saskatchewan River and three large towers were erected under the structure - one tower on each side of the fractured girder and a third tower under the unfractured girder (Figure 11).

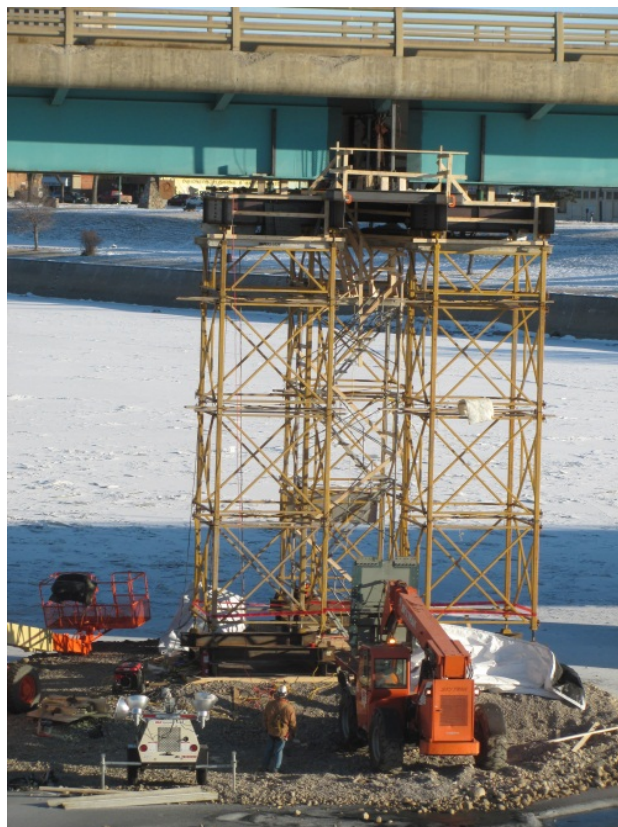
**Figure 12 Girder section cut out**

Before the damaged girder section could be cut and removed from the structure, the interior and exterior floor beam, and all interior horizontal and vertical bracing needed to be supported. Then, a section of the fractured girder was removed and a new section that had been fabricated to as-built dimensions was installed (Figure 12 and 13). Field drilled, bolted connections were used for all connections for several reasons not the least of which was to avoid welding during winter construction.

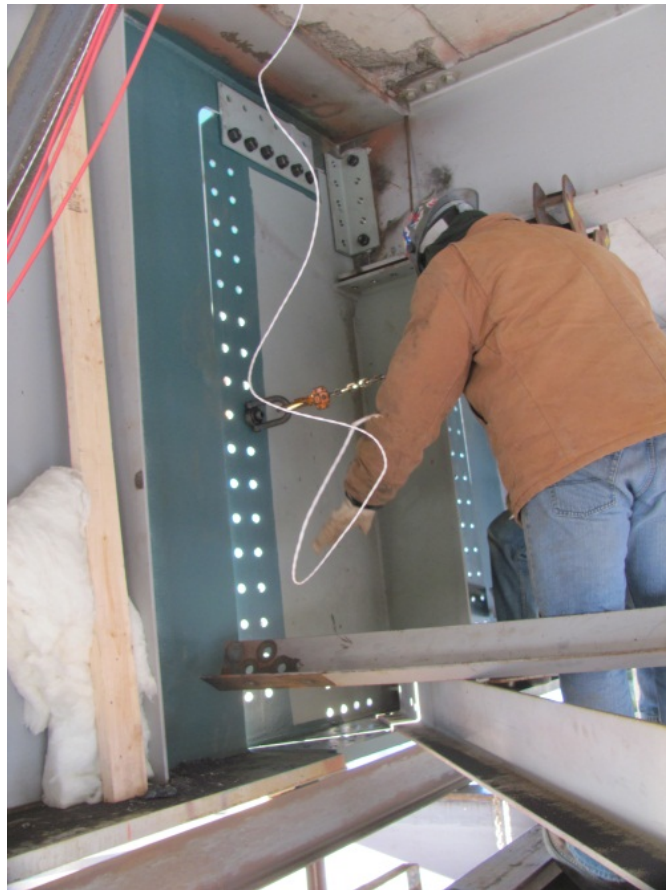
Figure 13 New girder in place

The new girder section was installed and bolted into place with web and flange splice plates, bracing elements were installed and all bolts were torqued. Strains in the girders, jacking forces and displacements were monitored throughout the process and adjustments made as necessary.

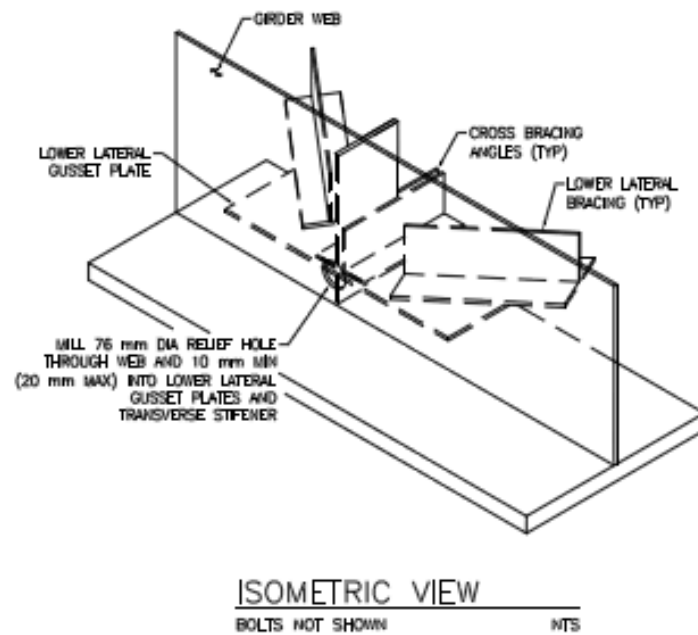
Figure 14 CIF Repair detail

It was determined that the risk associated with the 180 potential CIF locations in the structures was too great, especially in conjunction with high likelihood of incomplete fusion in the gusset to stiffener welds. A repair strategy was developed for the connection locations that had the identical or similar details and at which the girder was in a tension condition at the elevation of the gusset (160 locations). Similar in principle to the repairs in Connor et al, 2007 the repairs proposed consisted of coring (milling) a relieving hole at the location of the intersecting welds (Figure 14). The intent of the repair is to remove the intersecting welds, and points of high stress concentration that lead to CIF. The procedure was to be done with all live load off the bridge and in warm weather.

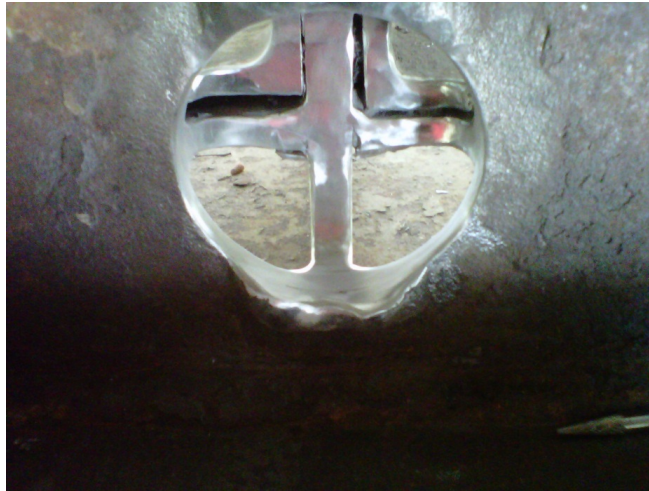
**Figure 15 Completed CIF repair**

The repairs were successfully completed in 2012 and at the same time rehabilitation work was carried out on deck joints and bearing. The milling repairs proved to be very effective way to mitigate the potential for constraint induced fracture (Figure 15).

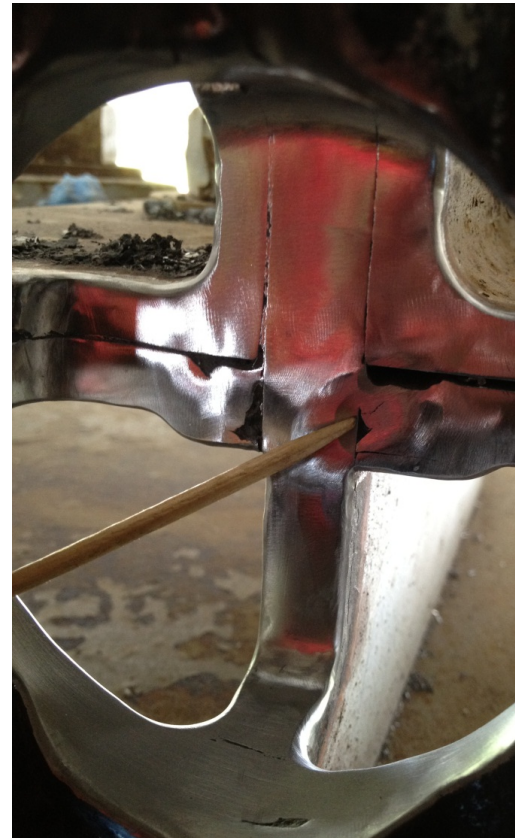
A very significant finding during the repairs was the extent to which the high concern gusset-to-stiffener groove welds had incomplete fusion. Poor weld fusion was observed at a large number of connections suggesting the risk for repeat CIF would have been high had the repairs not been done (Figure 16).

**Figure 16 Completed repair showing exposed incomplete fusion.**
