INVESTIGATION METHODOLOGIES AND DESIGN FOR RUNWAY PAVEMENT REHABILITATION AT CHURCHILL FALLS AIRPORT

Paper Prepared for presentation
at the Innovations in Geotechnique for Transportation Session

of the 2013 Conference of the
Transportation Association of Canada
Winnipeg, Manitoba

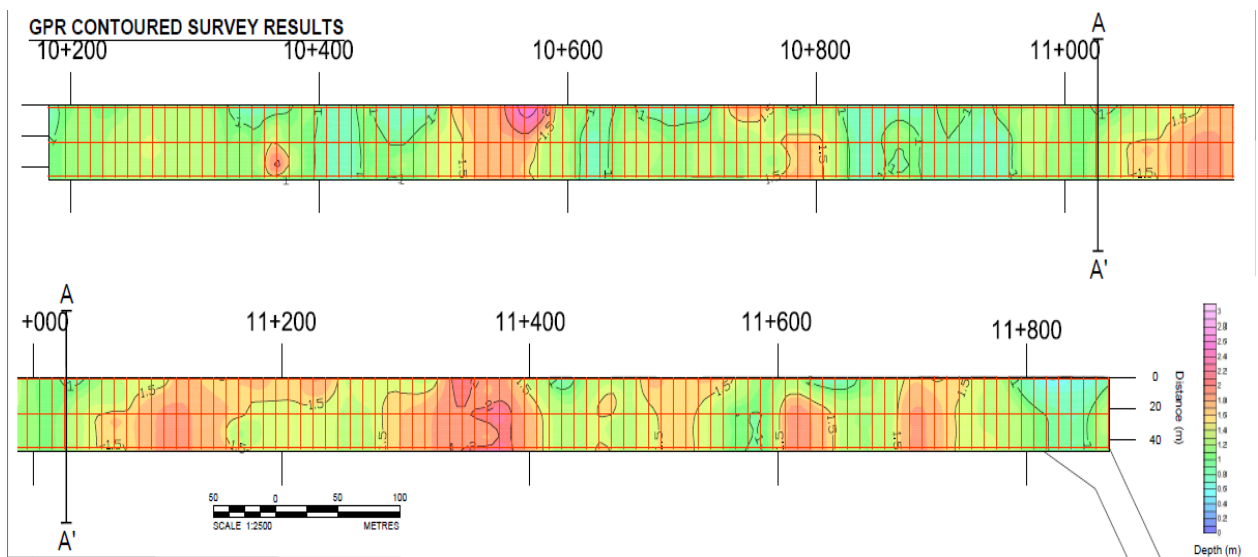
It was determined from previous investigation and our own limited geotechnical investigation that the bedrock at the airport site was undulating and very shallow at some locations. The frost heaving of the runway pavement was due to frost susceptible subgrade soils (glacial till) and shallow undulating bedrock trapping groundwater. In order to develop a suitable rehabilitation strategy to the severity of frost heaving it was necessary to obtain a detailed map of the depth to bedrock. This mapping and continuous profile was obtained by carrying out a GPR survey.

Interpreted results for the GPR grid are shown on a bedrock depth contour map in Figure 2. The results from interpreting the GPR data indicate the presence of significant variations in the overburden thickness within the runway area with the depth to bedrock ranging from 0.5 to 2.85 meters.

Figure 2: Bedrock contour map produced from GPR survey of runway pavement.
