**TITLE: BUILDING BRIDGES-
FASTER, BETTER, SAFER
UNDER EMERGENCY CONDITIONS**
CATEGORY: EMERGENCY RESPONSE
AT RIVER CROSSINGS
HIGHWAY #10 YUKON

PAPER PREPARED FOR PRESENTATION AT THE STRUCTURES-BRIDGES SESSIONS
OF THE 2013 CONFERENCE OF THE TRANSPORTATION
ASSOCIATION OF CANADA, WINNIPEG, MANITOBA

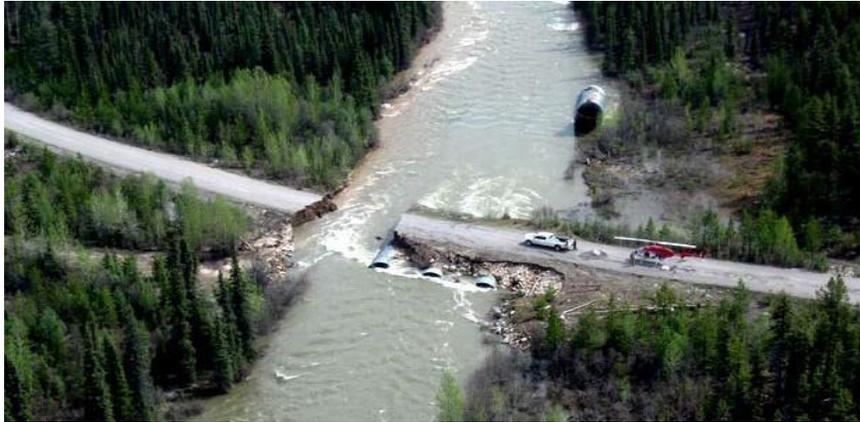
Figure 1: The Nahanni Range Road, which leads to the mine, was washed out in three locations. (Yukon Department of Highways and Public Works)

Heavy rains and snow melt wiped out culverts in three spots on the Nahanni Range Road. Company CEO Steve Leahy said without large supplies of fuel and food, they had to let most of their workers go until the road re-opens.

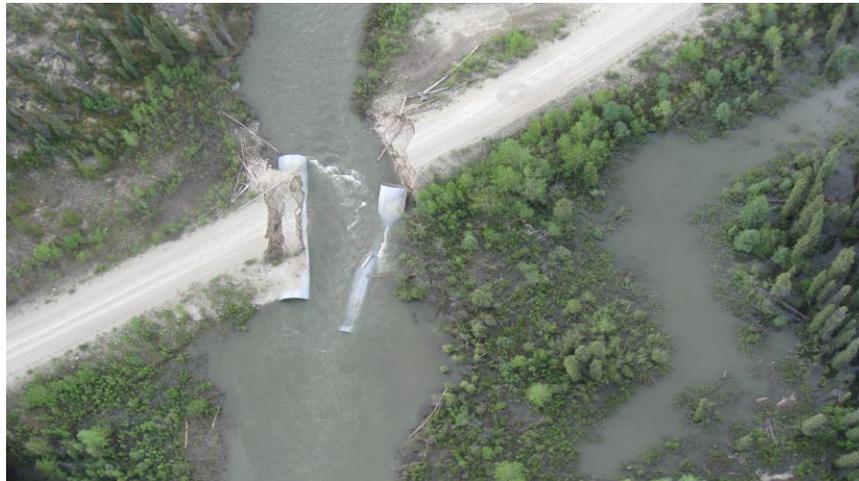
Figure 3: Aerial View of Highway#10 after washout Km74

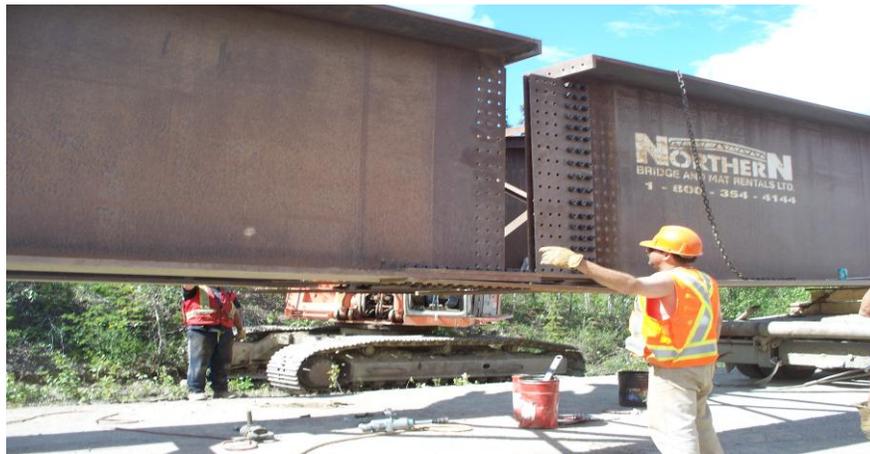
Two sets of girders were spliced together using two hi boy trucks driving back to back. Splice plates were bolted on one set of girders on the first truck. The other set of girders were on the second truck and were backed to fit-in. The challenge was to align the holes to run bolts through the predrilled holes. Once the splices were properly bolted, the truck at the back pulled out slowly for the preparation of launching. It was obvious that the centre of gravity would be outside the truck bed. To counter the load and to prevent the truck from tipping, concrete lock blocks size 750x750x1500mm were placed on top and front end of the loaded truck. Abutments were cut down to accommodate the girder depths at the edge (side) of the existing road, as this was the temporary location. Truck was backed slowly to the temporary location, overhanging the substructure over the river. On the other abutment, two excavators (EX400) were ready to support the cantilever ends of the substructure, once the girders were within their reach.

Figure 4: Two sets of girders to be spliced together on top of two trucks

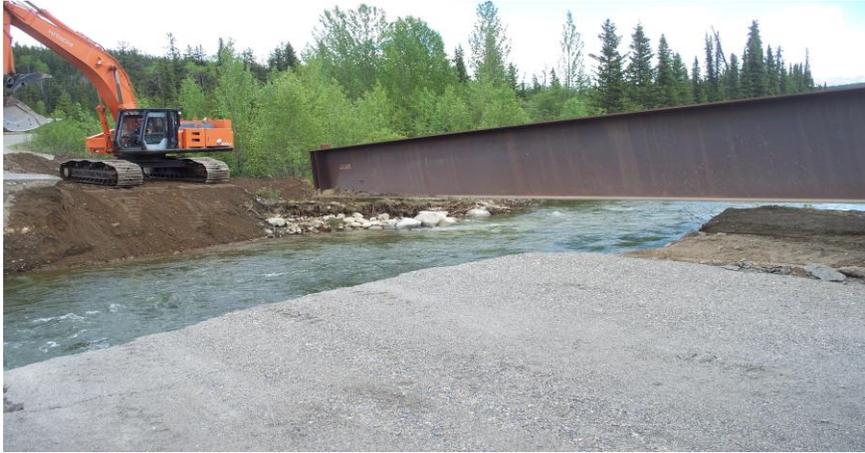
Figure 5: A view of girder launching

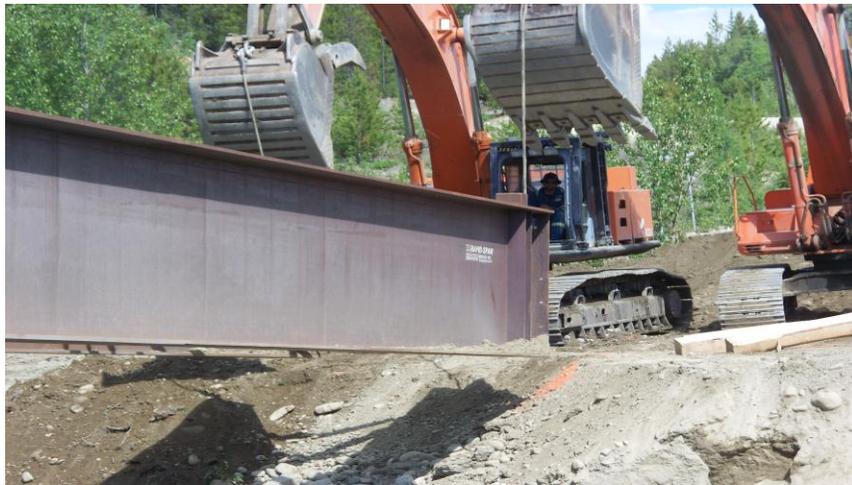
Figure 6: Bridge launching

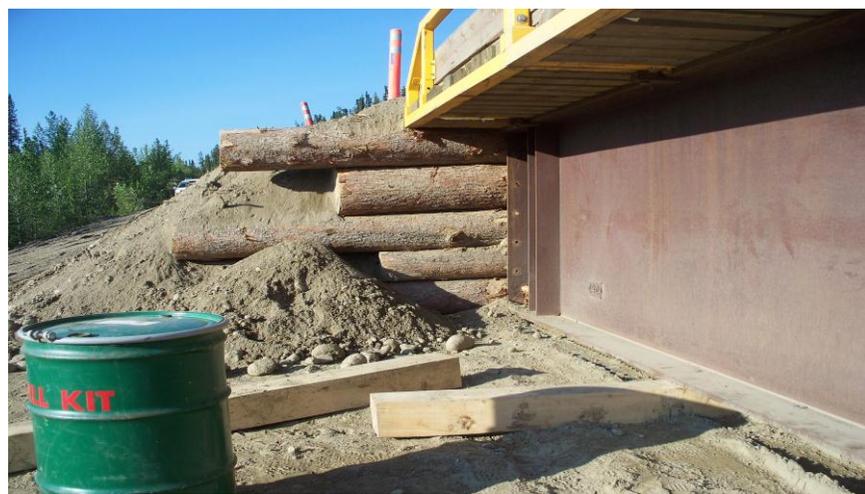
Back walls for the abutments were constructed from raw cut trees available locally and backfilled with previously excavated material. Deck modules were installed and the bridge was ready to open in a controlled manner.

Figure 7: Temporary back wall made of trees

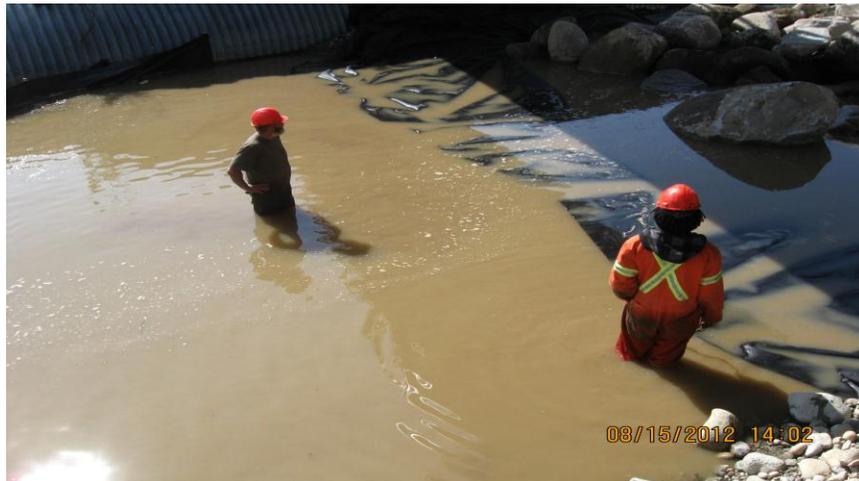
At km 38 (Dolly Varden), major erosion caused construction of north and south abutments very challenging. Abutments were to be built in fast moving water while maintaining environmental control. A temporary earth dam was built across the inlet of the open channel without altering stream bed or banks to guide the flow of water. The earth dam was about 1 meter above the water elevation. We dug a test hole up stream of the multiplates and found that the top 300mm consisted of stone 80mm with sand and small gravels. Below 300mm was hard due to natural cementation. We also dug a test hole near the edge of the proposed abutment location (under the old multiplate location), it was an easy digging to a depth of 800mm. It was hard to dewater this site sufficiently to place and compact material. Geotextile was placed and then rocks were used in the foundation above the water level. The voids were filled with the locally available fine sand with water jetting. Once backfilled above water level, granular material was placed in equal layers and geotextile was used to avoid any potential erosion in the future. Lifts and backfill were placed and compacted with the smooth drum roller to achieve the required compaction

Figure 8: Building foundation in progress

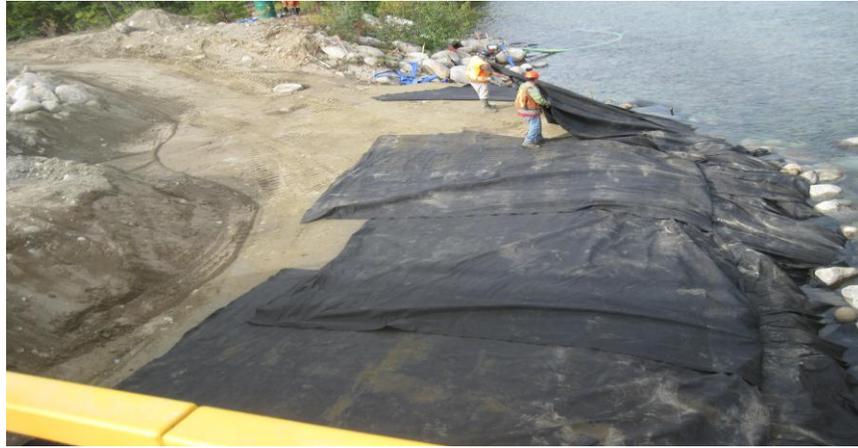
Figure 9: Building foundation and placing of geotextile

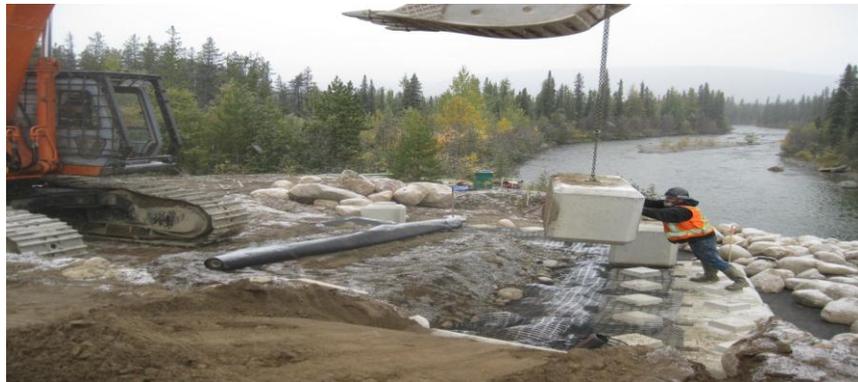
Lock blocks (750x750x1500mm and 750x750x750mm) were installed using Geogrid, Geofabric, Weeping tiles etc. A steel bearing plate was installed on top of the lock blocks to transfer the load.

Figure 10: Lowering and placing of lock blocks

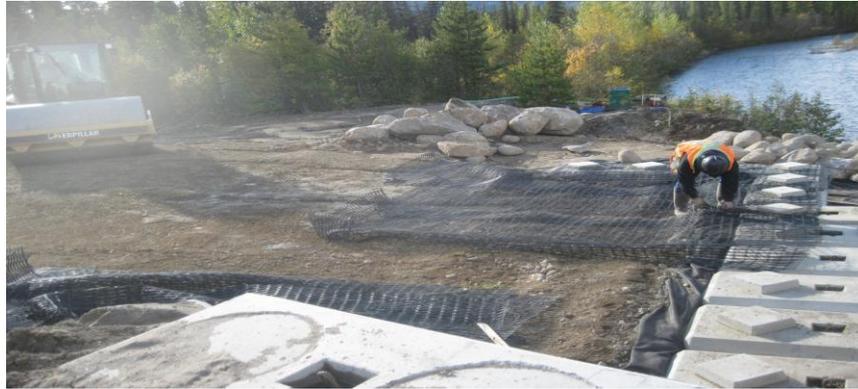
Figure 11: Placing of Geogrid

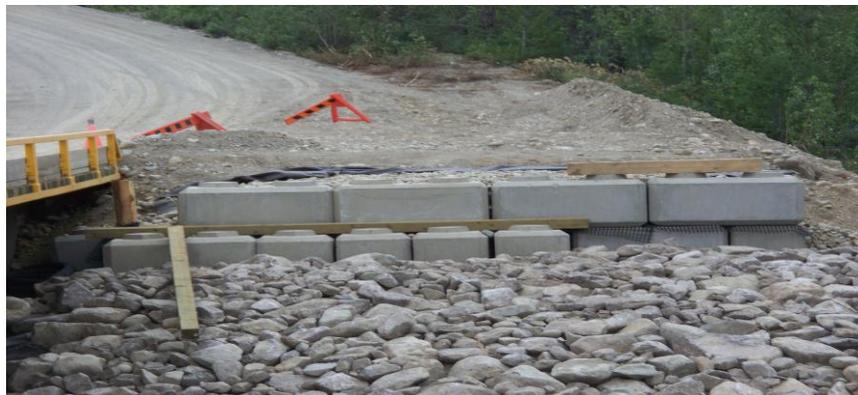
Figure 12: Half of permanent abutment

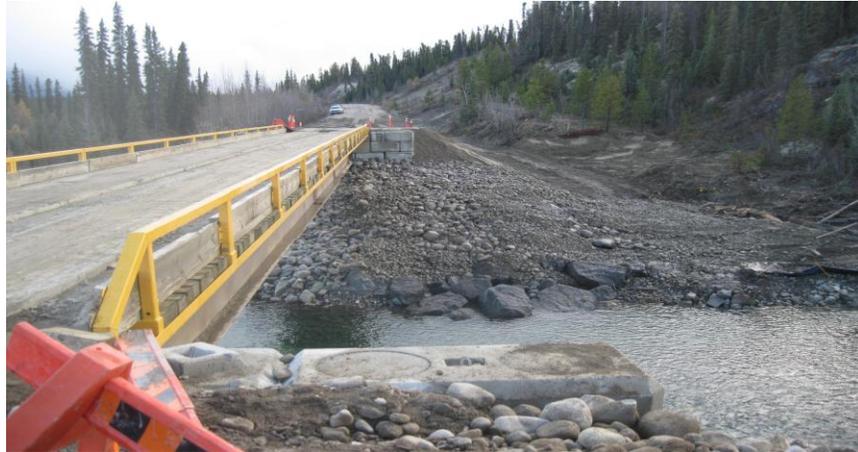
Figure 13: Bridge after placing on lock blocks

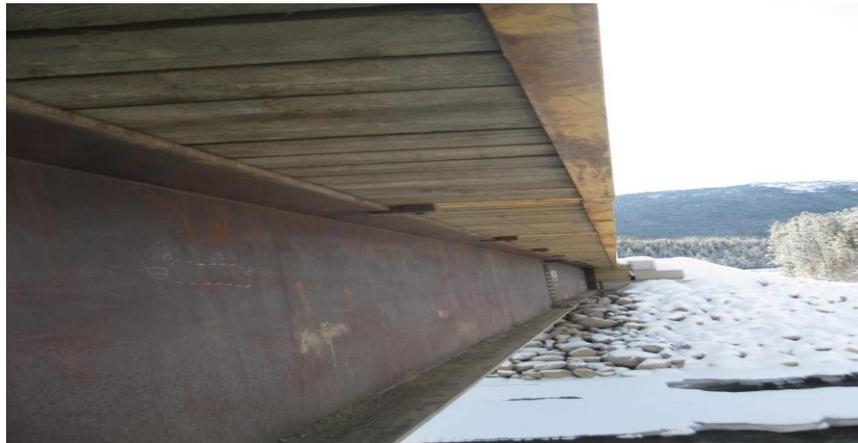
Figure 14: Underside view of girder and deck after permanent placement
