Pavement Evaluation to Detect Potential Voids Under the Surface After the Historic Flood of June 2013 in the City of Calgary

Paper prepared for presentation at the
“Emergency Repair and Reconstruction of Transportation Infrastructure Damaged by Catastrophic
Environmental Events” Session of the
2014 Annual Conference of the
Transportation Association of Canada
Montreal, Quebec

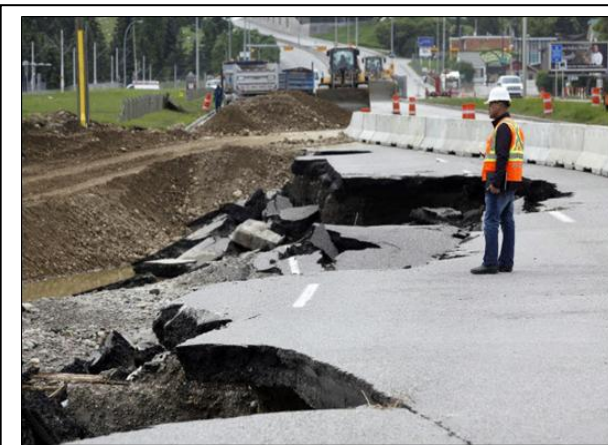
Washed out portion of Macleod Tr. at Victoria Bridge

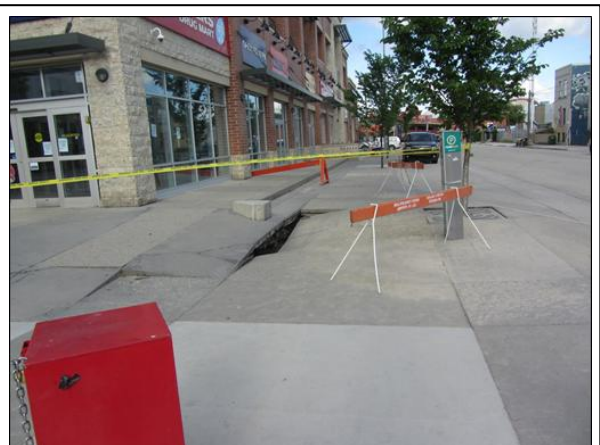
Undermined Sidewalk at 1st St. SE and 15 Ave. intersection

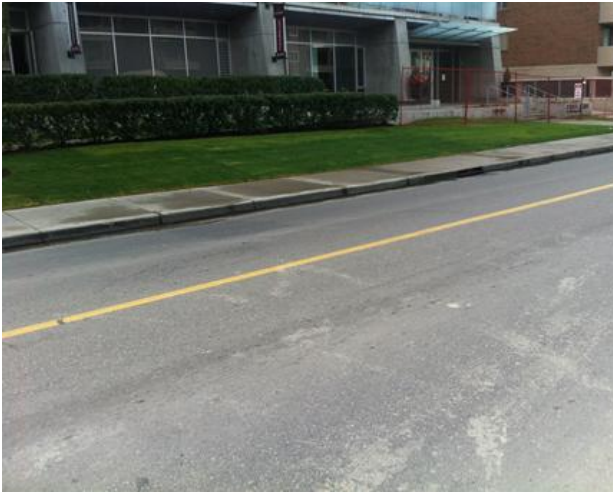
**Cracked sidewalk along 25th Ave. SE, West of 1st St SW
(Post Flooding)**

The photos above clearly indicate the damage caused to the roadway infrastructure by the flooding event.

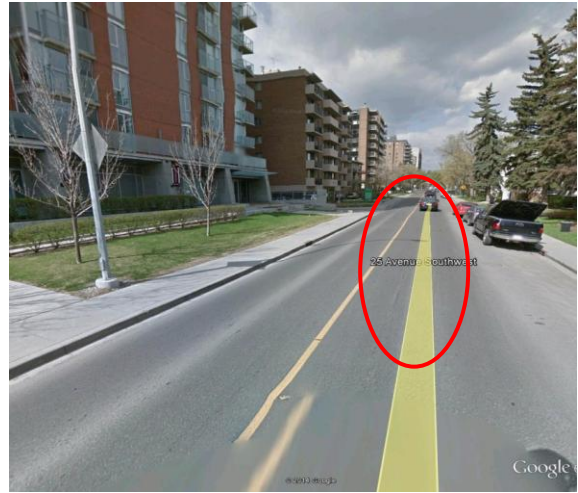
**Pre flooding image acquired from Google Earth Pro
dated May 2012 with no signs of any cracking**

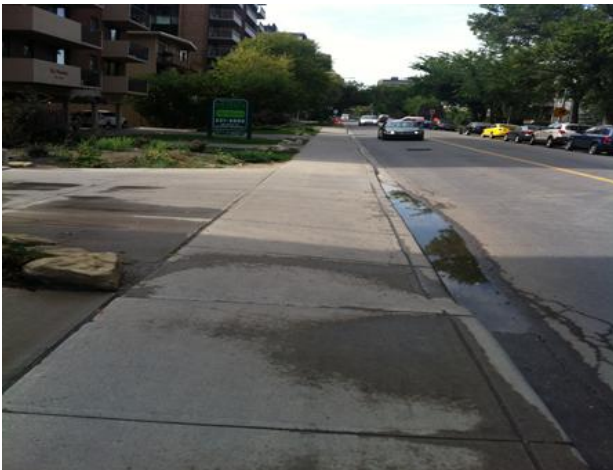
**Distressed pavement along 25th Ave S, East of 1st St SW,
South side of the road.**

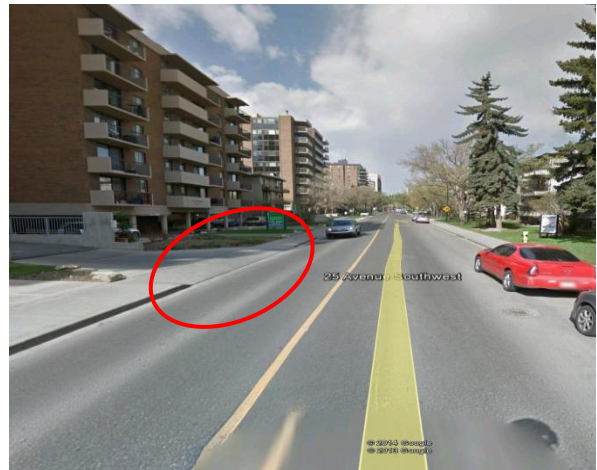
**Imagery acquired from Google Earth Pro. Image
dated May 2012. Distress free pavement surface.**

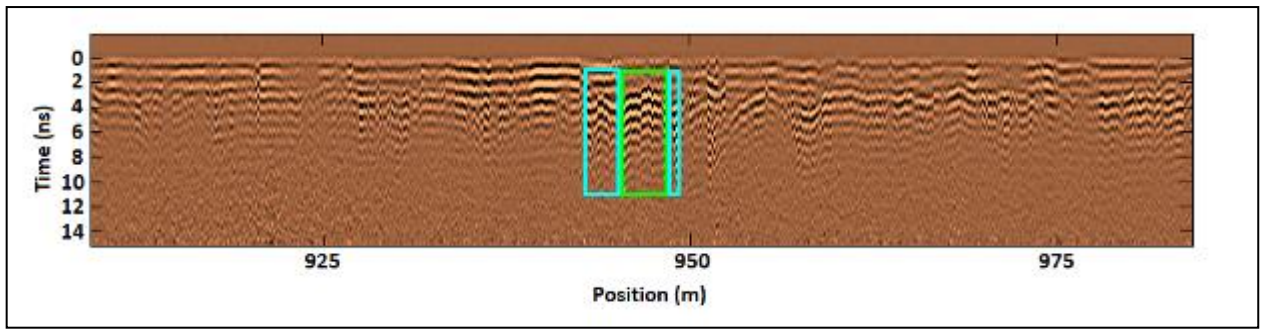
Figure 6: Radar Samples Annotated with Anomalies – Wet and Low Severity

Figure 6 shows, for a localized area of Macleod Trail SE, wet areas identified in light blue, and a low severity anomaly approximately at 945 m in light green. Figure 7 identifies the same section of data in the anomaly plan map. Anomaly Plan Maps for all five roadway segments surveyed were prepared.

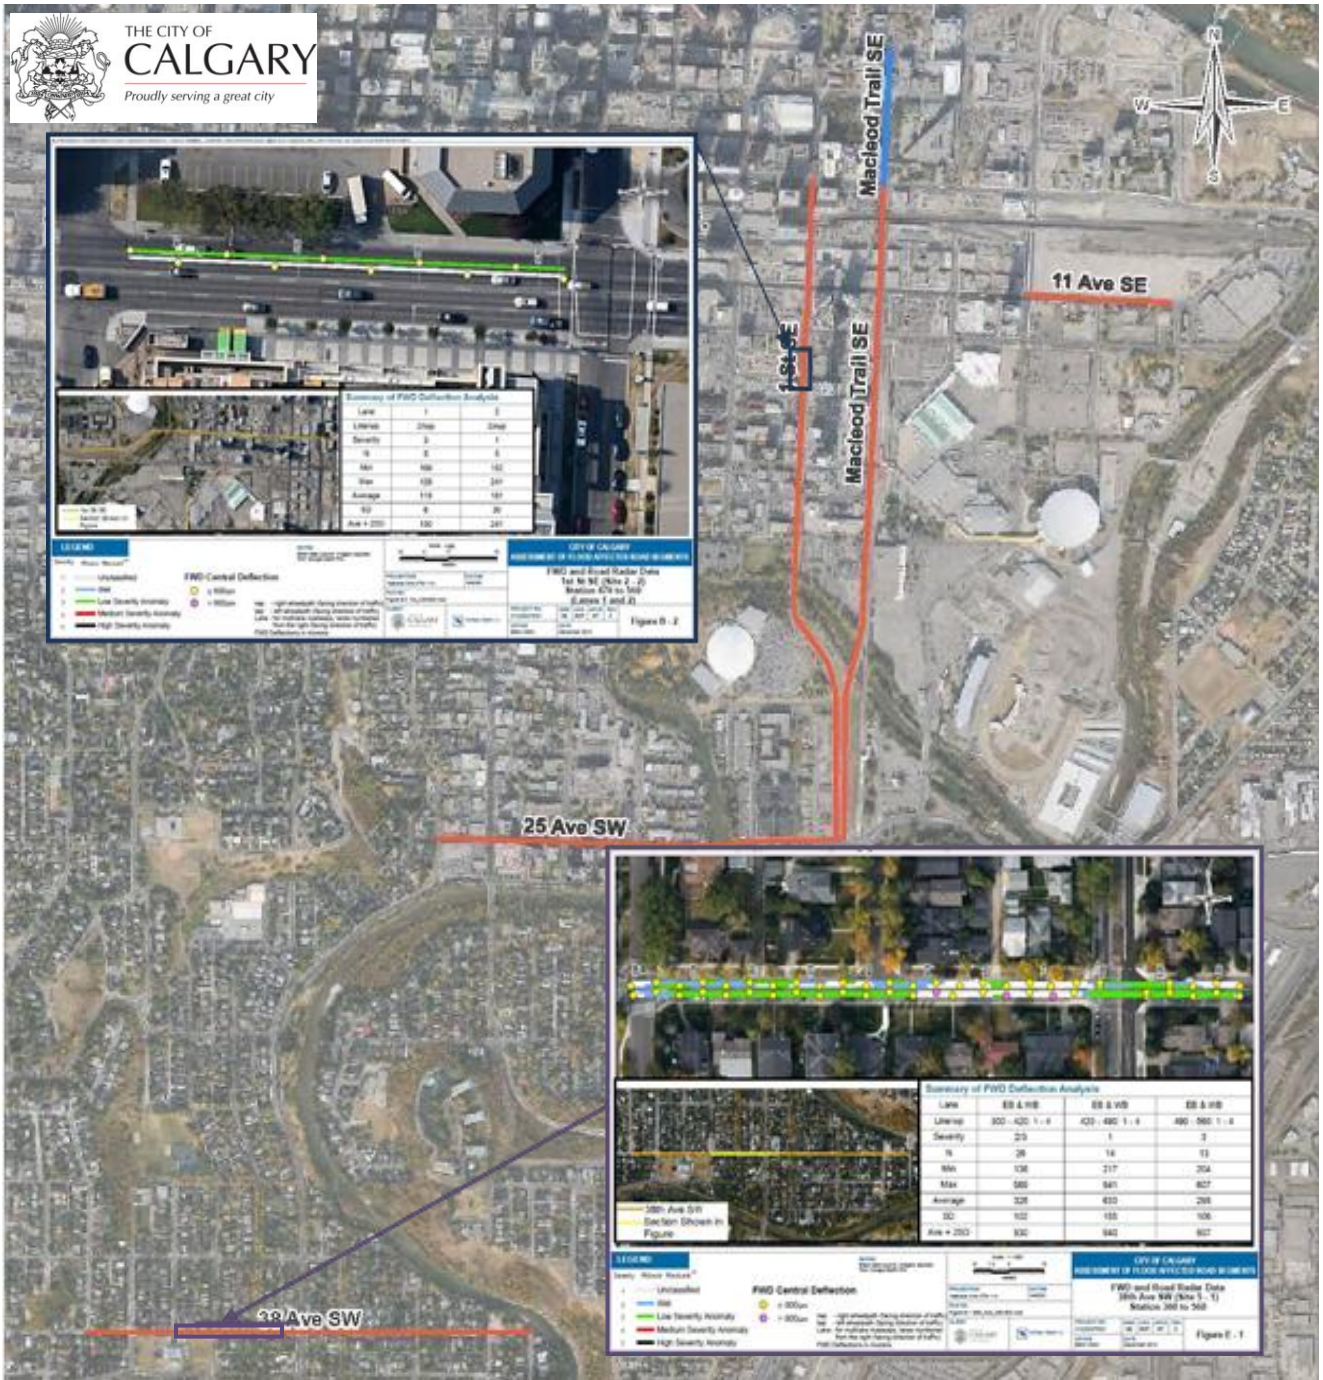
Examples of the analysis for Site 2-2 1st St SE and Site 5-1 38th Ave SE are shown on Figure 7.

- No discernable pattern or correlation of the reported anomalies and FWD
- The reported deflections were considered reasonable
- No conclusive evidence of the presence of shallow sub-surface voids
