Akamina Parkway Reconstruction and Hazard Mitigation

Scott Martin, P.Eng. – Tetra Tech EBA Inc.
Brian Cutts, P.Eng. – Tetra Tech EBA Inc.
Tara Hirsekorn, P.Eng. – Tetra Tech EBA Inc.
Jamie Sterling, P.Geo. – Tetra Tech EBA Inc.
Joel Kliner, P.Eng. – Tetra Tech EBA Inc.
Charles Hunt, P.Eng. – Tetra Tech EBA Inc.

Paper prepared for presentation at the
“Emergency Repair & Reconstruction Transportation of Infrastructure
Damaged by Catastrophic Environmental Events”
Session (519B) of the 2014 Conference of the
Transportation Association of Canada, Montreal, Quebec

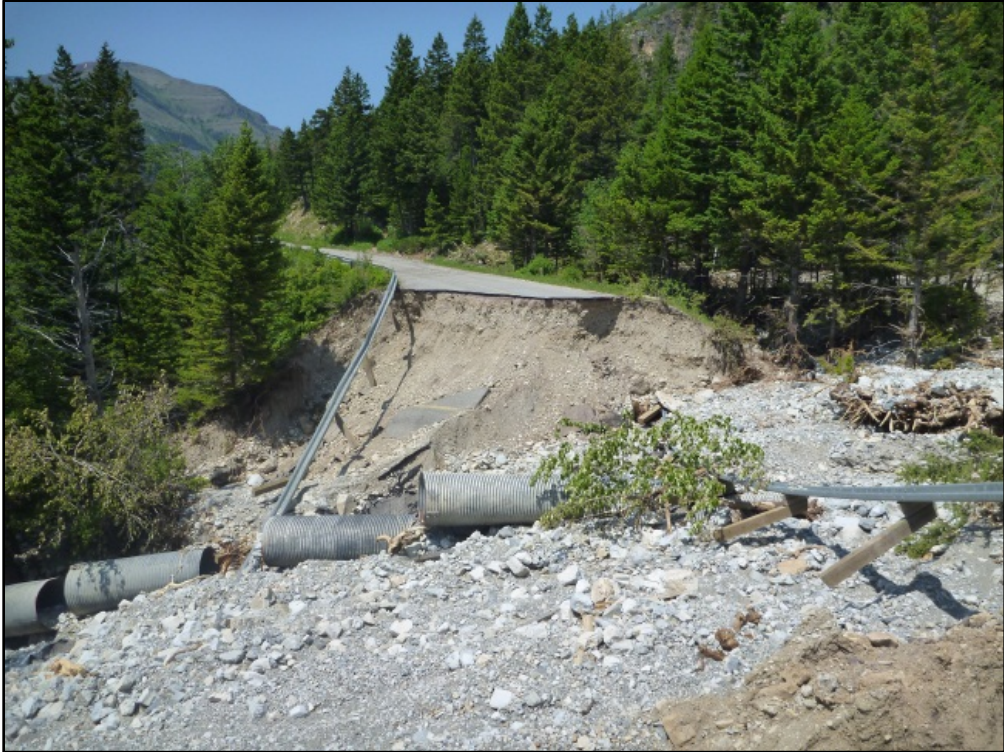
Photo 1: Typical washout of the Akamina Parkway following June 2013 Flood

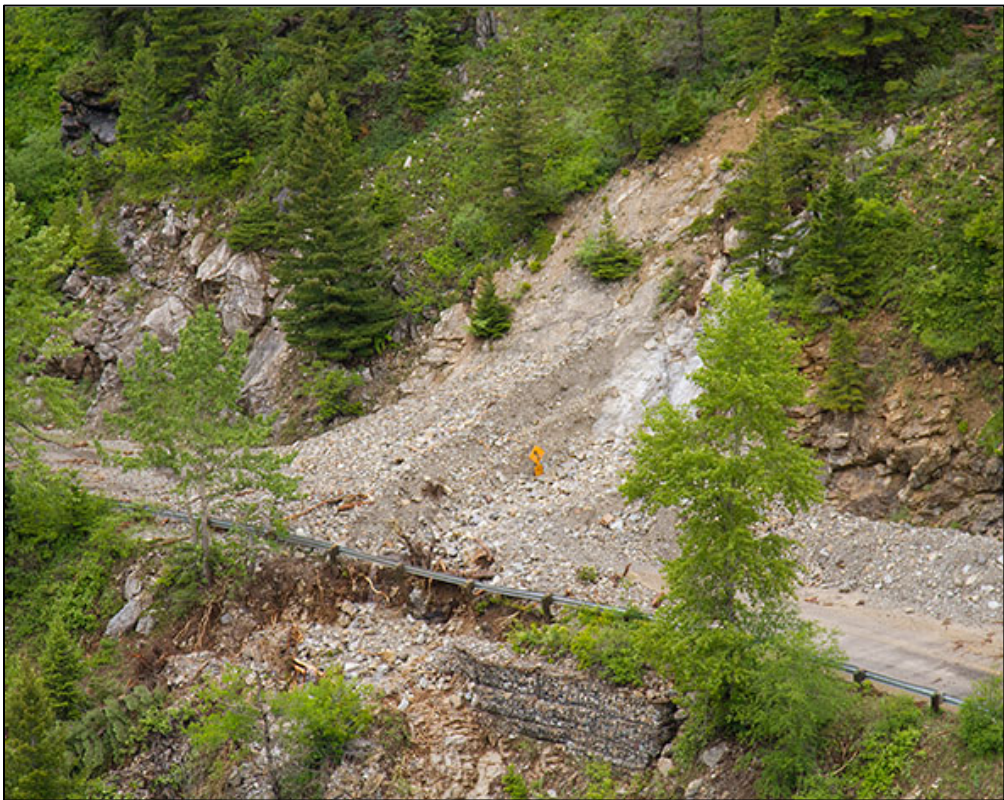
Photo 2: Debris deposited on Akamina Parkway and failure of fill slope retaining wall

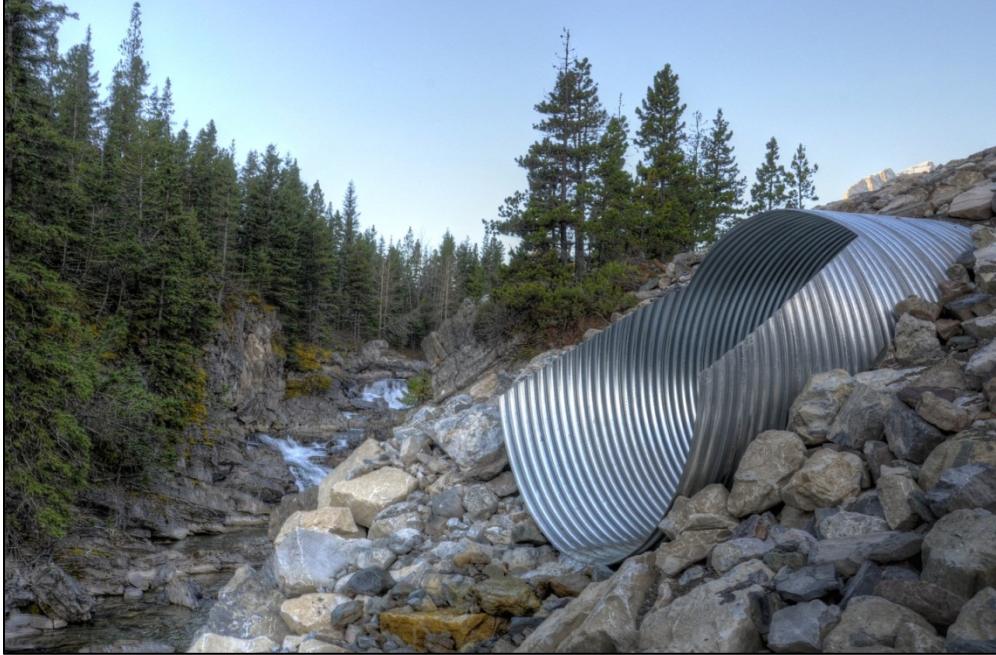
Photo 4: New culvert installation to replace effected location

Culvert slopes were built at 5% at all areas. On account of this relatively steep slope, all culverts were assumed to be inlet controlled. The hydraulic capacities of the culverts installed were determined using the Handbook of Steel & Drainage Highway Construction Products, 2007 and the nomograph Fig 4.10 on page 151. Standard practice is to use a headwater depth equivalent to the elevation of the crown of the pipe (HW/D=1) when determining pipe capacity. Additional capacity would be available if the headwater depth increased above the crown of the culvert. A debris rack was specified by Tetra Tech EBA to be built at the inlet of the culverts and scour protection was specified to be built at the outlet in the splash zone.

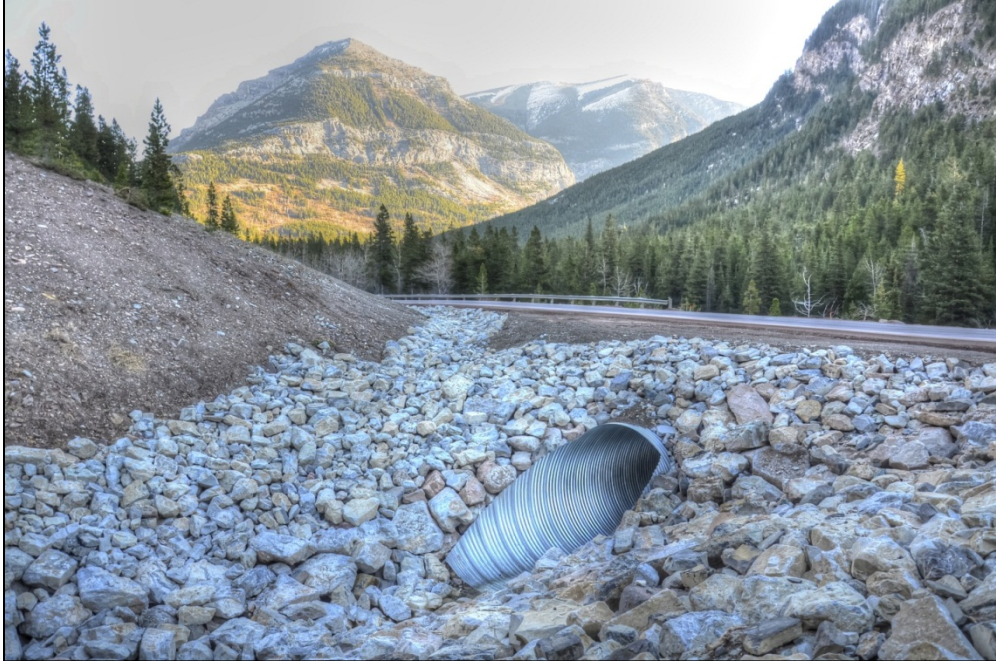
Photo 5: Inlet end of new culvert installation and associated debris storage basin

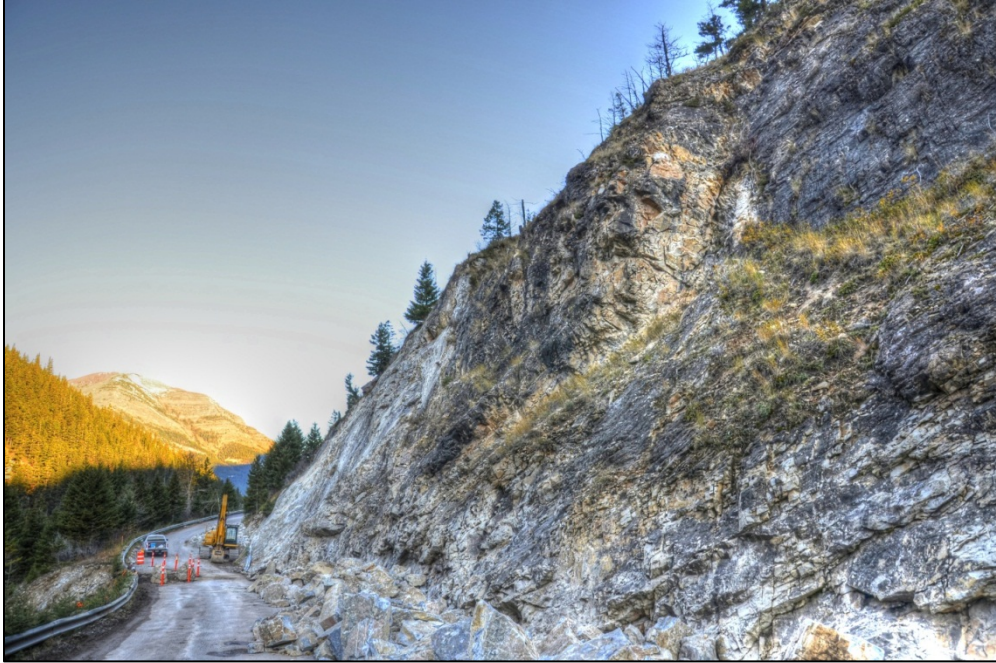
Photo 6: Rock scaling along the Akamina Parkway

Parks Canada routinely maintains all rock slopes above Highways and secondary roads. The actions of weathering, freeze thaw and kinematic instability mean that routine rock slope remediation is required. The rock slopes adjacent to the Akamina Parkway were last worked upon in 2010. The slopes were therefore in reasonable condition prior to the severe weather events of 2013. However, during the course of the work on the Akamina Parkway rock slope remediation was undertaken. It was recognized that machine scaling of the slopes could both mitigate the rock fall hazard as well as provide a source of coarse rock fill and rip rap to be used in the construction. A rock engineer from Tetra Tech EBA therefore directed the contractor as to which slopes required machine scaling so as to mitigate this risk. Excavation of the catchments at the base of the rock slopes was also undertaken. These excavations both improved the effectiveness of the catchments, and again provided a source of material for general fill in construction. Although the rock slope work along the Akamina Parkway was not extensive it did reduce the rock fall hazard, enabled locally sourced materials to be used (thereby reducing haulage costs) and will reduce the cost of the next rock slope maintenance program that is planned for Akamina in the near future.

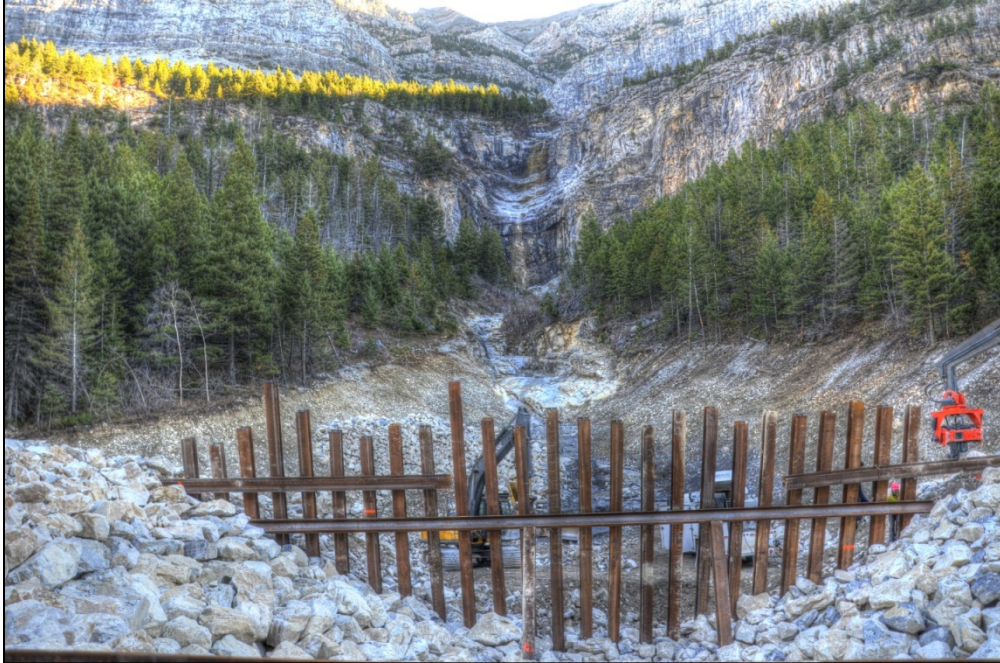
Photo 7: Newly excavated debris basin and trash rack at debris flow prone catchment

Debris racks were incorporated in the berms to allow small and medium sized sediment and debris to pass through. The intent of the debris racks were to capture the sediment and debris from large events, allowing the creek to convey clear water events through the opening in the berms. All large boulders and large woody debris would be trapped at the rack and contained within the debris basin while still allowing water to pass through the rack and into the culverts. The debris basins were designed to allow machine access (e.g., excavators and trucks) into the basins for dredging sediment and cleaning debris from the racks.

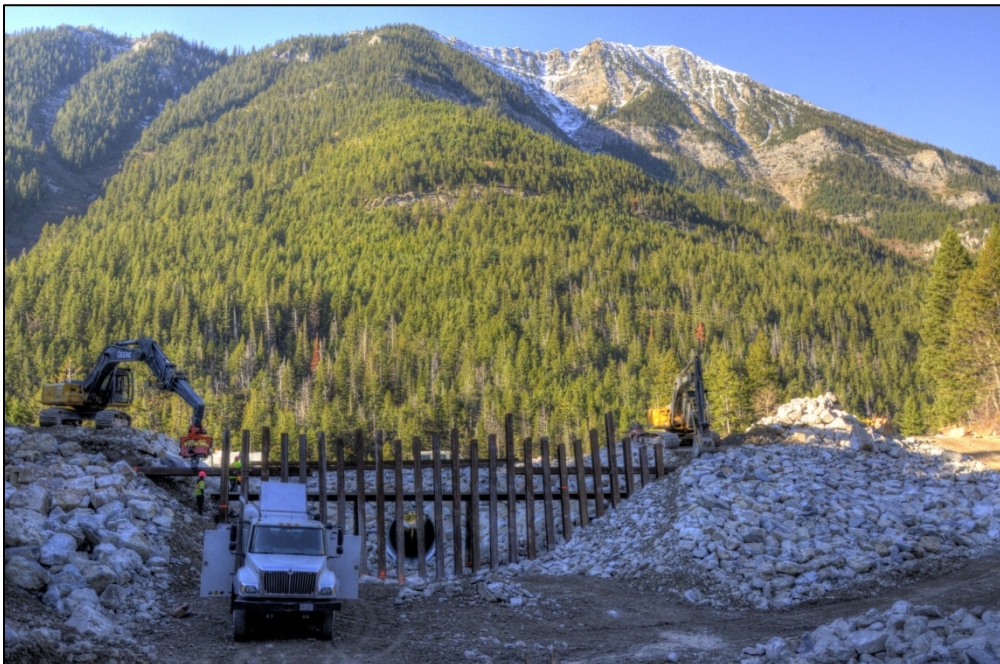
Photo 8: Installation of new trash rack and debris basin/berm

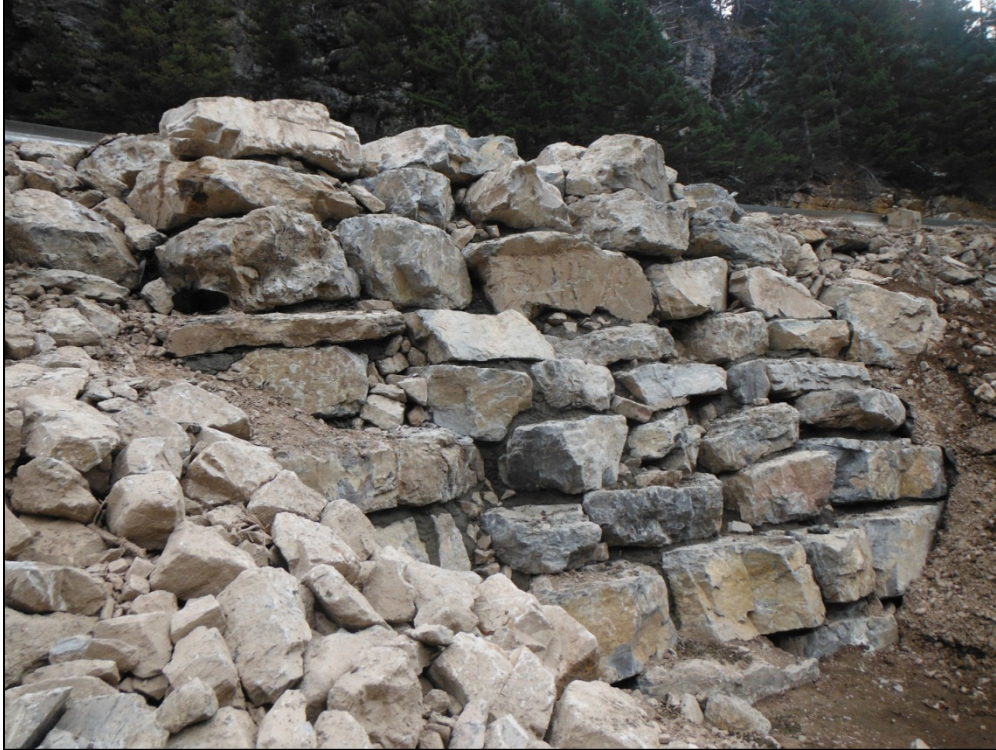
Photo 9: Newly constructed stacked boulder wall to support failed Akamina Parkway fill slope

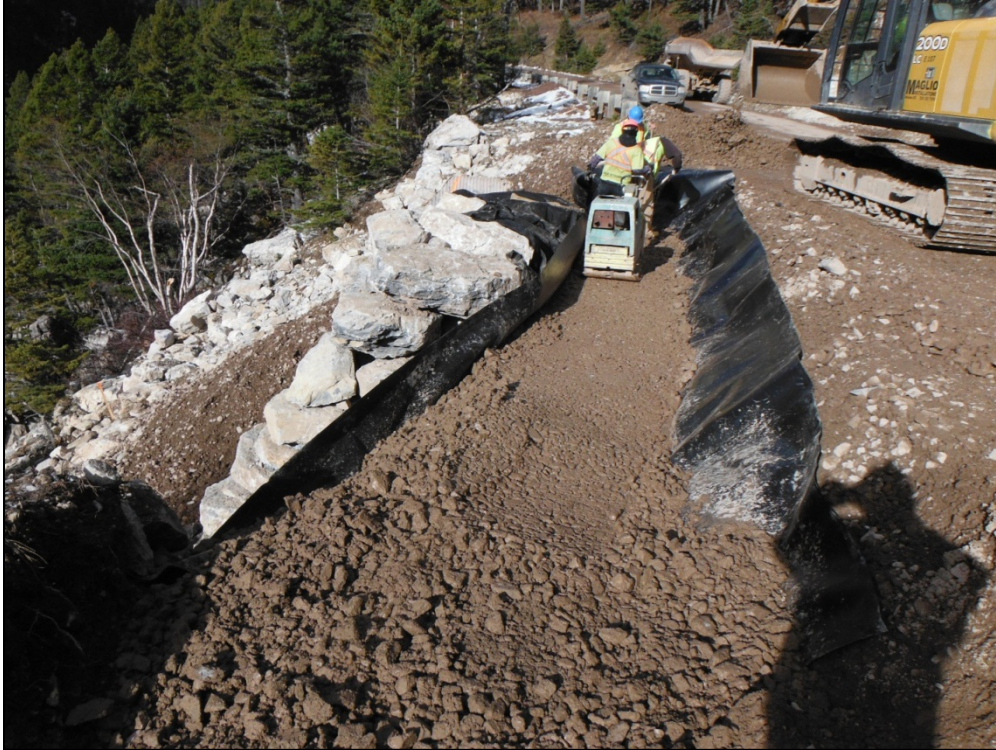
Photo 10: Construction of new fill slope retaining wall
