Bow River Bridge near Gleichen, AB, after the flood

Laurie McCarron, P.Eng., Bridge Engineer, Stantec Consulting Ltd.

Paper prepared for presentation

Transportation Association of Canada

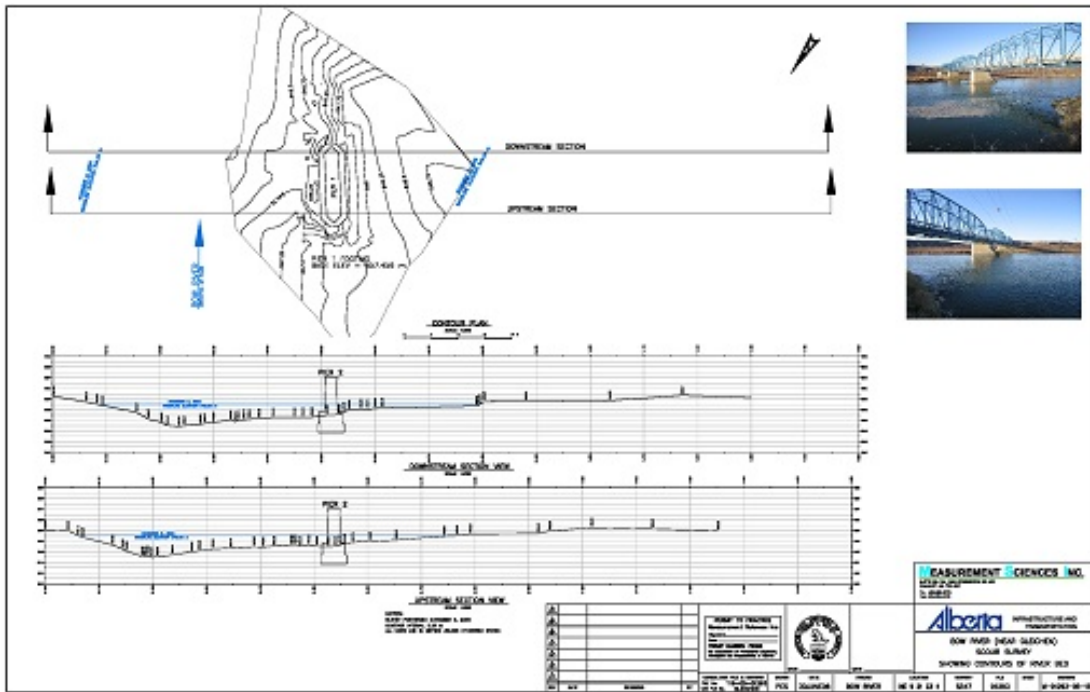
Figure 2: 2005 Scour Report (Alberta Transportation)

This site had a known history of scour concerns, with scour inspections noted on file in 1908, 1915, 1967, 1974, 1988, 1990, 1996, 1999, and 2005. Remediation work in the form of rock riprap placement around the pier was completed in 1909. Bank erosion was also a known concern with inspections noted in 1932, 1974, 1999, and 2005. Figure 2 below shows a typical scour report completed in 2005 showing streambed elevations in the vicinity of the bridge. Figure 3 shows a post flood aerial photograph, overlaid with historical banklines to show how much the river has moved laterally over the years.

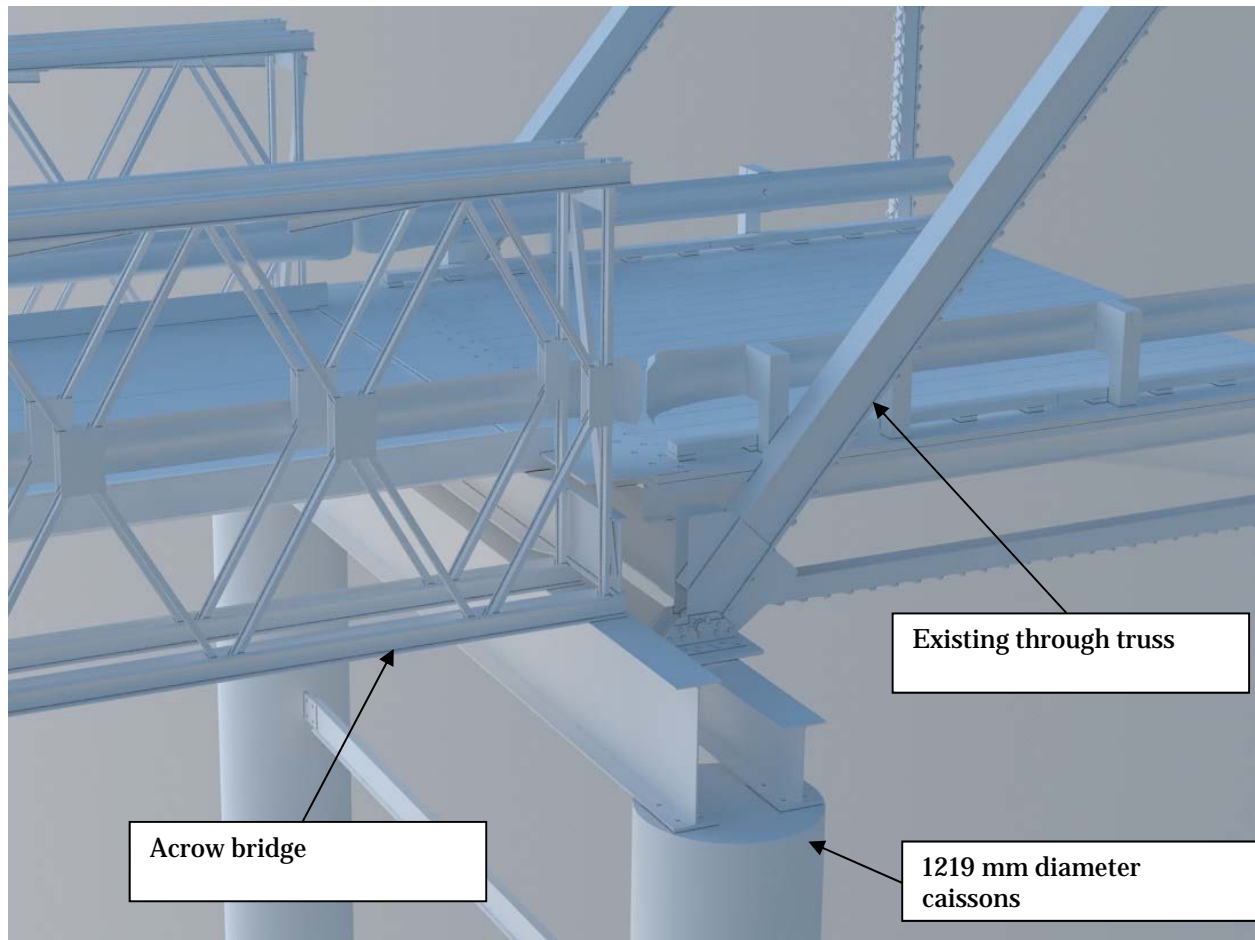
Figure 11: Bridge Design

There were complexities in designing a bridge system that would connect two very different bridge systems, in terms of overall geometry and design features. The existing through truss has a 5.1 clear roadway and timber deck and the Acrow bridge has a 4.2 m clear roadway and steel deck and these two bridge are not intended to be together. To necessitate movement of both bridges, there is a significant gap where they meet, although neither is intended to have an expansion joint. The only option is attach a steel deck plate to the timber deck of the existing through truss that is narrow enough to accommodate the clear roadway of the Acrow bridge. Additionally, the Acrow bridge has a diamond plated deck that is not preferred for winter driving. Therefore, a polymer wearing surface will be applied to the deck.

The superstructures of both bridges have different depths, so the pier cap was designed with different sized beams to not only support each bridge, but accommodate the differing dimensions, as seen in Figure 11. The pier cap has stiffeners welded to the caissons, designed to resist vehicle movement forces. The north end of the through truss is a fixed joint so the base of the bearing is welded directly to the new pier

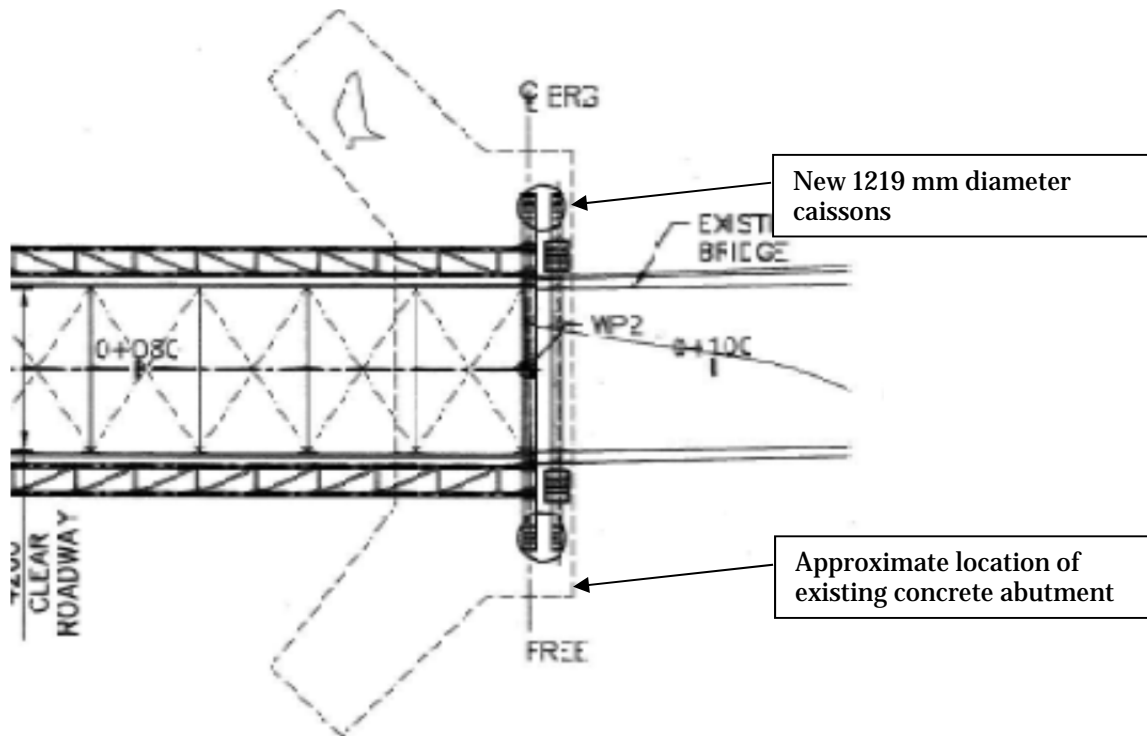
Figure 12: Caisson Locations

Referring to the as built drawings of the existing bridge, there was no indication of rebar or steel in the abutment. Since it was built solely with river rock and concrete, drilling the proposed caissons through the existing abutment was considered as part of the design. The pier is located in the active channel but due to the simplicity and depth of the caissons, does not require scour protection

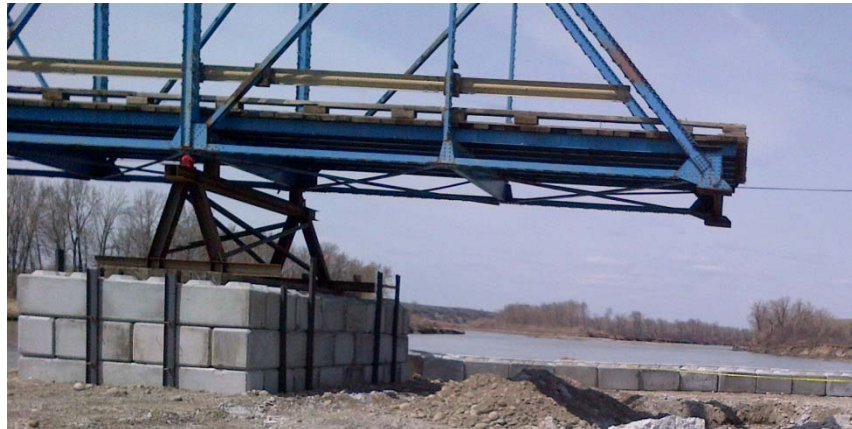
Figure 13: Shoring Tower under L2

The old concrete abutment was built with river rock, contained no rebar, and as built drawings indicates that there are timber piles at the base of the abutment driven into the ground. During partial demolition of the abutment, a wide horizontal crack propagated along the cold joint near the middle of the abutment, further compromising the entire structure. The abutment could no longer be used as a secondary support and for safety reasons was demolished to the top of the berm.

In the contract, ICCI was to build a temporary shoring tower at L2 to support the truss and keep as much of the existing abutment as a secondary support in case high waters were encountered while constructing the new pier. Once the pier was constructed and the existing through truss supported, demolition of the remaining existing concrete abutment and removal of the temporary shoring tower was to commence. The temporary shoring tower was installed under L2 on May 8, 2014 as seen in Figure 13

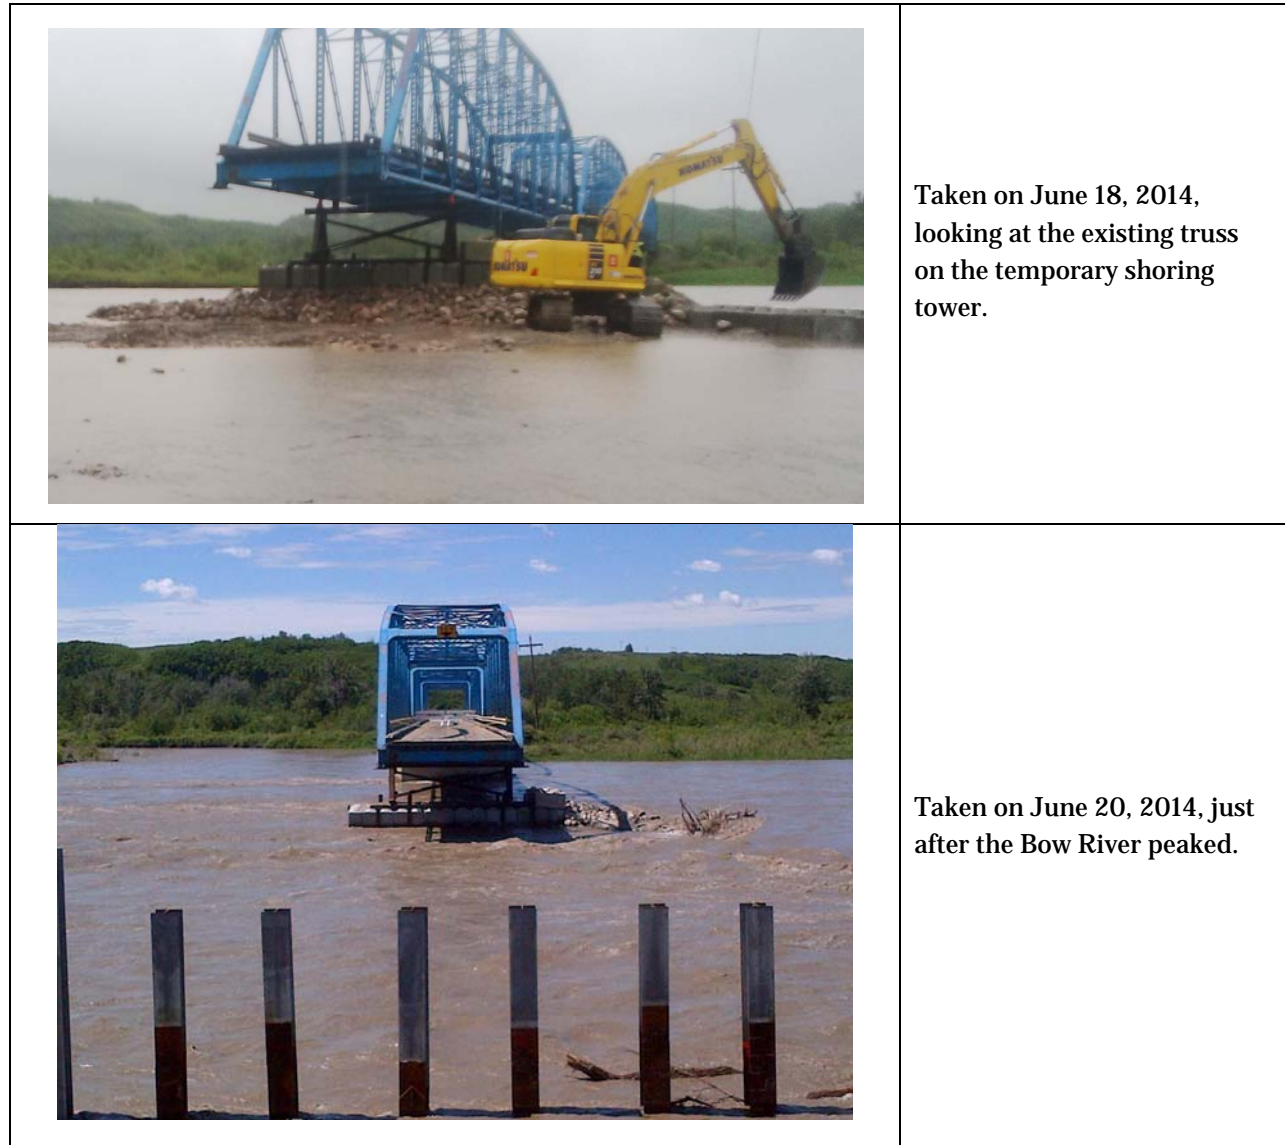
Figure 14: Shoring Tower under High Water Conditions

looming. The water levels under the berm are also the same as the water levels in the Bow River. On June 16, due to heavy rains and runoff from the mountains, a stream flow advisory was put in place by Alberta Environment and Sustainable Resources for the Bow River. A mitigation plan was developed to protect the shoring tower and was implemented shortly after. During heavy rains and rising waters, about 150 m³ of riprap was placed around the temporary shoring tower and we braced ourselves for the high waters as seen in Figure 14. The Bow river peaked on June 20, 2014 at 975 m³/s, and once the waters began to recede there was a sigh of relief since the shoring tower appeared virtually unscathed.
