**A Unique Pavement Rehabilitation Treatment for  
6<sup>th</sup> Avenue SE Calgary – Concrete Overlay**

Bozena Czarnecki, Ph.D., P.Eng.  
Principal Specialist, Engineering Practice  
Tetra Tech EBA Inc.

Paper prepared for presentation

of the 2014 Annual Conference of the  
Transportation Association of Canada  
Montreal, QC

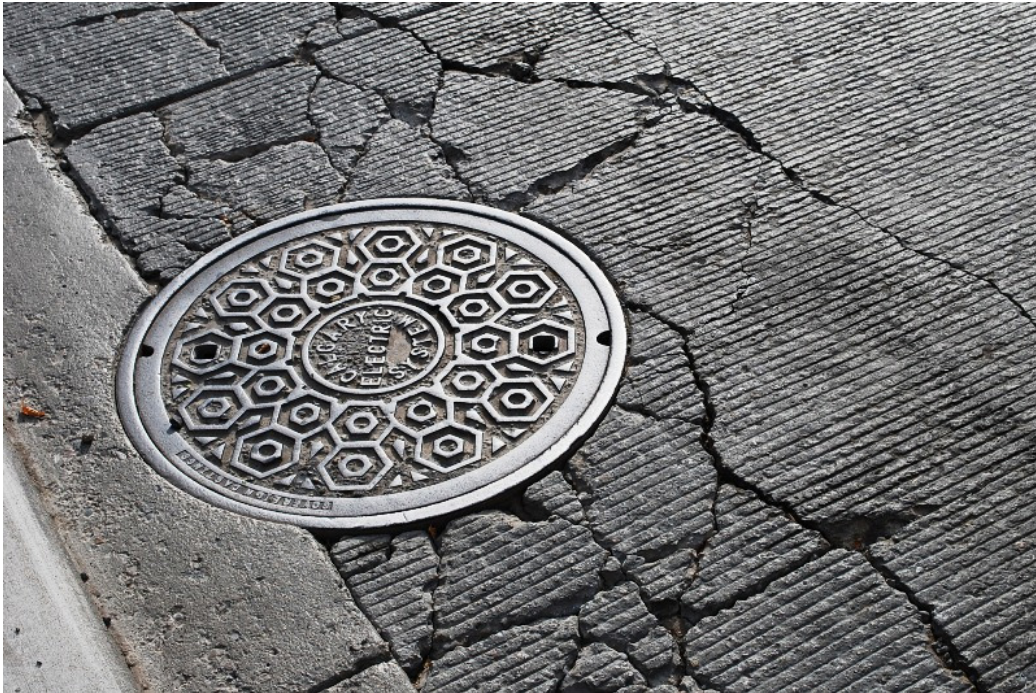
Numerous cracks were noted, with the cracking predominantly located around manholes, the bus stop and in mid-sections between tooled joints (Photos 1, 2 and 3).

Photo 1. Extensive cracking around the manhole

- Concrete overlay thickness – The design thickness was 100 mm. The core thickness was between 82 mm and 109 mm. The highest severity cracking coincides with the below design thickness area of the overlay and with the bus stop location.

- Joint spacing – The design joint spacing of 1.8 m squares took into consideration the lane width and the concrete overlay thickness. The actual spacing of about 3 m was random and did very little to prevent random shrinkage cracking and warping. The cracking was exacerbated by the lack of longitudinal joints and by the lack of joint detail around the manholes. In addition, transverse joint spacing of 2.4 m in

Special care was taken to clean the milled ACP surface after removal of concrete overlay. The surface was very dirty and power washing the sweep cleaning was necessary to achieve a good bond with the PCC overlay. Significant repairs were needed for the areas around the manholes and at the curb at the bus stop to assure PCC overlay performance.

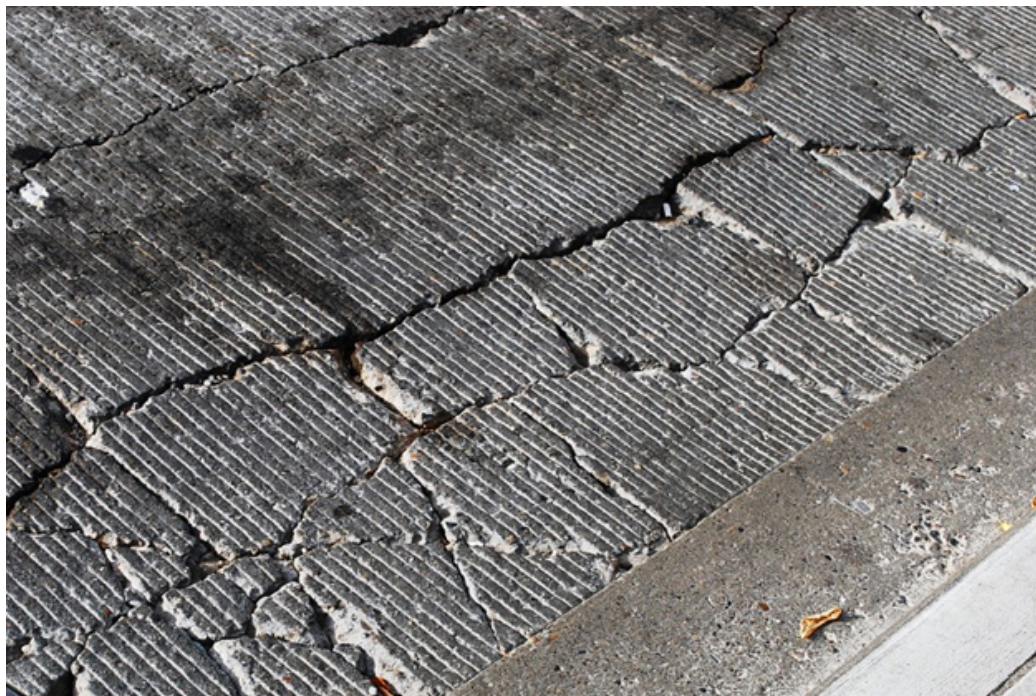
Photo 2. Concrete cracking at the bus stop

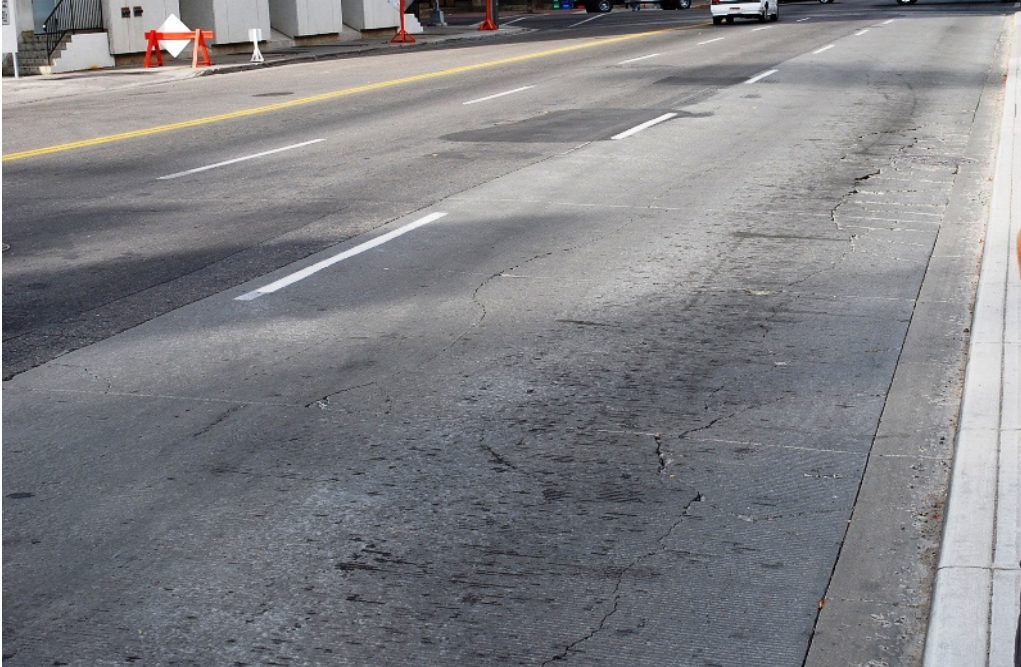
Photo 3. Cracking between tooled joints

- Joint construction – Timely joint sawing is necessary to prevent random cracking. Soff-cutt<sup>®</sup> technology was recommended to a depth of one third of the concrete overlay thickness. Instead, the joints were tooled to a depth of one quarter of the overlay, which reduced the ability to control cracking.

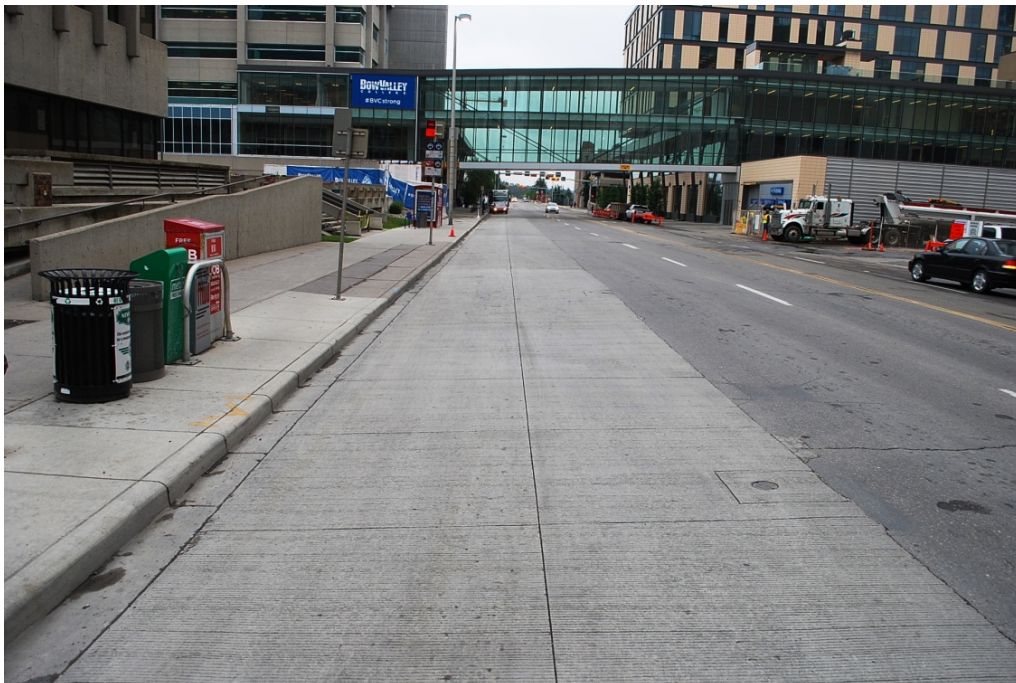
The PCC overlay was inspected and, in general, the concrete was found to be in a good condition (Photo 4). Some preferential cracking was identified extending from the adjacent sidewalk control joint (Photo 5). Transverse and random cracking around manhole was noted as the control joint pattern did not accommodate for a round manhole cover (Photo 6). The curing compound was evenly applied and the surface texturing tines were consistent.

Photo 4. Concrete overlay – general view

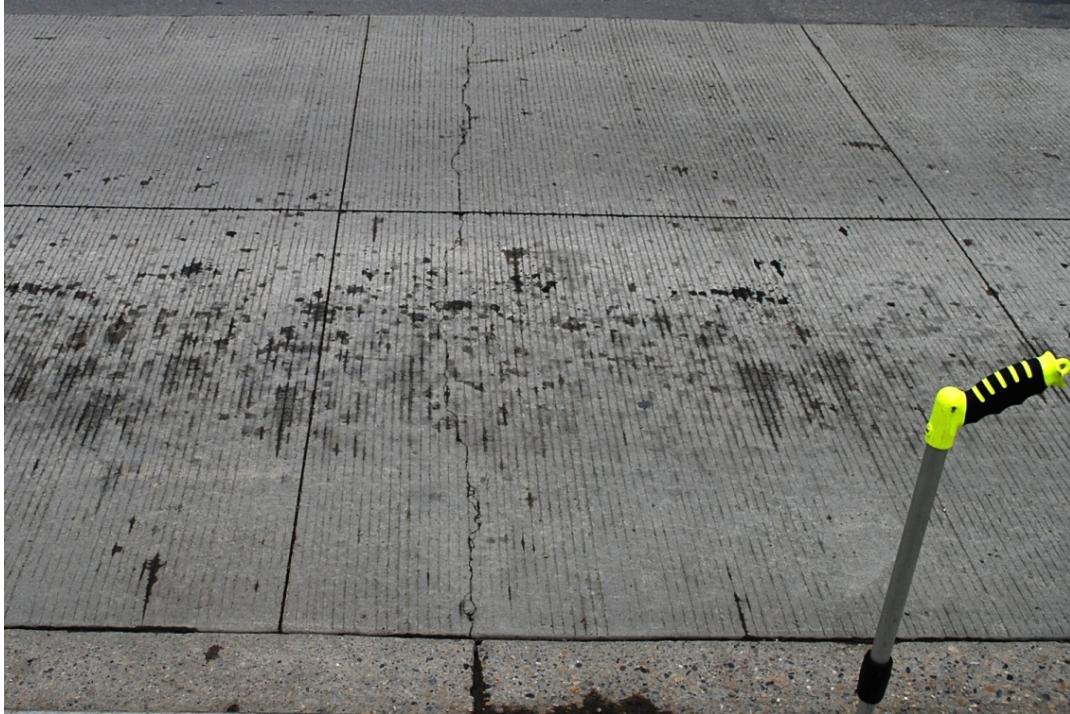
Photo 5. Preferential crack at adjacent sidewalk control joint

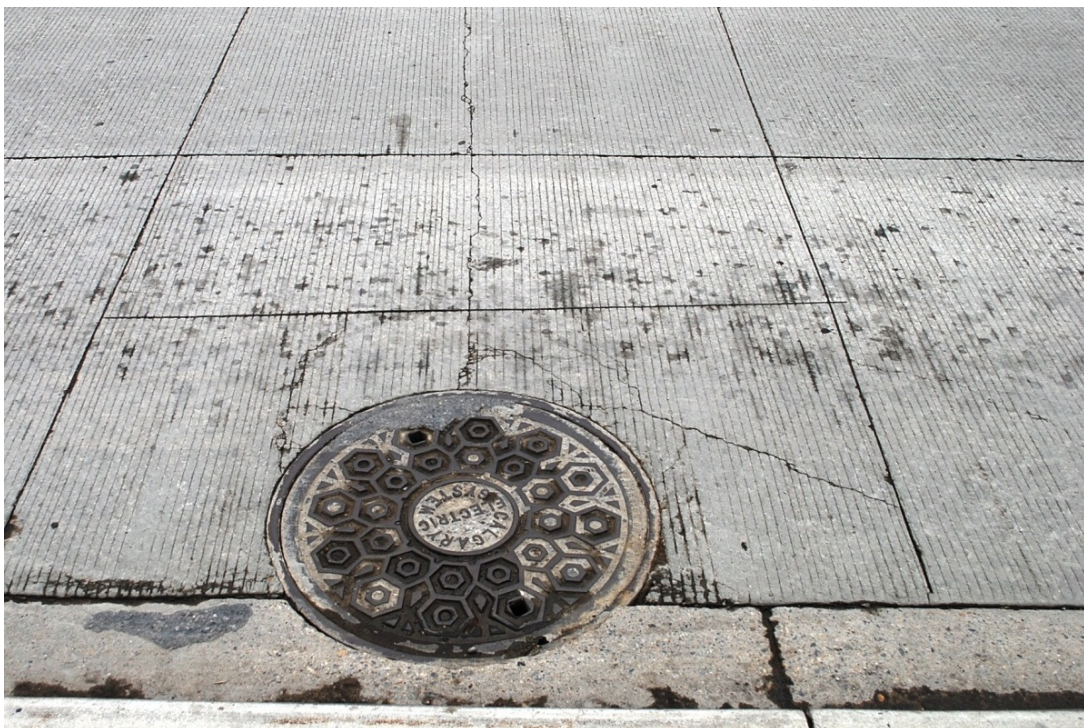
Photo 6. Transverse and random cracking around manhole
