REHABILITATION WORKS FOR PINAWA BRIDGE OVER WINNIPEG RIVER

Paper prepared for presentation
at the "Structures" Session
of the 2014 Conference of the
Transportation Association of Canada
Montreal, Quebec

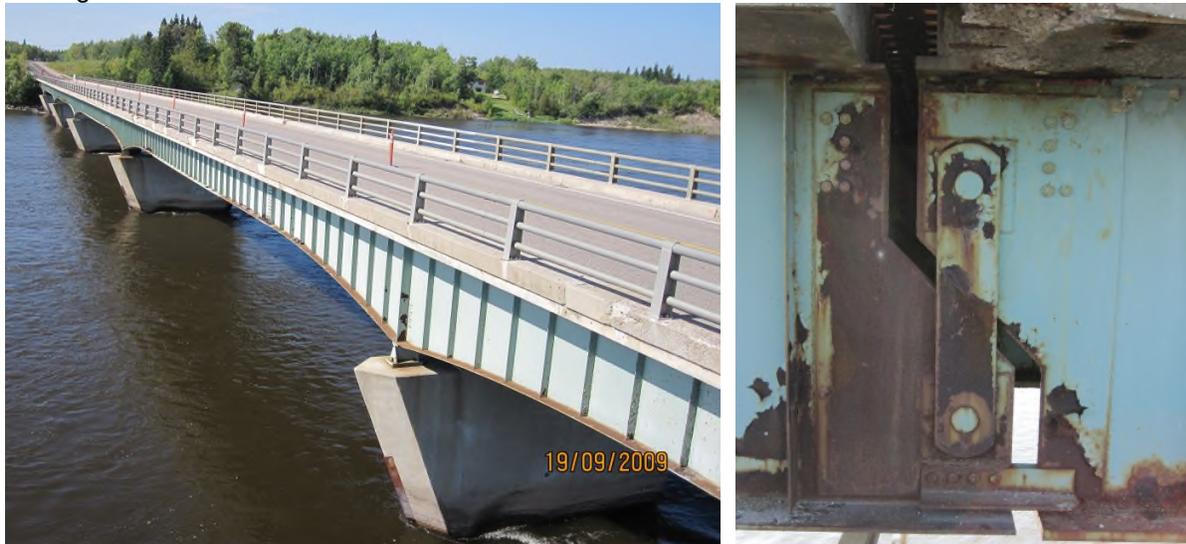
Figure 1 – View of the pre-rehabilitated bridge (left) and the pin-hanger system (right)

The girder steel at and adjacent to the existing pin hanger connections was observed to have areas of very severe deterioration during the DSSS due to deck joint leakage. Although not specifically observed during the DSSS, corrosion at pin hanger connection can have several detrimental effects on the pin which can potentially lead to catastrophic failure of the connection, which may include:

1. The cross-section of the pin can decrease due to corrosive section loss. This corrosion can produce pitting that may act as crack-initiation sites.
2. Corrosion can effectively lock the pin within the connection so that no rotation about the pin is permitted. This can lead to large torsional stresses within a reduced section of the pin. The torsional stresses, combined with the shear stresses, provide a likely location for the development and propagation of cracks and the eventual failure of the pin.
3. Crevice corrosion (pack rust) can develop between the hinge link plate causing the pin to migrate out of the connections, causing failure of the superstructure at the connection

Furthermore, installation of catcher beams under the bridge girders would have altered the bridge profile thus requiring a fresh submission for navigational approval and further delaying the project. Therefore, based on the above reasoning it was decided to replace the pin-hanger system with continuity splices and

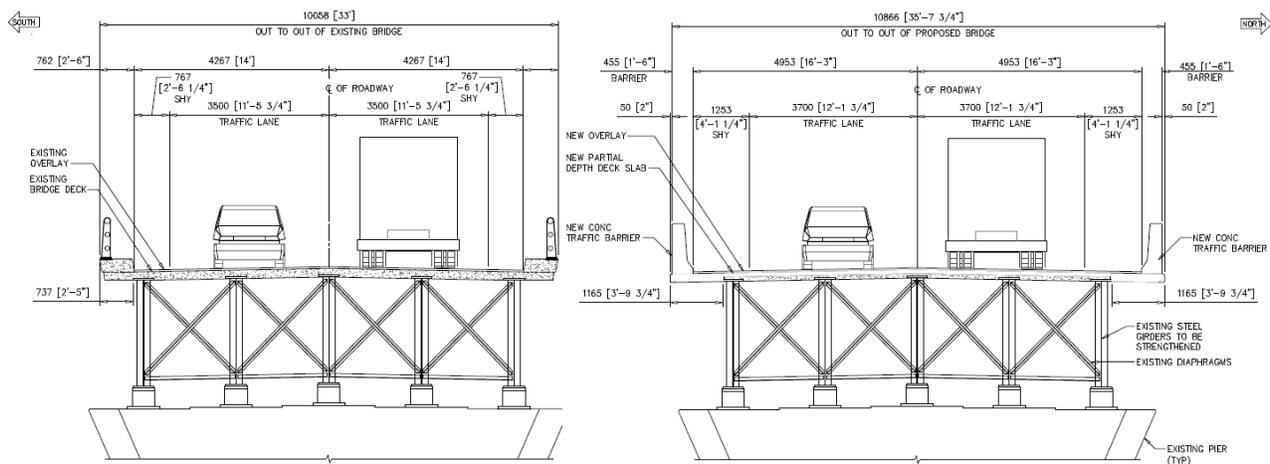
Figure 2: Original Bridge Cross-Section (Left) and Option 1 Bridge Cross-Section (Right)

did not satisfy the current GDC requirements. Option 1 was selected as it satisfied the GDC requirements and maximized the clear roadway width without adding an additional girder line or substructure widening. See Figure 2 for details. See Figure 2 for details.

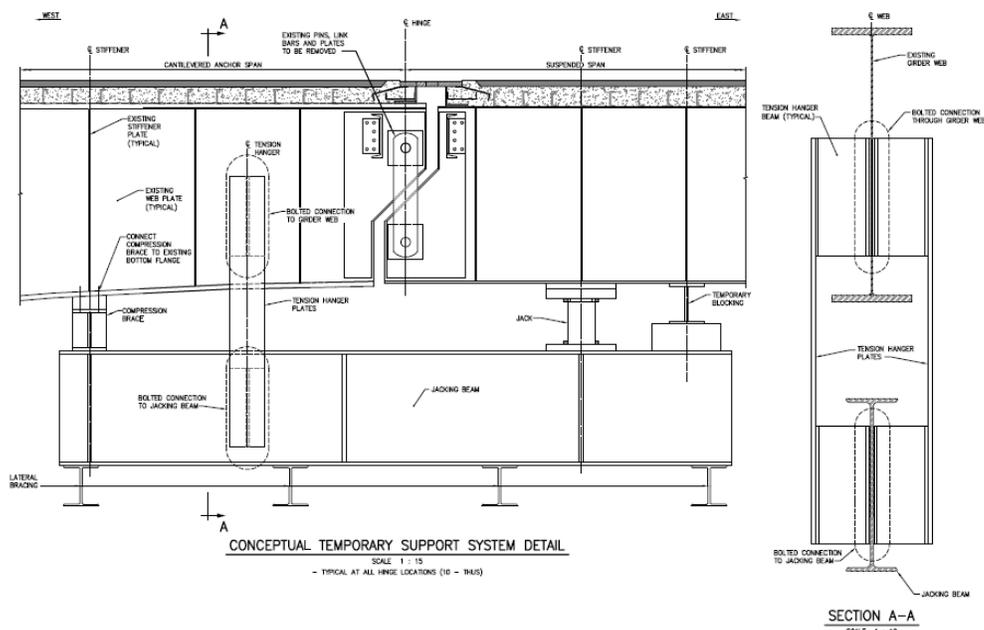
Figure 2 –Conceptual Temporary Support System Detail

As an alternate, an “above deck” supporting system was proposed by the design team to be included as a conceptual option in the detailed design drawings, however, it was decided that only a below deck temporary support system should be depicted as there was risk associated with traffic colliding with the support system. An “above deck” system may have been simpler to install, but with the requirement to maintain one lane of traffic at all times on the bridge, the “below deck” support system method was more preferable in terms of construction staging sequencing and traffic control. Ultimately, the final design decision on how to support both sides of the hinge with a “below deck” system during pin-hanger system removal was left to the Contractor. The conceptual temporary girder support design provided in the construction drawings is shown in Figure 3.

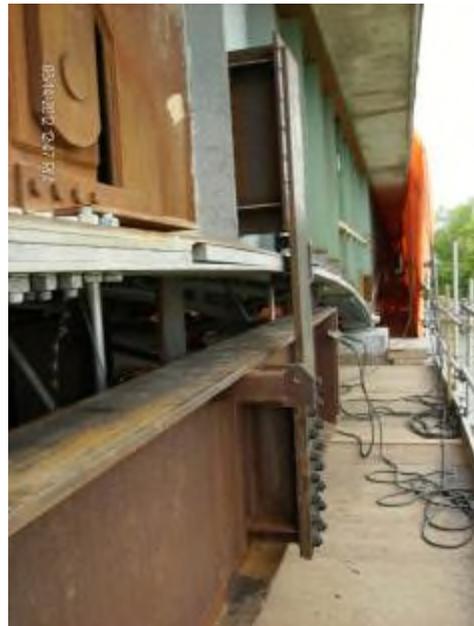
Figure 4 - Temporary Support System

1. Replace jacking beams at both abutments (due to existing jacking beams having insufficient capacity for abutment bearing replacement);
2. Jack and replace all bearings except at Pier No. 3 and install bottom flange lower steel strengthening plates on exterior girders at Pier No. 5; and
3. Install continuity splice including temporary hinge support systems.
