CHALLENGES AND INNOVATIVE SOLUTIONS FOR BRIDGE FOUNDATION REPAIRS

Drew Monnier¹, P.Eng. (Presenting)
Kimberly Yathon², B.Sc. CE (Presenting)
Ruth Eden¹, M.Sc., P.Eng.
Randy Fingas¹, P.Eng.
Emile Shehata², Ph.D, P.Eng.

¹Manitoba Infrastructure and Transportation
²Tetra Tech WEI Inc.

Paper prepared for presentation
at the "Structures" Session
of the 2015 Conference of the
Transportation Association of Canada
Charlottetown, PEI

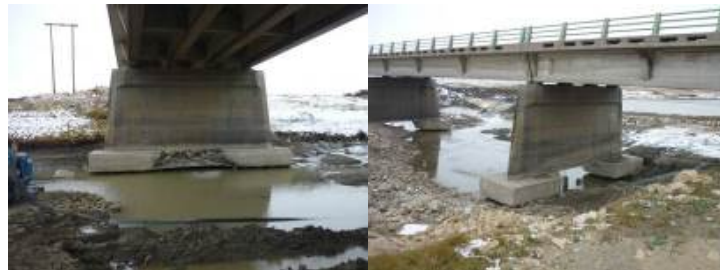
The bridge on Road 71N over the Portage Diversion Channel is a two lane, 127.9 m long, five-span, simply supported bridge, which was constructed in 1967. The substructure consists of reinforced cast-in-place concrete abutments founded on timber piles and reinforced cast-in-place concrete piers founded on steel H-piles. The bridge is located immediately downstream of the Portage Diversion Drop Structure No. 1. During the 2011 Flood, the bridge foundations were subjected to severely turbulent flow as water entered the diversion channel, with inflows substantially greater than the inlet was designed to accommodate. This resulted in scouring of the piers, which exposed the steel H-pile foundations up to six metres at several pier locations. Turbulent flows also contributed to scouring and bank instability of the channel between the bridge and the drop structure.

Figure 2 – Scouring Beneath Bridge Piers

The design consisted of new 3.0 m deep reinforced cast-in-place concrete pier footings, which would encase and join together the two existing 900 mm deep pier footing components to provide overall structural continuity. Detailed design was fast-tracked and all design elements considered an extremely tight construction schedule, with consideration made for an early spring melt. Connectivity between new and existing concrete was provided by means of dowels to fully and effectively transfer loads to the new foundations. Stability of the existing channel slopes was evaluated between the drop structure and around the bridge. A monitoring program was developed, along with a construction staging plan to not only maintain stability of the existing channel banks, but to also maintain integrity of the bridge itself during construction and exposure to live loads. Staging consisted of offloading of the upper channel embankments and providing toe stability, sequencing the construction of pier footings, moving from the centre of the channel outward, and phasing construction of the pier footings to maintain vehicular access at all times. Erosion protection around the bridge was coordinated with other work at the drop structure that was concurrently being undertaken by MIT. This consisted of placing Class 600 and 900 stone rip-rap. Design was completed in only 45 days. Figure 3 illustrates the proposed pier footing modification.

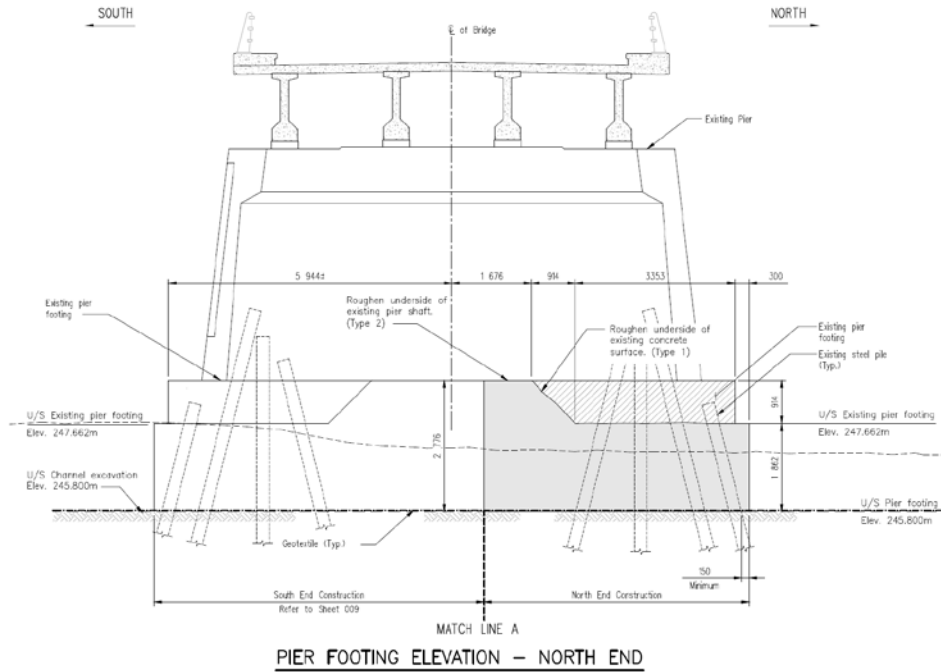
Figure 3 – Pier Footing Modifications

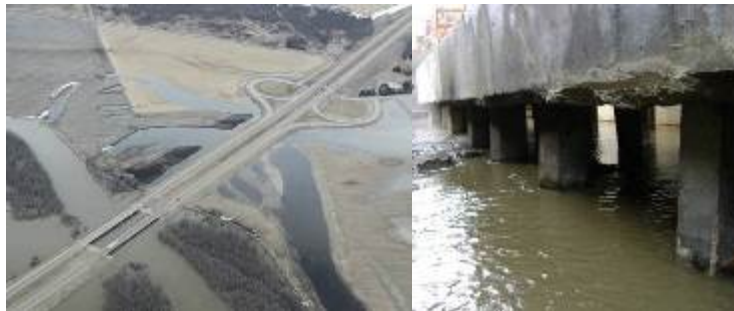
Figure 6 – TCH 1W During 2011 Flood (left), Exposed Piles Due to Scour at Pier SU.5 (right)

An emergency inspection was completed in early March 2012 to confirm the extent of scour and undermining of Pier SU.5. Scouring occurred due to constriction of the river at the bridge, combined with a bridge skew which exacerbated flow conditions, forcing spill out of the main channel to the adjacent flood plain. Divers confirmed that the extent of scour was restricted to only SU.5. An emergency drilling program was undertaken for two test holes to the east of SU.5 to confirm soil stratigraphy, to assess pile current pile capacities, and to evaluate the capacity of driven steel HP piles. Finally, slope stability of the existing banks was evaluated to determine if stabilization measures were required.

The design consisted of a new 3.0 m deep reinforced cast-in-place concrete pier footing, which enveloped the existing pier footing. The pier footing was supported on steel H-piles driven into shale, with anticipated lengths of 35.0 to 40.0 m. Eighteen additional steel piles were located around the perimeter of the existing pier footing to satisfy design loads for the foundation, eight of which were to be driven through the bridge deck. The use of a custom segmental steel cofferdam was required to isolate flow and enable construction of the new pier footing. A tremie concrete cofferdam plug would be necessary to isolate river flow within the cofferdam and support construction of the new pier footing. Steel reinforcing dowels were utilized to effectively transfer loads to the new foundation.

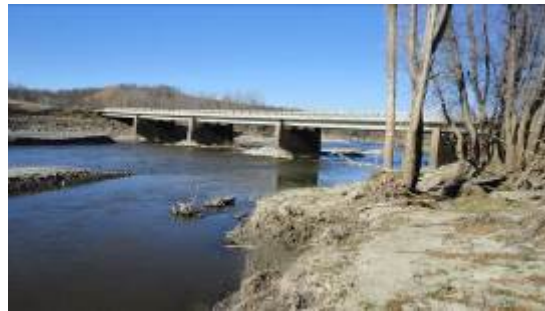
The rapidly moving river continuously contributed to erosion around the piers and abutments. Furthermore, river flow in the vicinity of the bridge was in a constant state of change; gravel bars formed within the channel, a series of braided channels formed around gravel bars, the river bed became unstable, and the main channel developed a tendency to migrate between its east and west banks. Scour protection efforts were undertaken for the west span in 2000 and 2009 by MIT to provide rock rip-rap protection to the channel slope. During the 2011 Flood, scouring was identified for at river piers with water levels nearly overtopping the bridge deck. Rip-rap was placed within the river to fill in scour holes and to protect pier foundations and the bridge was monitored for movement or channel settlement.

Figure 9 – Existing Bridge on PTH 2 over Souris River Following 2011 Flood

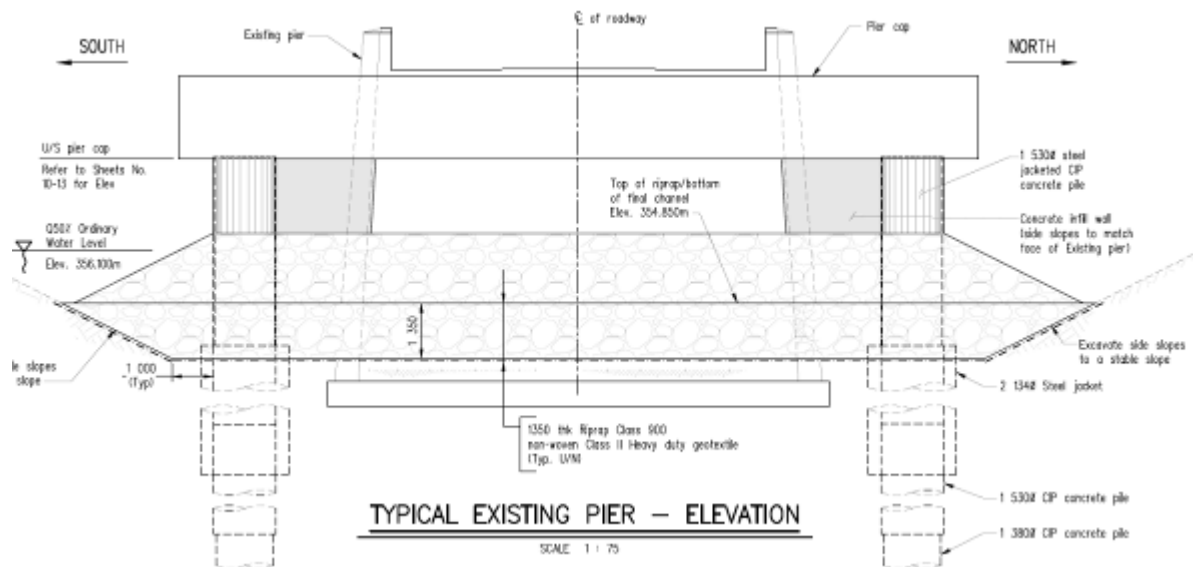
Figure 10 – Section of Pier, Showing Drilled Shaft Foundation, Concrete Pier Cap, and Concrete Infill Walls

The deep foundation system consisted of two reinforced concrete cast-in-place drilled shaft caissons. Each shaft consisted of two different diameters; the lower 5.0 m was 1,380 mm diameter supported against earth, while the upper 16.0 m was 1,530 mm diameter supported by a metalized steel jacketed sleeve. Drilled shaft caissons were reinforced using 35M black steel reinforcing for the full length of the shaft and developed into a reinforced cast-in-place concrete pier cap. Drilled and grouted steel dowels

were used to transfer loads from the existing piers to the new foundations. Galvanic protection, consisting of DAS anodes, was used in the pier caps and infill walls to protect new and existing reinforcing steel against corrosion. Concrete infill walls between the pier and caissons were provided to enhance the load transfer. Temporary sleeves would be required through alluvial deposits and within the surface of the shale layer to control seepage and to minimize softening of shale. During tender, prospective bidders were required to read the geotechnical design report to be made aware of subsurface conditions. Figure 9 provides a section of the modified pier showing the existing concrete pier and footing, along with the two new drilled shaft caissons and extended concrete pier cap.

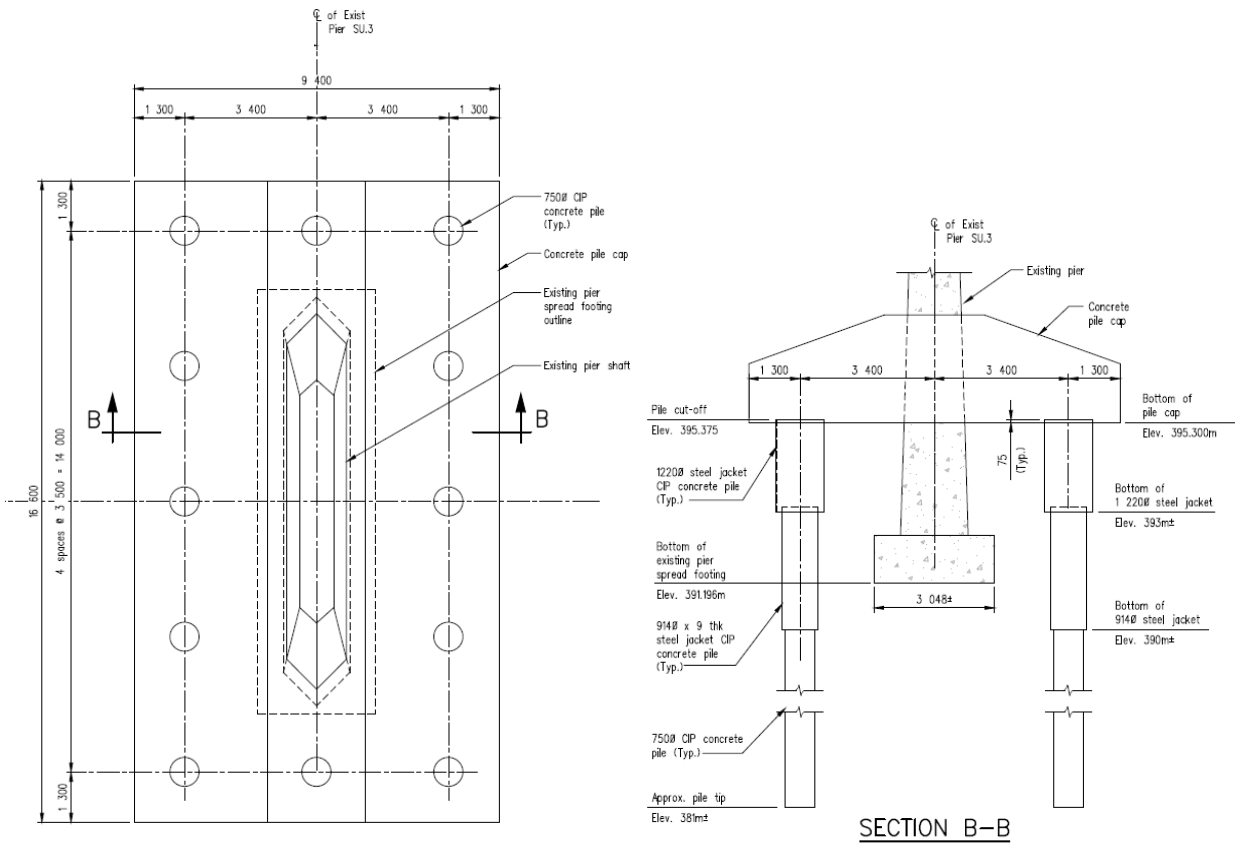
Figure 14 – Plan and Section Views of Modified Pier Cap and Deep Foundations

The rehabilitation strategy was to design a deep foundation system that could fully support twice the existing superstructure dead loads and two lanes of live load of the structure for future widening of the bridge. Deep foundations were considered the only feasible alternative to underpin the existing spread footings due to the presence of a dense cemented shale layer at the underside of spread footings. The shale layer at this site was more rock-like clay shale than was encountered at PTH 2, for which piles would be too shallow beneath existing footings. Therefore, the use of drilled shaft caissons extended into the shale was selected. The deep foundation system consisted of twelve 750 mm diameter, 9.6 m long, reinforced cast-in-place concrete drilled shafts. The upper 1.5 m was supported by 914 mm steel jacketed caisson. Caissons were fully reinforced with 25M black steel vertical reinforcing. Figure 14 illustrates the expanded pier foundation system.

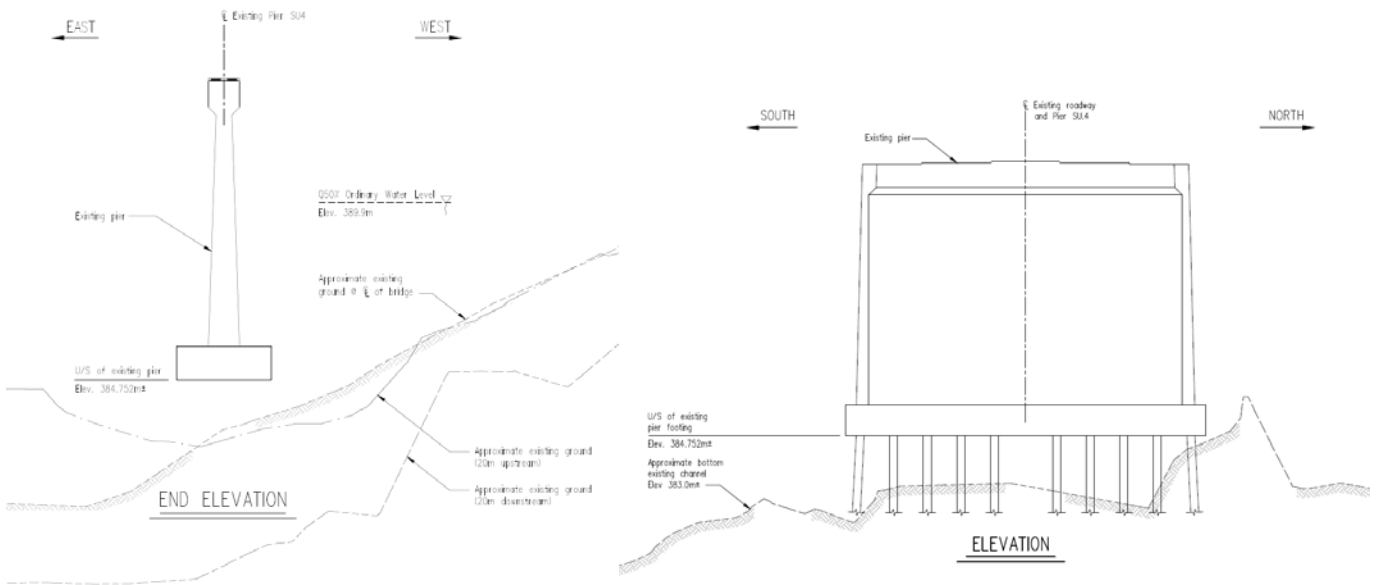
As a result of the bathymetric survey, the extent of scour became much more apparent. Scouring was observed to be approximately 2.0 m beneath Pier SU.4. Downstream of the bridge, however, a 20.0 m deep scour hole was present. The concern was that high river velocities would further contribute to scouring of the pier and lead to overall bridge instability. Deep foundations were considered the only practical solution for this site, due to the decrease in existing foundation capacity, the possibility of piles refusing before obtaining sufficient end bearing capacity, the requirement to keep the structure open to a single lane of traffic at all times, and the understanding of site conditions and an extremely tight construction schedule to meet. Subsurface stratigraphy consisted of alluvial sand interbedded with silt and clay, with an overlying hard soil-like clay shale. The design of the deep foundation system considered only shaft adhesion for foundation serviceability due to the practical limitations associated with cleaning and inspecting the base of the shaft and the possibility of a weak discontinuity in the shale below the

Figure 18 – Section of Pier SU.4, Showing Depth of Scour

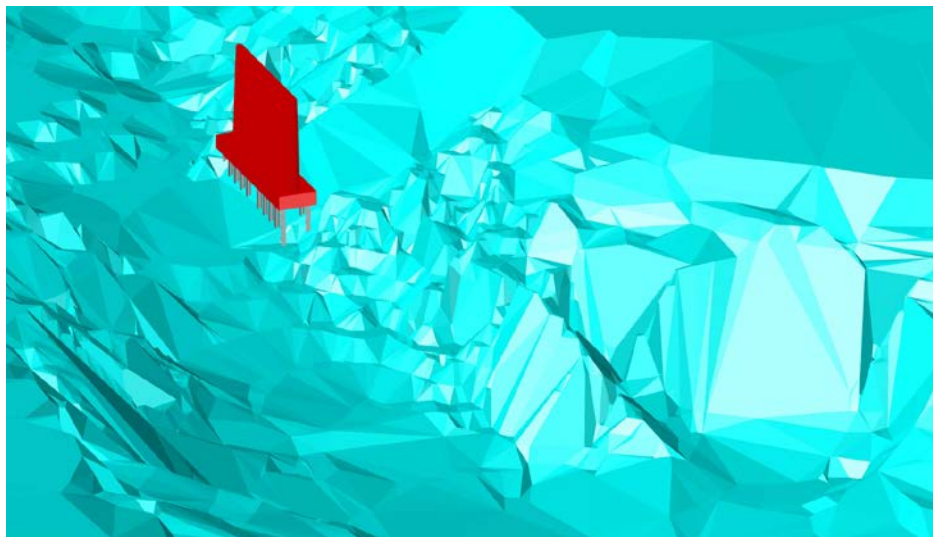
Figure 19 – Three Dimensional Image of Assiniboine River, Showing Existing SU.4 and Extent of Scouring Around Pier and Downstream of Bridge

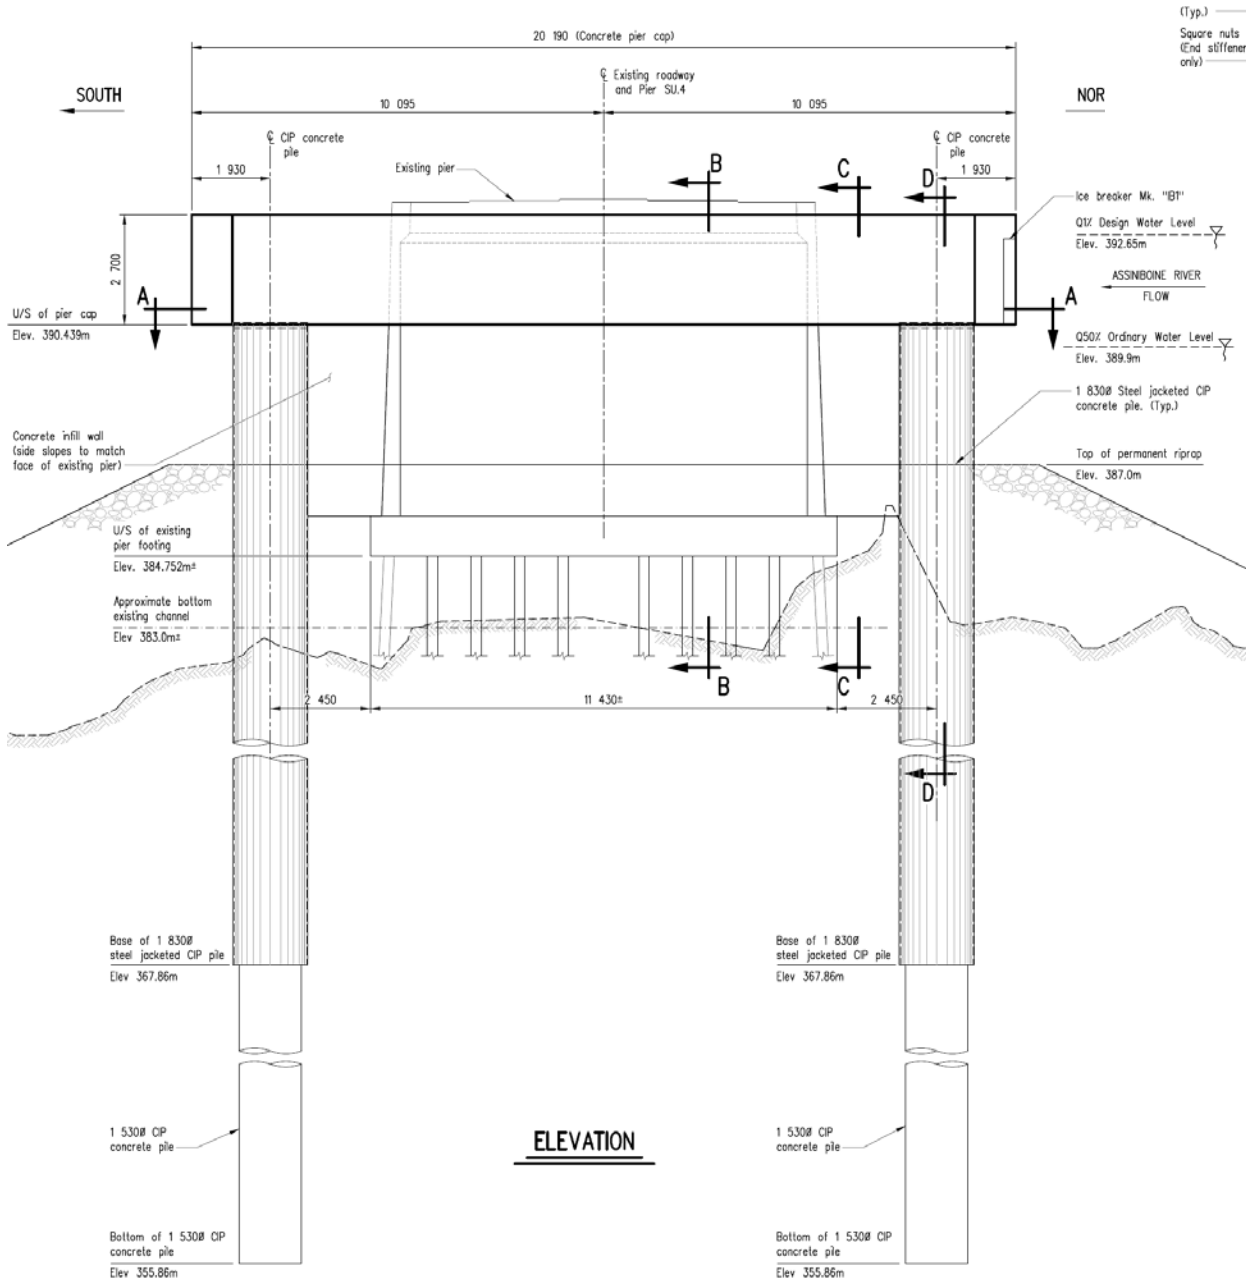
Figure 20 – Section of Pier, Showing Drilled Shaft Foundation and Concrete Pier Cap

The deep foundation system consisted of two 1830 mm diameter, 22.5 m long, steel jacketed reinforced cast-in-place concrete drilled shafts positioned on the upstream and downstream ends of a new cast-in-place concrete pier shaft. The lower 12m of the drilled shaft reduced to a diameter of 1530 mm, below the shale layer. Caissons were fully reinforced with 35M black steel vertical reinforcing for the full length of the shaft and developed into the pier cap. The massive new pier cap was designed to be 2.0 m wide, 20.2 m long, and 2.7 m deep, which trumped the size of the existing piers. The pier cap was designed to fully transfer superstructure loads to the new foundations. Drilled and grouted steel dowels were used to

transfer loads from the existing piers to the new foundations. Installation of temporary sleeve casings was deemed to be necessary to control seepage and sloughing through the alluvial sands. Consideration was made for multiple sleeves to penetrate into layers as necessary, while still providing sufficient space and working within crane capacities during construction. Figure 20 provides a typical modified pier section.
