ROADSIDE SAFETY STUDY: INVENTORY AND CONDITION AND RISK ASSESSMENT

Prepared for Presentation at the Transportation Safety and Security Session

*2015 Conference of the Transportation Association of Canada
Charlottetown, Prince Edward Island*

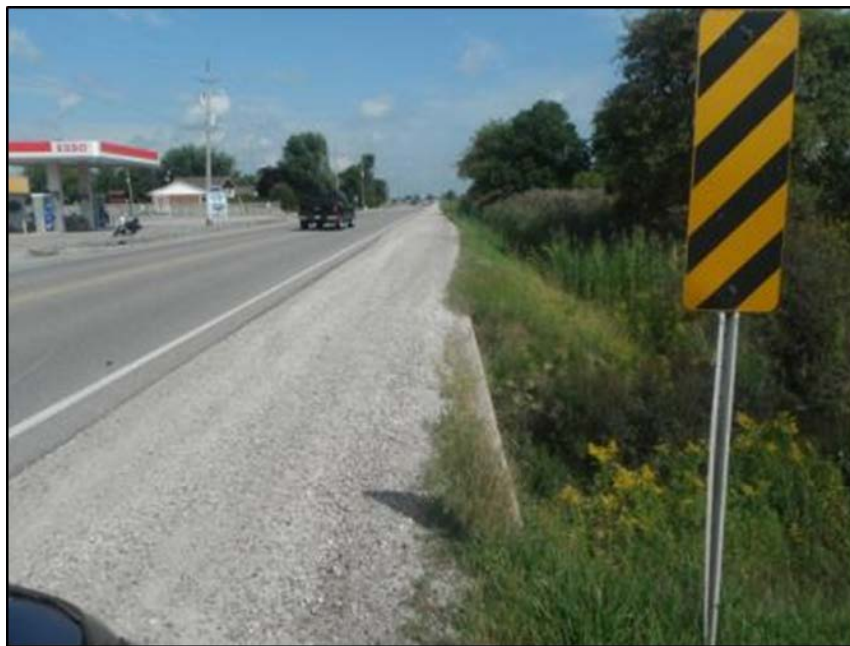
Figure 8
Fully Unprotected Roadside Hazard

Steel-beam guide rail, with or without channel, was the treatment of choice due to the effectiveness and life-cycle economics of this system. One example of an unprotected roadside hazard is shown in **Figure 8**. The length of need requirement was determined based on the *Roadside Safety Manual* [2], with the approaching and leaving end treatments extending beyond.

Since both the approaching and leaving ends of this new system would be in the minimum roadside clear zone for their respective directions of travel, a suitable end treatment was recommended for both the approaching and leaving ends. The end treatment of choice in conjunction with steel-beam guide rail was the extruder end terminal, based upon its effectiveness at design speeds up to 100 kilometres per hour, its ability to be retrofitted without grading modifications to the roadway shoulder or ditch/drainage design in most applications, and in consideration of the advantages of roadside safety system standardization.

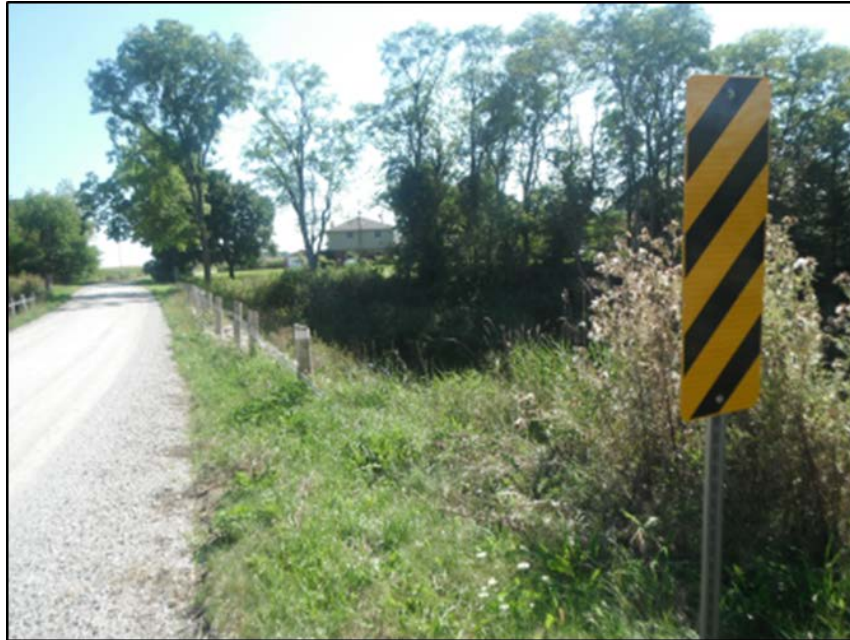
Figure 9
Partially Protected Roadside Hazard

Many locations were identified where: a roadside hazard was present within the minimum roadside clear zone and roadside protection in the form of guide rail was provided, but the system proved to be obsolescent, in poor condition, and/or of insufficient length to adequately shield the hazard from both directions of travel. One example of a system that is inadequate to protect a hazard is shown in **Figure 9**. In this instance, obsolescent three-cable guide rail, in poor condition, and of insufficient length, is present.

To upgrade the roadside protection to current standards, and to adequately shield the hazard, simply extending the three-cable guide rail is impractical. In this instance, the recommendations are to: remove the three-cable guide rail; replace it with the required length of steel-beam guide rail; provide guide rail extruder end treatments on the approaching and leaving ends of the system; and provide object markers visible to approaching traffic from both directions of travel.

Over time, this upgraded form of roadside protection will adequately shield road users from the hazard without introducing other risks into the roadside, while being less-costly and longer-lived to maintain.

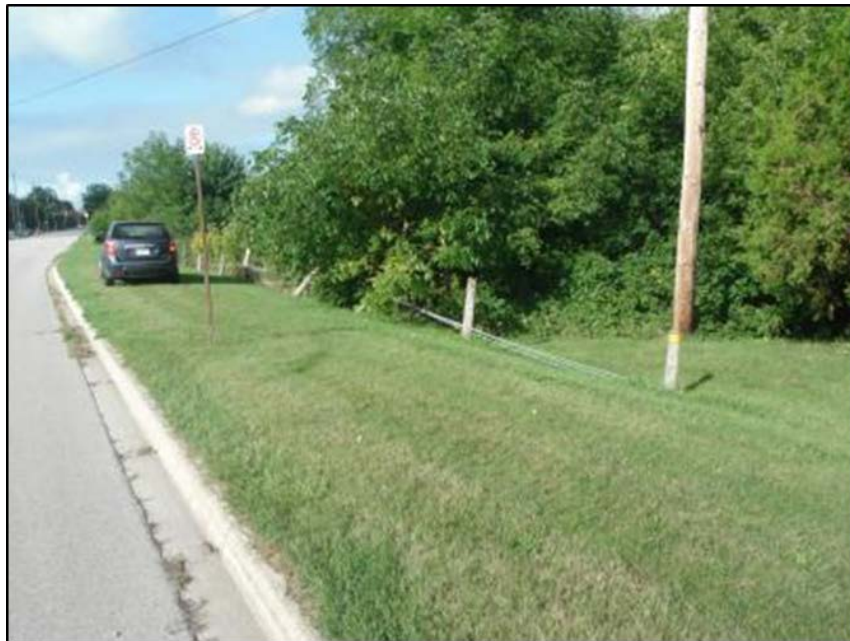
Figure 10
Unnecessary Roadside Safety System

In the example shown in **Figure 10**, no justifying hazard for the obsolescent three-cable guide rail was found, and as a result, its removal was recommended.

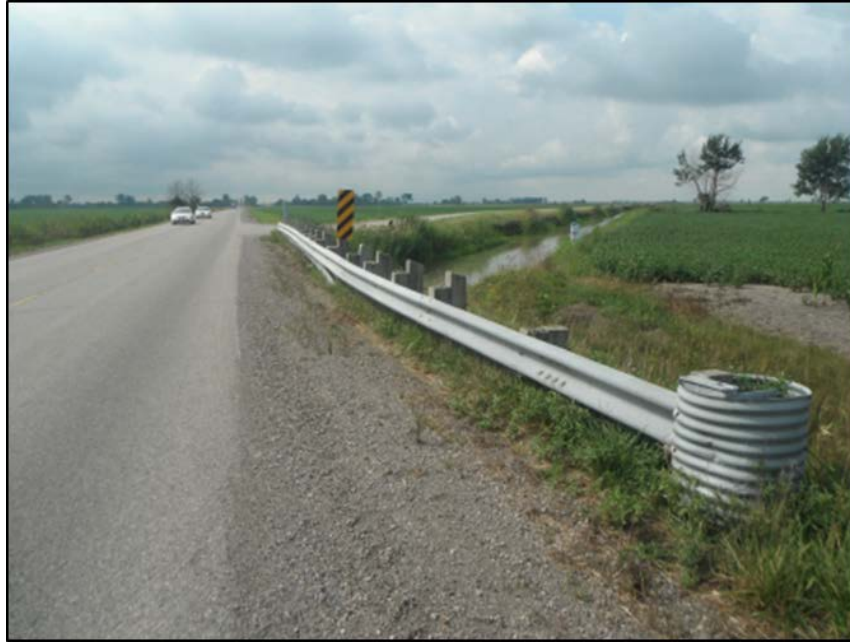
Figure 11
Entrance Conflict at Roadside Safety System Departure

Intersecting roadways, driveways, and field accesses may preclude the provision of a run of guide rail sufficient to meet length of need requirements and to prevent an errant vehicle from outflanking the system and reaching the hazard. In such instances, a special form of end treatment, known as a driveway return, is employed. The driveway return provides protection around a small radius and runs perpendicular to the roadway. Its approach end may either employ an extruder (generally reserved for public roadway approaches), or it may be flared and buried or may be left upright (driveways and field entrances).

In the example shown in **Figure 11**, the eccentric loader is recommended for removal, and a driveway return with an object marker is recommended to replace it.

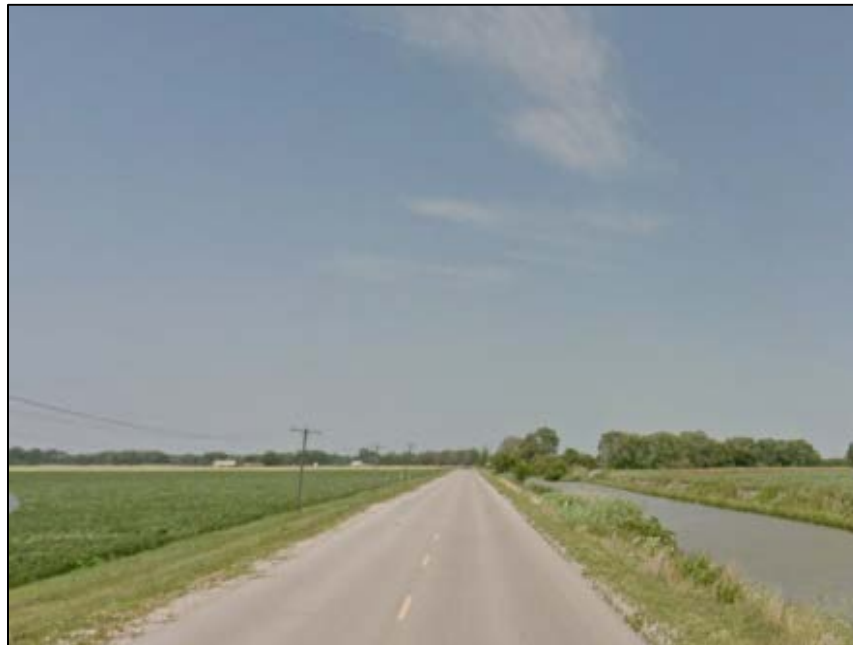
Figure 12
Roadside Drainage Ditch

Large, water-filled agricultural irrigation ditches, some extending for several kilometres, were present within the roadside clear zone, adjacent to several rural roads. An example of one such drainage ditch is presented in **Figure 12**. These watercourses pose a submergence hazard throughout their length. However, the provision of roadside protection throughout is difficult to justify given that the roadways are generally straight and flat, and the traffic volumes upon them are relatively low; the cost to employ a steel-beam guide rail would be far too extensive for many municipalities to install for many kilometres.

Collision histories suggest that roadway departures involving these features are infrequent, and rarely if ever result in vehicle submergence. Shielding road users from such extensive hazards would be expensive. Three-cable guide rail, which deflects up to three metres on impact, may not prevent vehicles from reaching the hazard. A reduced speed limit would likely achieve poor compliance and prove ineffective, as most road users would fail to perceive the connection between it and roadside threat.

Applying best-practices gathered from various municipalities within the area whom have completed similar studies, options include: shielding road users from the hazard by means of a low-cost roadside safety system (e.g. three-cable guide rail); road edge delineation to assist road users in selecting an appropriate speed and path so as to remain on the roadway; or a reduction in the posted speed limit to reduce the likelihood of roadway departures.

Delineation, to help keep road users on the road, is both effective, and cost-efficient. Options include one or more of the following: painted edge lines; partially-paved shoulders; edge line rumble strips; permanent retro-reflective pavement markers; and post-mounted delineation. Any or all of these treatments could be considered in order to clearly define the extent of the roadway, and the hazard area beyond, allowing road users to make decisions in support of their own safety. On this basis, a delineation treatment is recommended.
