MEDICINE RIVER BRIDGE REHABILITATION

Bob Ramsay, UMA Engineering Ltd.

of the 2003 Annual Conference of the Transportation Association of Canada St. John's, Newfoundland and Labrador

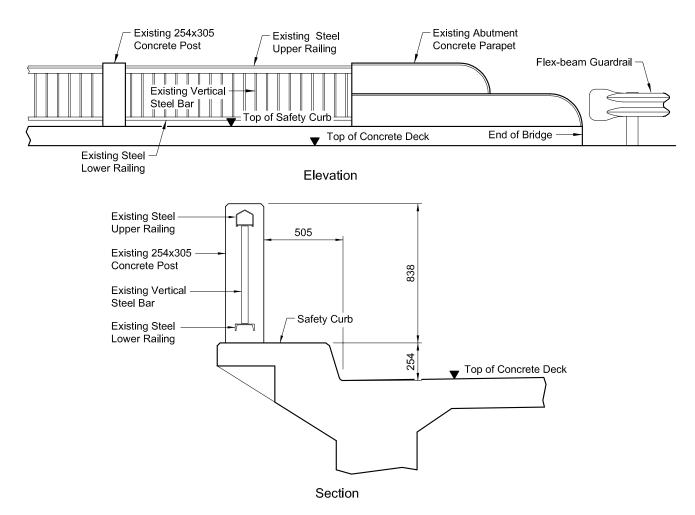
The existing bridgerails on the Medicine River Bridge consist of concrete posts and upper and lower steel railings (see Figure 4). Vertical steel bars fill the gap between the upper and lower railings. The bridgerails are mounted on safety curbs and terminate in concrete parapets at the abutments. Flex-

-inadequate strength to resist the barrier loads specified in the CHBDC;

-concrete posts not being setback from the steel railings resulting in the potential for excessive vehicle snagging on the posts;

-safety curbs that had the potential to vault vehicles over the bridgerails or cause vehicle rollover; and

-approach guardrails that did not adequately protect the ends of the bridgerails against vehicle collisions.

Due to the above bridgerail deficiencies and the 1999 recommendation to delay bridge widening for 10 years it was recommended that the bridgerails be upgraded to meet Performance Level 1 (PL-1) requirements as specified by the CHBDC.

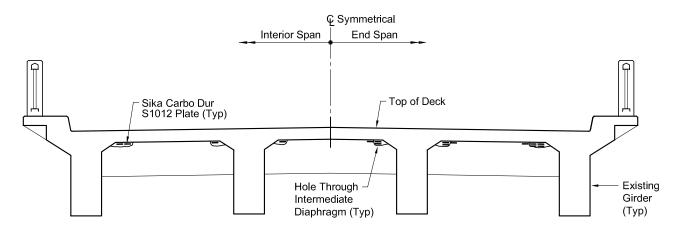
Figure 6 - Girder Strengthening with CFRP Plates

Based on the above it was concluded that the concrete "T" girders required strengthening in negative moment only. Negative moment strengthening was recommended not only to increase the negative moment capacities of the girders but to also limit the widths of any negative moment cracks occurring at the end span quarter points closest to the piers. It was feared that negative moment cracking at these locations might lead to increased shear cracking and a reduction in the shear capacity of the girders.

The bridge load evaluation showed that negative moment strengthening of the girders was required from 0.5L to 0.8L in the end spans and from 0.2L to 0.4L and from 0.6L to 0.8L in the centre span. Two alternatives were considered for negative moment strengthening. The first alternative was to attach steel plates to the bottom of the concrete deck using adhesive anchors (see Figure 5). The second alternative was to attach carbon fibre reinforced plates (CFRP) to the bottom of the deck using epoxy adhesive (see Figure 6).

The construction cost of strengthening with steel plates was estimated to be 7% less than the construction cost of strengthening with CFRP plates. However, the CFRP strengthening alternative was selected for detailed design and construction. This decision was made because it provided an opportunity for Alberta Transportation to tender and construct a project using CFRP technology in a low risk setting, i.e. no increase in bridge loading after strengthening.

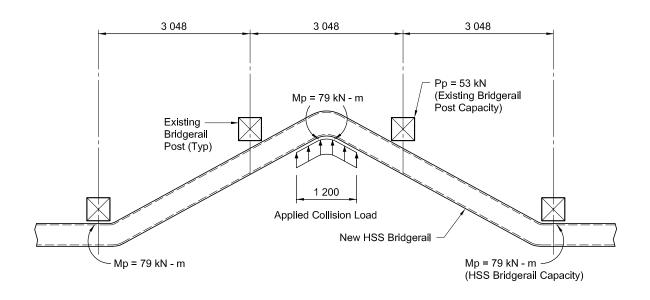
Figure 9 - Upgraded Bridgerail Failure Mode

The HSS152x152 bridgerail was designed to distribute vehicle collision loads between the existing concrete posts to the extent necessary to reduce the loads to a level less than the existing post capacities. This design was carried out in accordance with the provisions of Appendix A13.3.2 of the 1998 AASHTO LRFD Bridge Design Specifications. The governing failure mode occurred over three bridgerail spans (see Figure 9).
