Using Ground Penetrating Radar as an Assessment Methodology in Roadway Rehabilitation

Paper prepared for presentation
at the Soils and Materials Session
on
“Assessment and Rehabilitation of the Condition of Materials”

In the spring of 2003, a detailed pavement investigation for the proposed pavement rehabilitation of Highway 401 from the Credit River to the Highway 410/403 Interchange, in the Region of Peel was completed. This work project (W.O. 00-23019) was located in the Ministry of Transportation (MTO) Central Region and extends a distance of approximately 6.0 km.

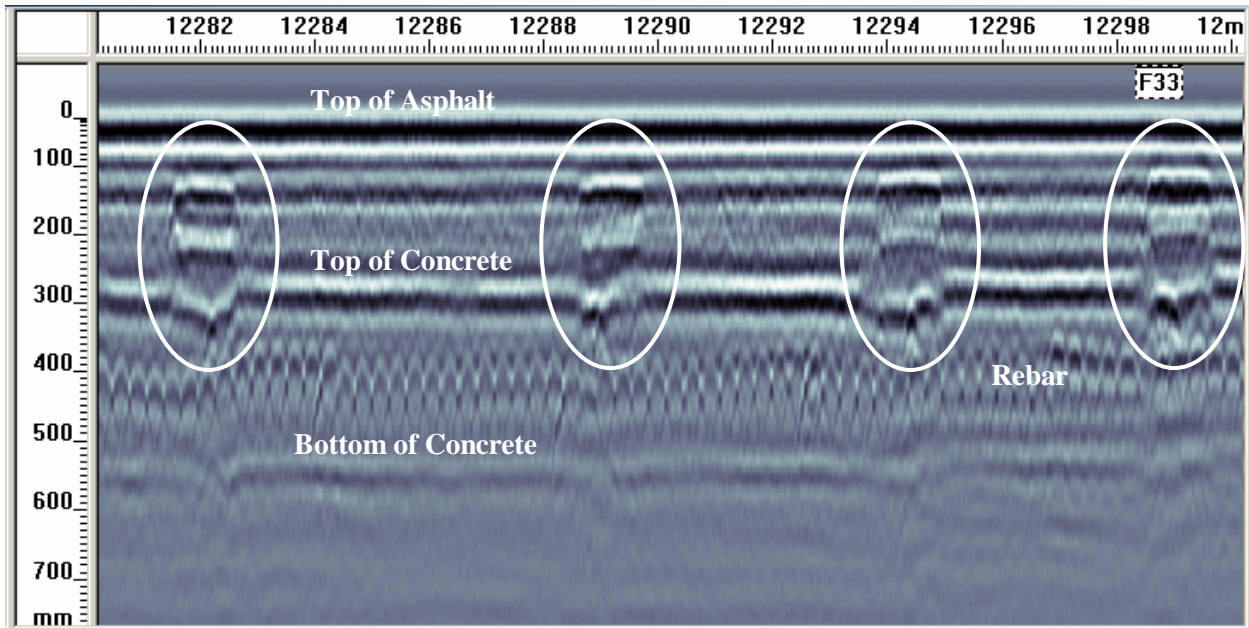
Figure 3. GPR cross-section image showing repaired patches (circled) concealed beneath subsequent resurfacing.

The GPR located numerous subsurface repair patches concealed by subsequent resurfacing. Typical asphalt crack repairs are shown in Figure 3 at the circled locations. Although these repairs did not extend through the PCC base, it does appear that partial depth repairs may have been completed on the PCC base before patching with asphalt concrete. These repair locations were not observed during the detailed condition survey, as this area had been resurfaced after the repairs had been completed.

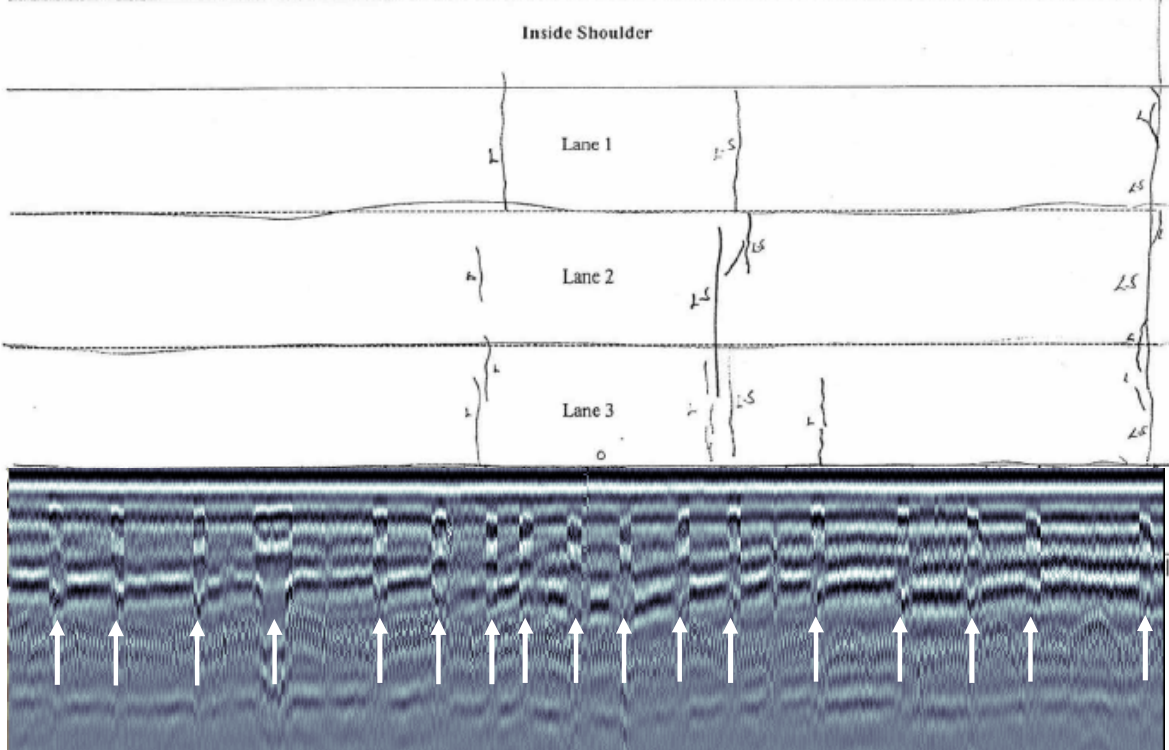
A comparison of the GPR interpretation and the pavement distress mapping survey has been provided in Figure 4. The observed surface cracks correlate with the indicated location of some of the repair patches. The 100 m section displayed had 17 repair zones, typically 1 m in length and not visible on the pavement surface.

Figure 4. A comparison of GPR interpretation with the detailed pavement distress mapping. (Note: The arrows indicate the location of the repair patches that can also be seen in the GPR cross-section image. Note that the GPR data is shown in the outside shoulder location, but applies to Lane 3.)

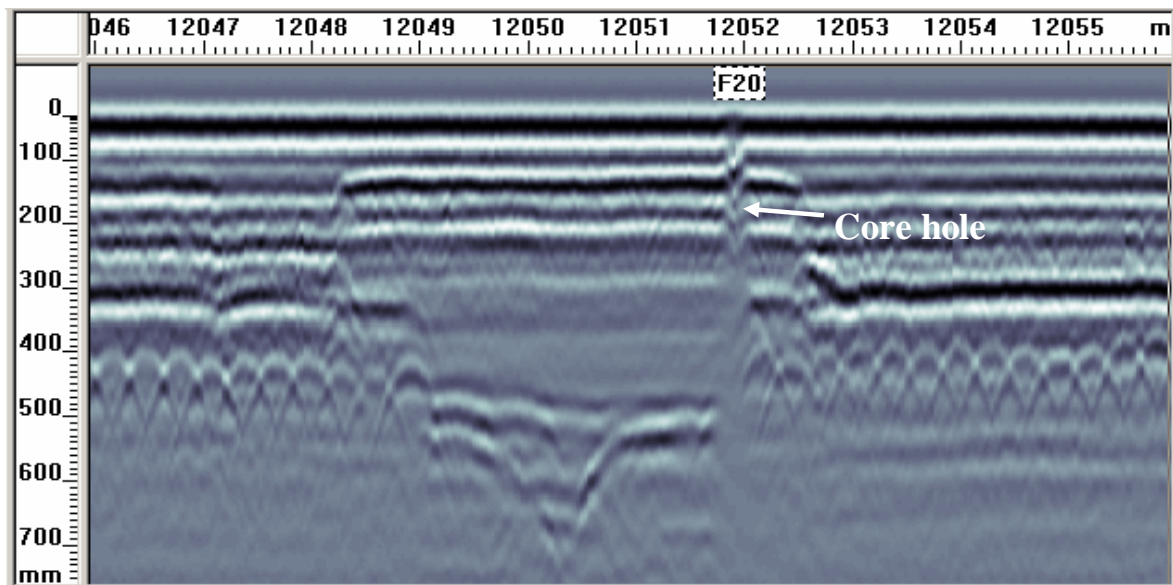
From the information provided by the core/borehole advanced at Station 12+050, no PCC base was found to underlay the asphalt surface. The missing PCC base observed in the core was confirmed by the GPR (Figure 5) survey that showed a full-depth patch, with PCC base removal over a 3 m interval from 12+049 to 12+052. The core/borehole location is identified by the fiducial marker F20, marked during GPR data collection, and the empty core hole can also be seen in the GPR image directly below the fiducial marker.

Figure 5. A core/borehole located in a full-depth repair.

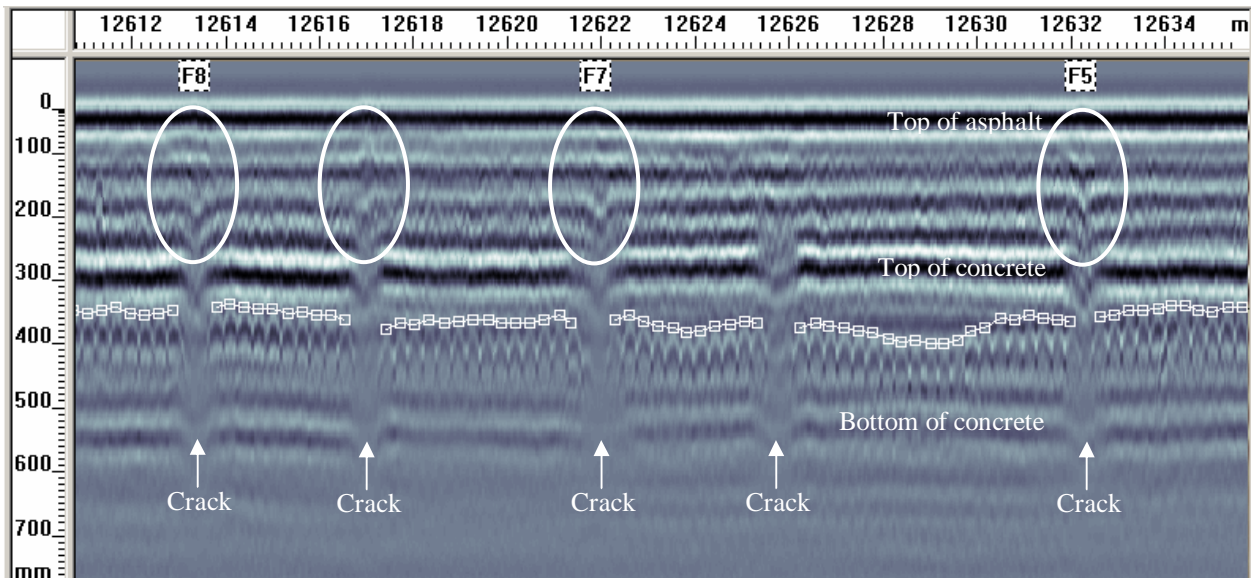
The location of cracks and joints through the PCC can be identified in the GPR images by breaks in the horizons at the top and bottom of the PCC layer, sharp offsets in the depth to the top of the PCC layer, abrupt changes in slope of the top of the PCC layer and the presence of scattering hyperbolas at the top of the PCC base near the center of the repair zones. Some of these effects are visible in Figure 6 where the cracks have been identified. In some cases there is a disruption in the normal horizontal layering within the asphalt layer that is attributed to a crack penetrating through the asphalt indicating that there is potential movement at the crack in the PCC layer. A number of these crack manifestations are seen below in the GPR cross-section image. It is clear

from the GPR cross sections that many of the cracks in the PCC layer also occur at the location of the concealed repair patches.

Figure 6. GPR cross-section image showing joints/cracks and rebar. (Note disruption in asphalt above PCC indicating active crack at circled locations. The fiducials F5, F7 and F8 at locations of surface cracking observed during GPR data collection. The symbols at the apex of each scattering hyperbola mark the locations of each individual rebar.)

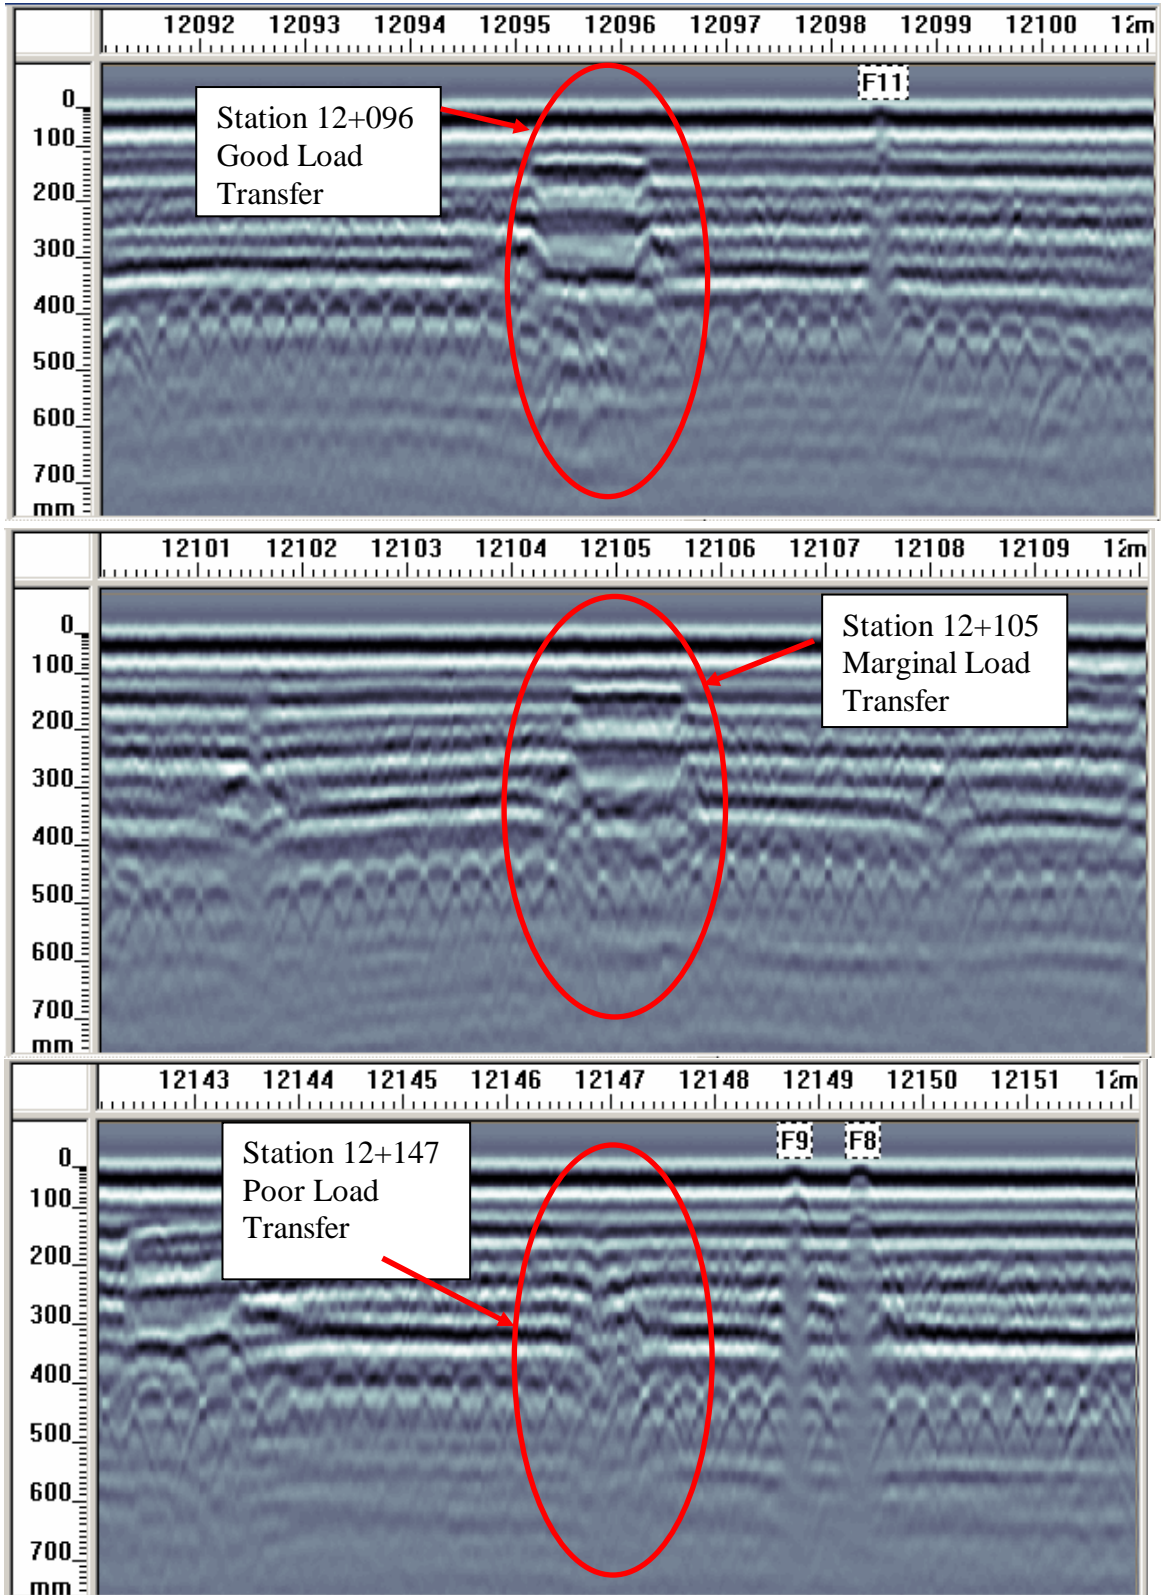
From the GPR survey, there is a noticeable difference between each of the three-load/deflection test locations. Disruptions at the bottom of the concrete reflectors are visible at all three crack locations, which indicate the likelihood of a possible joint/crack location in the underlying PCC base.

At Station 12+096, the GPR image identifies a subsurface full-depth repair area, which would explain the low severity crack reflecting through the surface course. The FWD testing at this location measured load transfers of 80 percent at the approach-side, and 84 percent at the leave-side to indicate a good quality of load transfer. Although the area had been previously repaired (prior to overlay), the image appears to be relatively consistent throughout the repair area, with no major disruptions.

Figure 7. GPR cross-section images at three load/deflection test locations. (Note: Fiducial markers F8, F9, and F11 are core locations.)

A partial depth repair area was identified at Station 12+105, and at this location the FWD testing measured a marginal load transfer. At this crack location, movement of the PCC base is noticeable on either side of this repair area. The additional movement of the tilted PCC slabs would increase the rate of deterioration at this crack location, and would explain the reduction of load transfer at this crack location.

Poor load transfer was measured on the low severity crack at Station 12+147. Unlike the previous two crack locations, no previous repair areas can be seen at this location, however disruptions are noticeable within the asphalt and PCC layers. Prior to the recent resurfacing, this distressed area had been overlooked for repair. As a result, cracking had reflected through the overlay to deteriorate the surface course.

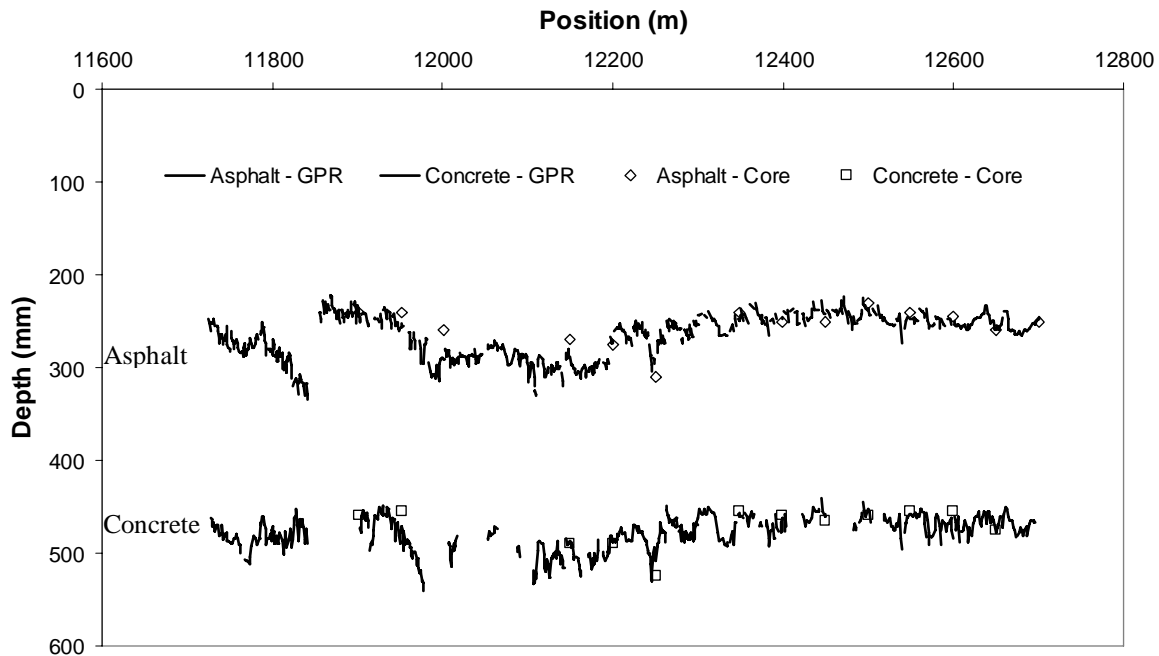
The results of the horizon picking process (Figure 8) show substantial variation in the depth of the asphalt and concrete. The core data results are quite comparable to the GPR determined depths. The average RMS deviations of the GPR depths compared to the core depths were found to be 3.1 mm for the asphalt layer and 3.5 mm for the concrete layer.

Figure 8. Depths of asphalt and concrete layers determined from GPR compared with core data. (Note: Cores collected at repair zones are not included.)
