Redwood Bridge – Rehabilitative Maintenance and Related Works

Paper prepared for presentation

of the 2007 Annual Conference of the
Transportation Association of Canada
Saskatoon, Saskatchewan

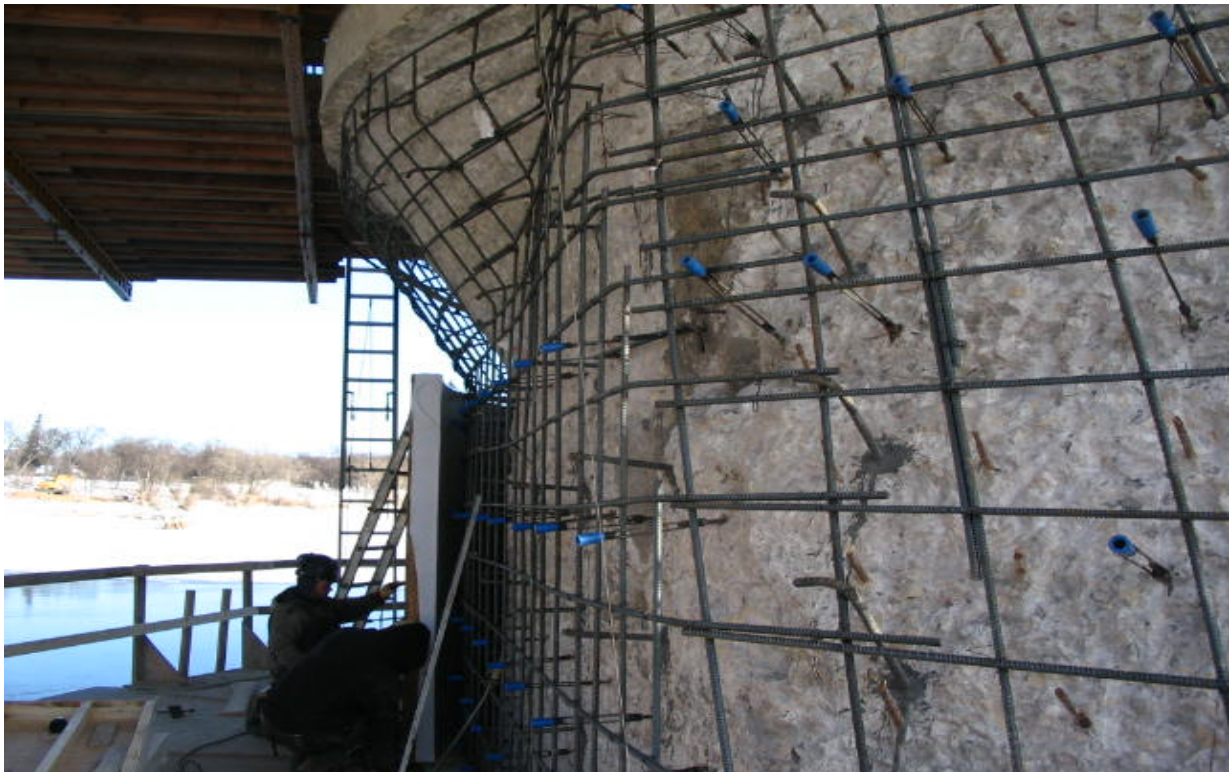
All the piers in the river were in poor condition. Both the concrete and ice breaker were deteriorated. A minimum 150 mm of deteriorated concrete was removed from the pier. All of the piers were encased with a minimum of 300 mm thick reinforced concrete that was poured on the pier surface. 15M dowels, spaced at 300 mm on centre were installed on the pier surface to make sure that the new concrete would adhere to the existing pier.

Figure 2. The pier concrete encasement reinforcing cage

In addition, all the superstructure repair work below the bridge deck in the designated navigational channel had to be completed before the shipping season began. Figure 2 shows the removal of the pier concrete encasement reinforcing cage.

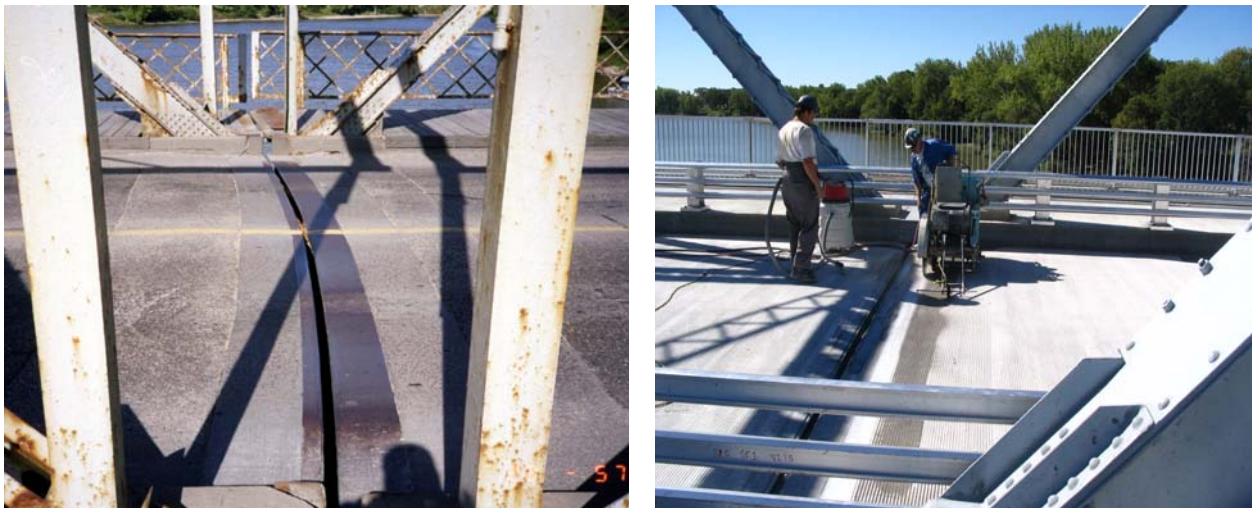
The open circular expansion joints for the swing span and other expansion joints on the bridge had to be replaced with modern straight expansion joints with box seals, as shown in Figure 3. The existing top of the bearing seats were covered with winter sand and the bearings were severely corroded. The bearings had worn, moved out of alignment, and had ceased to function.

Figure 3. Replacing expansion joints

All the existing bearings were removed and replaced by modern steel reinforced elastomeric fixed and expansion bearings. Extensive preparation work was required prior to installing the new bearings. The steel trusses were raised, one at a time, for the removal of the existing bearings and installation of concrete pedestals. The final adjustments to the bearings were made for the installation ambient temperature.

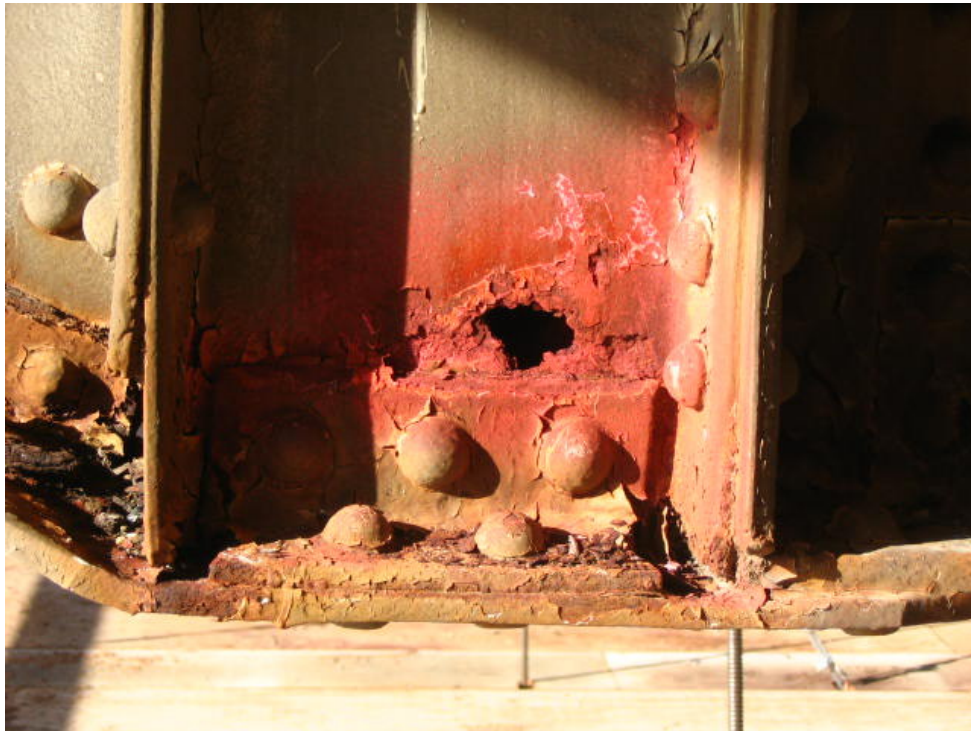
Significant corrosion and section loss occurred at the bottom of the vertical members of the through truss. These members were fabricated from back-to-back channels. All these deteriorated sections were removed and replaced by similar sections. Figure 4 shows a sample of the deteriorated steel structural component.

Figure 4. Bottom truss vertical member rusted through

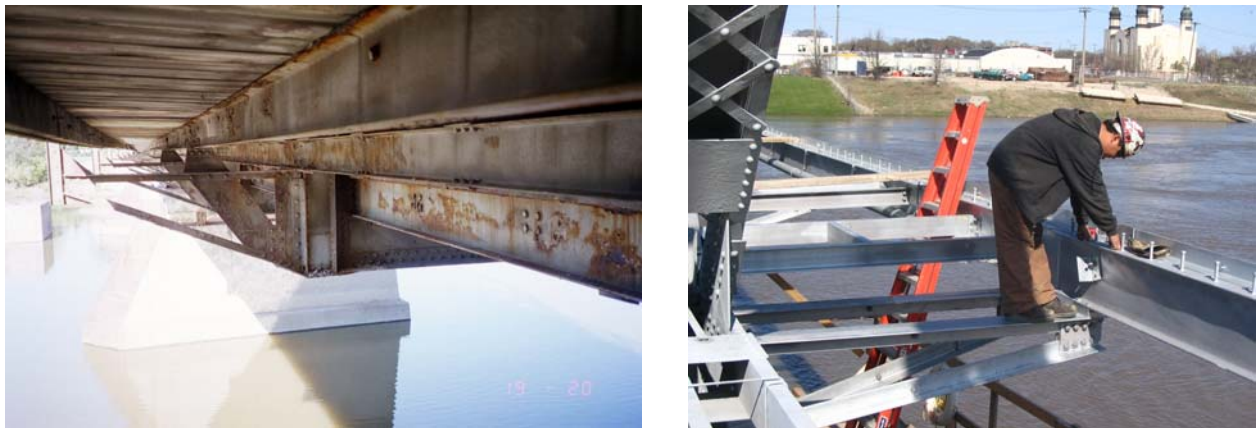
The existing wooden sidewalk and railing system on each side of the bridge were unsafe for pedestrians. All the wooden sidewalks, railings and supporting elements were removed and replaced with reinforced concrete sidewalks with curbs and railings. Galvanized metal decking was used as a stay-in-place form and new sidewalk supporting elements were installed as shown in Figure 6. The new sidewalks are wider than the existing sidewalks, and were designed to carry a small underbridge crane and snow removal equipment. The sidewalk support brackets were also designed to carry two forcemains for the City of Winnipeg Water and Wastewater Department.

Figure 6. Existing and new sidewalk support brackets

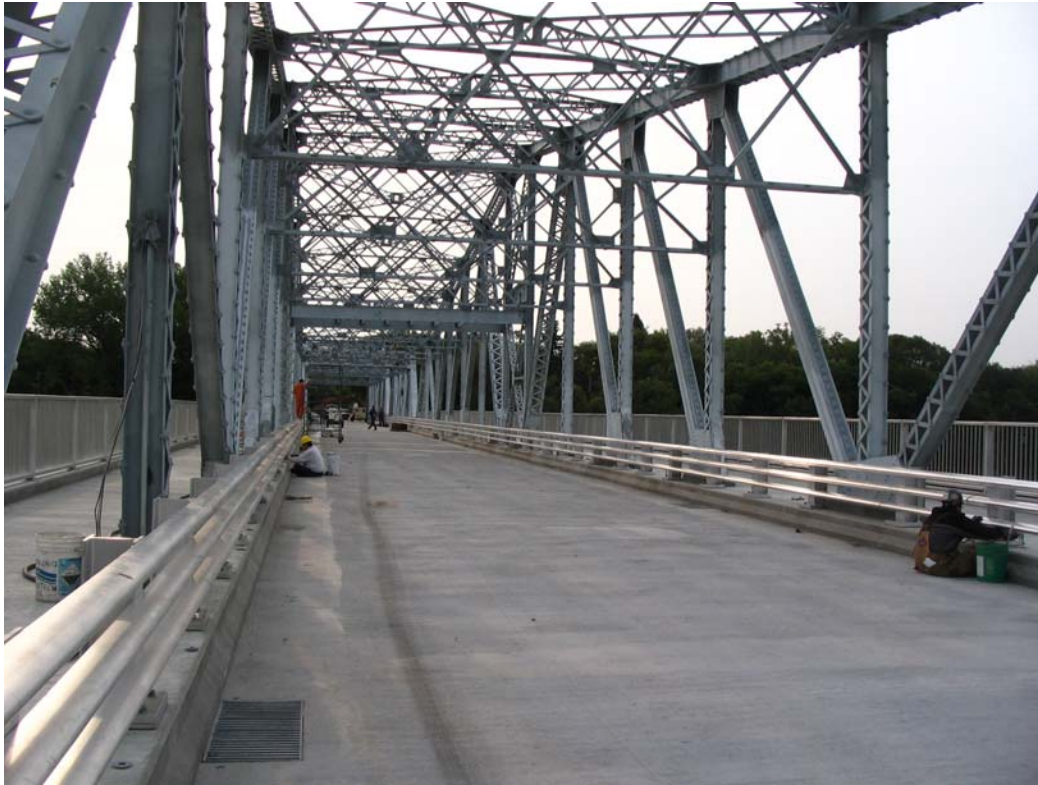
The existing bridge did not have any railing system to prevent errant vehicles from hitting the vertical and diagonal members of the steel through trusses or pedestrians on the sidewalks. To improve the safety on the bridge, a bridge railing system was installed. It consisted of aluminium rails and posts as shown in Figure 7.

Figure 7. Bridge traffic railing system

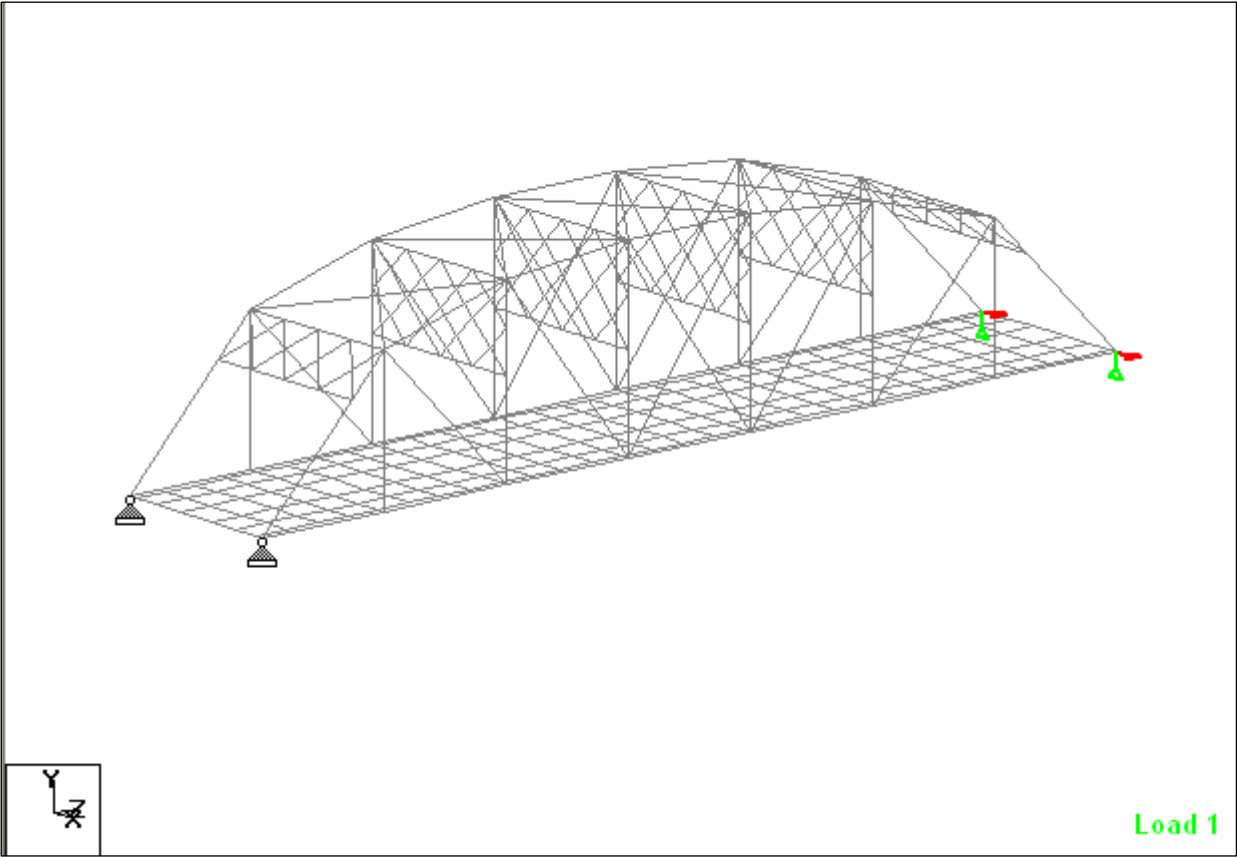
The portal frame knee braces of this bridge were damaged frequently by over-height trucks, which resulted in costly repairs. To prevent this from occurring, a structural analysis was carried out to determine whether or not the knee braces at the portal frame could be removed without any negative impact on the performance of the existing trusses. Three dimension models of the trusses were generated and subjected to various combinations of wind and truck loadings, as shown in Figure 8. Based on the analytical results, all the knee braces on the portal frames were removed and thereby minimized the over-height trucks hitting the trusses.

Figure 8. Three-dimensional analysis of a through truss

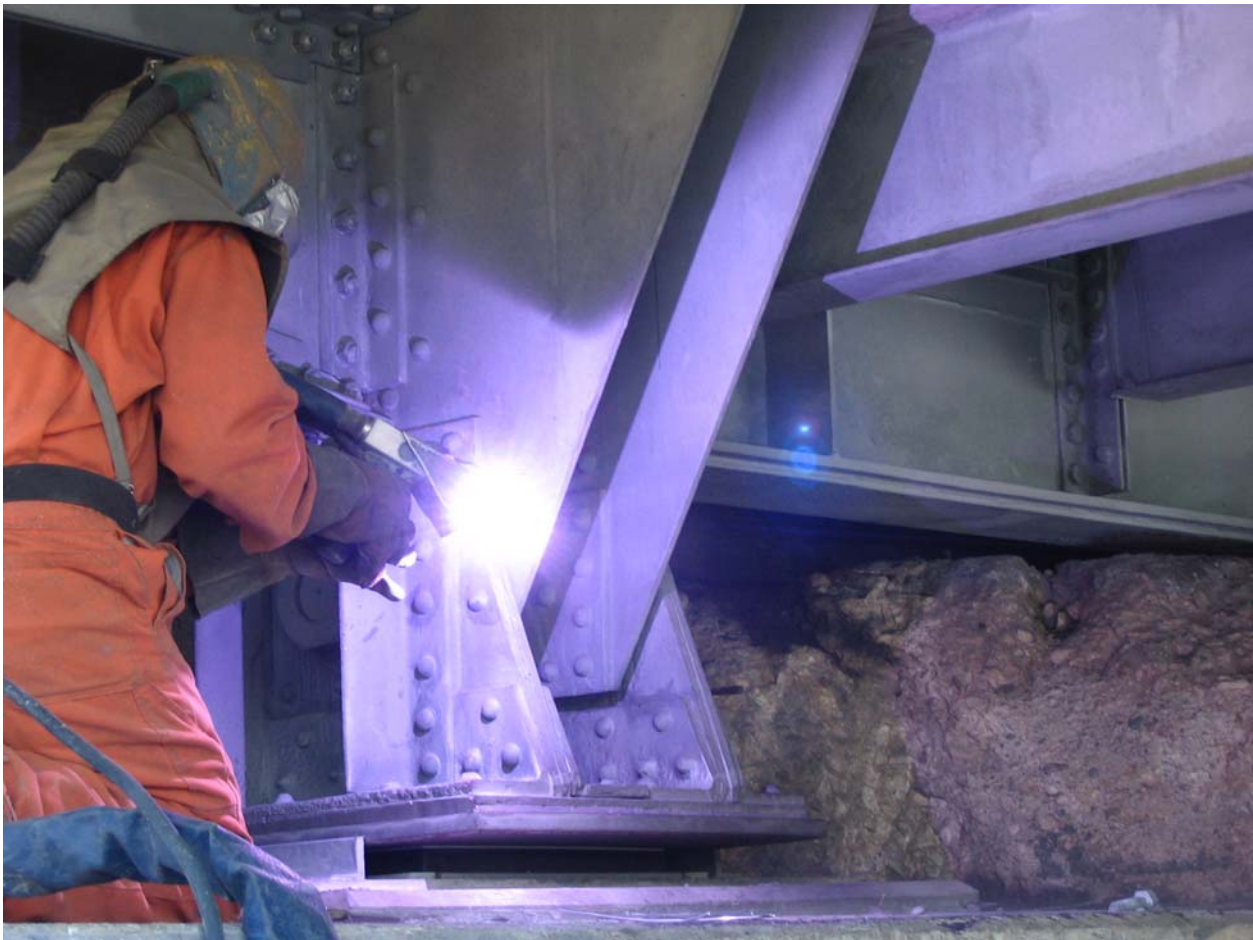
The entire bridge was rustproofed by applying molten zinc to all steel surfaces. Extensive preparation of steel surfaces is required prior to the application of molten zinc. A high-pressure water wash was used to effectively dissolve and wash away de-icing chemicals, such that the residual level of chloride ion content of 30 mg/m² was not exceeded. Any area exceeding this upper limit required high-pressure water wash and/or re-blasting. Freshly prepared steel surfaces were coated as quickly as possible. If the freshly prepared steel began to rust prior to the coating, the steel was re-blasted to meet the Steel Structures Painting Council (SSPC) Specification.

Figure 9. Zinc metallizing process

Most of the existing connections were riveted, including the batten plates, gusset plates, filler plates and structural members, as shown in Figure 9. With regular maintenance, this coating will last for at least 40 years.
