Fish Habitat Compensation Projects along Yukon Highways

Paper prepared for presentation at the Session
Fish Habitat Compensation –
A Requirement for Some Transportation Projects

Of the 2008 Annual Conference of the Transportation Association of Canada
Toronto, Ontario

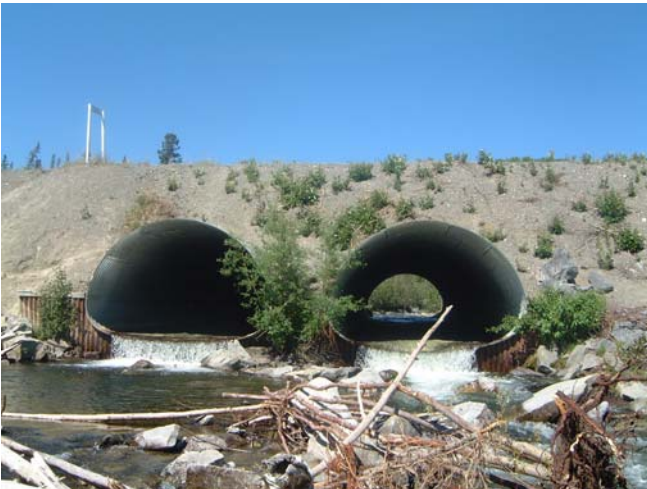
In 1967, a bridge spanning Marshall Creek was replaced with two 5 m wide closed bottom multi-plate arch culverts. Over time, scouring of the outlet pools resulted in a significant drop at the outlet and the culverts were became a barrier to fish. In 2002 for instance, hundreds of Arctic grayling were observed attempting, unsuccessfully, to enter the culverts (1).

The fish passage problems were due not only to the velocities, but also to the drop i.e. the jump at the outlet. The pool directly below the culverts had a maximum depth of 0.65 m (Table 2). An adult Arctic grayling could jump up to 0.52 m (calculated from Table 3 - pool depth should be 1.25 times the jump height) with a measured pool depth of 0.65 m. The perch height was slightly more (0.55m) so a strong adult could have made it. However, even if the pool depth was increased 1.25 times, the height of the drop would likely still be too high for adult and juvenile grayling, whitefish, and Dolly Varden (assuming rainbow trout are generally considered better jumpers than these species and the maximum jump height for a 120 mm rainbow trout is 0.6 m).

Figure 1. Culverts prior to restoration works. Photo D. Stillwell (YG HPW).

We met the objective by backwatering the culvert and creating a deeper pool on the outlet with a Newbury riffle (section 2.3.1). This design decreased the jump height into the culvert and increased the pool depth below the culvert. The velocities were reduced by installing baffles in one of the culverts (section 2.3.2).

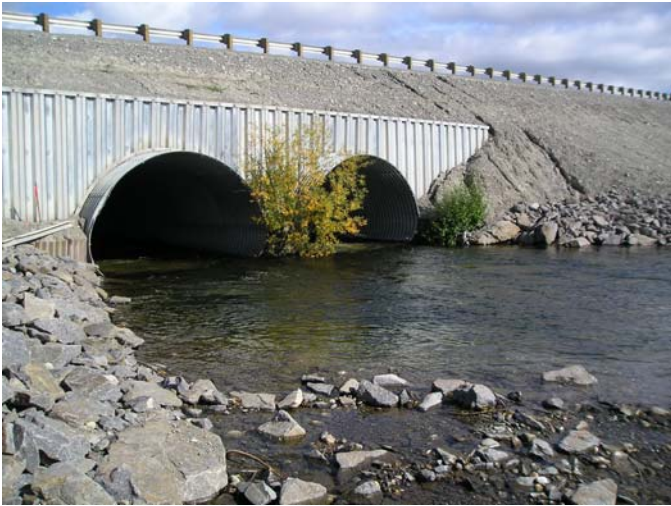
Figure 6. Culverts post construction. Photo T. Omtzigt (YG HPW)

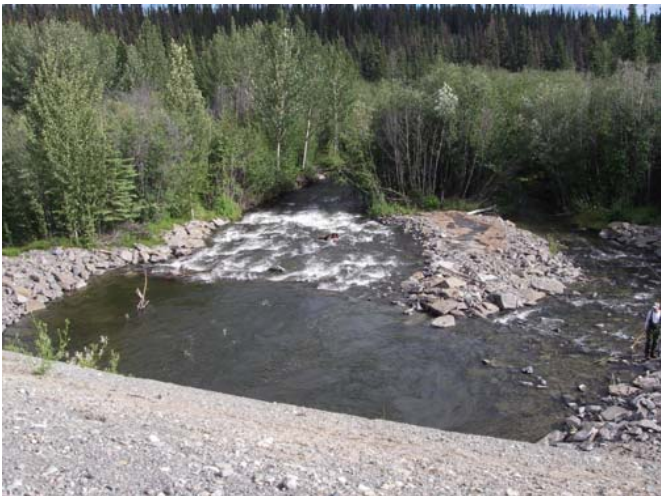
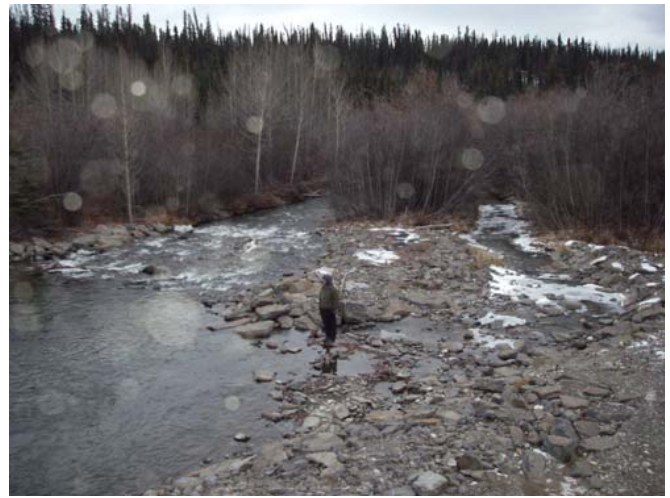
Follow-up monitoring in 2007 (4) showed that the fish passage restoration structures were functioning as designed. The Newbury Riffle backwatered the culverts during all observed flow levels and the baffles provided resting areas (i.e. – lower velocities) within the culvert for migrating fish. While velocities over the baffles may limit migration of juvenile fish through the culverts during high flow levels, it appeared juvenile fish were getting by (likely opportunistically,

i.e. during some flow levels). The lower section of the primary riffle appeared steeper than designed and should be monitored in future to find out if it requires modification.

Figure 7. View of Newbury Riffles in July (left) and during low water levels (right October 2007). Photos EDI.

For this project, the downstream face of the Newbury riffle was designed to mimic a natural riffle that occurs in Marshall Creek with a maximum slope of 5% (1). The crest of the riffle was built 16 m away from the outlet which created a large resting pool. To backwater the culvert to the outlet (rather than inlet), with a 5% gradient, the riffle required a crest that was approximately 1 m high and 25 m long. The site plan (Figure 4) and the structure profiles (Figure 5) show the design details.

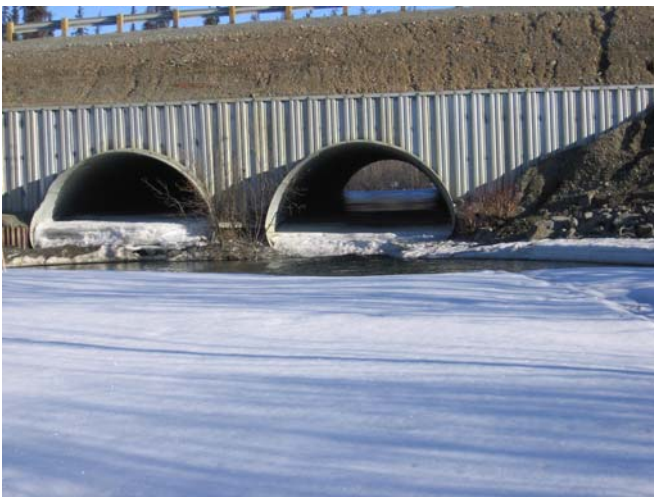
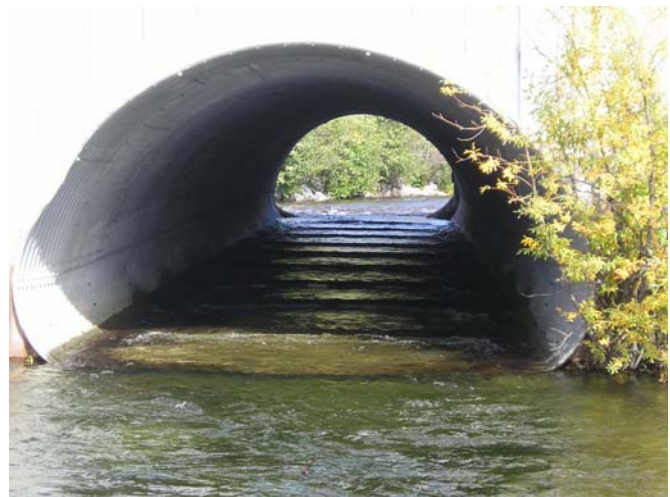
The baffles were installed in the winter of 2006. There was no flow in the culvert at that time, but a large amount of ice had accumulated in the bottom (Figure 8). The contractor hired for the work set up propane heaters and melted the ice out at each section where a baffle needed to be installed. The baffles were supposed to be bolted in place. However, the prescribed type of bolt couldn't be installed in the frozen soil surrounding the pipe, so the baffles were welded to the bottom instead.

Figure 8. Culvert on left received the baffles; note ice in culverts. The picture on the right shows the baffles in place. Photos T. Omtzigt (YG HPW)

There are different types of baffles available and we used a modified version of a Wildstone baffle insert from Atlantic Industries Limited (7). The design included nine baffles with 4 m spacing.
