# **DEVELOPMENT OF CONCRETE LINK SLABS TO ELIMINATE BRIDGE EXPANSION JOINTS OVER PIERS**

Paper prepared for presentation

of the 2008 Annual Conference of the  
Transportation Association of Canada  
Toronto, Ontario

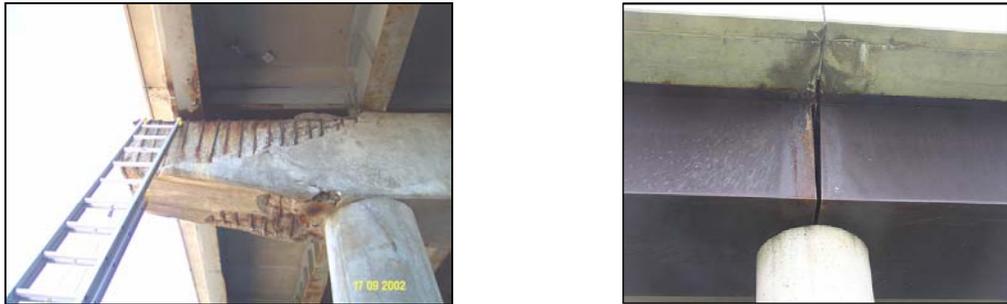
It was common practice before the 1970's to design multiple-span bridges as single-span structures, which were simply-supported on piers and then connected by expansion joints or paved-over joints at the pier locations (Figure 1). While this system provided a simple and effective structural solution, it brought along a range of maintenance issues that have compromised the durability of many of these structures. Historically, bridge expansion joints have never performed up to design expectations. Their recurring inability to provide reliable and effective long-term leakproof performance has led to early leakage of chloride-contaminated water through those joints, thereby causing premature corrosion at girder ends and supporting substructures below. Typically, the damage is exemplified by cracking, spalling and disintegration of the concrete deck slab in the area adjacent to the joints as well as spalling and delamination of the concrete around the bearing seat and pier cap below (Figure 2).

Figure 2: Typical Corrosion Damage Caused by Leaking Deck Joints

To address this problem, the Ministry of Transportation of Ontario (MTO) has tried to eliminate the expansion joints in older bridges by using a number of approaches that included converting the simply-supported spans into a semi-continuous deck system by encasing the girder ends in a monolithic transverse concrete diaphragm or providing continuity of the concrete deck slab over the piers by means of a link slab segment while keeping the supporting girders discontinuous. This paper discusses some recent deck rehabilitation projects, structural solutions that were adopted, their performance and subsequent improvements that were made based on field experience and finally a comparison of the costs of the different systems.

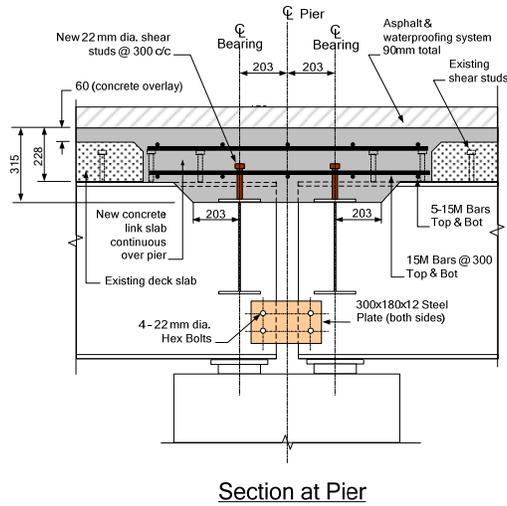
Section at Pier

Field Observations: The rehabilitated bridge has been in service for over thirteen years and based on the biennial visual inspections of the bridge, the link slab detail has performed well. There has not been any evidence of cracking or water leakage at the soffit of the link slab and the condition of the asphalt over the link slab has been generally good. This system was implemented as a trial project and has not been used as a routine method for eliminating deck joints.

Figure 3: Link Slab Details for Trent River Bridge

Rehabilitation Details: The deck was rehabilitated in 1995, when the expansion joints at the piers were eliminated and the deck slab was made continuous at those locations, while the girders remained discontinuous. A 1.2 m wide section of the deck at the pier locations was replaced with a link slab with an overall haunch depth of 315 mm and topped with a 60 mm thick concrete overlay (Figure 3). The link slab was reinforced longitudinally with top and bottom layers of 15M steel bars at 300 mm spacing and transversely by two layers of five 15M steel bars at both top and bottom of the slab. The haunched section of the link slab was made composite with the existing transverse diaphragm members by a single row of 22 mm diameter shear connectors spaced at 300 mm on each diaphragm. The webs of the existing girders were

connected by two 12 mm thick splice plates that were bolted to the girder web with four 22 mm diameter hex bolts.

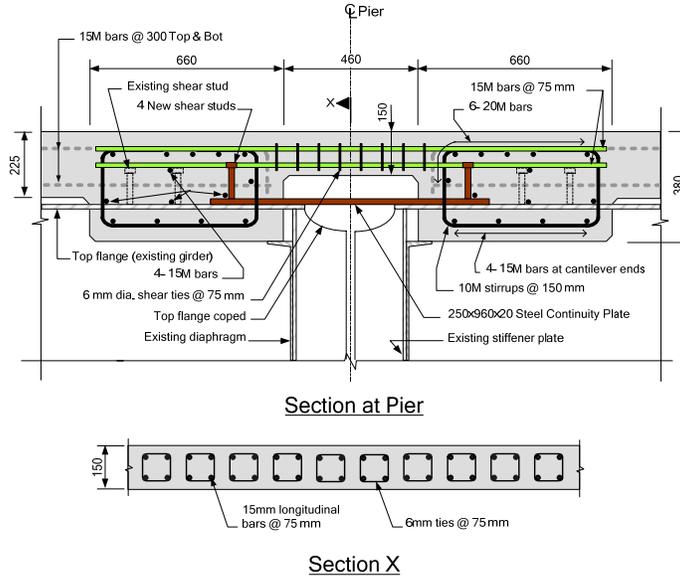
Field Observations: Visual inspections of this structure in 1997 and 1998 revealed that the link slab was performing well structurally. There was no evidence of cracking or water leakage at the soffit of the link slab itself and the condition of the asphalt over the link slab was good. However, there were signs of water leakage at the fascia of the deck in the area just below the bond breaker that was placed underneath the barrier wall. This detail would need to be improved to prevent water from seeping through the bottom of the barrier wall.

Figure 4: Link Slab Details for Kent County Road No. 10/ Hwy 401 Underpass

The link slab was 150 mm thick and 460 mm wide and spanned between two haunched beams, 380 mm deep by 660 mm wide, which were designed to provide the rigidity such that any rotation and cracking were confined to the link slab element. The relatively thin and short link slab provided the continuity over the pier supports and was designed to accommodate the end-rotations of the simply-supported girders. The overall width of slab that needed to be cut out and replaced by the new link slab was about 1.78 m.

A portion of the top flange of adjoining steel girders was coped to provide rotational freedom at the girder ends. A 20 mm thick steel continuity plate was welded to the top of adjacent girders primarily to maintain a uniform gap between the top flanges during construction and also to minimise the possibility of cracks forming in the link slab concrete during the initial curing due to traffic on the adjoining lane. To further protect the link slab from possible salt ingress, rubber membrane reinforcement was laid over the link slab to reinforce the waterproofing system.

The link slab was reinforced longitudinally with 15M bars @ 75 mm spacing (top and bottom) and transversely with 15M bars @ 150 mm (top and bottom). In addition, shear reinforcement was provided in the link slab and consisted of 6 mm diameter stainless steel ties spaced 75 mm apart. These reinforcing details were designed for a maximum rotation of 0.17 deg (0.003 rad) at the girder ends and to satisfy the OHBDC [2] serviceability requirement of a maximum crack width of 0.25 mm.

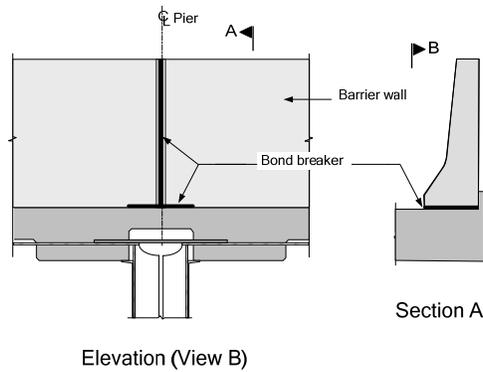
Figure 5: Barrier Wall Details over Link Slab at Kent County Road No. 10/ Hwy 401 Underpass

To allow full unrestricted rotation of the link slab due to live load on the structure, it was decided to install a bond breaker underneath the barrier wall over the full length of the link slab. In addition, full discontinuity of the barrier wall was ensured at the pier centreline by installing a 13mm rigid bond breaker over the full depth of the barrier (Figure 5).

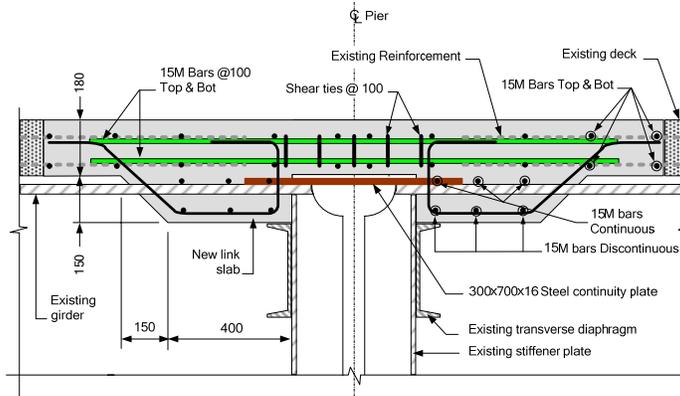
Field Observations: Visual inspections of this structure in 1998 revealed that the link slab was performing well structurally. There was no evidence of cracking or water leakage at the soffit of the link slab itself and the condition of the asphalt over the link slab was good. In addition, there were no signs of water leakage at the fascia of the deck in the area above the bridge pier supports. This confirmed that the revised barrier wall detail used in this bridge (Figure 7) had resolved the water leakage problem that was observed at the Kent County Road No. 10/Hwy 401 Underpass. However, a subsequent inspection in 2000 revealed the presence of medium to wide cracks under the fascia and based on the efflorescence that was observed around the cracks, water leakage was still occurring.

Figure 6: Link Slab Details for Hwy 427 SBL Overpass @ Dixon Road

Rehabilitation Details: The existing deck was rehabilitated in 1997 as follows: (a) the deck was widened by approximately 6.0 m with the addition of a new 225 mm thick slab, and (b) the existing deck joints at the pier supports were replaced with a continuous 2.0 m wide link slab element that bridged the gap between adjacent girders, which remained discontinuous at the piers. The link slab system (Figure 6) was generally similar to the design used in the first trial application at the Kent County Road No. 10/Hwy 401 Underpass. The main differences were due to the implementation of the recommendations of the new design guidelines, which included revised reinforcement in the link slab and new barrier wall details over the link slab (Figure 7). Note that the shear ties were still used in this structure but they were dropped in later projects.

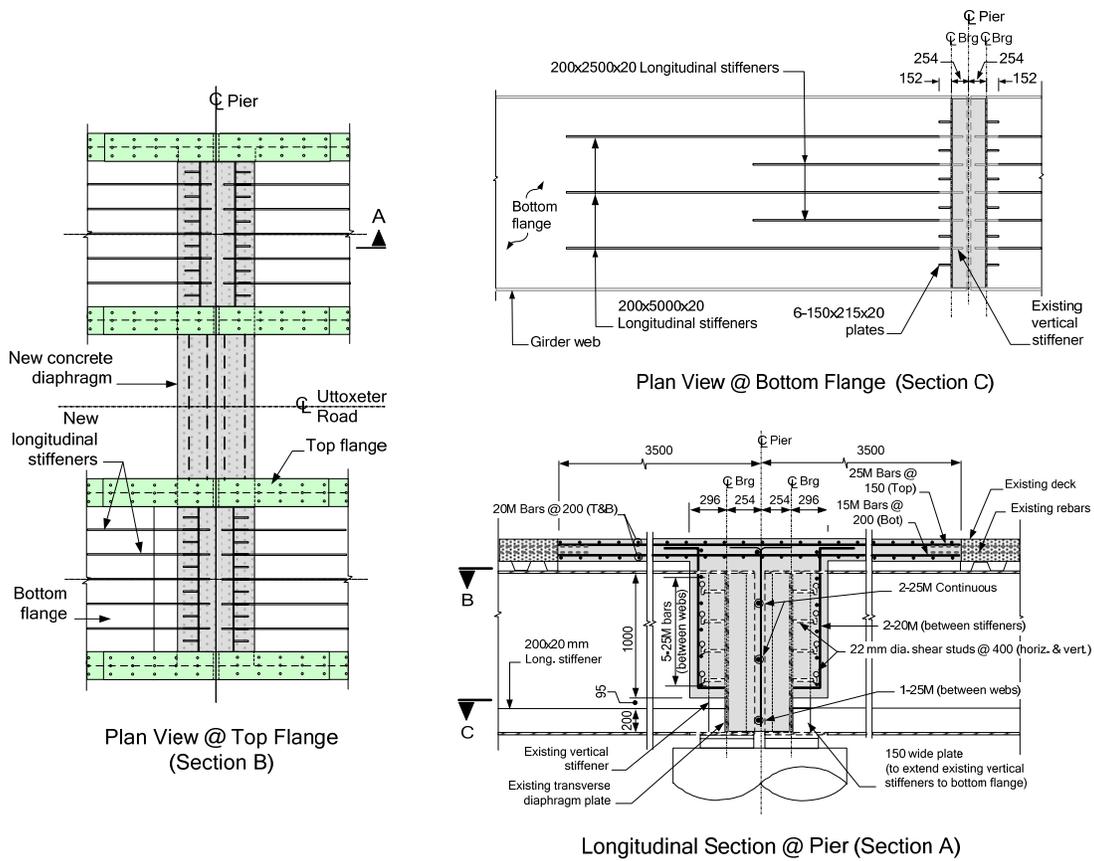
Field Observations: Visual inspections of this structure in 2004 revealed that the rehabilitated bridge was performing well structurally. There was no evidence of cracking in the new concrete diaphragm or the new deck slab section and no visible reflective cracks were found on the

asphalt pavement within the rehabilitated area. However, some hairline cracks were observed on the new parapet wall sections over the pier location. It was noted that the crack patterns were generally vertical and were symmetrical on both walls. Some of the cracks were observed to extend into the sidewalk. These crack patterns indicate that tensile stresses were induced in the parapet walls due to the negative (hogging) moment that developed over the pier after the simply supported spans were made semi-continuous. This suggests that the longitudinal rebars in the barrier wall could have mistakenly been left continuous through the control joint.

Figure 8: Semi-Continuous Girder Details for Uttoxeter Road/Hwy 402 Underpass

The main rehabilitation details were: (i) the steel boxes were strengthened with additional stiffeners in the bottom flange and transverse diaphragm at the pier location and additional steel plates were bolted to the top flanges, (ii) a seven metre-section of the original concrete deck was removed over the pier and replaced with a new slab, which was cast monolithically with a new 1.1 m deep by 1.1 m wide reinforced concrete diaphragm to provide continuity at the pier location, (iii) a 19 mm wide control joint was formed in the parapet walls at the pier centreline location with discontinuity in the reinforcements to minimise negative bending in the parapet walls due to rotation of the box girders, and (iv) the whole deck surface was repaved with a 90-mm thick asphalt and waterproofing layer.

Figure 8 shows the main structural details used to convert the initial simply-supported box girder system into a semi-continuous system for live load. It can be seen that the modifications are extensive with major retrofitting of the steel box girders required to resist the negative moment at the pier support. As a result, the costs of this rehabilitative scheme became expensive. Figure 9 shows the construction work inside the box girder and the completed concrete diaphragm between the box girders.

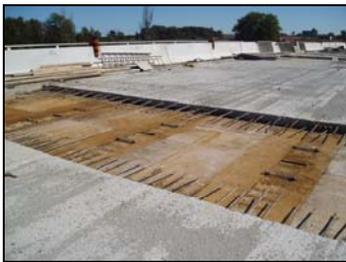
Figure 11: Removal of Strip of Deck Slab at Pier

Construction of the link slab consisted of: (i) removal of a 3.4 m wide strip of existing deck symmetrical about the pier centreline including all existing shear studs within the deck removal limits (Figure 11), (ii) replacement with a new 180 mm thick link slab (Figure 12), which was cast on top of the exposed girders but debonded from the top flanges, (iii) addition of a new 60 mm concrete overlay over the entire deck, and (iv) repaving the whole deck with a 90-mm thick asphalt and waterproofing layer.

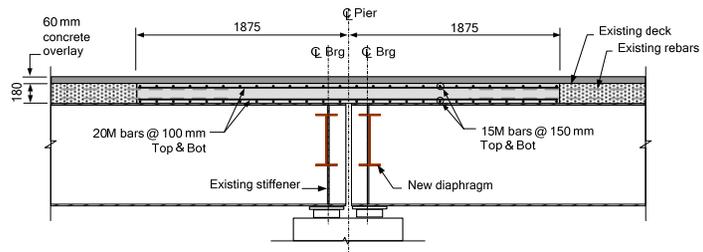
Section at Pier

Field Observations: Based on visual inspections carried out in 2006, the structure was performing well. There was no evidence of leakage in the immediate area of the link slab or cracking in the asphalt wearing surface. However, some minor transverse hairline cracks were observed at the top of the sidewalk above the link slab panel as well as vertical hairline cracks on the fascia of the link slab panel above the pier centreline. It is recommended that a control joint be provided in sidewalks immediately above the link slab, at the pier centreline.

Figure 12: Debonded Link Slab Details for Orford Road/Hwy 401 Underpass

The link slab was reinforced with 20M bars @ 100 top and bottom longitudinally and 15M bars @ 150 top and bottom transversely. Continuity of the longitudinal reinforcement in the link slab was provided by straight laps with existing rebars.

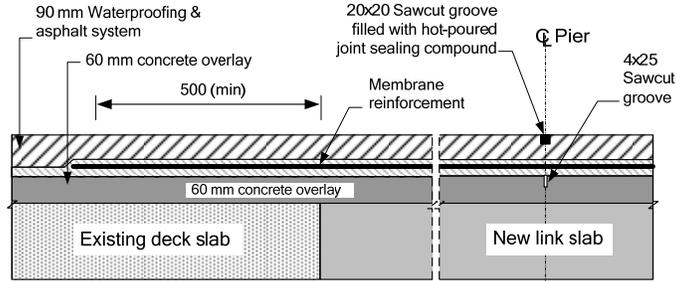
Figure 13: Membrane Reinforcement & Crack Control Details

As cracking of the link slab is expected to occur as a result of the rotational movements at the girder ends, the link slab was further protected by a layer of membrane reinforcement placed over the entire link slab (Figure 13). Additional measures were also taken to control cracking by incorporating (a) saw-cut details along the pier centreline in both the link slab and the asphalt

layer (Figure 13) and (b) a 35mm wide expansion joint detail in the parapet walls at the pier centreline where the reinforcement is also made discontinuous.

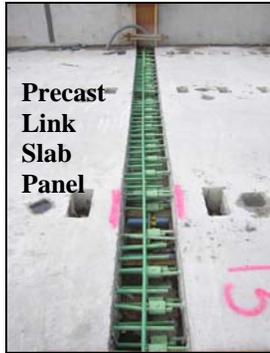
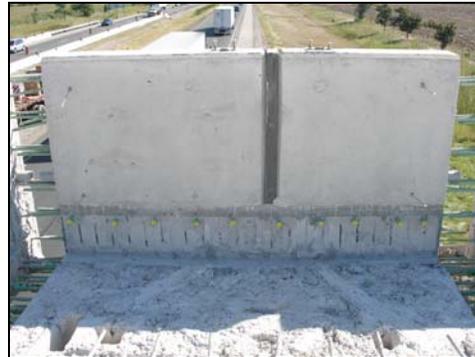
Field Observations: Based on visual inspections carried out in 2007, the structure was performing well. There was no trace of water leakage in the immediate area of the link slab and no cracks were observed in the asphalt wearing surface. However, some minor transverse hairline cracks were seen at the top of the sidewalk above the link slab panel as well as vertical hairline cracks on the fascia of the link slab panel at the pier centreline.

Figure 14: Prefabricated Link Slab Details for Mull Road/ Hwy 401 Underpass

The entire deck was repaved with a 90-mm thick asphalt and waterproofing layer. The link slab was further protected by a layer of membrane reinforcement placed over the entire slab. A 50mm wide expansion joint detail was provided in the parapet wall at the pier centreline, where the reinforcement was made discontinuous (Figure 14(b)).
