Case Study of an Innovative Forensic Investigation of a Dramatic Pavement Failure, 14 Street NW, Calgary, Alberta.

Art Johnston, C.E.T.
Principal, Transportation Practice
EBA Engineering Consultants Ltd.

Joe Chyc-Cies, P.Eng.
Materials & Research Engineer
City of Calgary, Roads

Paper prepared for presentation
at the Introducing Innovation into
Pavement Design and Engineering Session
of the 2009 Annual Conference of the
Transportation Association of Canada
Vancouver, British Columbia

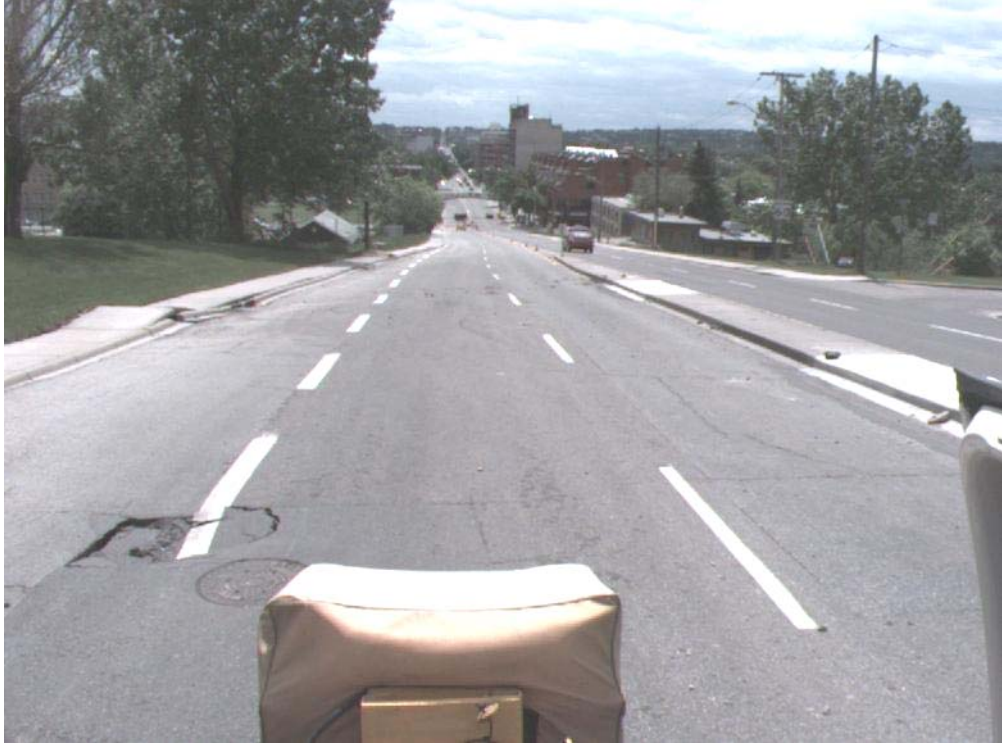
Figure 4: 14 Street NW Pavement Distress

The majority of the distress was exhibited by the northbound lanes. The pavement distresses included severe heave and blow-outs of the asphalt concrete surfacing. Other pavement distresses noted included a severe longitudinal crack along the roadway centre-line (i.e. between the northbound and southbound lanes) at the south end of the section.

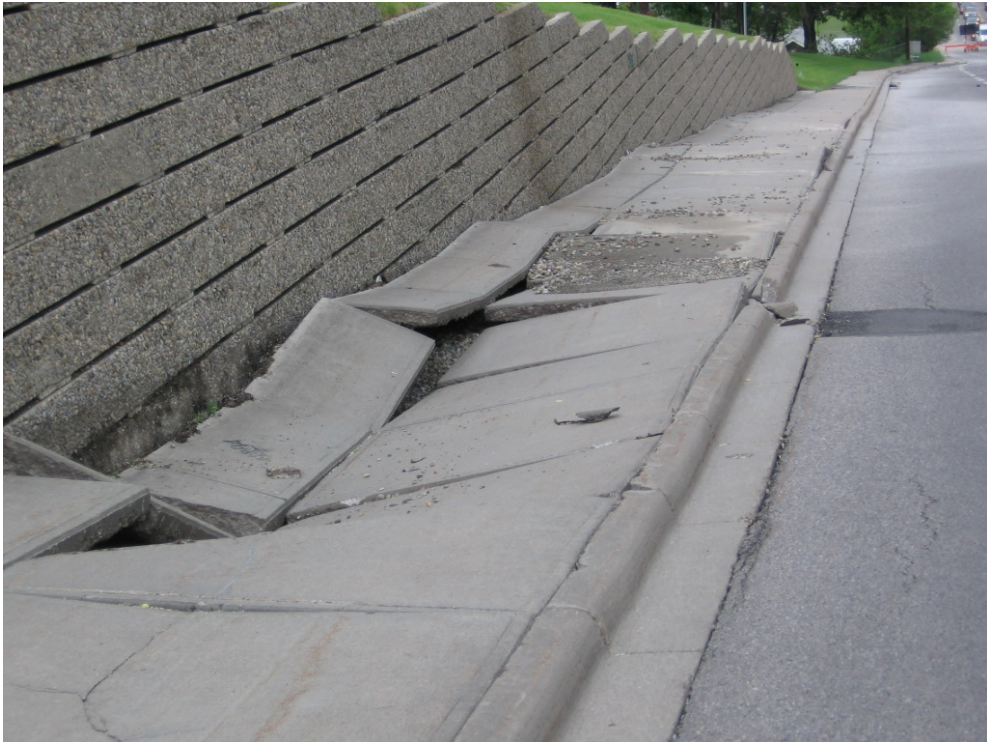
Figure 7: 14 Street NW Sidewalk Distress

In addition to the pavement distress, significant sidewalk distress was noted along the section. This included total concrete slab upheaval and a severe slab faulting. Separation of the monolithic curb and sidewalk and pavement, with in many cases differential vertical movement was also noted. In the south portion of the section there appeared to be significant spalling of the curb and gutter joints, resulting in a 30mm to 50mm gap.

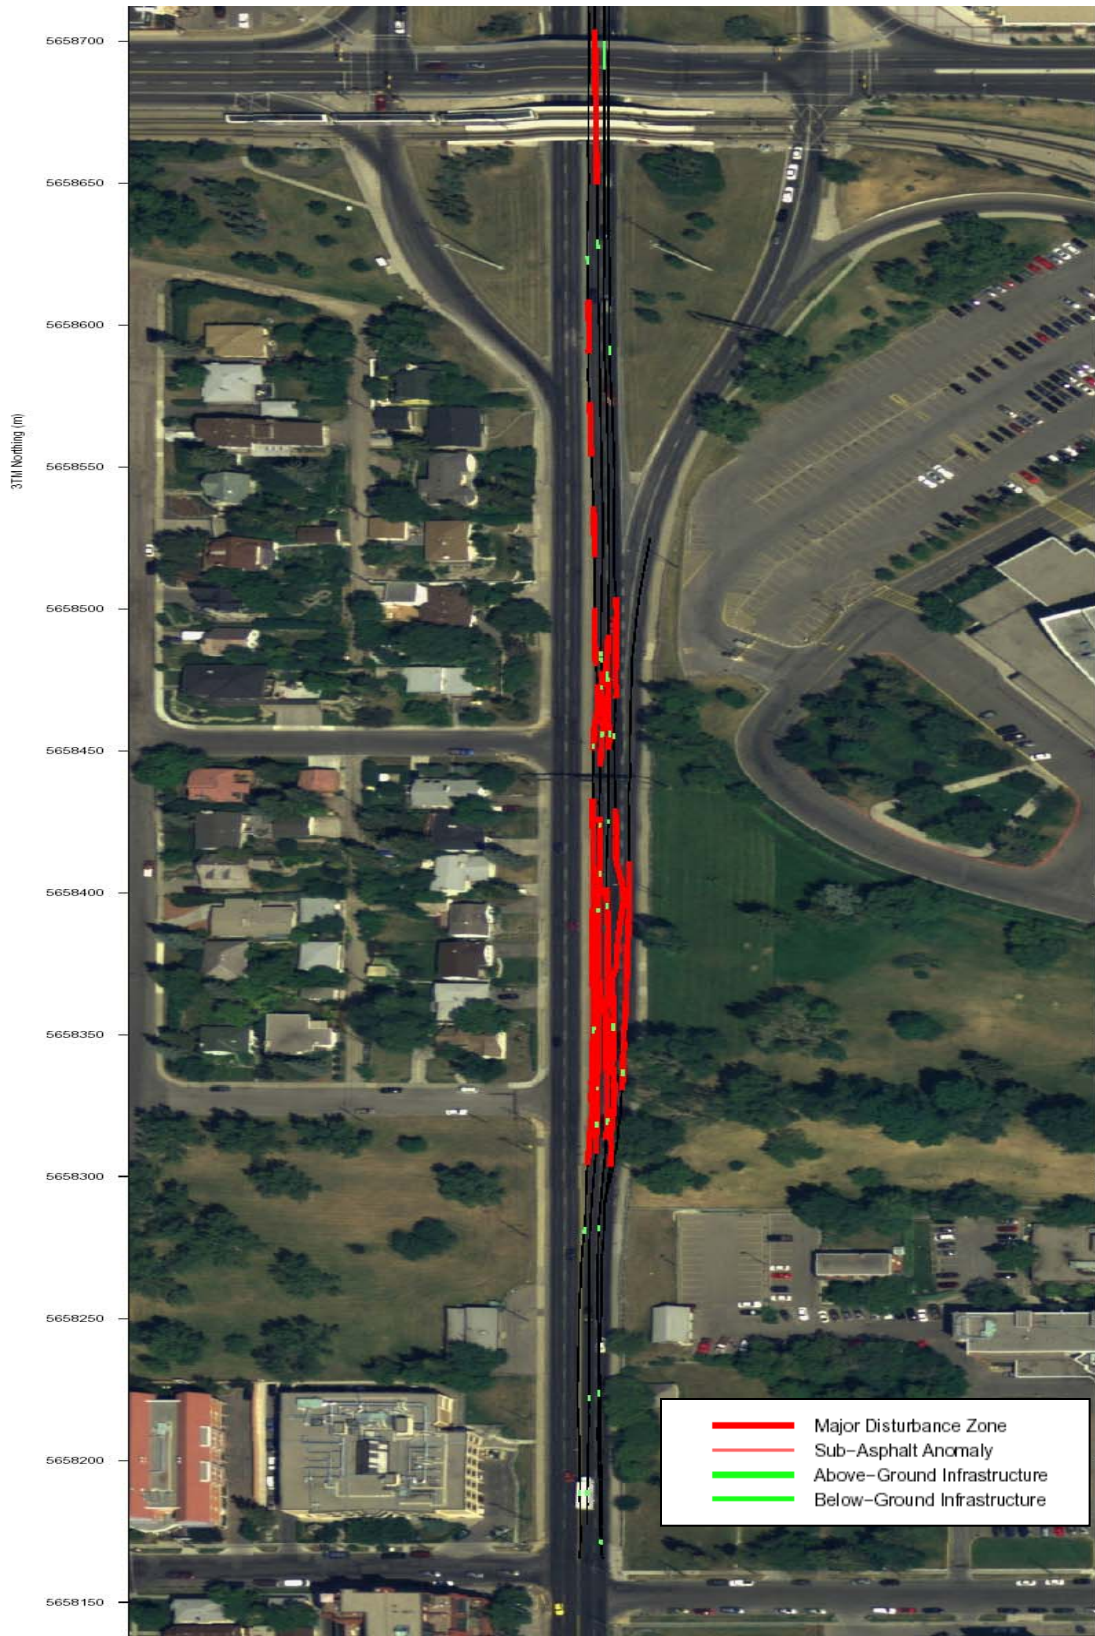
Figure 8: 120 MHz GPR Anomaly Analysis (2 to 3 Metre Depth)

Analysis of the GPR data involved the identification of four distinct types of reflection signatures: above-ground infrastructure (i.e. bridges, overhead signs), below-ground infrastructure (pipes, man-holes, and gutters), major 'disturbed' regions, and individual anomalous 'sub-asphalt' reflectors. Disturbed regions and sub-asphalt reflections were identified by the nature of the profiles in those regions, relative to the nature of the profile in areas that didn't appear to suffer damage (i.e. the extreme northern and southern ends of the survey area).

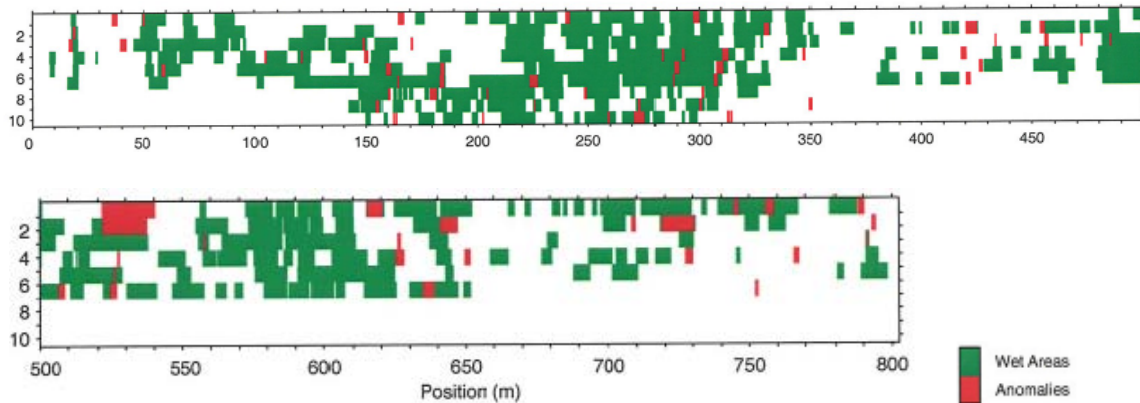
Figure 12: ROAD RADAR™ Subsurface Anomalies Plan Map

This plan map shows the location and areal extent of the anomalies detected between the interpreted Asphalt/Granular Base boundary. These features have been classified as wet areas and anomalies. Wet areas are anomalies delineated by localized dielectric increases. The remaining anomaly features (red areas) are areas in the radar data with abnormal radar signature characteristics at the asphalt concrete/granular base boundary. These signatures were identified as areas where the base material fines may have

washed away due to the heavy flooding, and therefore, represented localised air or water filled voids at the time of survey.

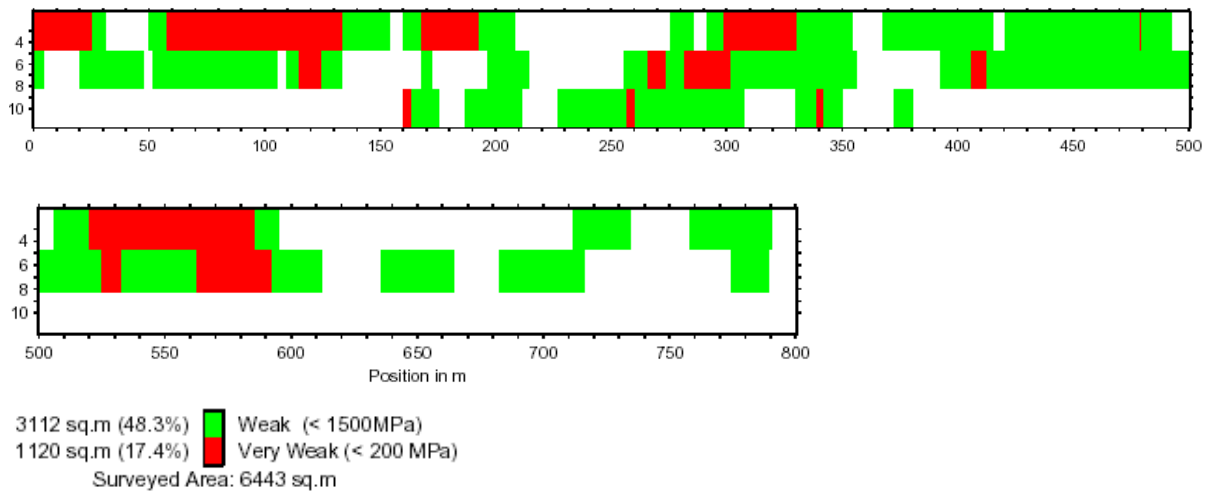
Figure 13: ELMOD Derived Base Resilient Modulus Plan Map

This plan map shows the location and areal extent of the derived ELMOD base layer resilient modulus values. The in-situ post-flood base strength as determined using ELMOD has been divided into three categories: Normal (white areas), Weak (values less than 1500 MPa) and Very Weak (values less than 200 MPa).

As shown by Figure 13, extensive areas of the subject pavement were identified as weak or very weak granular base support.

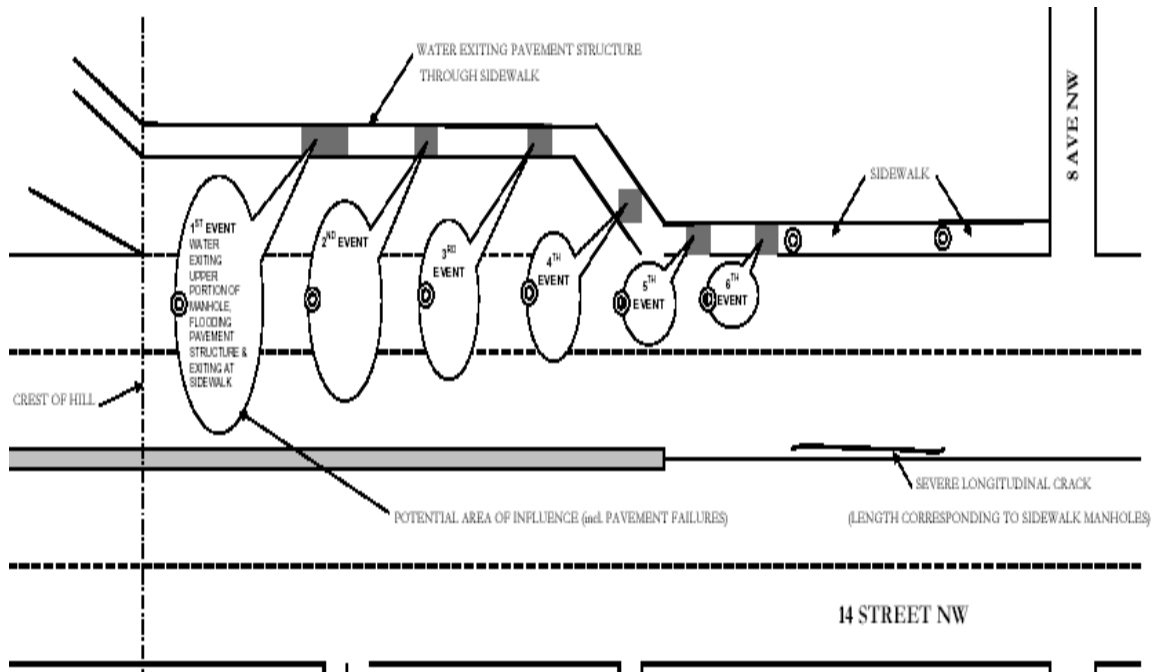
Figure 14: Schematic Showing 14 Street NW Distress Manifestations

“As a result of the relatively short duration / high precipitation storm event, the storm sewer was beyond its capacity and pressurized to a point where the storm water escaped, in very high quantities, from the “weakest link”; the upper portion of the storm manholes. The escaping water permeated and saturated the surrounding pavement structure, within the granular base layer, trapped by the relatively impermeable subgrade below and the overlying asphalt concrete layer. The water built in pressure within the pavement structure, in some cases causing failure of the overlying asphalt concrete layer, finally finding relief in the adjacent sidewalk where it escapes at an approximate 45° angle “downstream” of the manhole where it originated. The first occurrence of this “venting” was at the manhole located just below the crest of the hill. Subsequently, after some time interval, this occurred at each of the six storm manholes located within the roadway, sequentially moving downhill. The pressure and volume of water escaping each successive manhole lessened, resulting in less pavement damage and subsequently less damage to the concrete surface works when the water escaped.”

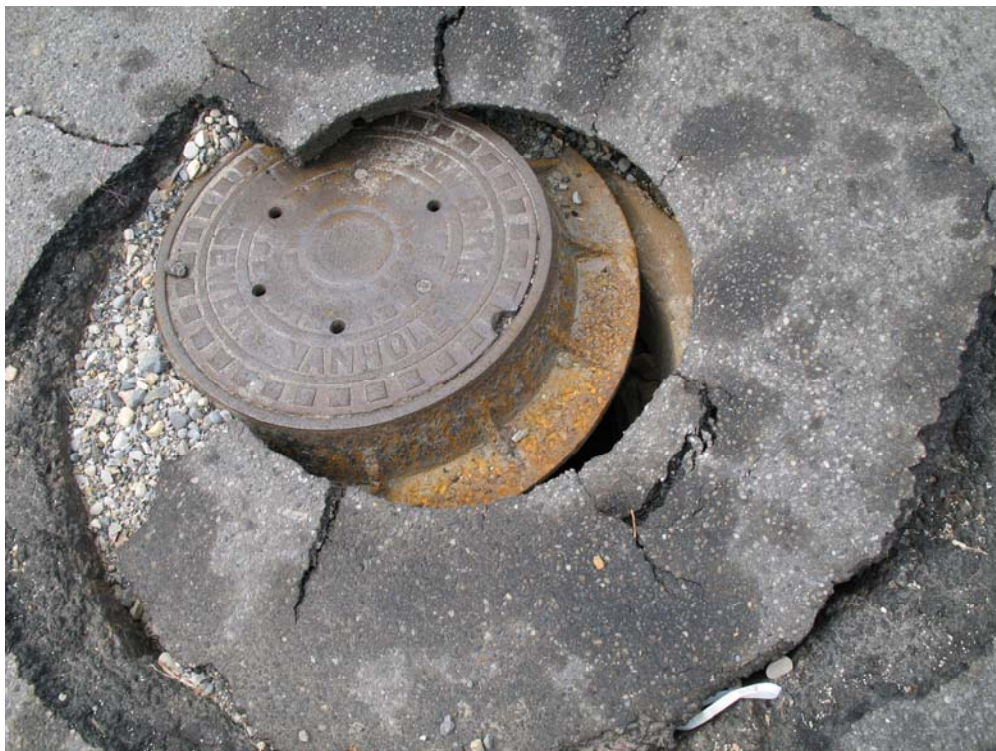
Figure 15: Primary Point of Failure at Storm Manhole

- The upper 300mm to 400mm for most manholes in the affect area (typically constructed with concrete rings and/or bricks to enable grade corrections) was compromised.
- The nature of the system in terms of catchments area and storm sewer capacity, would indicate that the greatest system pressure during an extreme storm event would initially be located at the manhole south of the crest of the hill, with pressure generally decreasing going south (or downgrade) in the system.
- Due to storm sewer manhole lids dislodging previously during storm events, some manhole lids, if not all, had been secured to the manhole collar by tack-welding.

Figure 15 provides an illustration of one of the primary failure points, as described in the hypothesis.
