**Long Term Performance and Acoustic Properties of an
Aging Open Graded Friction Course Asphalt Pavement Surface**

Paper prepared for presentation at the
Introducing Innovation into Pavement Design and Engineering Session of the
2009 Annual Conference of the Transportation Association of Canada
Vancouver, British Columbia

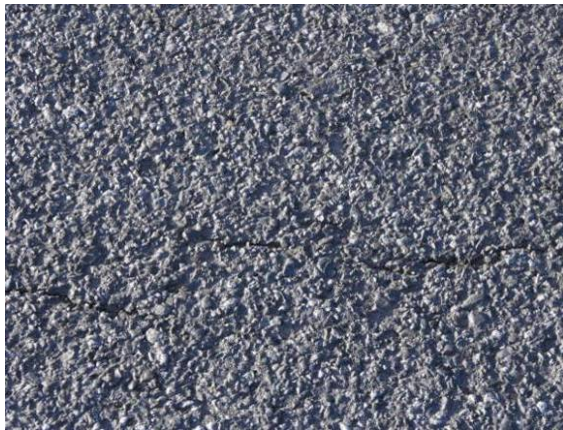
A comparison of the shoulders with no traffic and the driving lanes showed only a modest amount of ravelling (photographs 1 and 2). There was some structural distress evident in the driving lanes and a minor amount of intermittent longitudinal joint failure (photograph 3). These joints were not painted with emulsion during construction in order not to impede lateral drainage. The amount of failure was minor and certainly did not suggest a need to do anything differently.

Photo 1: Driving Lanes Phase 1 - 200 m from South End – Note Structural Cracking

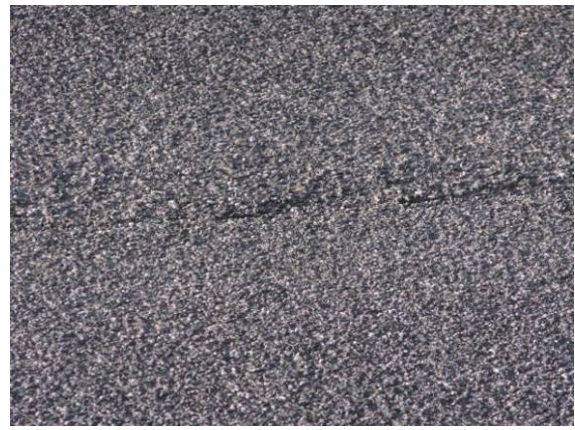
Photo 3: Longitudinal Joint Failure - Same Area as Photo 1 and 2

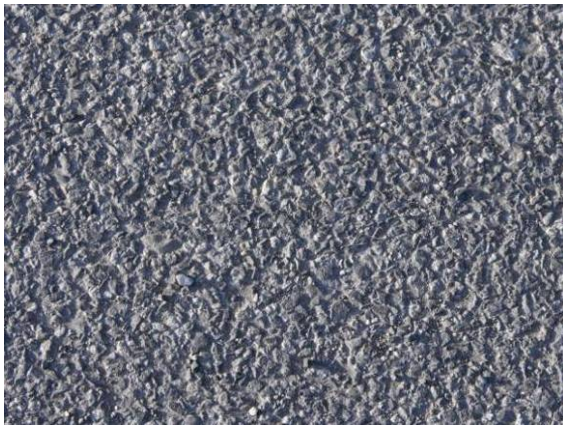
Photo 2: Shoulder - Phase 1 - 200 m from South End

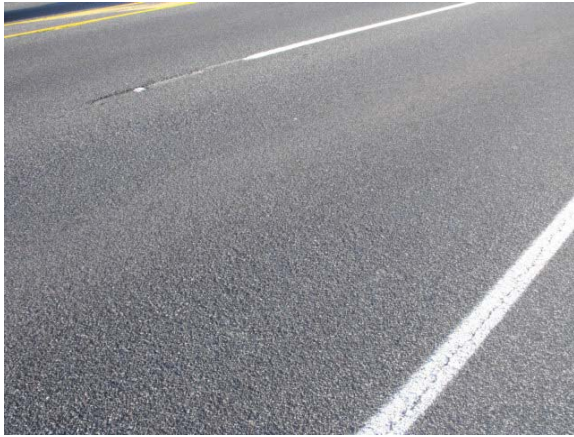
Wheelpath wear was also quite evident throughout Phase 1. It was minor and not severe enough to affect the functionality of the pavement. If this was a dense graded pavement this much wear might have created a water channel and been a safety concern.

Photo 4: Wheelpath Wear Phase 1

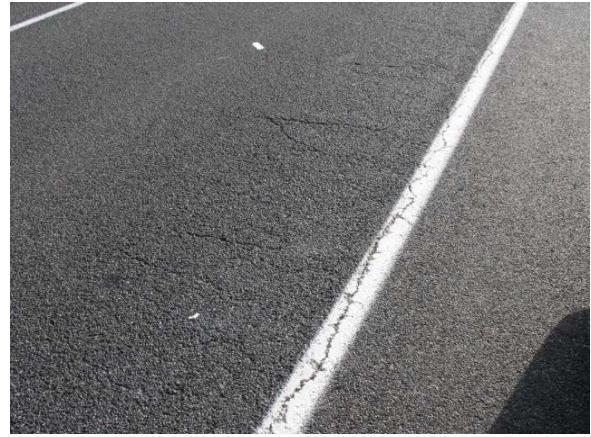
Photo 5: Alligator Fatigue Cracking about 400 m North of Project Start

The southbound slow lanes in Phase 1 exhibited much more structural distress than any other part of this project. Very little of this lane was excavated in 1995 and this wheelpath failure is to be expected considering the advanced age of the original structure (30 years +).

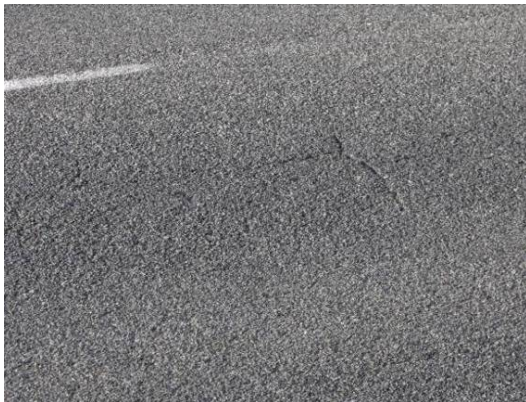
Photo 6: Alligator Failure North Bound Slow Lane

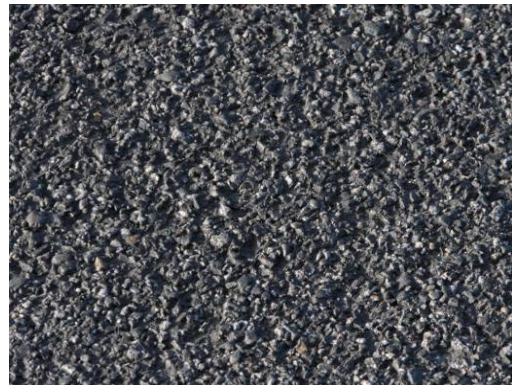
Photo 7: Wheelpath Condition

The next two photographs indicate the contrast between the shoulder condition and the wheelpath condition. It was evident that there was some minor ravelling in the wheelpaths.

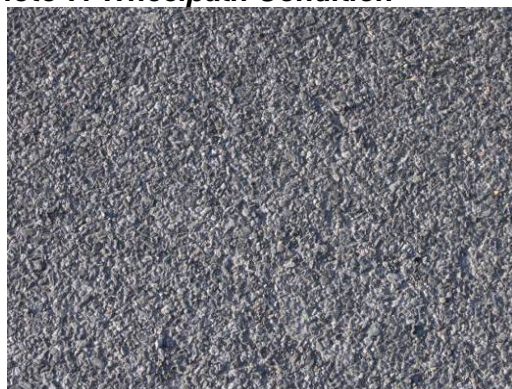
Photo 8: Shoulder Condition

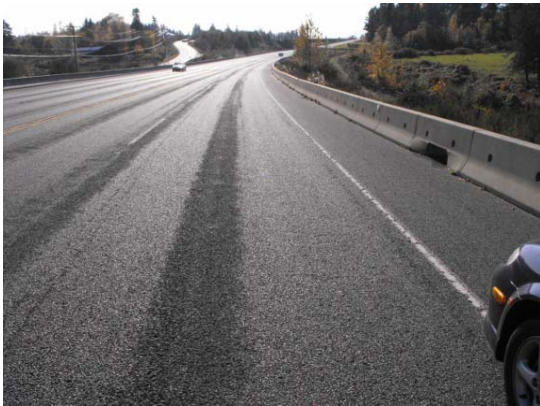
Photo 9: Wheelpath Contrast

At first glance this appeared to be rutting in the wheelpaths and that the winter maintenance equipment had been damaging the high areas between the wheelpaths. However, it is more likely that the traffic has tended to seal the surface of the wheelpaths creating higher contrast between them and the balance of the roadway. A close examination of the following two photos from the same area shows that there has been very little aggregate loss.

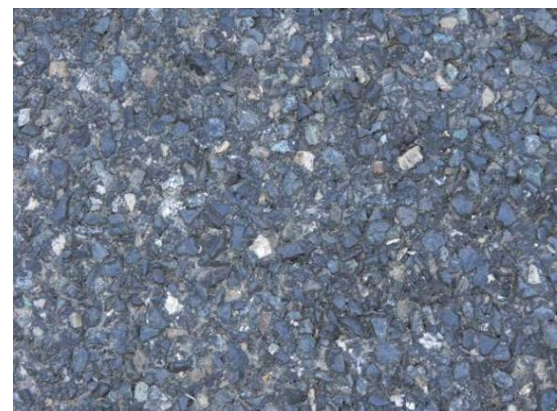
Photo 12: Shaded Area

In comparison to the previous pictures the rock was quite exposed and the surface asphalt appears to have worn off. There does not seem to have been any aggregate loss.

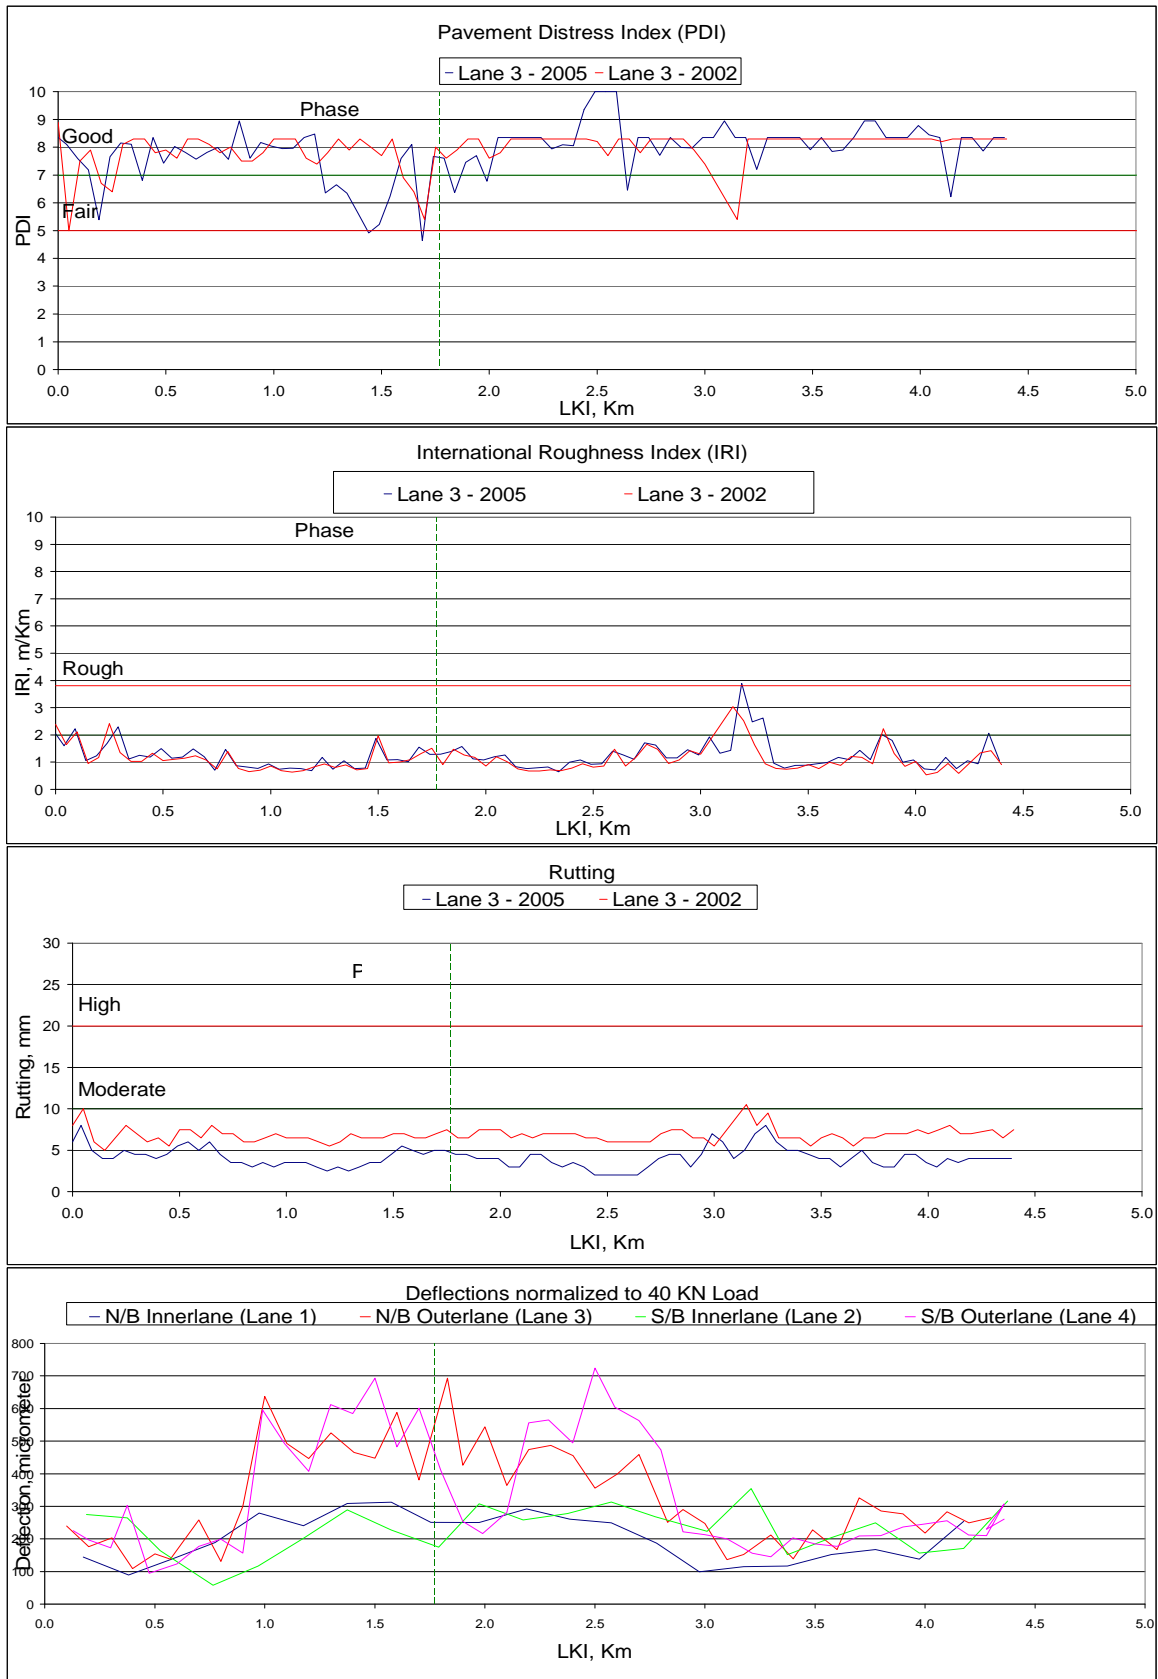
Figure 2: Roadway Pavement Management Data Highway 19A - North Nanaimo

Plots of the RPMS data for Highway 19A are presented on the following page. Analysis of the RPMS data for lane 3 (northbound outer lane) for 2005 showed that the PDI ranged between 4.64 and ten with an overall average PDI of 7.87. The PDI index is dominated by pavement cracking. A PDI of ten represents a perfect condition, while zero represents the worst condition possible. A PDI above seven is considered *good*, between five and seven *fair*, and below five *poor*.

The roughness of lane 3 for 2005 as measured by the International Roughness Index ranged between 0.65 m/km and 3.89 m/km with an overall average of 1.24 m/km. IRI below two metres per kilometre is considered *good*, between two and 3.8 *moderate*, and above 3.8 *rough*. The average roughness for 2002 was 1.12 for both lane 3 and lane 4. The cumulative analysis of roughness data for 2005 (lane 3) showed that only seven percent of the pavement was found to have moderate roughness ($3.8 > \text{IRI} > 2$), while 93% of the pavement was found to have low roughness ($\text{IRI} < 2$). The data analysis showed that there was no significant increase in roughness between 2002 and 2005.

Rut depth of lane 3 for 2005 was found to be of low severity (rut depth < 10 mm) and ranged between two and eight millimetres with an overall average of four millimetres. This is consistent with the subjective visual observations.

The normalized deflection values are presented on the above RPMS plots (Figure 2). The cumulative analysis of deflection data showed that the deflections in the inner lanes were smaller than the deflections in the outer lanes and therefore the inner lanes were stronger at the time of testing.

The strength analysis indicated that there is a need to strengthen this roadway to achieve a new 20 year design fatigue life.

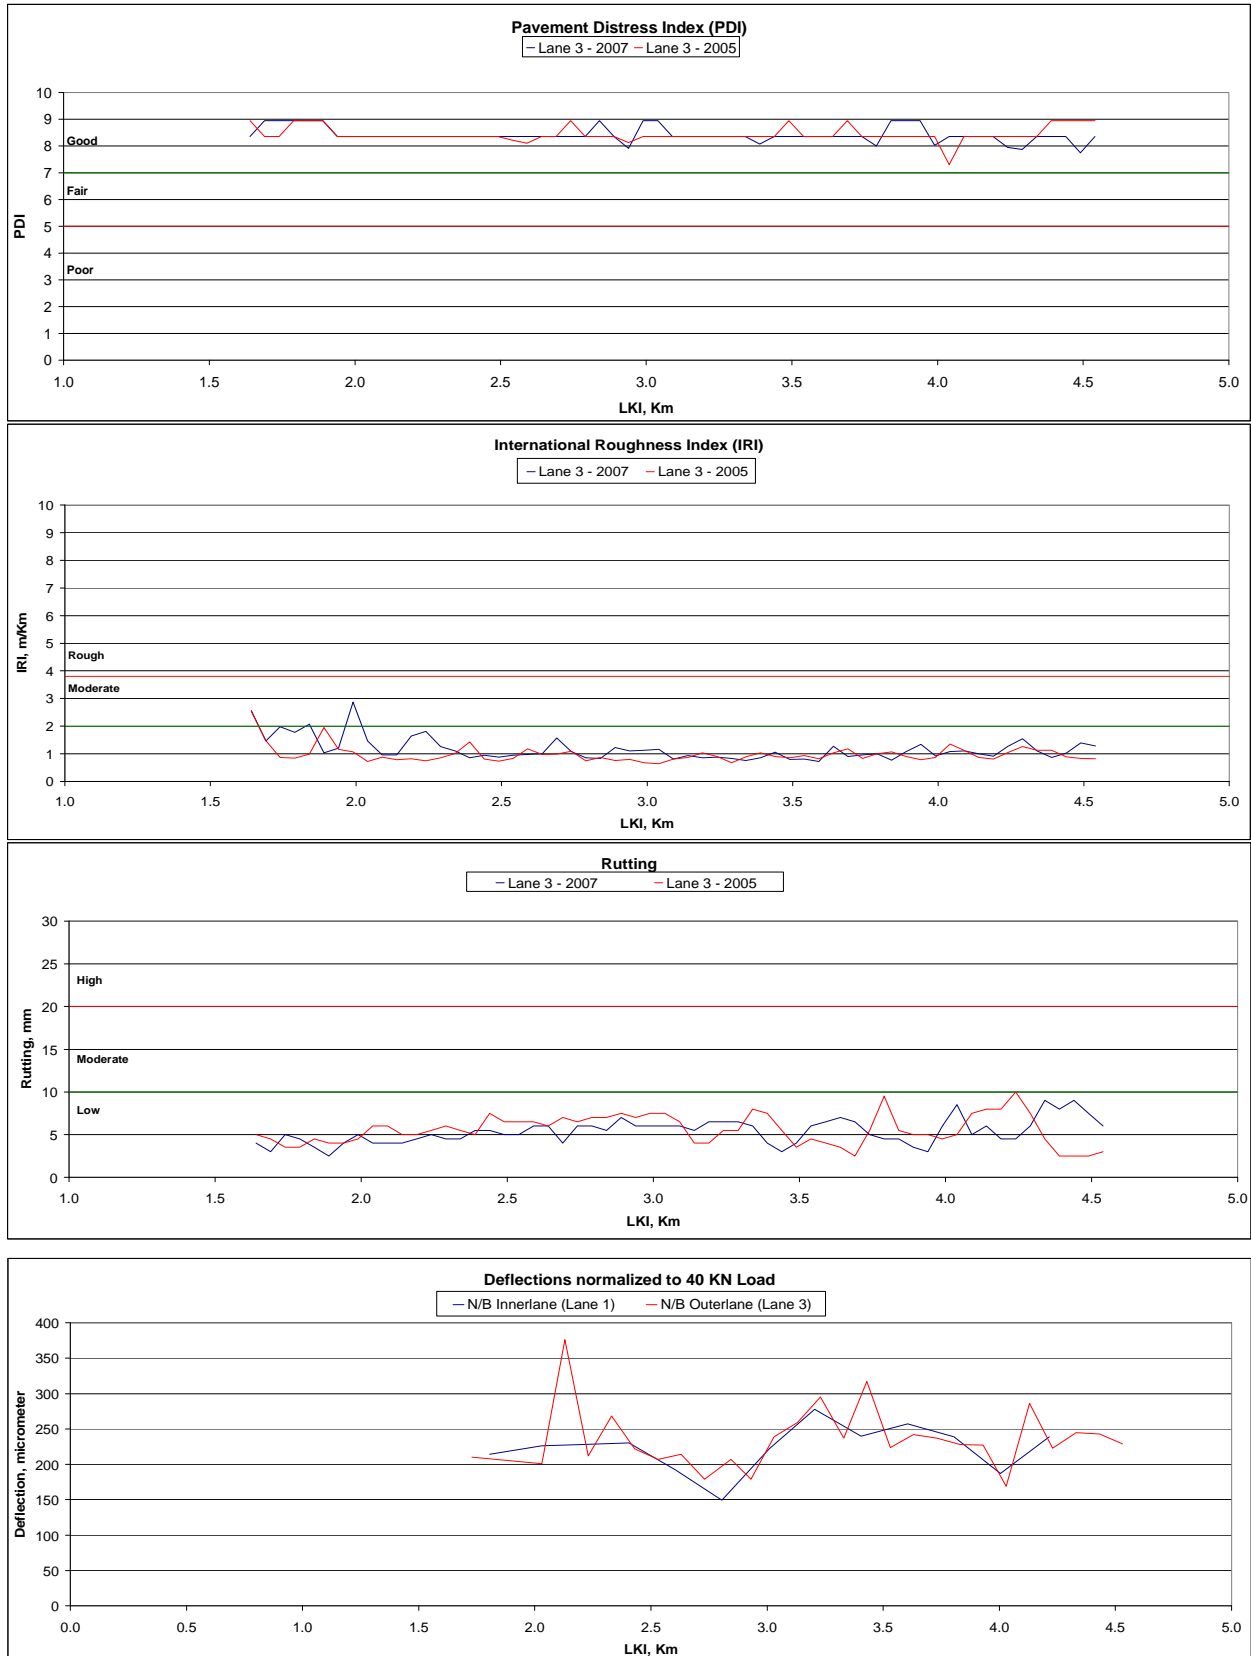
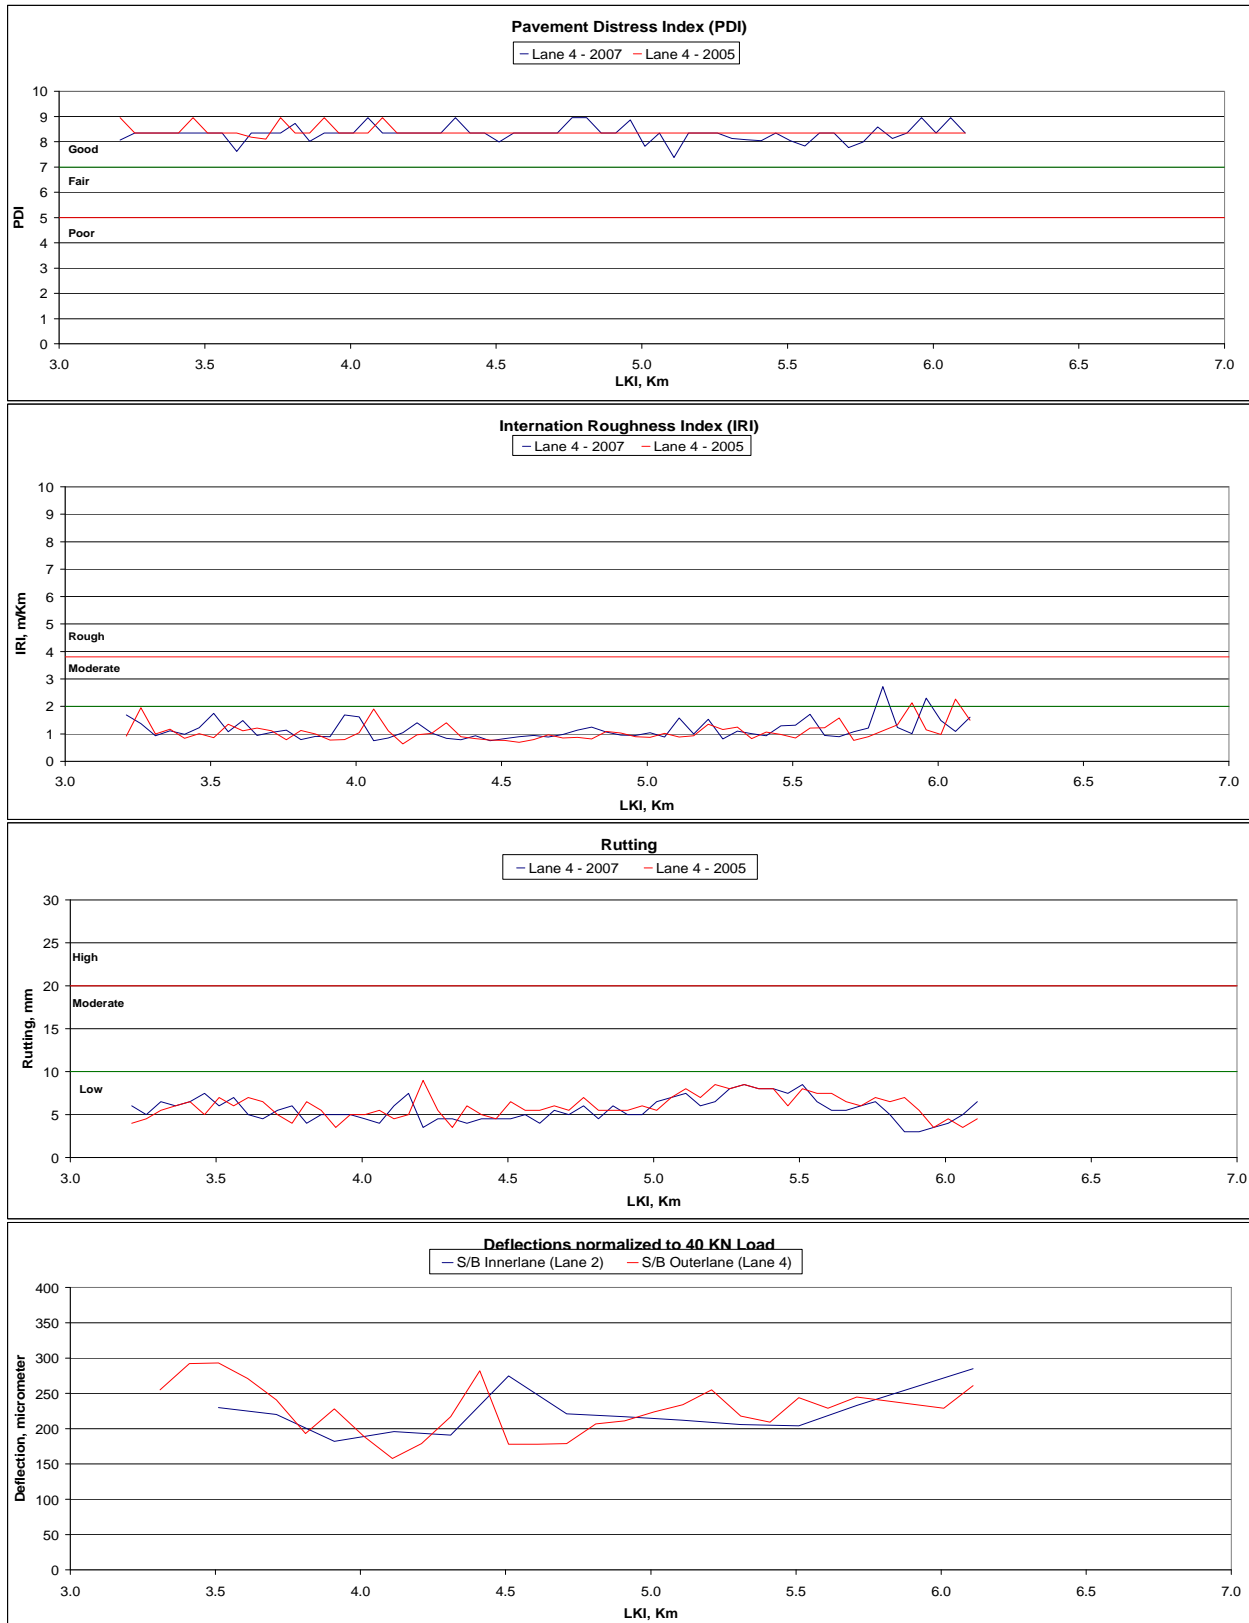
Analysis of the RPMS data for the year 2007 showed an average PDI of 8.41 for lane 3 (northbound outer lane) and 8.33 for lane 4 (southbound outer lane). The average PDI for 2005 was 8.43 for lane 3 and 8.39 for lane 4. The cumulative analysis of PDI data of lane 3 and lane 4 for 2007 showed that 100% of the pavement was in good condition ($PDI > 7$).

Roughness of lane 3 ranged from 0.73 m/km to 2.87 m/km. The average roughness was 1.17 m/km. It was found that 95% of lane 3 has low roughness ($IRI < 2.0$ m/km). The roughness of lane 4 ranged between 0.75 m/km and 2.72 m/km with an overall average of 1.16 m/km. Some 97% of lane 4 has found to have low roughness. The comparison of 2005 and 2007 roughness data showed no significant increase in pavement roughness.

Rut depth for lane 3 and lane 4 for 2007 was found to be of low severity (Rut depth < 10 mm).

The normalized deflection values are presented on the above RPMS plots (Figures 3 and 4). A cumulative analysis of the deflection data showed higher deflections on the outer lanes than the inner lanes in both directions.

The strength test results indicate that this roadway is structurally adequate with no need for an overlay.

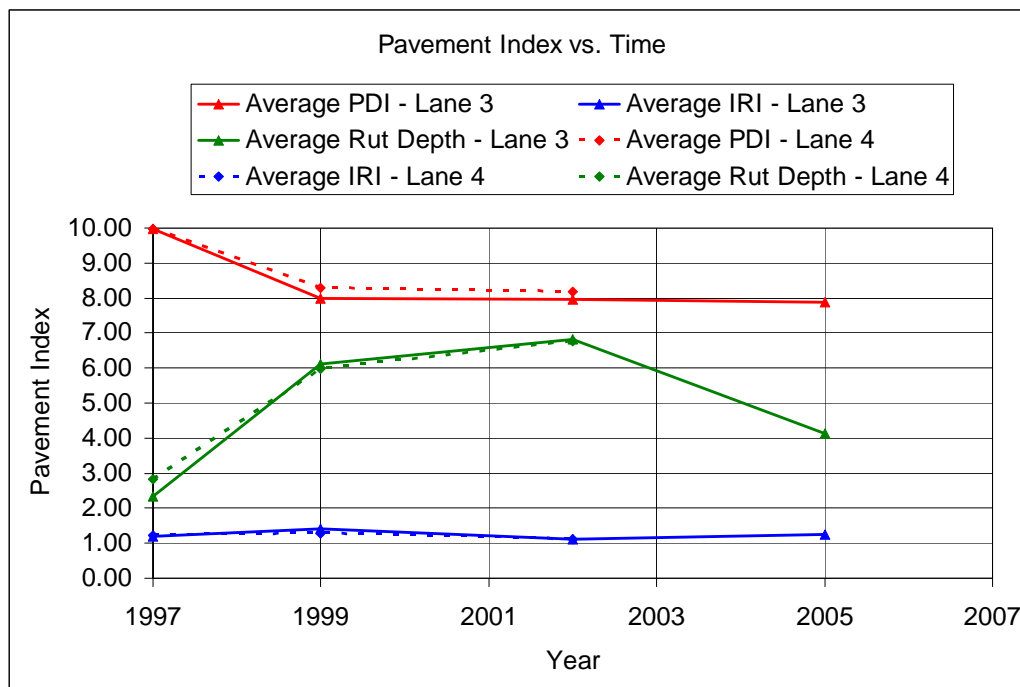
Figure 5: RPMS vs. Time – Highway 19A

The figure below shows the RPMS data vs. year starting in 1997. It shows that the average Pavement Distress Index (PDI) dropped from ten to eight during the first two years and has remained fairly constant thereafter.

In the same time, rut depth increased from 2.3 mm in 1997, to 6.0 mm in 1999, then to 7.0 mm in 2002. There appears to have been a reduction in rut depth from 2002 to 2005. The apparent reduction is likely a function of the accuracy of the automated data collection system, the BC MoT acceptance criteria for automated rut data collection allows plus or minus three millimetres variation from manually collected rut measurementsⁱⁱ. The pavement condition of Phase 2 was found to be slightly better than Phase 1 (PDI higher, rut depth and roughness lower). However the roughness of both phases is quite the same after 2002.

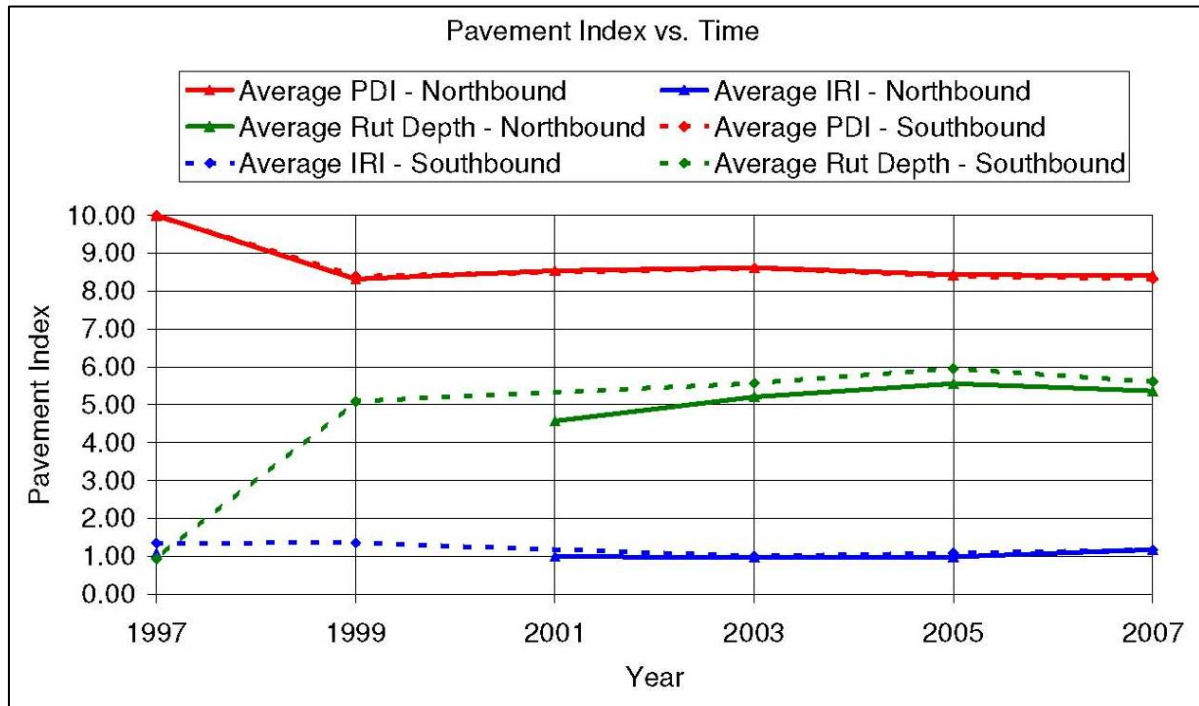
Figure 6: RPMS vs. Time- Highway 19 - Duke Point

The figure below shows the RPMS data vs. year from the time that the OGFC was placed. It shows that the PDI has dropped from ten to 8.3 during the first two years of operation of the highway after 1997 and has remained fairly constant thereafter.

IRI appears to have remained fairly constant from 1997 to 2007 at between one and 1.5 m/km.

Rutting depth has increased from 1.0 to 5.0 mm from 1997 to 1999, and increased to 6.0 in 2005.

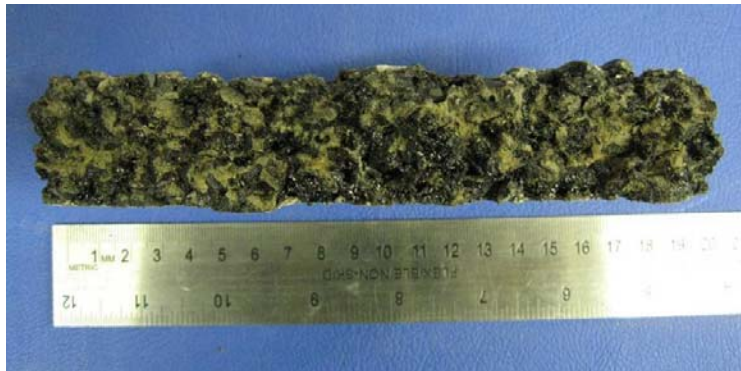
The cores were cut at the horizontal joint between the OGFC layer and the rest of the core. The OGFC portion was then placed in an oven for one hour at 60° C. The cores were broken in half and examined with a magnifying glass to try to determine if there was any visible evidence of asphalt stripping. None was found, but the void structures in all of the cores were observed to be filled with dirt and fines. As can be seen in the below photograph below the amount of dirt was significant and would seriously impede water flow. This was in evidence for all of the cores that were taken.

Photo 13: Side View of Core Showing Voids Filled with Debris

An extraction test was done to determine the approximate quantity of dirt being held by the interconnected voids. A comparison of the fines content from the extraction to that of the original mix design indicated that the core contained approximately five to seven percent fines debris by dry mass.

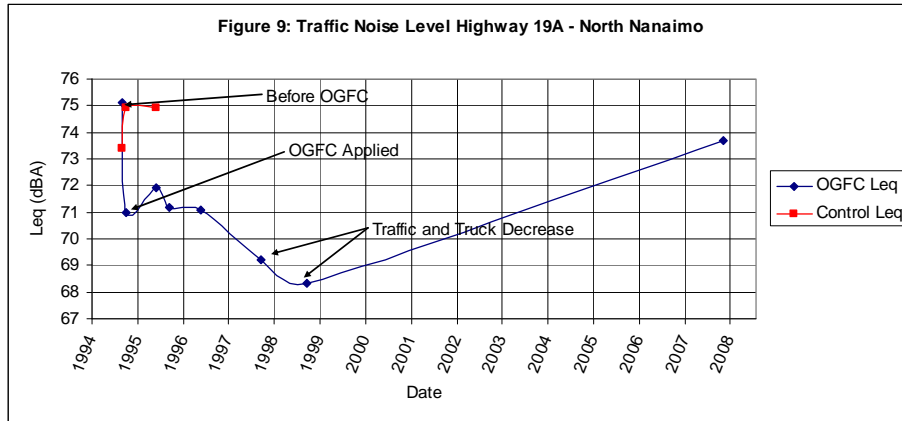
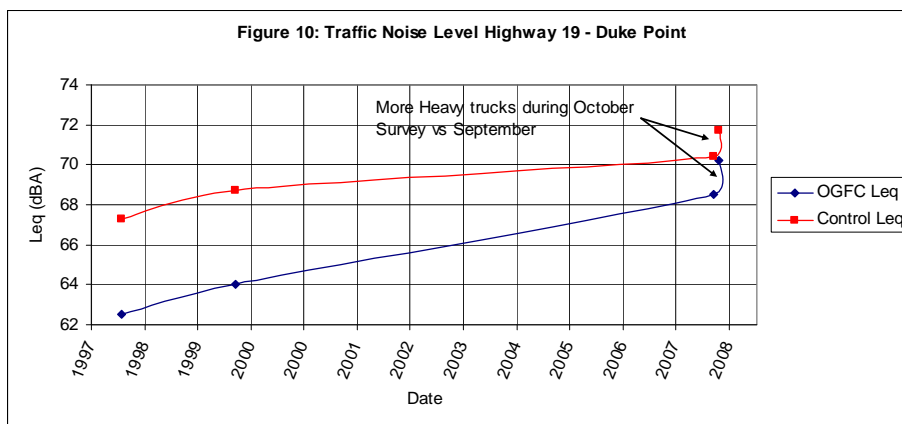
The average traffic noise level measured on October 22, 2008 at the north Nanaimo site was 1.4 dBA lower than that measured 13 years before in September 1995 prior to the application of the OGFC. However, when the necessary traffic noise level adjustments are made to account for the lower traffic volume, average vehicle speed and heavy vehicle mix that now exist on this section of Highway 19A, the noise reduction benefit of the OGFC was found to have essentially disappeared. The residual noise reduction benefit of the OGFC as measured on the Duke Point Highway in September and October of 2008 was found (after adjusting for the five kilometres per hour higher vehicle average speed observed on the conventional asphalt section) to be approximately one decibel.

It may be concluded that, after 13 and 11 years of service respectively, the OGFC pavements applied on Highway 19 in north Nanaimo and on the Duke Point Highway demonstrate little or no residual noise reduction benefit. The primary reason for this loss of noise attenuation performance over time is believed to be the gradual clogging with dirt, sand and tire rubber debris, of the many interconnecting voids which characterize these open-graded pavements. It would therefore be of interest to explore the effects that cleaning this debris from the OGFC pavement could have on its noise reduction capacity.
