Use of Launched Soil Nails to Stabilize Shallow Slope Failure on Urban Access Road 172

at the 2009 Annual Conference of the
Transportation Association of Canada
Vancouver, British Columbia

The selection and design of launched soil nails is described in this paper. The LSN technique was used to stabilize a shallow slope failure at a site designated by Alberta Transportation as a Geohazard Risk Management Program (GRMP) site NC47, located in the North Central Stony Plain region. The geographic location of the site is about 40 km south east of Edmonton, on Urban Approach Road (UAR) 172 to the Village of New Sarepta (Figure 1).

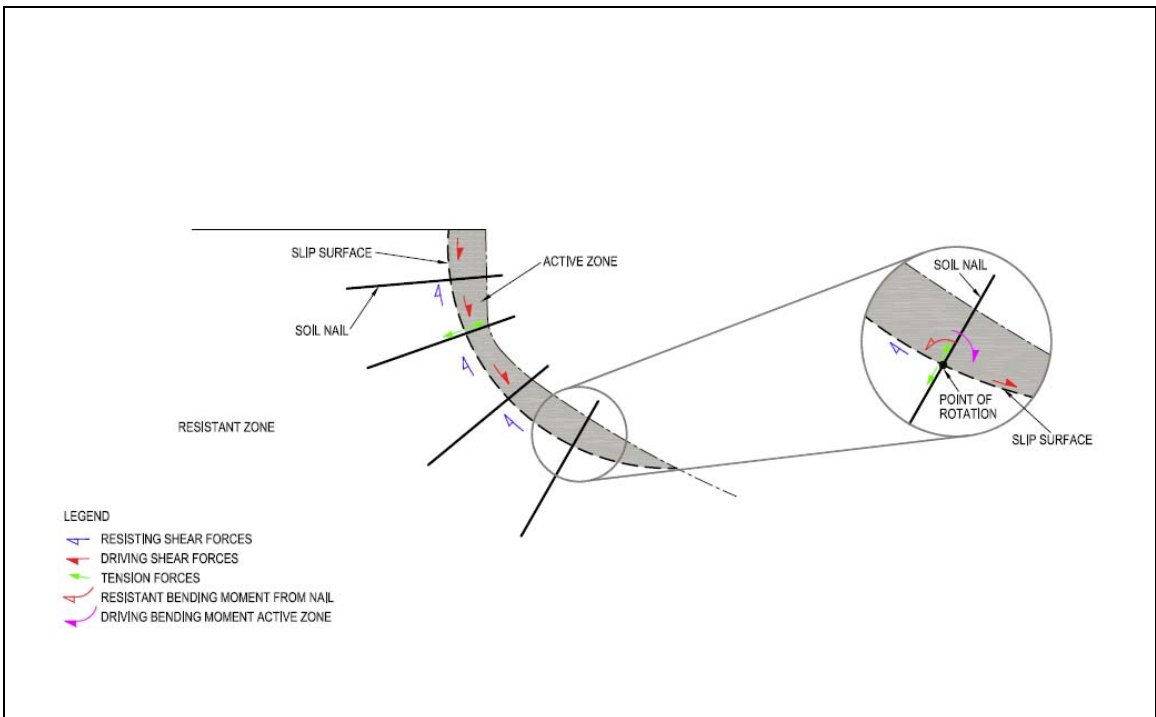
FIGURE 2: Force diagram of soil nails at the slip surface

The depth of nail penetration is dependent on air pressure and soil resistance. For this project site, the nails were launched at over 350 km/h using compressed air pressure of approximately 18 MPa. The nails typically are “shot” normal to the potential slip plane. See Figure 2 for the forces acting at the slip surface. The nails are installed by pulling the nails from the tip. This pulling action and launch velocity puts the nails into tension immediately.

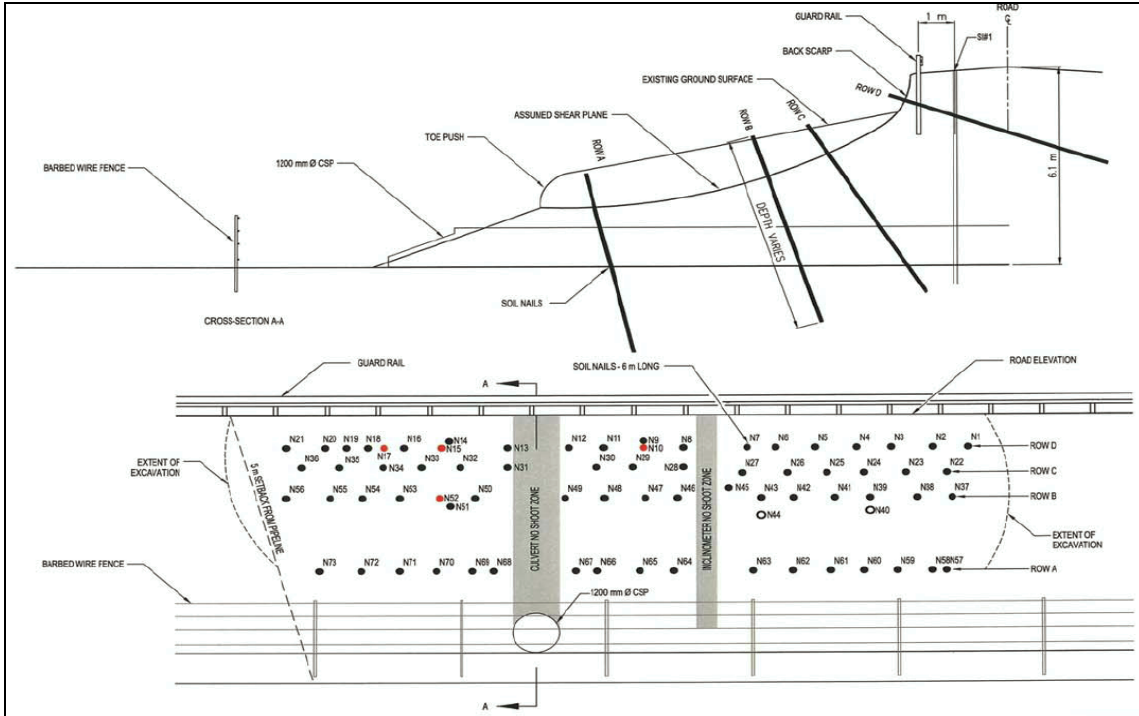
FIGURE 3: As-built of NC47 showing launched soil nails layout (not to scale)

The design required 80 nails to be installed onsite; however, seventy-one nails were eventually installed. The decrease in the number of nails installed was reduced because the spacing had to be altered around appurtenances, namely the 1200 mm diameter CSP culvert and the slope inclinometer, as each required a buffer zone of 1.0 m and 0.5 m respectively on either side in order to prevent a potential conflict. As a requirement from the pipeline company, nails were not installed within a 5 m exclusion (or setback) zone established on both sides of the high pressure oil pipeline. See Figure 3 for the final soil nails layout.

The design that was used for construction was submitted by Morsky and consisted of installing nails in a standard 1 m² grid with each row offset by 1 m. The Morsky design was checked by EBA using a simplified wedge design method described by Steward (1994). Use of this method indicates using 90 nails and a nail spacing one nail every 1.4 m² which would provide a factor of safety of 1.2.

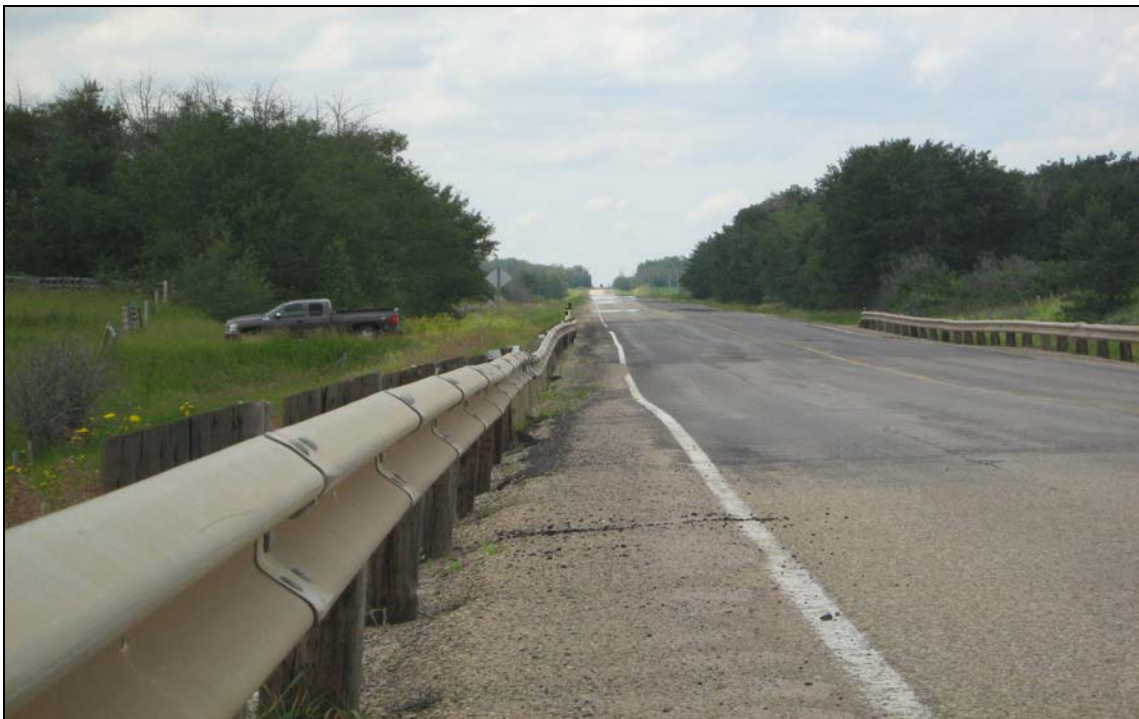
The NC47 site is a 6 m high road fill embankment through a seasonally swampy area. The sideslopes are steep, the right-of-way is narrow, and there are a number of buried services in the immediate vicinity of the site. The shallow slope failure was threatening the eastbound lane of UAR 172 and the notable impacts to the roadway were a parallel longitudinal crack in the eastbound lane about 2 m from the edge of pavement, a sag in the guardrail and roadway (Photo 1) and a back scarp associated with the unstable slope right up to the guardrail posts near to the edge of the pavement (Photo 2). This slope failure was identified at an initial site visit made in June 2005.

- A steep 2 H : 1 V sideslope, with the right-of-way boundary at the base of the slope
- A vertical scarp approximately 2 m high immediately to the south of the guardrail posts
- A w-beam weak post guardrail system

PHOTO 1: Looking west along the eastbound lane; notice the sag in the guardrail & roadway

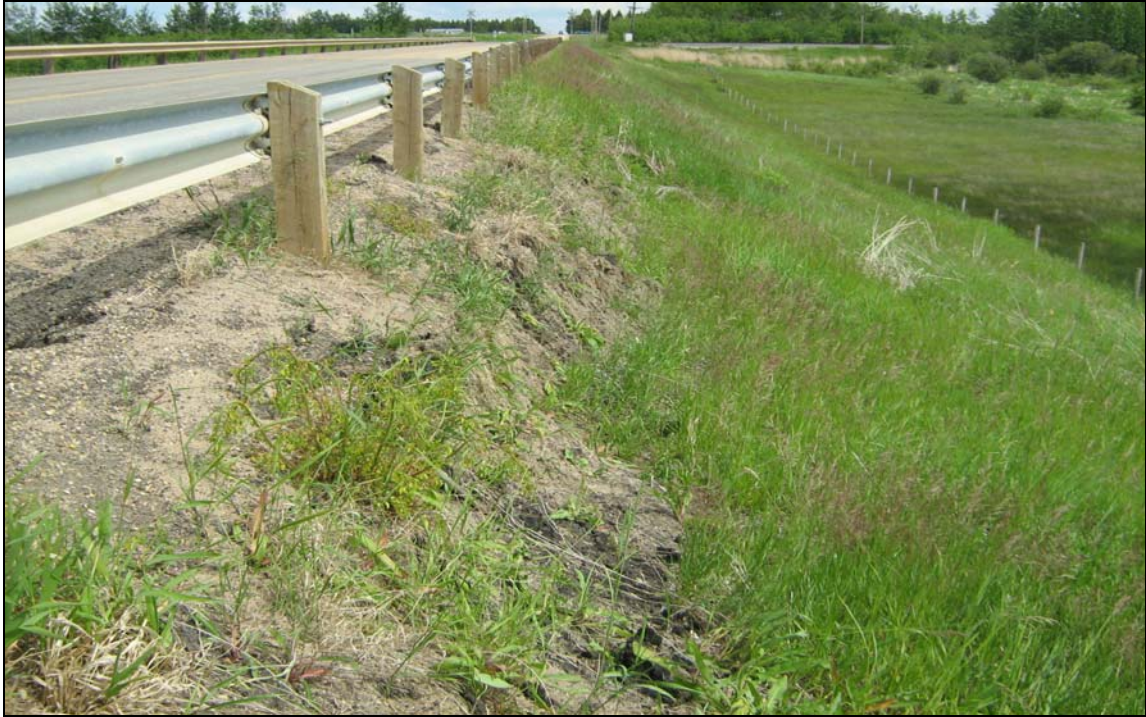
The slip plane was estimated to be at a depth of 1.5 m to 2 m based on the locations of the scarp and toe.

PHOTO 2: Looking eastbound; notice the vertical scarp close to the guardrail posts

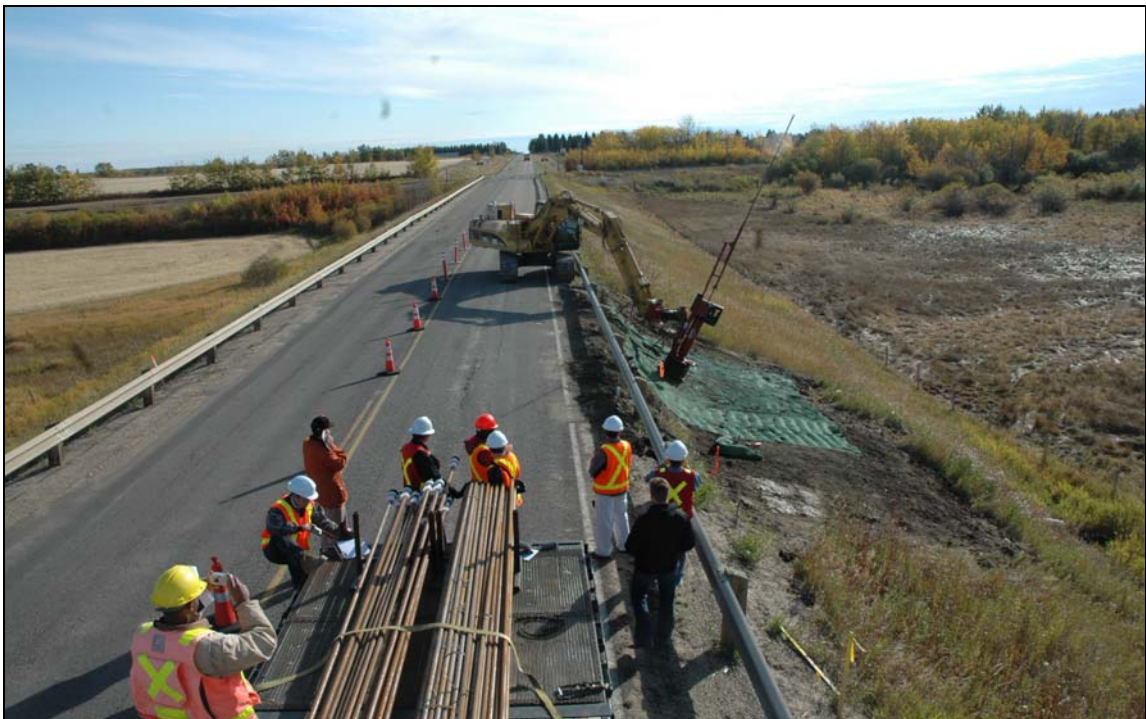
PHOTO 3: Advantage of using soil nailing is that only a single lane closure is needed and this reduces road user disruptions

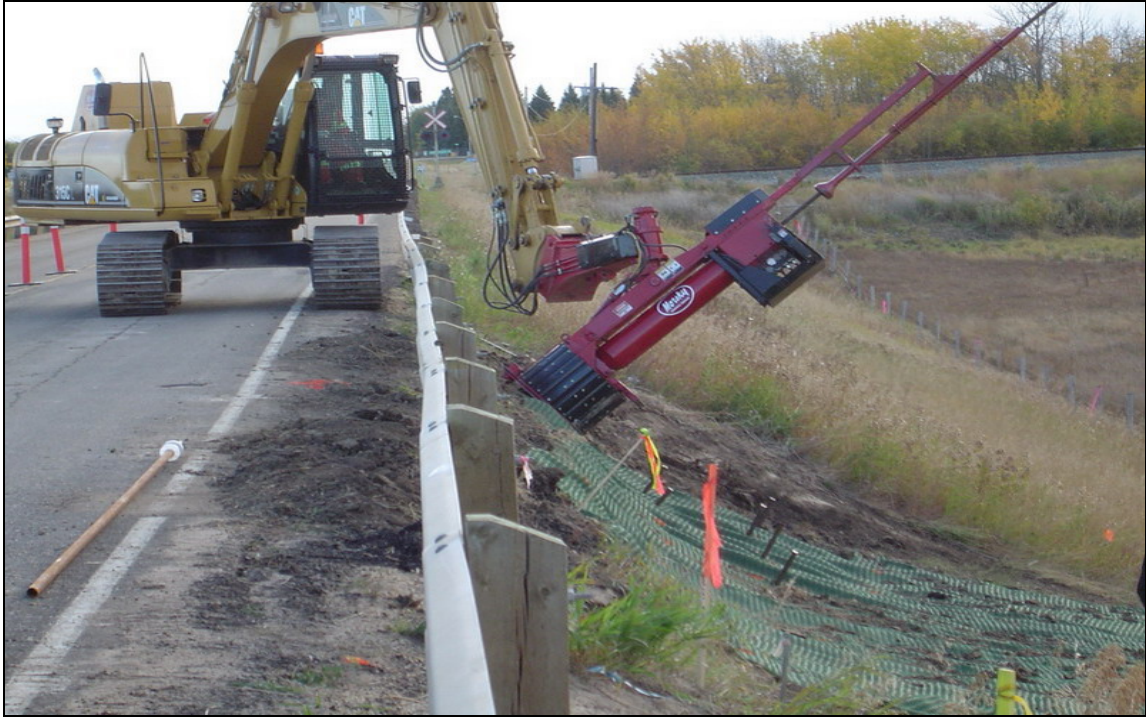
PHOTO 4: Closer look at the launcher's ability to reach around obstacles and utility services to install nails
