# **MECHANISMS AND KINEMATICS OF RIVER VALLEY LANDSLIDES IN EDMONTON**

K.W. Soe Moe,  
BGC Engineering Inc. Edmonton, Alberta, Canada  
D.M. Cruden, C.D. Martin,  
University of Alberta, Edmonton, Alberta, Canada  
D. Lewycky, P. R. Lach,  
The City of Edmonton, Edmonton, Alberta, Canada

Paper prepared for presentation  
at the Rock, Slope and Embankment Engineering Session  
of the 2009 Annual Conference of the  
Transportation Association of Canada  
Vancouver, British Columbia

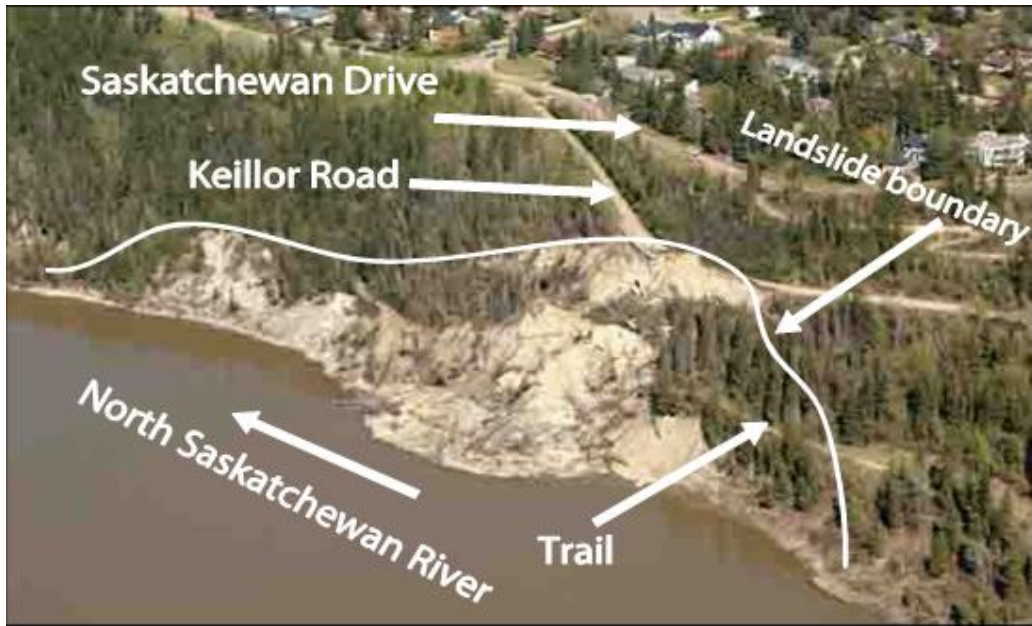
Figure 1 Keillor Road landslide (May 2005, the City of Edmonton)

The Keillor Road Landslide occurred in the fall of 2002 on the outside bend of the North Saskatchewan River, where Keillor Road traverses down from a flat upland area to a low level terrace (Figure 1). Due to the failure, a 5 m deep graben appeared at the head of the displaced material and the toe of the slope moved 22 m into the river. The total volume of soil and rock involved in the landslide was in the order of 100,000 m<sup>3</sup>. After the 2002 failure, continued slope movements caused further downward movement of the graben over a period of 2 years, resulting in a further 3 m retrogression of the main scarp. Movement of displaced materials continues to be observed up to the present day.

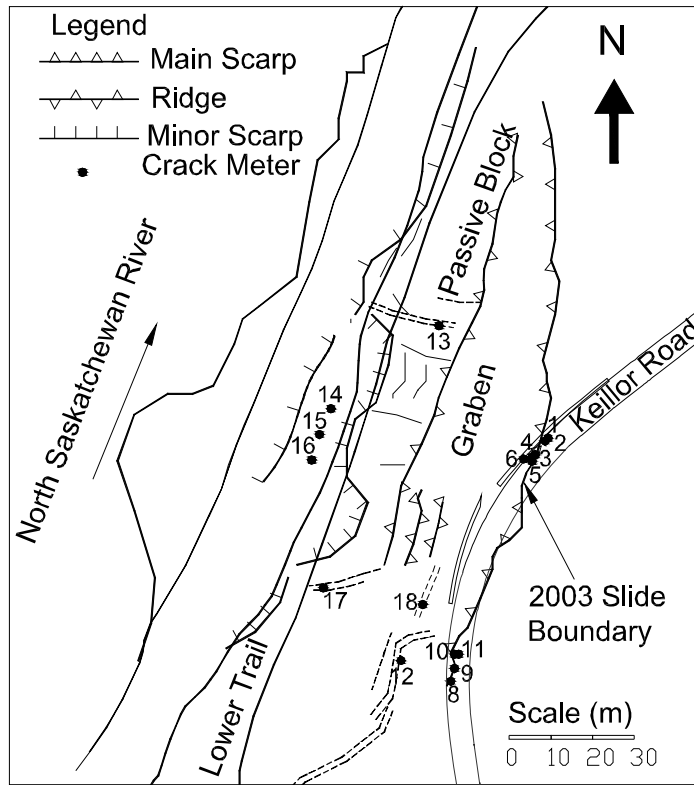
Figure 3 Landslide map of Keillor Road (2003)

In the fall of 2002, 18 crack meters (CM) were installed in the displaced material to monitor the surface expression of the slope movements (Figure 3). Vertical and horizontal movements of the CM were monitored regularly in the spring and summer of 2003 and 2004. As the landslide progressed, significant slope movements occurred and middle part of the main body slid into the river in July 2004. The maximum movement of the counter scarp was 3 m toward the river from May of 2003 to May of 2004. Minor scarps which formed at the lower portion of the displaced material, were attributed to retrogressive failure.

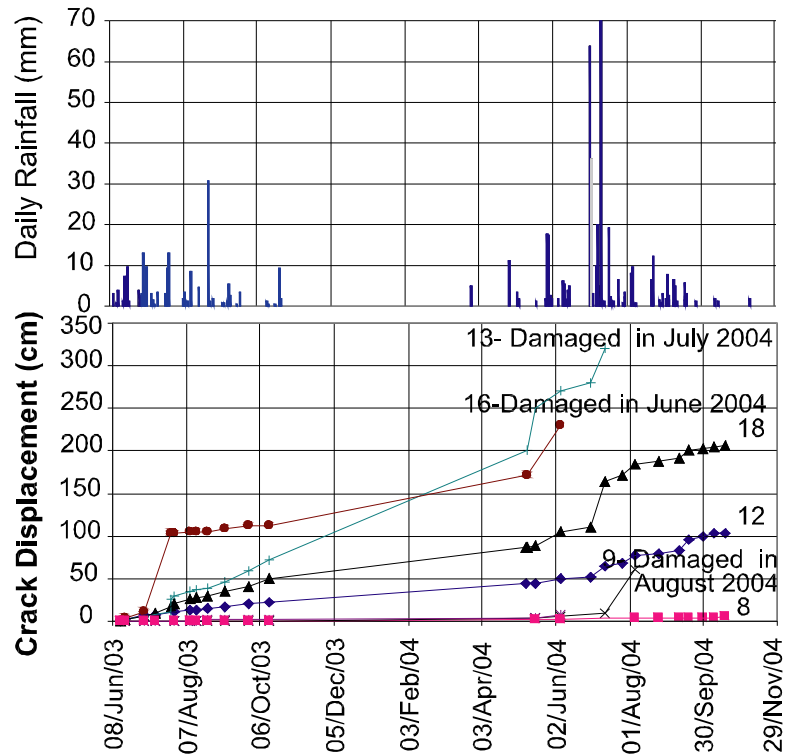
Figure 4 Horizontal displacements of crack meters

The horizontal movements of CM are presented in Figure 4. CM-13 was located in the initial toe of the slide and slid down to the river after a period of heavy rainfall in July 2004.

CM-16, located at the toe of the slide, was damaged by the slide in early June of 2004. Maximum movements were observed at the centre of the slide. As shown in Figure 15, the recorded crack displacements increased significantly after periods of heavy rainfall.

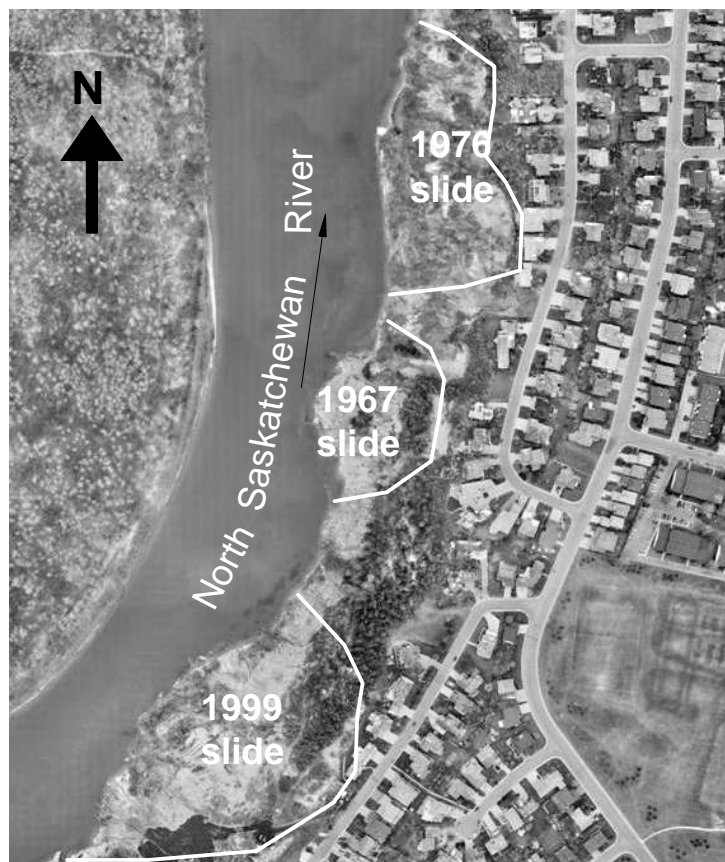
Figure 8 Landslides along Whitemud Road (May 2002, City of Edmonton, Line 17E, Scale 1: 5000)

Prior to the major landslide in 1999, several movements had occurred downstream of the 1999 landslide location (Figure 8). In 1967, a failure occurred 300 m downstream of the 1999 landslide location. But the failure did not affect the residential properties behind the valley wall. In 1976, a second failure occurred north of the 1967 failure involving the overlying glacial deposits and the bedrock. Significant observations before the 1999 landslide are listed below.

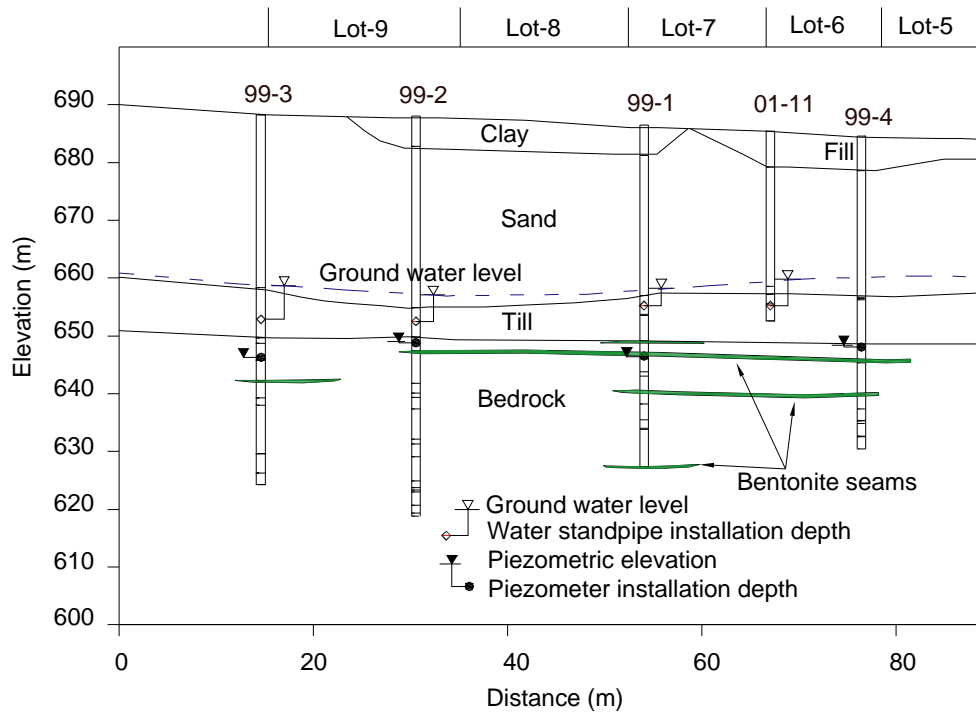
Figure 9 Cross-section along Whitemud Road

Post failure borings (Barlow 2005; Barlow and Froese 2000) revealed that the bedrock comprises interbedded layers of mudstone, clay shale and sandstone with thin bentonite layers (Figures 9). The bedrock is Upper Cretaceous in age and part of the Horseshoe Canyon Formation of the Edmonton Group (Bayrock and Hughes 1962). When exposed to weathering processes, the bedrock swells and softens, particularly in areas of seepage discharge. The sandstone varies from a low plastic sandy clay to a weakly cemented soft rock. The mudstone and clay shale are generally hard, massive, high plastic and without any distinct fissility. Three separate bentonite layers with a varying thickness from 50 to 400 mm were identified from deep borings (Figure 9).

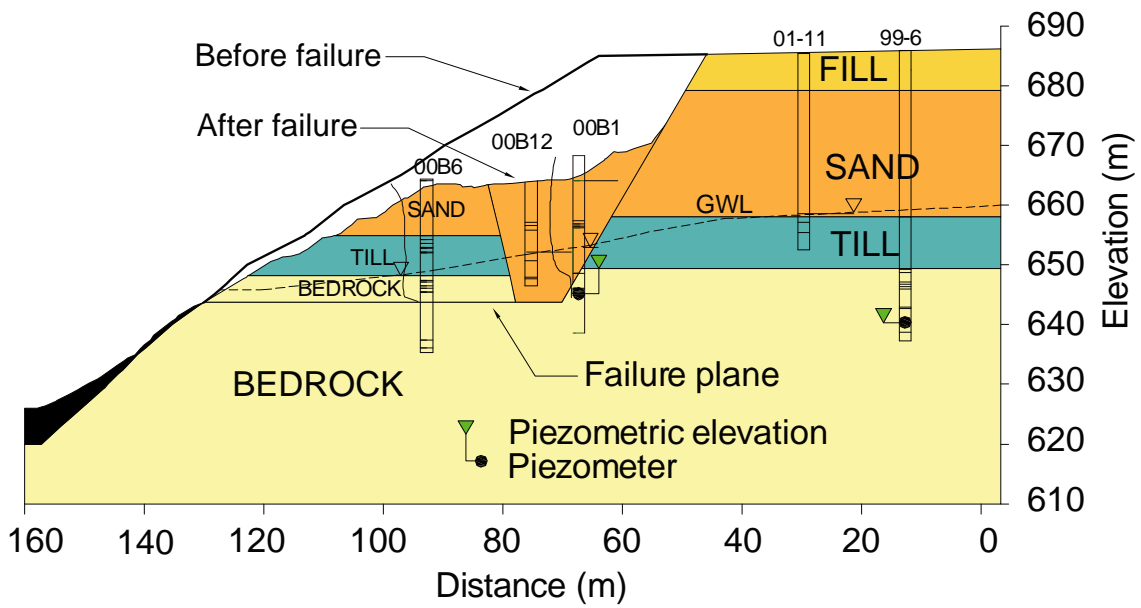
Figure 10 Pre and post-failure cross section of Whitemud Road Landslide

Major movements in the Whitemud Road landslide occurred within one day (Barlow and Froese 2000). A distinct graben feature formed at the head of the displaced material as the main body translated along a weak plane in the bedrock. Figure 10 presents pre-failure and post-failure cross-sections of the slide area and identifies soil and rock layers deduced from the drilling information (SoeMoe et al. 2006). As shown in the figure, the failure geometry of the Whitemud Road slide comprises a steeply dipping main scarp and a

surface of rupture seated in the bedrock. Boreholes advanced inside the displaced material revealed two different profiles. The borings inside the graben encountered mostly sand, indicating most of the materials inside the graben are from the overlying sand deposit. Boreholes drilled outside of the graben boundary revealed an almost undisturbed stratigraphic profile of sand and till overlying bedrock, indicating that these materials translated along a weak plane.

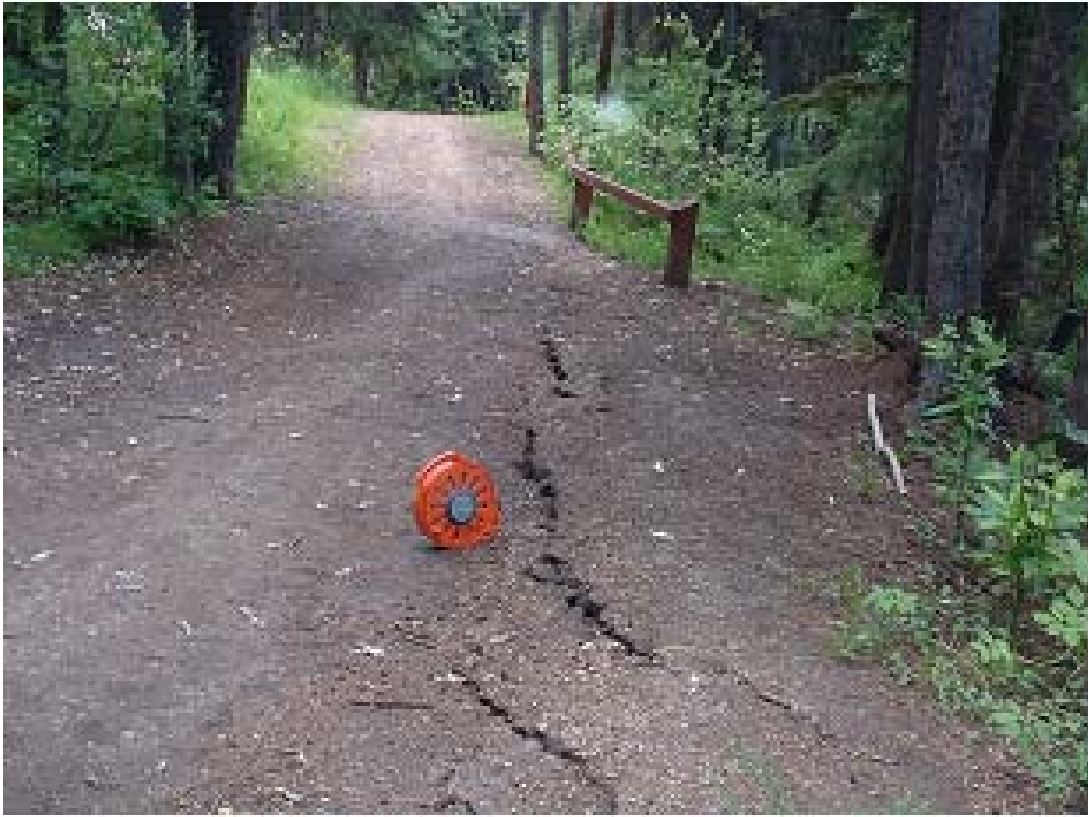
Figure 13 Tension cracks in the lower trail

In June of 2005, the level of the North Saskatchewan River increased above the elevation of the toe berm. This flooding event caused significant toe erosion, and tension cracks soon appeared along the lower trail as shown in Figure 13.

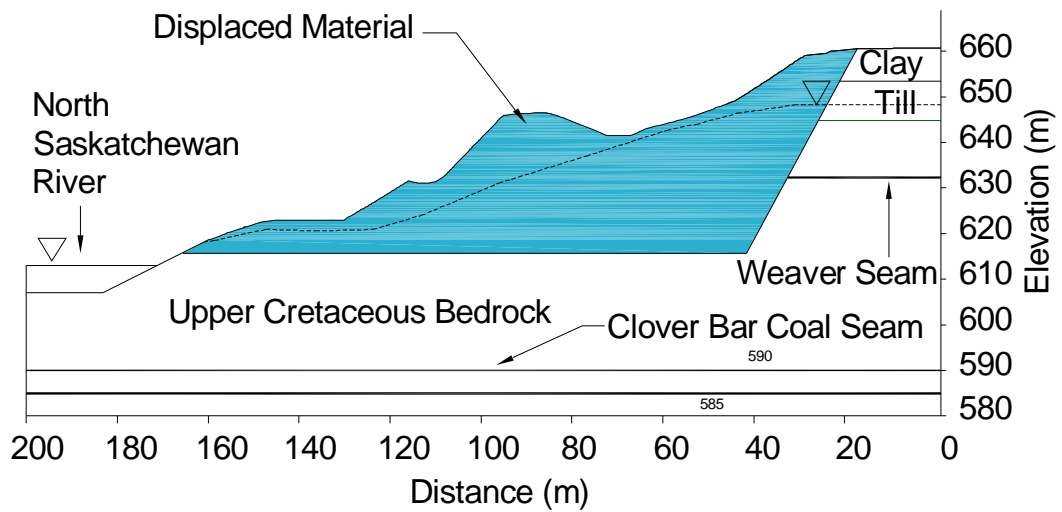
Figure 14 Cross section of the valley wall together with coal seam elevations

Since most of the old mine workings extracted coal from the Weaver seam, located at mid height of the valley wall, it is probable that coal extraction from the Weaver seam had the greatest impact on the stability of the valley wall. The effects of mining the Clover Bar coal seam appeared to be minimal, since this seam is located 25 m below the failure plane. The location of the coal seams together with the displaced material is shown in Figure 14.
