Alternative Condition Assessment for Concrete Bridge Decks – A Case Study

The City of Calgary commissioned EBA Engineering Consultants Ltd. (EBA) to undertake a condition survey in 2008 of the 16 Avenue Bridge (TransCanada Highway Bridge [TransCanada Bridge]) over University Drive NW. The bridge was constructed in 1959 and was rehabilitated in 2001. At the time of rehabilitation, the deck underwent hydrodemolition to a depth of 90 mm and to a depth of 105 mm at the pier strips. The new deck reinforcing was reportedly galvanized steel, and the concrete deck was covered with a HD concrete overlay with steel fibres. Due to the presence of steel fibres in the overlay and galvanized reinforcing steel, copper-copper sulphate half-cell potential testing was not conducted. Instead, a comprehensive concrete deck coring program was proposed to determine the concrete condition and to determine chloride profiles for life cycle modelling. The program was accepted by The City of Calgary, and the visual condition survey and core extraction from the bridge deck commenced in the summer of 2008. During that time, EBA's Calgary Materials & Pavement Group had been awarded EBA's internal Applied Techn

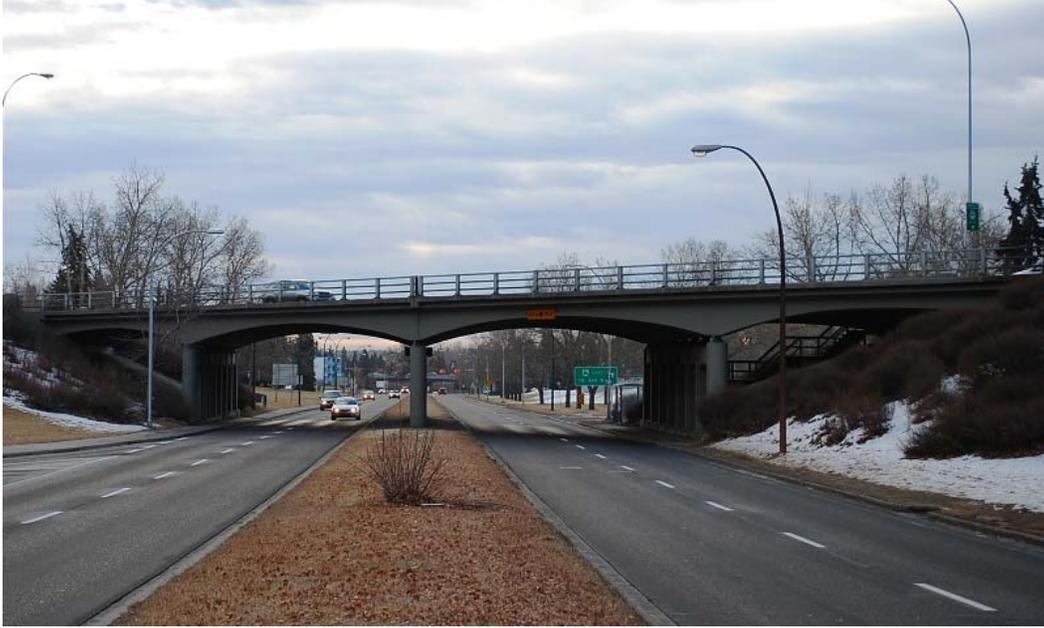
Photo 1: General view of the TransCanada Bridge.

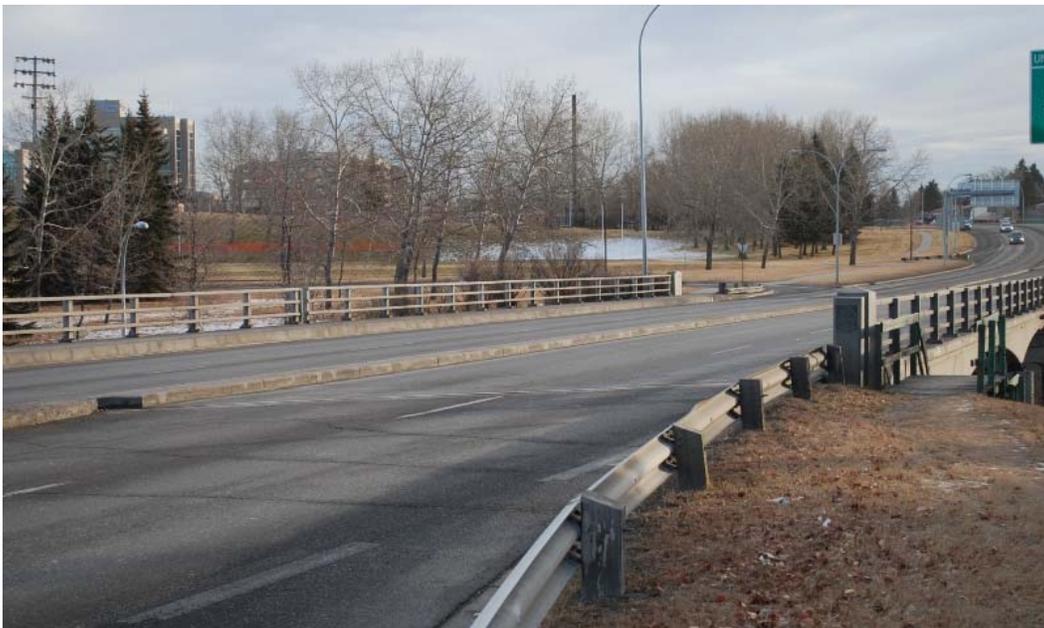
Photo 2: General view of the bridge deck.

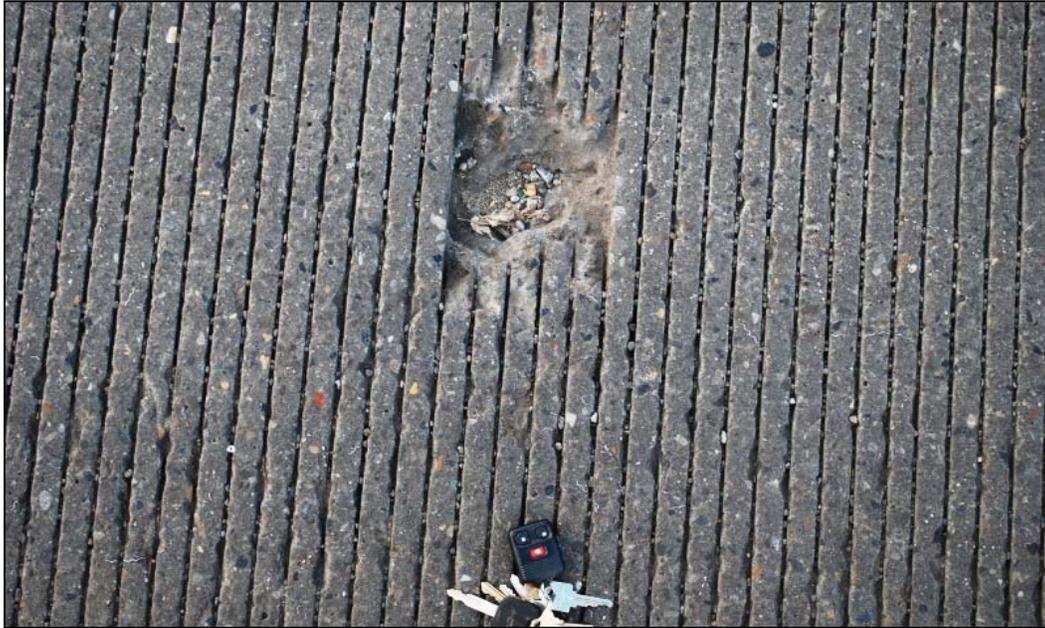
The concrete overlay, which contains steel fibres, was constructed in 2001 when the bridge was rehabilitated. The overlay thickness varies from 90 mm to 190 mm. Steel reinforcement was found in the overlay. The concrete surface was tined. Spalling was evident on the deck, as well as small map cracking (Photo 3). Light scaling was noticed throughout the deck (Photo 4). At the time of the inspection, it was noticed that the

Photo 3: Spalling surface of the concrete overlay.

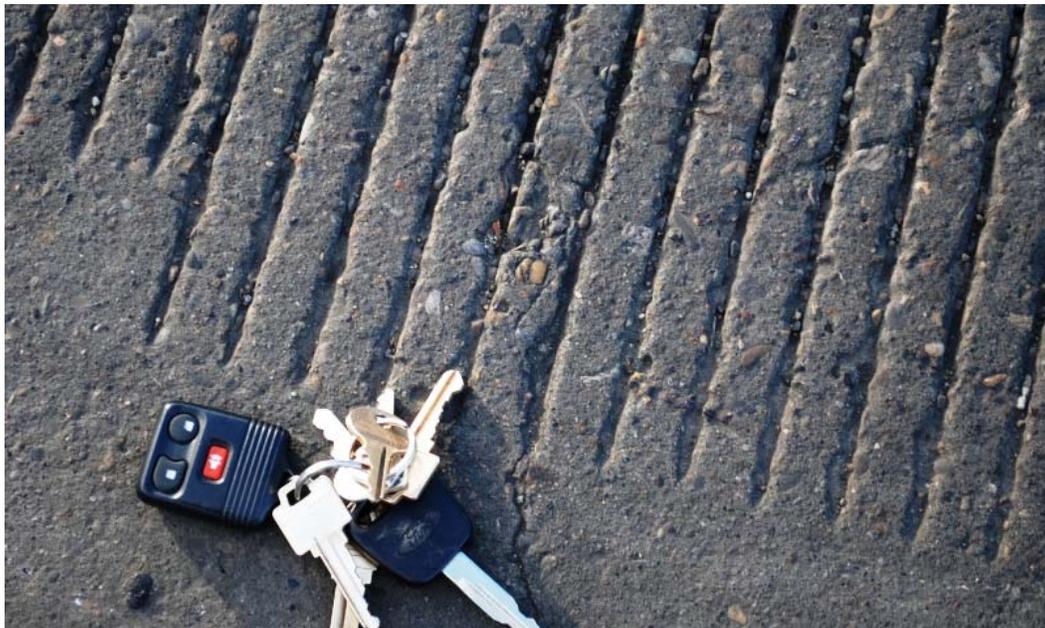
Photo 4: Map cracking and light surface scaling.

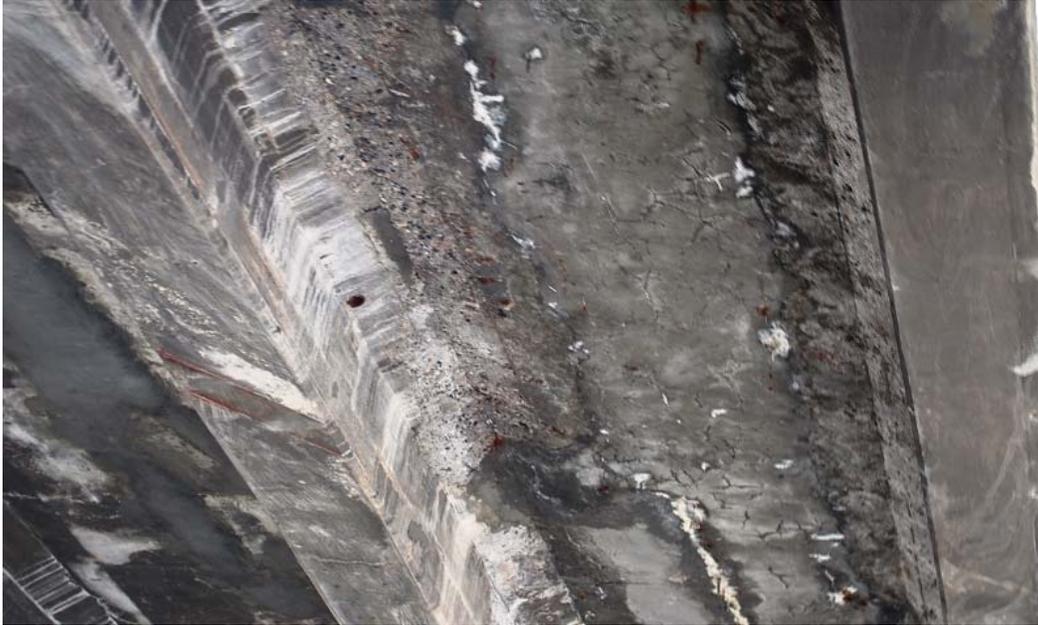
The concrete deck was inspected from beneath the deck. Large cracks and rust staining were evident. The underside of the bridge was patched; however, cracks were propagating through the patches. Leaching was also evident from the bottom of the deck (Photo 5).

Photo 5: Leaching and patched areas under the bridge.

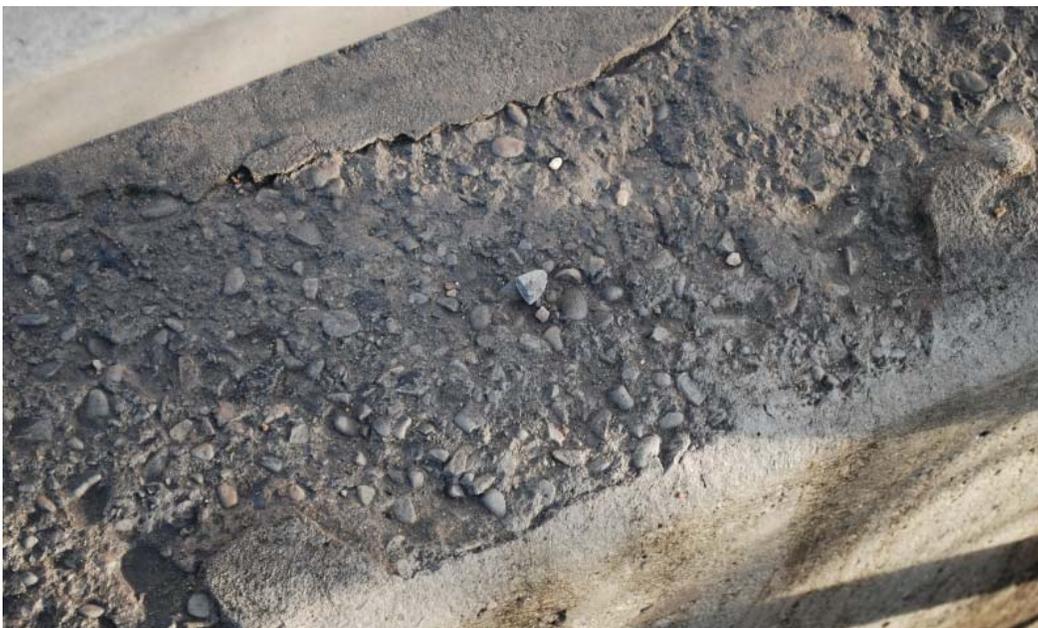
The bridge elements consist of a median, curb, and sidewalk on the north side, and curb on the south side of the bridge. The cracking was observed on the median, sidewalks, and curbs. Spalling was noticed on the curb at the southwest edge of the bridge (Photo 6). Light scaling was evident on the median, sidewalks, and curbs. There are two expansion joints on the bridge, one at each end of the bridge. No signs of joint leakage were observed. The expansion joints were filled with sand and gravel that was accumulating in the corners of the deck.

Photo 6: Spalling of concrete curb.

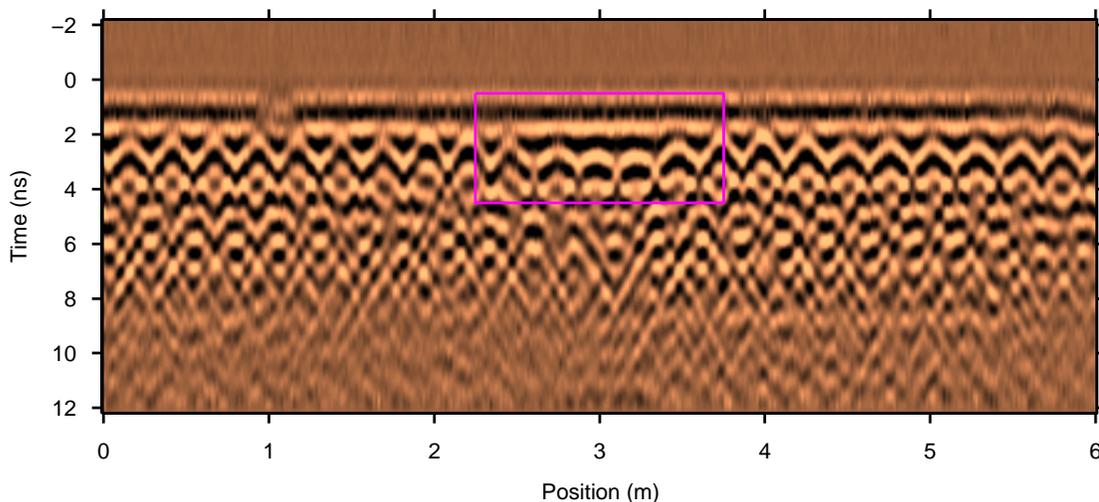
Subsurface rebar anomalies identify radar signatures for distresses existing within the deck structure. Significant subsurface (deck) anomalies of interest for monolithic structures typically occur between the PCC deck surface and the top layer of reinforcing steel, with the most significant occurring at the level of the rebar. Deck anomalies are further categorized as low, medium, and high severity. The anomalies are distinguishable by their abnormal radar signatures in comparison with the normal hyperbolic signature for transverse reinforcing steel bars (highlighted on Figure 3).

A low severity classification is consistent with areas in the initial stages of concrete deterioration/delamination at the rebar level. Medium and high severity deck anomaly signatures are indicative of areas exhibiting characteristics for delamination, debonding of concrete overlay from the deck, and/or significant spalling of the upper portion of the deck structure. Deck anomalies were classified in the context of potentially complicated or unusual rebar placement schedules and steel corrosion or pitting. In such cases, sophisticated post-processing techniques were used to interpret the effects of atypically placed longitudinal bars, which can complicate consistent transverse rebar layer condition assessment.

Figure 3: Bridge deck radar data showing an area with rebar distress signatures.

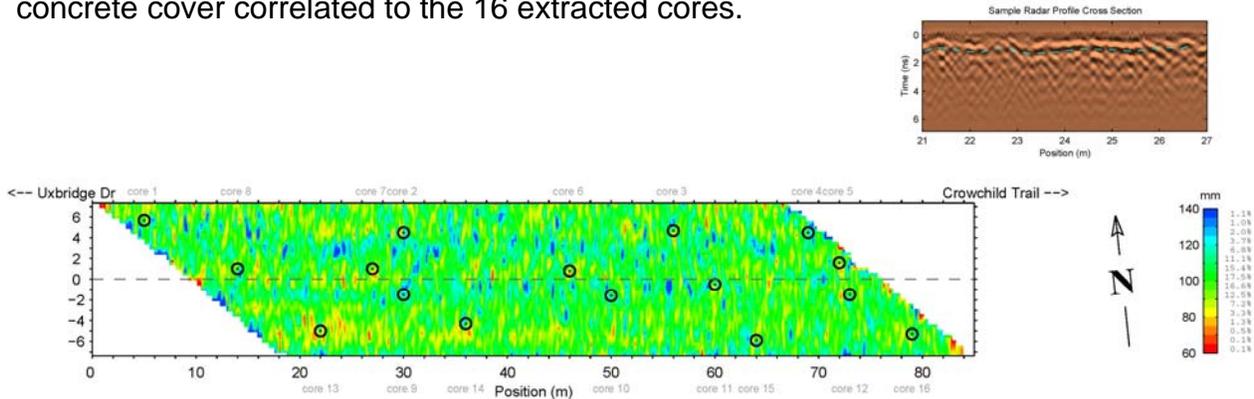
Figure 4 presents the thickness of the concrete cover (total concrete cover above the top mat of rebar, including the steel-fibre reinforced HD concrete overlay) for this bridge. This plan map shows a variable thickness PCC cover ranging from less than 60 mm to more than 140 mm, with an average thickness of 100 mm across the bridge deck. A sample of the radar data with a line marking the location of the rebar interface is included on the plan map. In general, the thickness measurements from the total concrete cover correlated to the 16 extracted cores.

Figure 4: Steel-fibre PCC cover plan map.

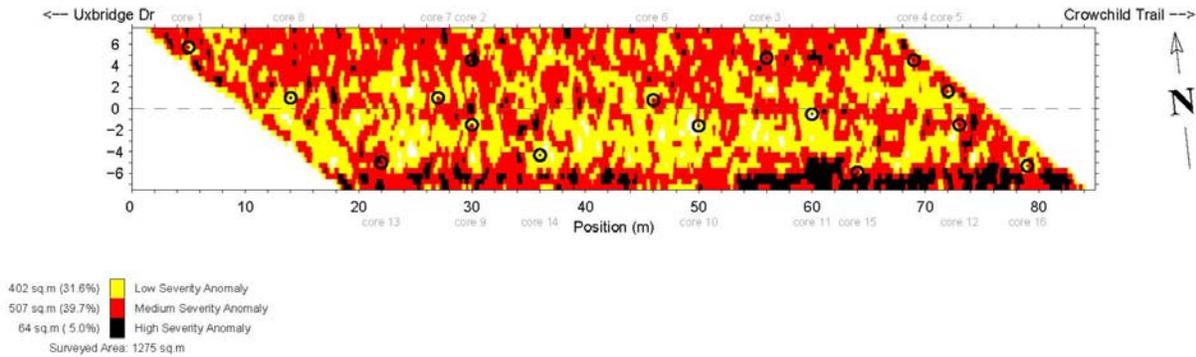
Figure 5 presents deck anomalies detected at the surface of the structure. The medium and high severity anomalies on this bridge cover 44.7% of the area of the bridge. These anomalies indicate planar variations in the bridge structure at or above the level of the top mat of reinforcing steel. In most cases, high severity anomalies were identified along the south curb along the eastbound outside lane. The locations of these anomalies are consistent with low-lying drainage areas for the deck. Low and medium severity anomalies identify radar signatures characteristic of areas in the initial stages of distress, such as concrete durability failure or a delamination of overlay concrete.

Figure 5: Deck anomaly plan map.

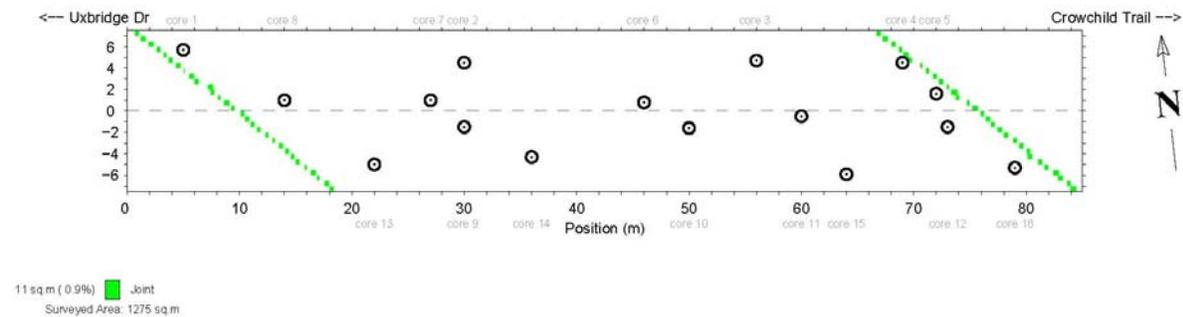
Figure 6 presents the structural anomalies for the structure. The structural anomalies are anomalous from a radar perspective, but are typically associated with normal structural discontinuities (construction or expansion joints) from a bridge structure viewpoint. This plan map identifies the locations of expansion joints along the bridge deck.

Figure 6: Structural anomaly plan map.

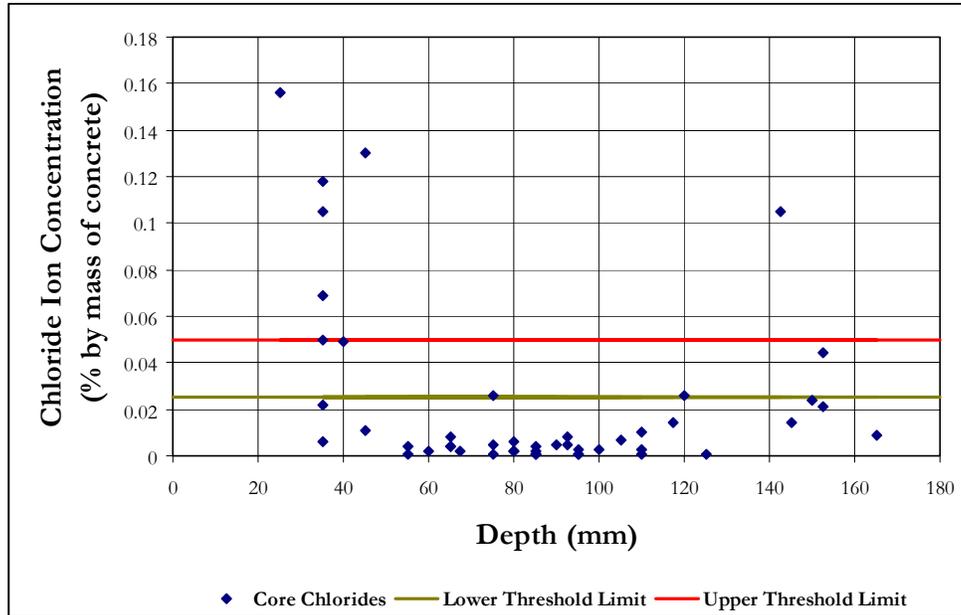
Figure 7: Chloride ion concentrations vs. depth.

The chloride concentrations presented in Figure 7 indicate that the chloride ion content is rising closer to the surface and closer to the overlay/deck bond. There is no good correlation between the concentrations and the depth of concrete mainly due to chlorides left in old concrete and the upward transport of chlorides within the old/new concrete interface. The range of chlorides at about 40 mm below surface is large (0.006% to 0.130%) and can only be explained by concrete uniformity/construction issues at the time of the rehabilitation work.

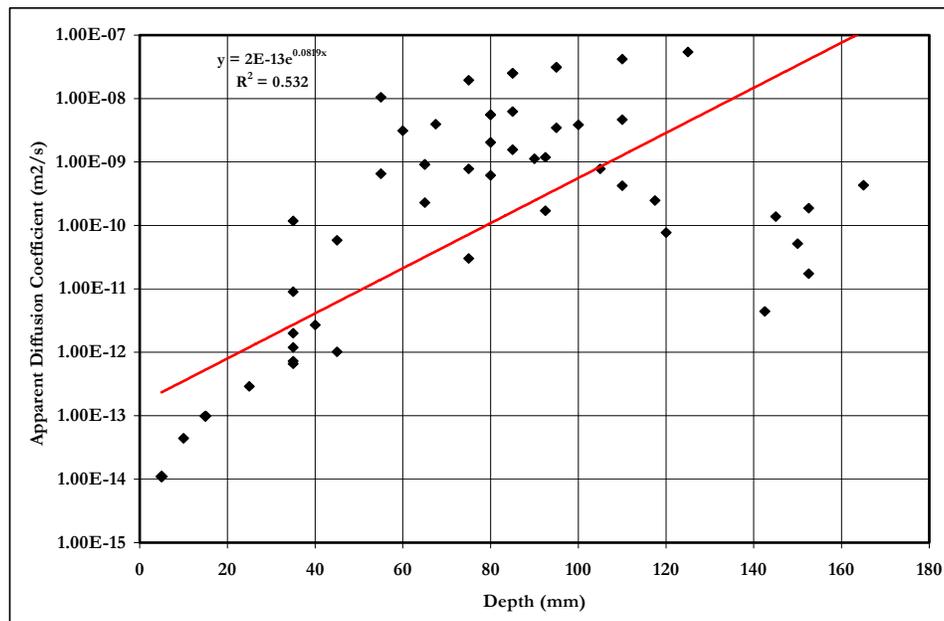
Figure 8: Correlation between diffusion coefficient and depth from surface (diffusion coefficient in log scale).

The coefficient of determination R^2 indicates that over 53% of the samples have the diffusion coefficient dependent on the depth from surface. The outliers are likely due to the sorption and desorption within the top 10 mm, surface cracking and tanning, and possibly something other than diffusion transport mechanisms. In addition, chloride transport patterns on the new/old concrete interface affect the correlation with depth. The wide range of chloride concentrations at the 40 mm depth also contributed to the poor correlation.
