Characterizing Field and Laboratory Performance of Cementitious Partial Depth Repair Materials

Paper prepared for presentation at

the "Successes and Innovations in Maintenance Methods and Practices" Session

of the 2011 Annual Conference of the Transportation Association of Canada Edmonton, Alberta.

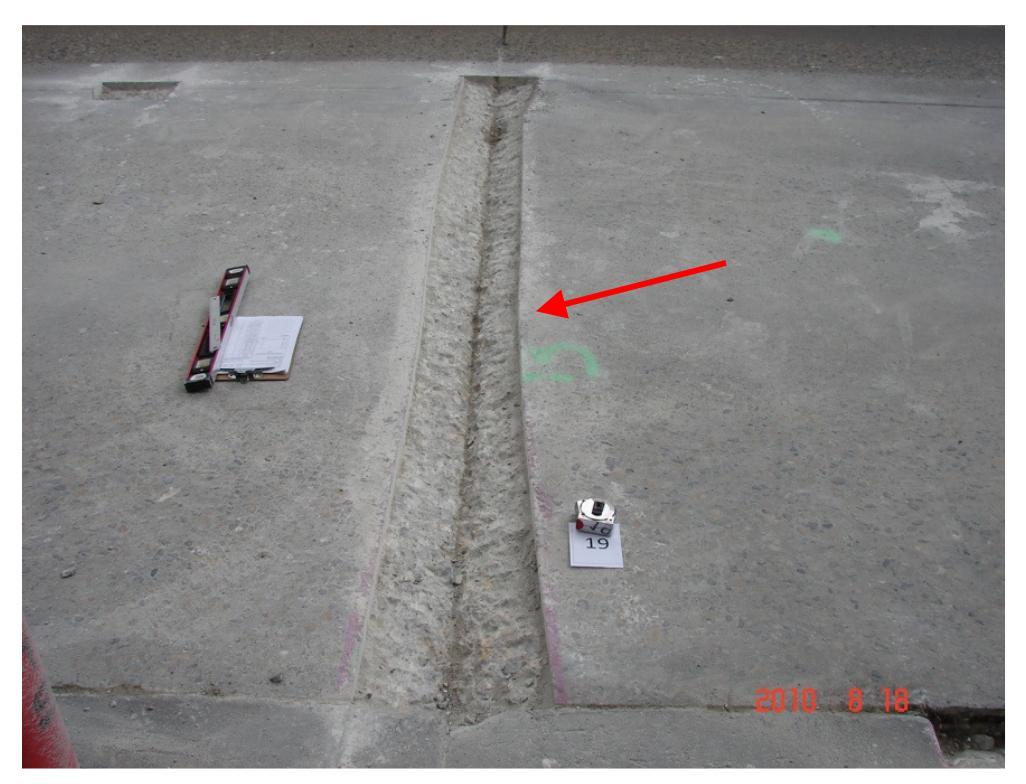
Figure 1: Typical Finalized Repair Surface

The deteriorated concrete marked within the repair area was removed by the saw and patch method. This method consisted of saw cutting the marked edges of the repair to a depth of 40 mm from the pavement surface using a concrete cut-off saw mounted on a cutting cart. Once the repair boundaries were cut, the concrete was removed by a 11.3 kg jackhammer. The concrete was removed by first jackhammering near the center of the repair area and working outwards to the saw-cut. Then the repair surface along the bottom edge of the saw-cut was jackhammered in order to fully expose the vertical surface of the cut. The concrete within the repair area was removed to the bottom of the saw cut or 10 mm below visually sound and clean concrete [3,4]. Once finished, the repair surface was at a typical 10 to 45 degrees angle from the horizontal as shown in Figure 2.

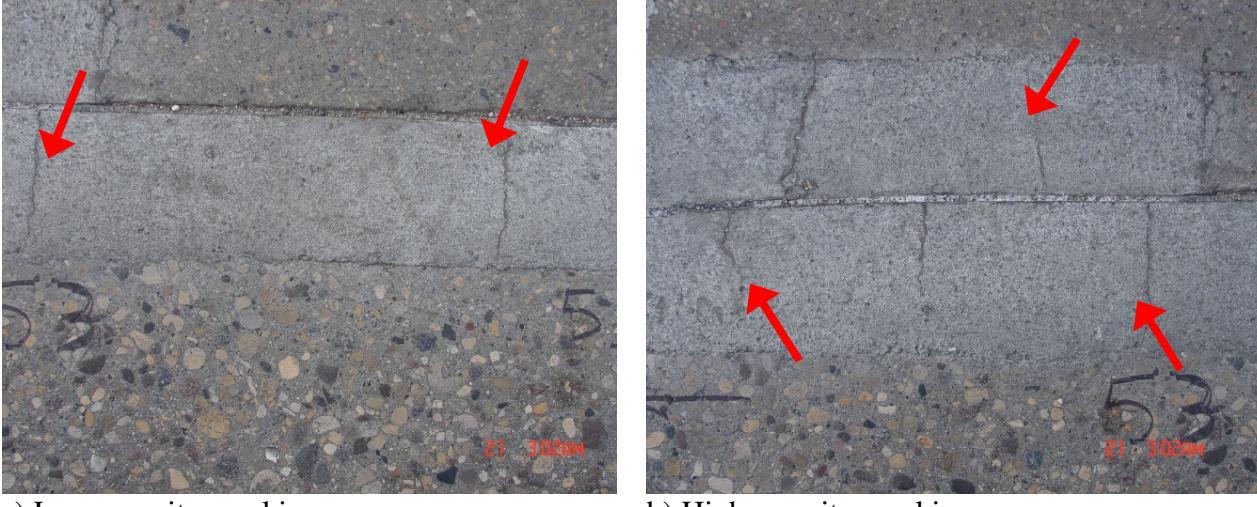
#### Figure 4: Transverse Cracking in the Repair Area

Transverse cracking, shown in Figure 4, represents the cracks in the transverse direction of the repair area. The severity of transverse cracking was categorized as low, medium, or high according to the spacing between cracks along the repair area. Longitudinal cracking, as shown in Figure 5, represents the cracks in the longitudinal direction of the repair area. Cracking at the saw-cut surface, as shown in Figure 6, represents the initiation of separation between the repair material and the original concrete. Surface finish, as shown in Figure 7, represents the regularity of the repair surface after installation of the repair material.

a) Low severity cracking

b) High severity cracking

The frequency of the distresses for each repair material one month after installation is shown in Table 4. Areas repaired with materials E and F had lower percentage of transverse cracking than the remaining materials. Repair materials that had high water content during mixing experienced higher percentage of transverse cracking. All of the repair material had no or very small percentage of longitudinal cracking except for repair material B. The longitudinal cracking near

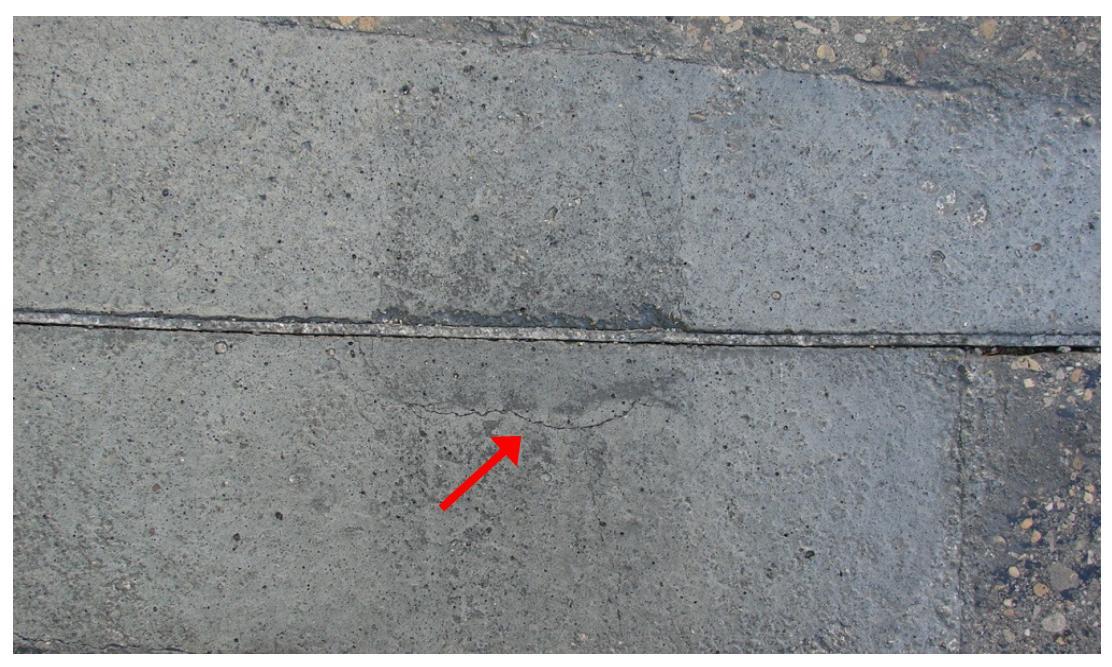
Figure 5: Longitudinal Cracking in the Repair Area

the wheel path can be attributed to the structural instability of the patched area and are not related to the type of repair material. For cracking at a saw-cut surface, materials D and F had the lowest percentage of cracking, while material B the highest percentage of cracking. All the repair materials had good surface finish except material A, where 32% of these patches had a poor surface finish.
