Case history on the design, implementation, and conclusions of a study of haul roads associated with a wind farm development in Southwestern Ontario

Robert A Douglas, Senior Geotechnical Engineer, Golder Associates, Ltd.* Ivana Marukic, M.Sc., Pavement and Materials Engineering, Golder Associates, Ltd. James D Rodger, Principal, Golder Associates, Ltd.

of the 2011 Annual Conference of the Transportation Association of Canada Edmonton, Alberta

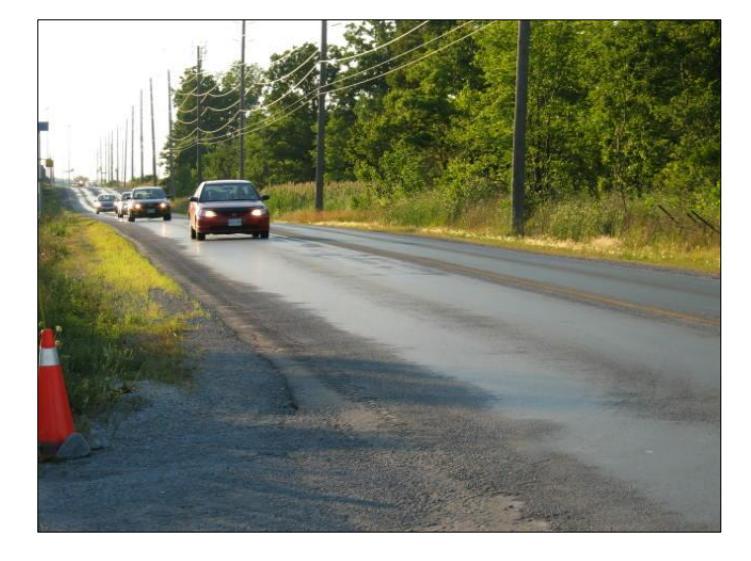
- Figure 4. Typical distresses. (a) flushing in surface-treated pavement (b) rutting in asphalt pavement (c) alligator cracking in asphalt pavement.

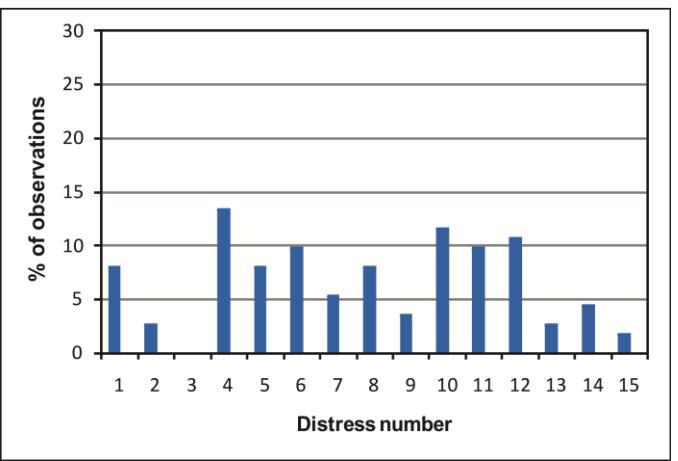
Figure 5. Distress observations, asphalt-surfaced roads.

For the asphalt-surfaced roads, Figure 5 indicates that wheel track rutting, single and multiple pavement edge cracking, transverse cracking, single and multiple longitudinal cracking, and alligator edge cracking were dominant distresses. Missing or infrequently observed were rippling and shoving, random cracking, flushing, transverse alligator cracking, and centreline alligator cracking.

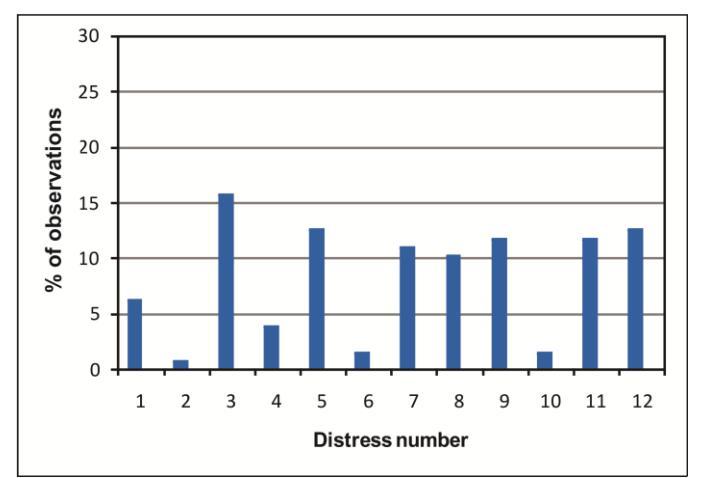
Figure 6. Distress observations, surface-treated roads.

Surface-treated pavement distress data is presented on Figure 6. A significant number of observations of all distresses were made with the exception of streaking, rippling and shoving, transverse cracking, and potholing.

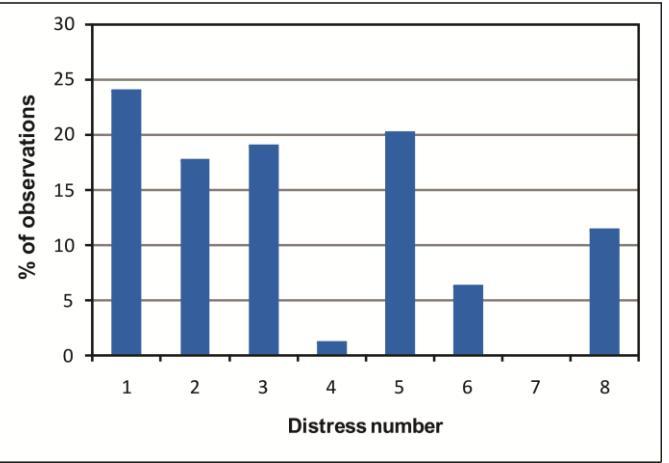
Figure 7. Distress observations, gravel-surfaced roads.

Figure 7 shows the distress observation data for gravel-surfaced roads. Significant numbers of observations of loose gravel, washboarding, potholes, dust, and distortion were made, while little or no flat or reverse crown, breakup, or rutting were observed.

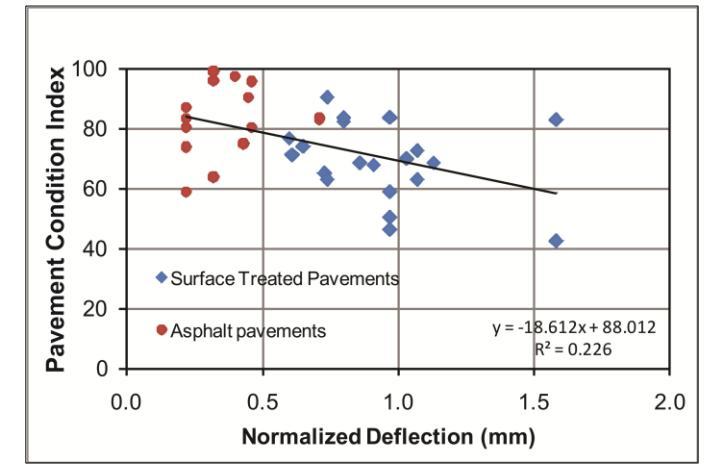
Figure 8. Correlation of PCI to FWD deflections.

The combined set of data for the asphalt and surface-treated pavements is plotted on Figure 8. The asphalt pavement points extend the trend set by the surface-treated pavements into the low-deflection, high-PCI region of the graph. Linear regression results in an r^2 value of 0.23, indicating weak correlation. The trend does go the expected way (greater deflection, lower PCI), however. It must be recalled that the PCI values are artificially high, because with no RCR data recorded, RCR was arbitrarily set at 10.
