Forensic Investigation of Cracking in a Portland Cement Stabilized Full Depth Recycled Pavement

Christopher L. Barnes, Assistant Professor Dept. of Civil and Resource Engineering, Dalhousie University

of the 2010 Annual Conference of the Transportation Association of Canada Halifax, Nova Scotia

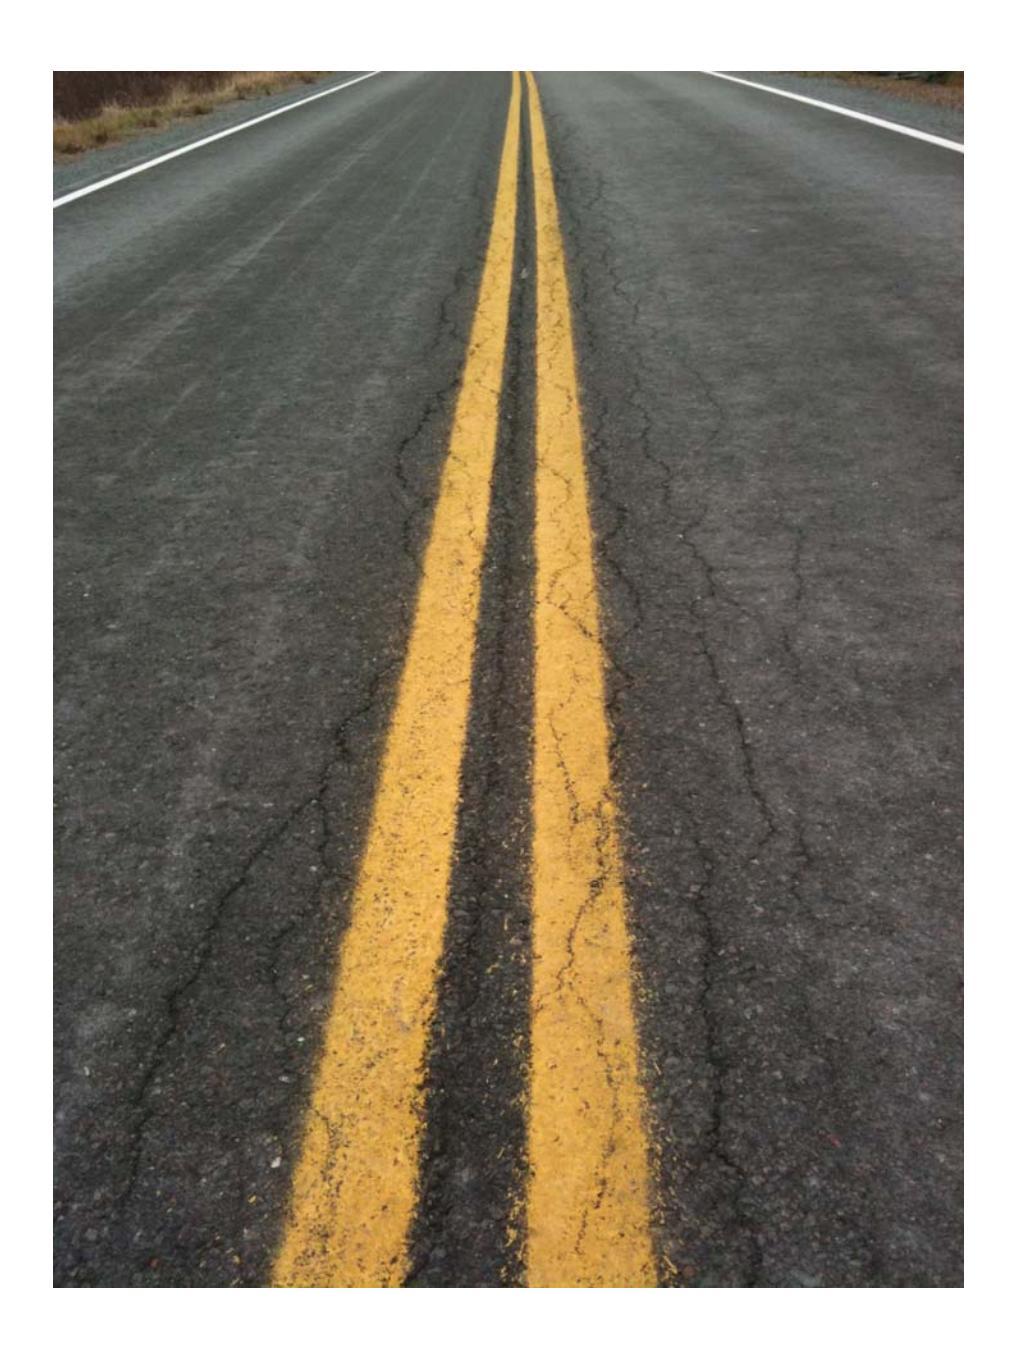
Contrary to expectations and the reported historical success of the method, the Pt. Michaud Beach Road, and some of the other PC-FDR projects that have been completed in Nova Scotia in 2008-2009, have exhibited moderate to severe centreline cracking, as shown in Figure 1, and both frequent transverse and shoulder edge cracking. Inspection of the cracked centreline areas revealed that the crown was actually depressed by 4-6 mm in many locations, as shown in Figure 2. As a result, the Nova Scotia Department of Transportation and Infrastructure Renewal are reviewing the completed projects in order to determine the cause of the cracking and the feasibility of continuing the program.

Figure 1 – Severe centreline cracking observed on Pt. Michaud beach Road PC-FDR pavement.

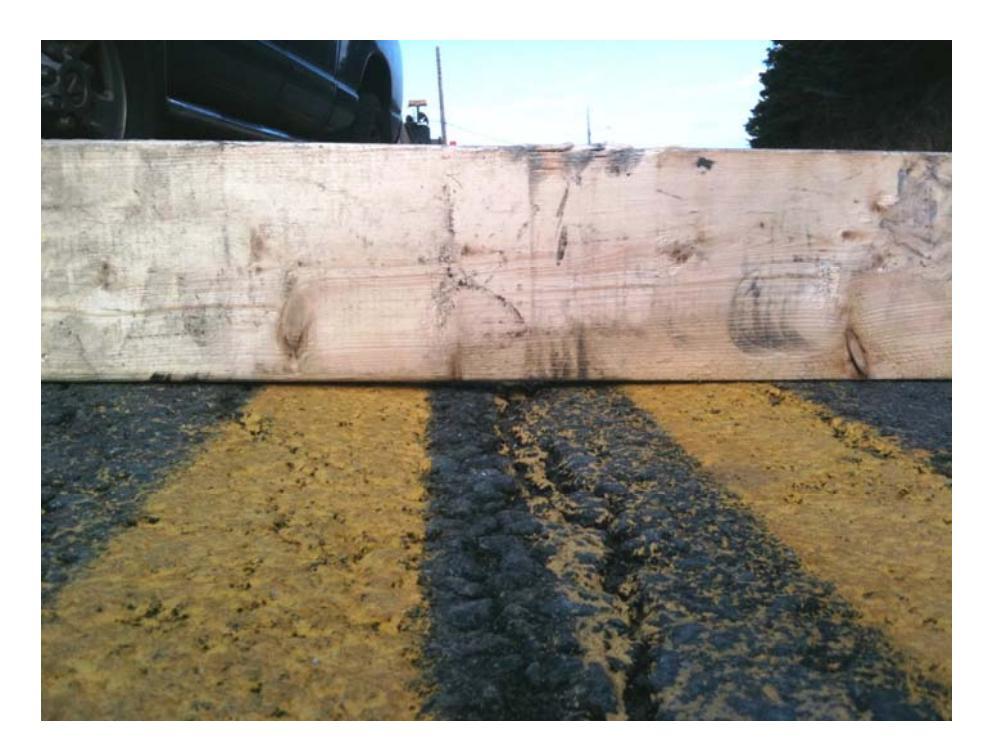
Figure 2 – Depressed crown in a region of moderate centreline cracking.

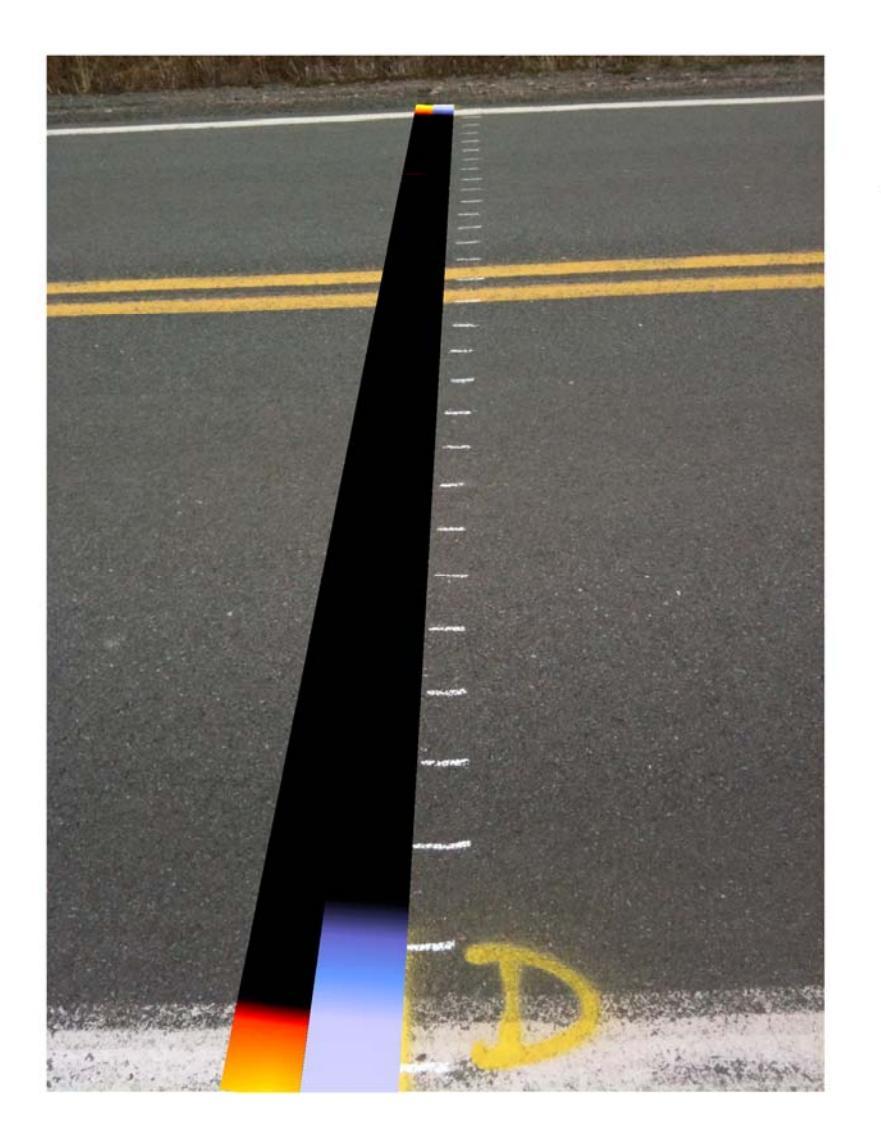
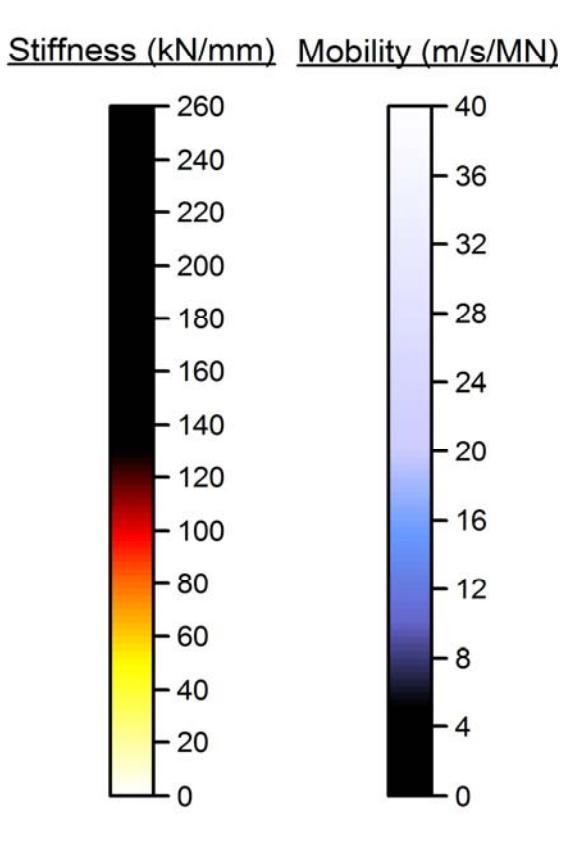
Figure 3 shows a photograph of a section on the Pt. Michaud Beach Road where no cracking was observed on the pavement surface. Impulse-response tests were conducted at 0.2 m intervals to determine the variation in dynamic stiffness and mean mobility across the width of the paved surface. Reduced values of dynamic stiffness, shown as 'hotter' red-yellow colour, and higher values of mobility, shown as brighter blue-white colour, can be observed near the outer edges of the pavement surface. Since no visible evidence of damage was observed, it was assumed that these reductions corresponded to reductions in structural rigidity associated with the less supported free edge of a rigid pavement slab. Furthermore, the dynamic stiffness and mobility appeared to be consistent throughout the interior of the pavement width, including the region of the crown where cracking damage was observed elsewhere. This might provide some evidence against the idea that the pavement was cemented twice near the centreline during the construction process. This also appears to indicate that the softened behaviour of the free edge seems to converge to that of an interior loaded plate within 35-40 cm of the plate edge for this pavement.

Figure 3 – Variation in dynamic stiffness and mobility across an undamaged pavement section.

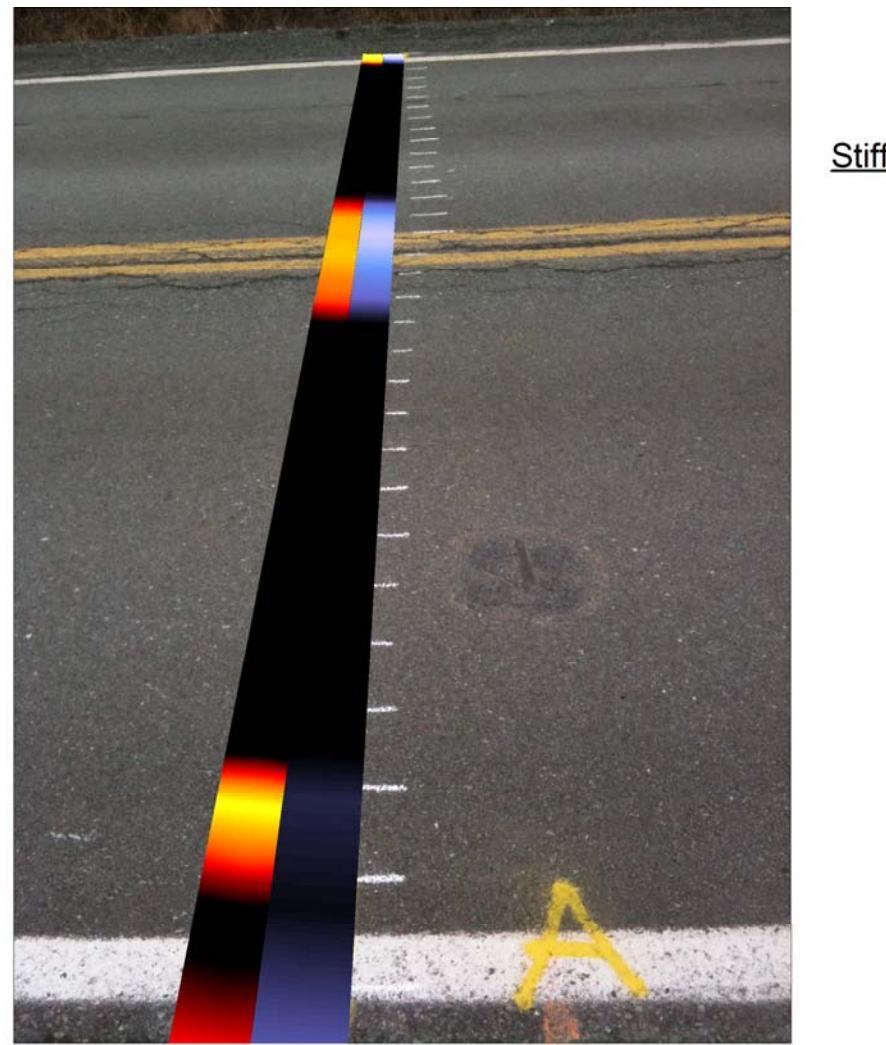
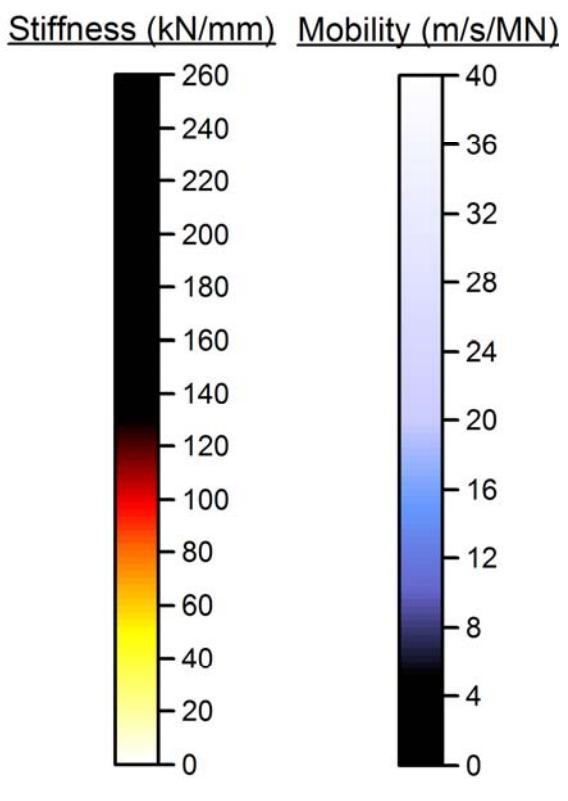
Figure 4 shows a photograph of a typical damaged section where only heavy centreline cracking was observed. Similar reductions in stiffness and increases in mobility can be observed near the pavement edges. However, a significant decrease in the stiffness can be observed near the 0.25 m distance from the pavement edge (foreground) and near the centreline of the pavement. A slight increase in mobility can be observed at the 0.25 m distance from the pavement edge, while a large increase in mobility can be observed near the centreline. The changes in stiffness and mobility are readily associated with the heavy cracking observed near the centreline, but indicate that the damage likely extends beyond the asphalt layer into the PC-FDR. If only the asphalt layer were affected, a subtle change in the measured stiffness might be expected due to the higher PC-FDR modulus and thickness. Furthermore, the increase in mobility indicates that the PC-FDR layer below the asphalt layer is likely deteriorated, providing reduced support conditions. The testing also revealed the likely presence of a crack in the PC-FDR at the 0.25 m distance from the shoulder which has not yet propagated up through the asphalt concrete, resulting in decreased stiffness and a slight increase in mobility.

One of the impulse-response test sections was cored to investigate the condition of the PC-FDR materials in the damaged centreline area and the apparently undamaged mid-lane area. The filled core locations can be observed to the right of the chalked test locations in Figure 4. Figure 6 shows a photograph of an intact PC-FDR core extracted from the outer wheel path near the impulseresponse tests. A delamination near the interface between the asphalt concrete and the PC-FDR base can be observed which may have developed during the drilling operation. An intact sample of the PC-FDR base materials could not be obtained from the centreline region. The bit was able to core through the asphalt concrete layer, but refused to progress farther than 50-60 mm into the stabilized base. Upon extraction of the bit and the asphalt concrete core, it was observed that the stabilized materials were heavily damaged, resulting in loss of the matrix binding the coarse aggregate particle and fragmentation during drilling. Figure 7 shows the intact asphalt core and a sample of the PC-FDR fragments retrieved from the drilled hole. A second attempt at drilling the pavement in this location vielded the same result.

Figure 4 – Variation in dynamic stiffness and mobility across a typical damaged pavement section.

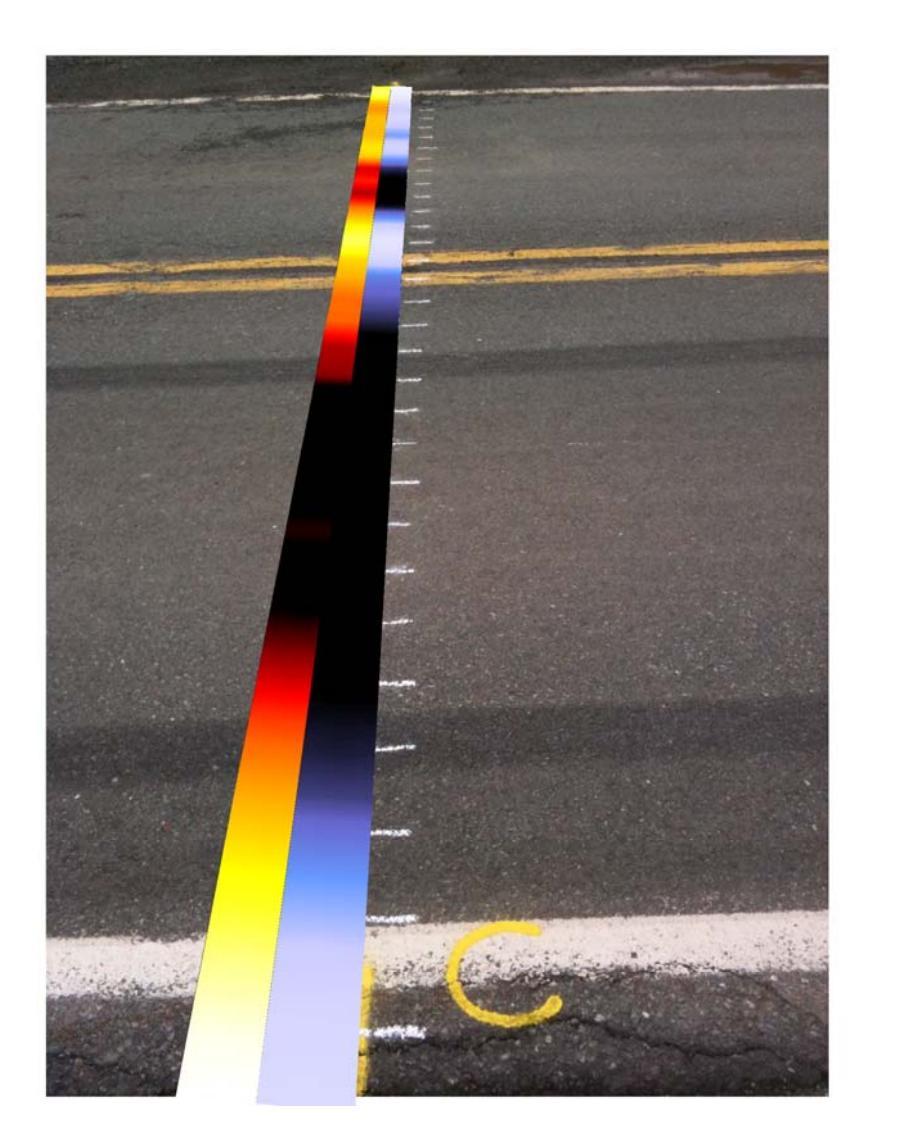
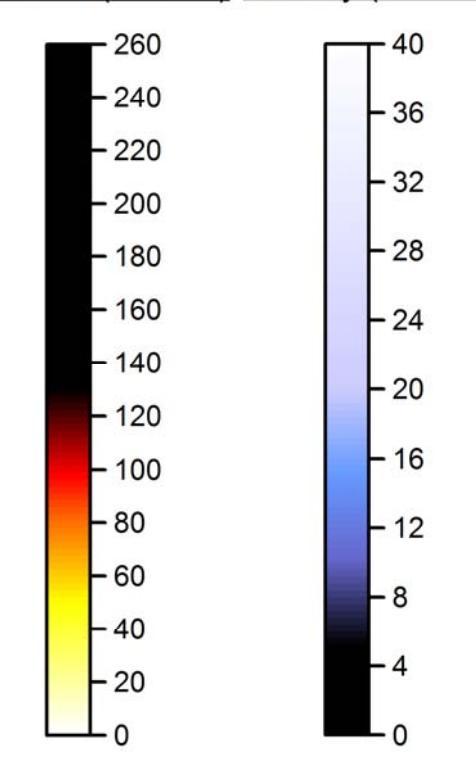
Figure 5 shows a photograph of a non-typical damaged section with both centreline and shoulder edge cracking, plus a wet, porous region that can be observed in the asphalt concrete. Shoulder edge cracking can be observed in the first 10-20 cm of asphalt concrete in the forefront of the photograph, but decreased stiffness and increased mobility can be clearly observed extending 1.10 and 0.90 m into the lane. It is likely that the shoulder area of the PC-FDR has become damaged but has not yet resulted in reflective cracking into the asphalt layer. Similar reductions in stiffness and increases in mobility can be observed near the observed centreline cracking in the asphalt concrete. The majority of the westbound lane exhibits decreases in stiffness and increases in mobility. It is likely that these effects are the result of moisture damage in both the asphalt concrete and the PC-FDR. A gravel road exits on to the Pt. Michaud Beach Road at this location and water was observed trickling down onto and the pavement.

Figure 5 – Variation in dynamic stiffness and mobility across a non-typical damaged pavement section.

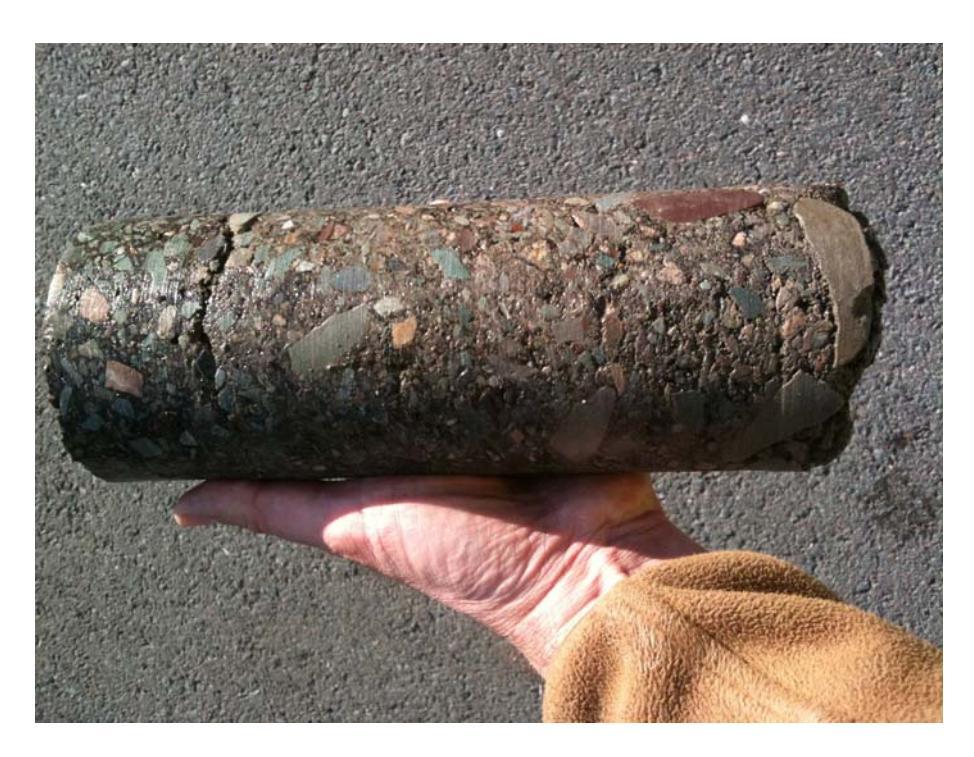
Figure 6 – Photograph of intact asphalt concrete and stabilized base core extracted from outer wheel path area.

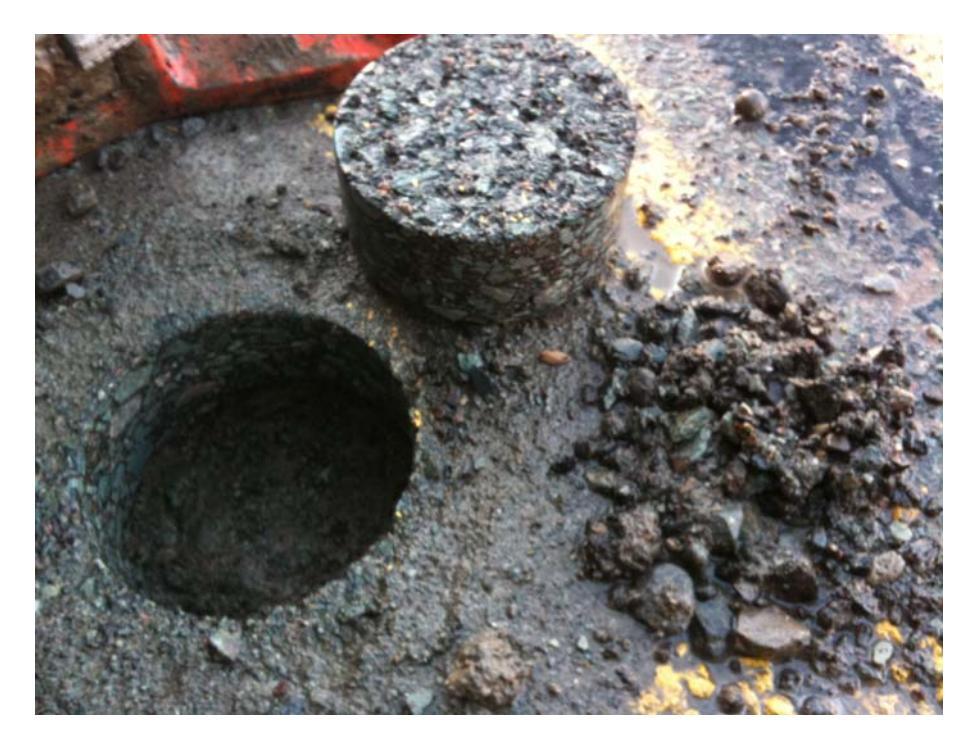
Figure 7 – Photograph of core location in heavily damaged PC-FDR base near the pavement centreline.

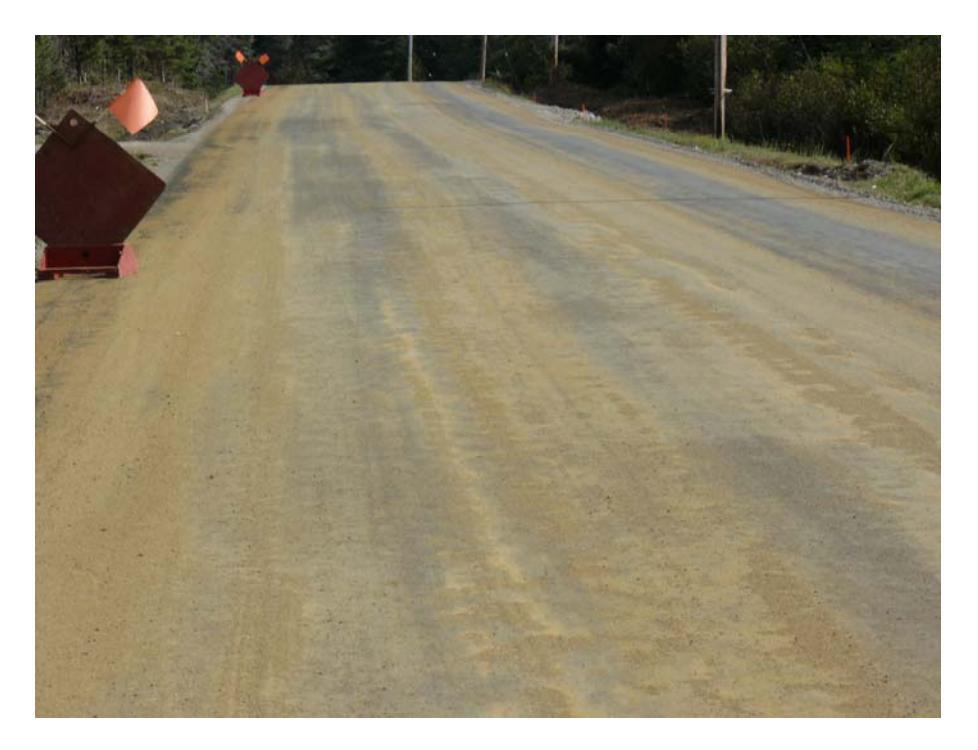
attempts at micro-cracking that the roller drum was not making full contact with the surface of the materials, but was focusing the load application near the extremities of the drum, due to some surface ruts. These ruts may have occurred due to a combination of poor nozzle spray patterns from the water trucks and the construction and local traffic driving on the compacted, but uncured, materials. The spray patterns of the curing water trucks were causing some erosion and loosening of the uncured PC-FDR surface which may have been tracked away by the traffic. Figure 8 shows the poor contact pattern of the initial micro-cracking effort on the PC-FDR mat, leaving the rutted areas uncracked. As a result, the rolling pattern was changed from a single pass being centred in the middle of each lane to adjacent passes spanning over the shoulder and the centreline edges of each lane.

Figure 8 – Poor contact of micro-cracking effort on rutted surface of uncured PC-FDR mat.

1) Ensure that the spray nozzles on moist curing water supply trucks are functioning properly to avoid erosion and subsequent loosening and loss of the uncured stabilized mat surface under local traffic. An alternative curing approach is the application of a sprayed on asphalt sealant to prevent the loss of internal mixing water. This approach also avoids the possibility of alternating wetting and drying cycles of the mat at early ages.

- 3) Micro-cracking efforts should be confined to the centre of each traffic lane only. Roller patterns used for micro-cracking should avoid the slab edges and crown area by at least 35-40 cm to avoid cracking the shoulder edges and rupturing the crown of the road. Rollers should be prevented from spanning both lanes across the crown.
