## **Impacts of Increased Loading Due to Heavy Construction Traffic on Thin Pavements**

Paper prepared for presentation  
at the Effects of Increased Loading on Pavements Session

of the 2011 Annual Conference  
Transportation Association of Canada  
Edmonton, Alberta

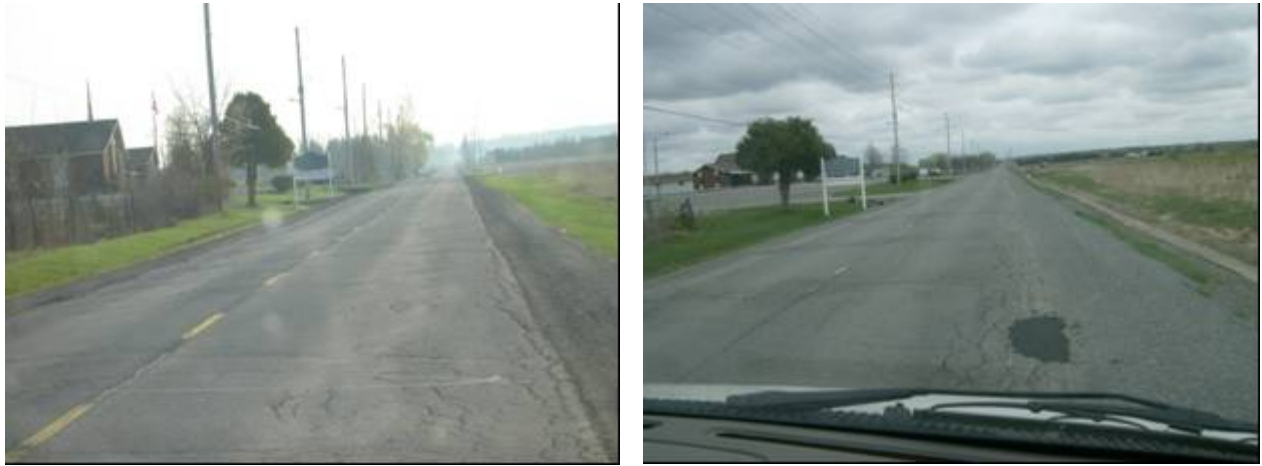
On the eastbound lane, the pavement distresses observed pre and post construction were similar; however, in a few locations the severity and extent of the distress had increased slightly. The following distresses were observed:

- Medium to high severity transverse cracking throughout
- Medium to high severity edge cracking and alligator cracking throughout
- Longitudinal and transverse cracking throughout
- Infrequent slight potholes throughout

**Figure 2: Alligator Cracking, Pre and Post Construction (left and right respectively)**

Images from the pre and post construction detailed visual condition assessments completed on the three 100 m long representative sections of the eastbound lane of Parkway Road are presented in Figures 2, 3, 4 and 5.

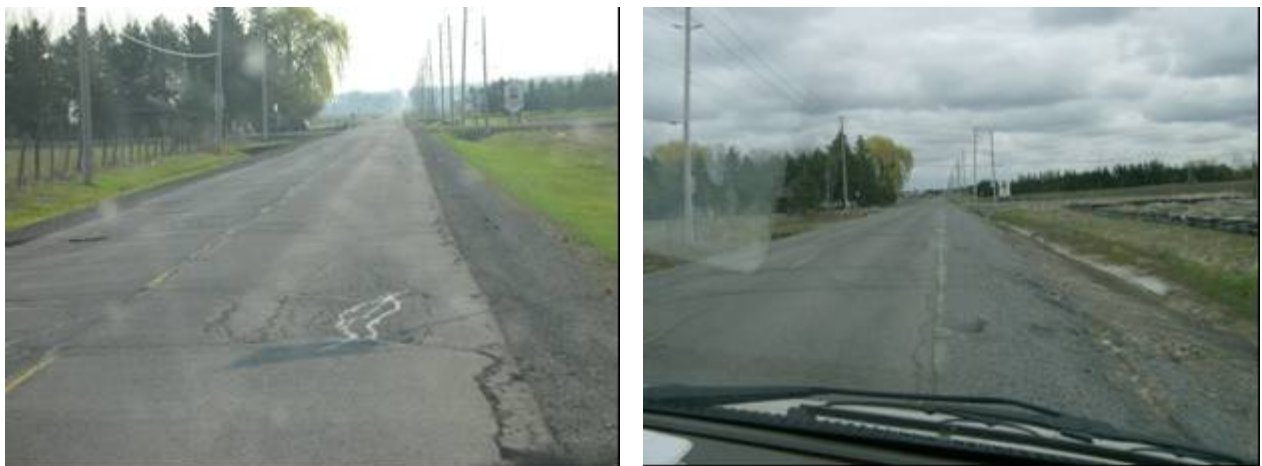
**Figure 3: Edge Cracking, Pre and Post Construction (left and right respectively)**

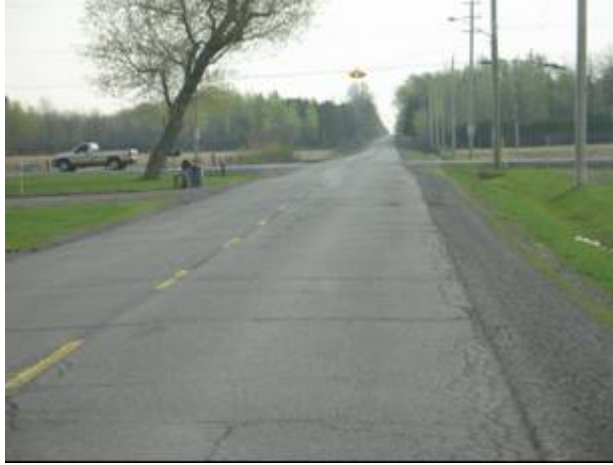
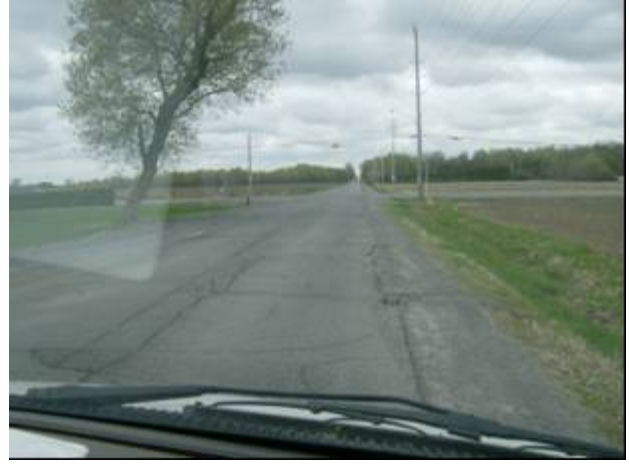
**Figure 4: Transverse Cracking, Pre and Post Construction (left and right respectively)**

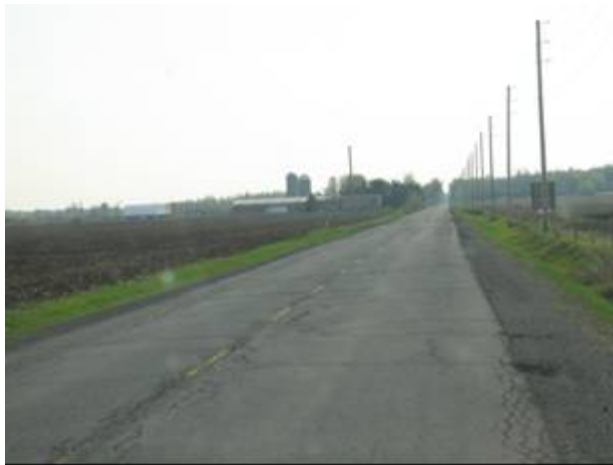
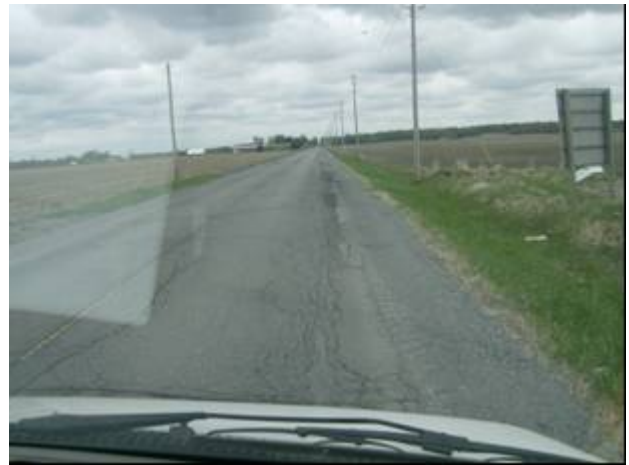
**Figure 5: Alligator Cracking, Pre Construction (left) and Post Construction (right)**

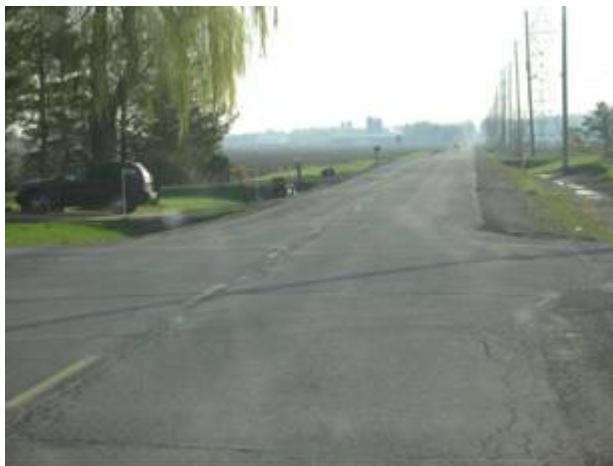
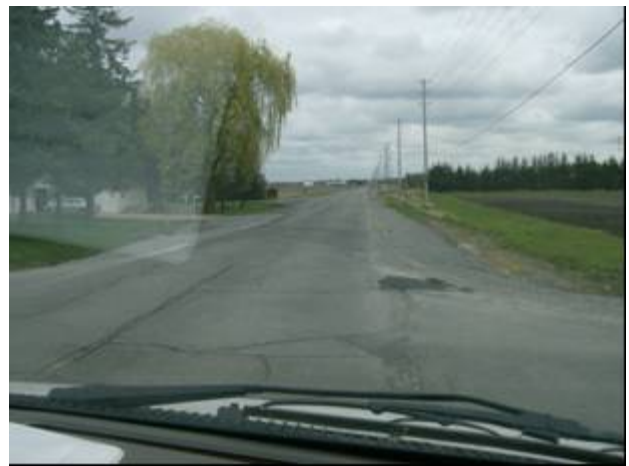
On the westbound lane, similarly to the eastbound lane the pavement distresses observed pre and post construction were similar. However, in a few locations the severity and extent of the distress had increased slightly. The following distresses were observed:

- Medium to high severity transverse cracking throughout
- Medium to high severity edge cracking and alligator cracking throughout
- Longitudinal and transverse cracking throughout
- Infrequent slight potholes throughout

**Figure 6: Transverse Cracking, Pre and Post Construction (left and right respectively)**

Images from the pre and post construction detailed visual condition assessment completed on the three 100 m long representative sections of the westbound lane of Parkway Road are presented in Figures 6, 7, 8, and 9.

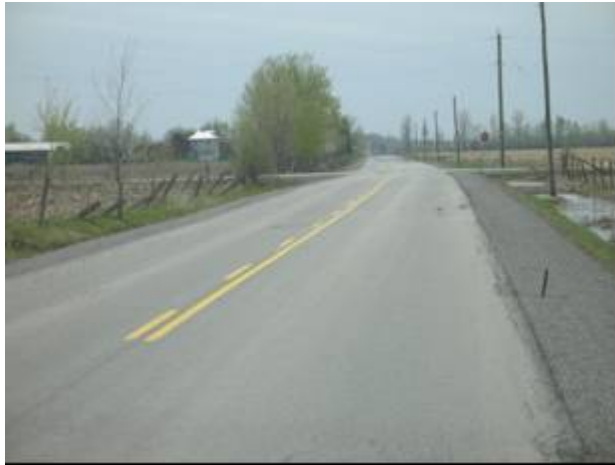
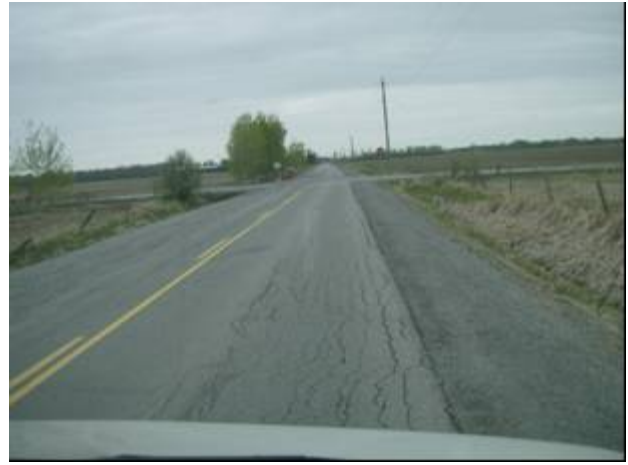
**Figure 7: Edge Cracking, Pre and Post Construction (left and right respectively)**

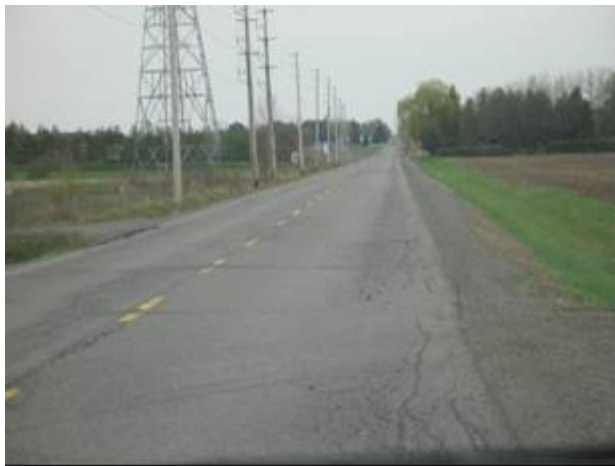
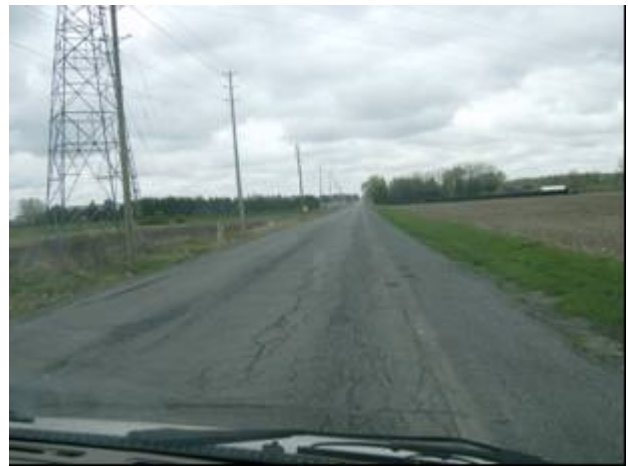
**Figure 8: Alligator Cracking, Pre and Post Construction (left and right respectively)**

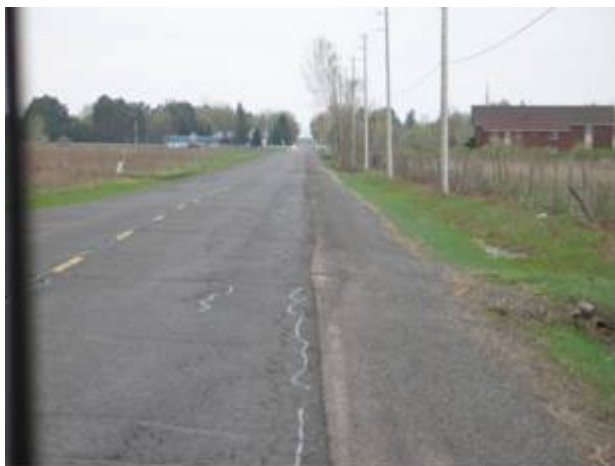
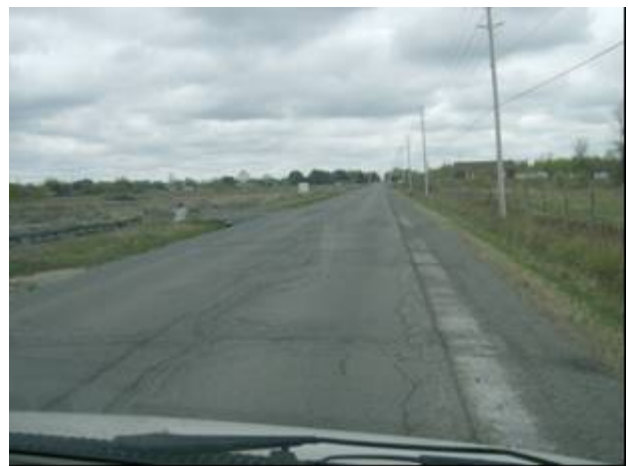
**Figure 9: Transverse Cracking, Pre and Post Construction (left and right respectively)**
