Design and Construction of the Capilano Cliffwalk

Paper prepared for presentation at the Session

2011 Annual Conference of the Transportation Association of Canada

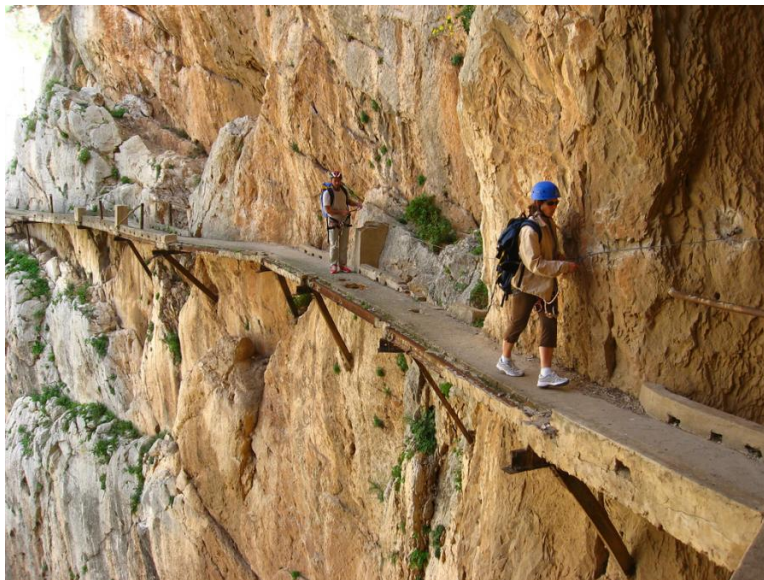
Figure 2 - El Caminito del Rey, Spain

El Caminito del Rey (The Kings Little Pathway) in Spain was constructed in 1905 between Chorro Falls and Gaitanejo Falls (see Figure 2). The 1.0 meter wide walkway is up to 330 meters high. The concrete path is supported by a steel support structure that is cantilevered off of the cliff face.

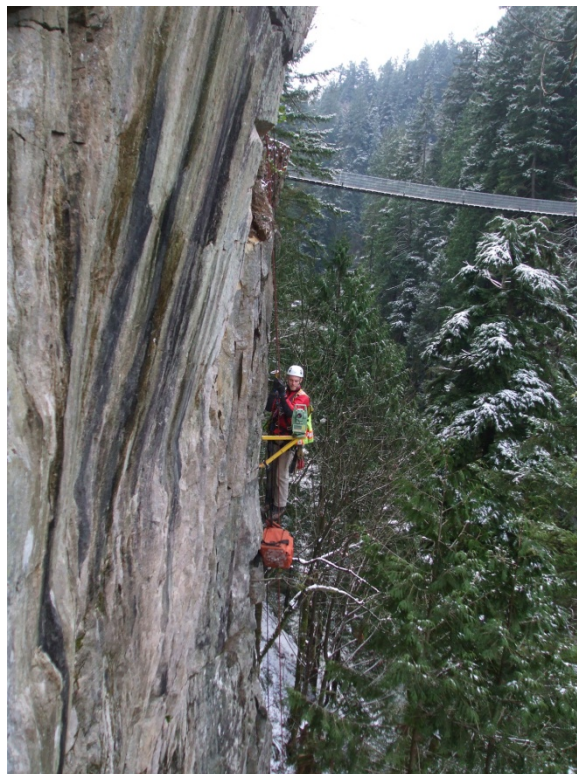
Figure 3 – Typical topographic survey

Gaining access to the cliff face and sloped ground below required the use of ladders, ropes and intense application of fall protection procedures (see Figure 3). Due to the unusual access requirements of this survey, personnel were trained in basic fall protection procedures as well as advanced vertical lifeline techniques. Throughout the project, difficult access was an issue but was overcome with a combination of experience, training, good planning and patience.

Surveyors worked their way along the cliff mapping the face from the base of the cliff. A Leica TCRA 1103 total station was selected for its superior reflectorless specifications and relatively light weight for its class of instrument. Customized survey legs were prepared to aid in setting up on very high angled ground. The majority of data was collected using the reflectorless capability of the total station however in some cases it was impossible to have direct sightlines to features on the cliff. In these cases and as necessary throughout the project, a surveyor would rappel down the cliff face with a reflector to survey particular features on the rock face. This survey was the first of many iterative surveys that were refined in scope as the design was finalized.

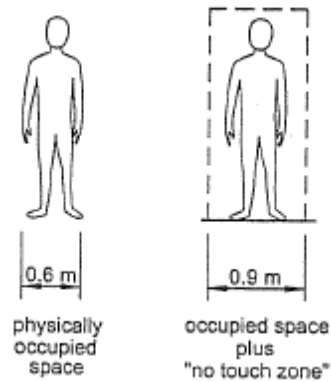
Figure 4 - Basic Pedestrian Dimensions

According to TAC Figure 2.2.6.3 (see Figure 4), the physically occupied space of a person is 0.6 meters. A 0.9 meter space provides a no-touch zone. It followed that a 0.5 meter wide deck with an upward opening hand rail (see Figure 5) provides sufficient width to accommodate one-way single file pedestrian traffic. The deck width is similar to that of the bridge structures that comprise the Treetop Adventures. The width between the handrails is 0.8 m at a height of 1.2 m above the deck. The narrow

0.5 m deck width was also required to minimize loading and hence the scale of the structure and its impact on the environment.

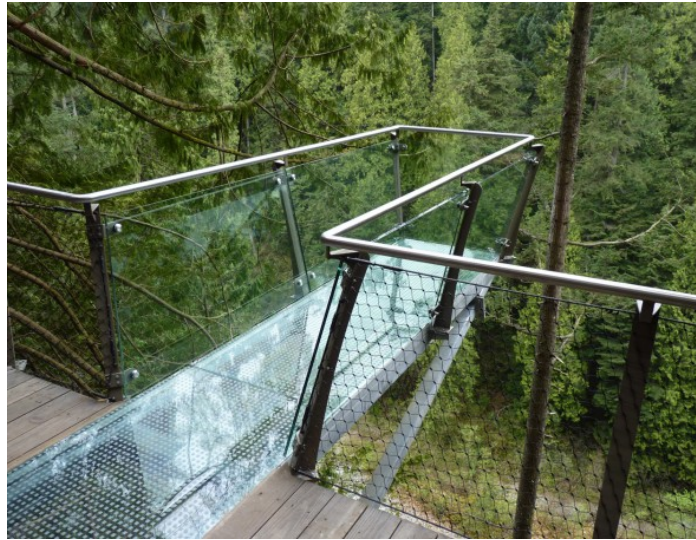
Figure 6 - Glass Floor

The walkway also includes two glass floors that project out from the main walking area (see Figure 6), allowing guests the choice to walk on to the glass floors. Being in a rainforest, the slippery glass floor had to have a baked on ceramic anti-skid coating. The glass floor areas also include glass guard rails mounted on steel posts. At the onset of the project it was originally conceived to have one glass floor, but a decision to retrofit one of the other viewing platforms was made partway through the project. This was a common theme during the project to make improvements to the structure's configuration as the construction developed.

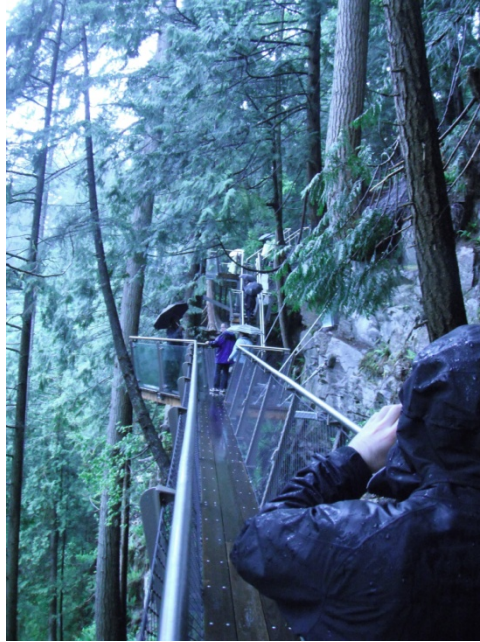
Figure 7 - Typical Walkway Configuration

The stairs are distributed over the length of the Cliffwalk to mitigate fatigue of the guests. The stairs have been arranged so that there are no more than two flights of stairs in succession and wider landings are provided between successive flights to allow persons to rest after climbing a flight of stairs without blocking circulation. Platforms with larger areas are also provided at several locations along the walkway (see Figure 7).

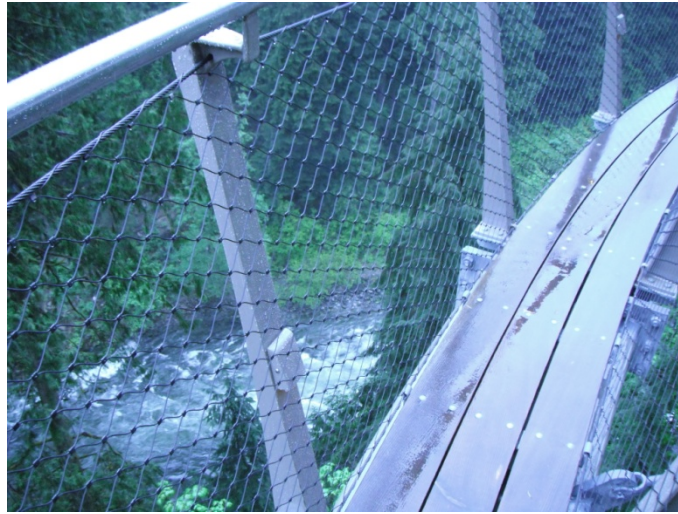
Figure 8 – Guardrail System

The design development of the guardrail and posts was also an iterative process and the key element was to provide a safe guard that was transparent. Glass was conceived as a suitable candidate at the beginning of the project, but the maintenance required to keep this material clean on a daily basis, in conjunction with the wind load consideration negated this as a viable solution by the design team. Initially, a non-climbable guardrail system using a system of 13 horizontal tensioned cables was conceived and a prototype was fabricated in the shop. This system included posts that were inclined from the vertical with an overhanging handrail to reduce the climbability. This system provided the desired transparency but proved to have a number of deficiencies in its safety and was abandoned. The final system chosen (see Figure 8) was a proprietary system X-TEND® available from Carl Stahl® DécorCable. This system is a 2 mm diameter stainless woven wire mesh that resembles chainlink mesh, but can be designed to conform to 3D shapes. The woven wire mesh is then woven on to an 8 mm diameter upper and lower cable and terminated with vertical cables at the ends of the bridges onto

terminal posts. The cables and mesh were treated with a black oxidizing process to effectively dye the mesh black to enhance the transparency of the guard.

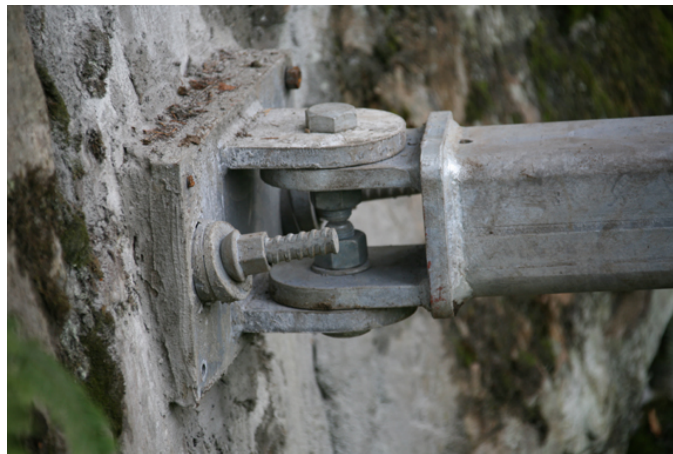
Figure 9 – Strut Beam Plate and Rock Anchors

The propped cantilevers that provide support for the stairs and bridges have small, light anchor plates for both the tension ties and the strut beam (see Figure 9). This allowed steel plates to be attached to the rock face via rock bolts to support the tension ties and the compression strut. Once the plates were installed, their locations were surveyed and this information used to update the 3D steel model in ProSteel to finalize the geometry and connection details for the structural steel frame.

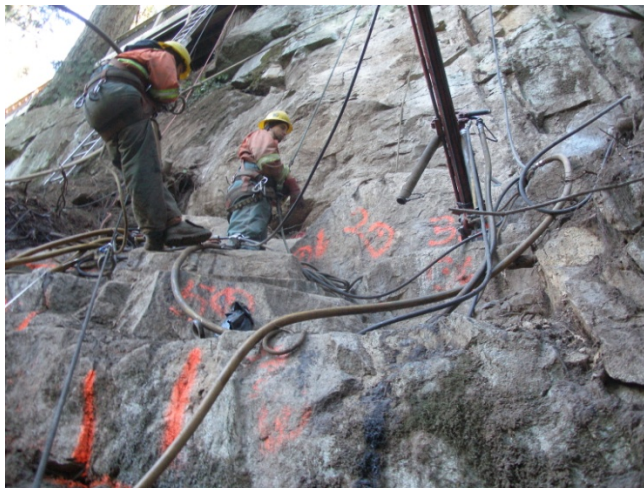
Figure 10 - Typical Rock Bolting Construction

The geotechnical investigation involved rappelling down the face over the full length of the alignment to map the rock and locate geological features such as faults, open tension cracks and areas of fractured

rock. For each of these features, a decision was made as to the most appropriate remedial measure (see Figure 10). That is, either the foundation was moved to a stable location, or the rock was stabilized by a combination of hand scaling to remove loose blocks of rock and installation of rock bolts. In some instances, this remedial measure was not determined until the rock drilling was underway, requiring structural solutions to be designed while components were already being fabricated.

The rock bolts are all galvanized steel bars, either 25 mm or 32 mm diameter and up to 4 m long, depending on the rock conditions and the loads applied by the structure. The bolts are anchored with cement grout over the full length of the bar so that the combination of galvanizing and embedment in cement provides corrosion protection for the steel. The total length of rock bolts, installed for both rock reinforcement and securing the foundations, is 510 m.

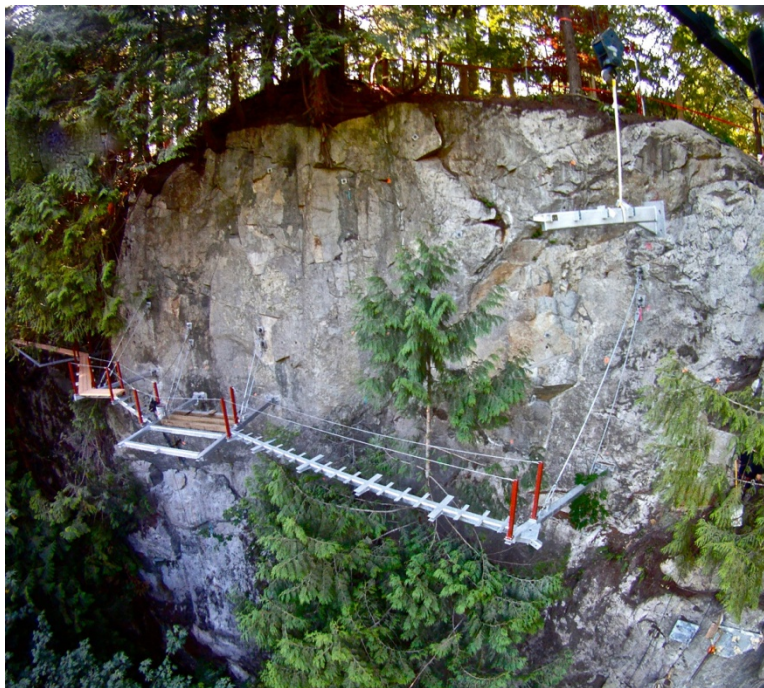
Figure 11 - Erecting the Steel Framework

The steel framework was installed as the foundations and rock bolts were established (see Figure 11).

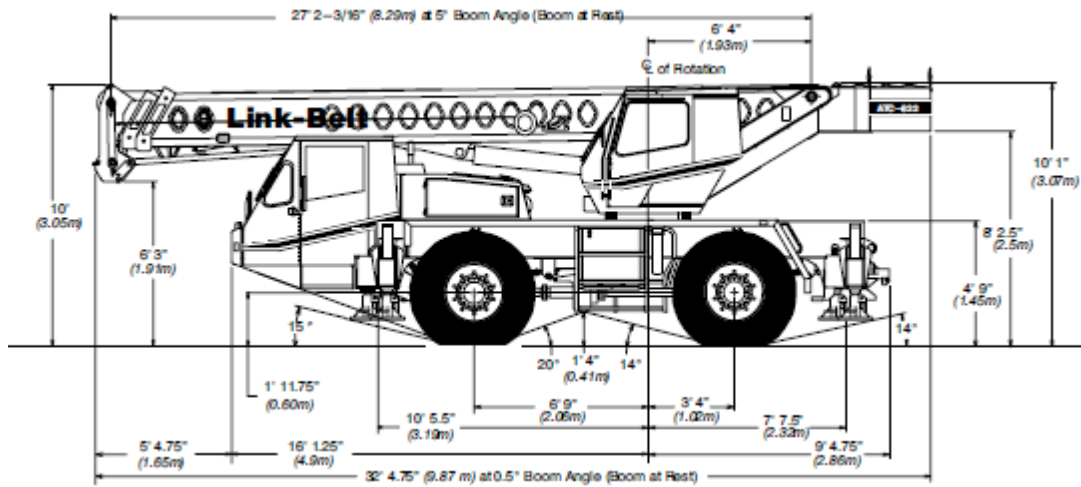
Figure 12 - Crane Configuration used for the Curved Bridge

The largest crane that could be brought in to the area of the park near the curved bridge was the Link-Belt ATC-822, Telescopic Boom All Terrain Crane (see Figure 12), which at only 2.66 m wide, still required one corner of the roof of one of the park buildings to be trimmed off.

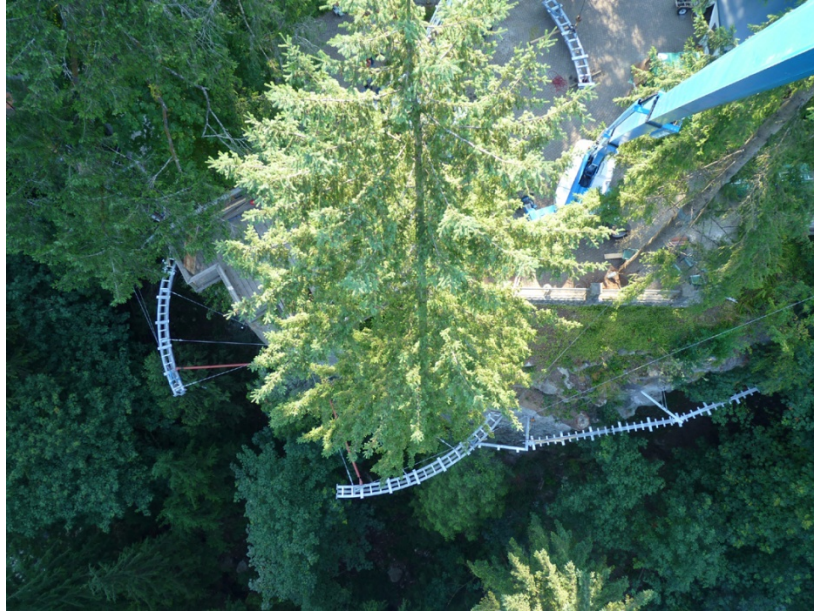
Figure 13 - Erection of the Curved Bridge

To install the curved bridge in stages, two adjustable compression bracing members were designed to help maintain the geometry of the curve while resisting the tension in the main support cables prior to all the segments being installed (see Figure 13). These bracing members were essentially large turnbuckles with an adjustment length of ± 150 mm. The threaded portion of the member was reinforced with an outer sleeve to prevent buckling. The braces were pinned to a temporary anchor in the rock face at approximately the same elevation as the top chord / deck of the curved bridge, and they were bolted at the other end to existing guardrail post holes in the curved bridge deck ties. The braces were set horizontally rather than with a vertical angle in order to simplify any geometry adjustments and to be able to better predict the loading in the cables during the construction stages.

To better control the geometry, steel receiving plates were installed at both abutment locations of the curved bridge on the rock face and their locations surveyed. The survey information was then used to update the fabrication model in ProSteel. The steel plates connected to the five rock bolts that were drilled and grouted at these locations.

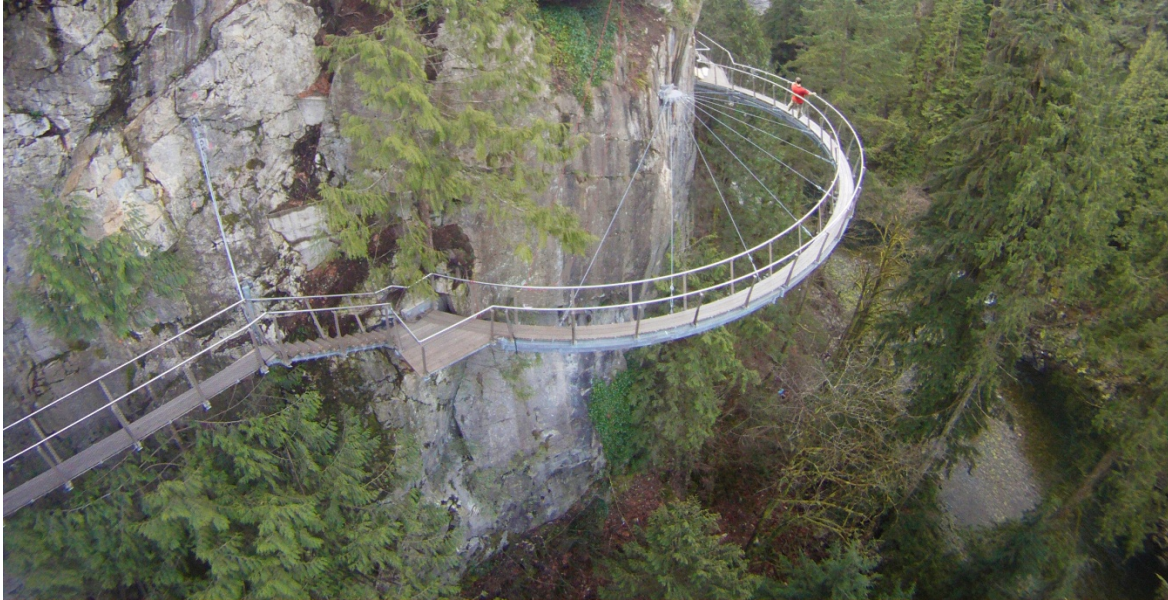
Figure 15 – Constructed Curved Bridge

The design and construction of the Cliffwalk has resulted in a visually appealing and unique “bridge” structure that reinforces the sustainable tourism model already in place at the Capilano Suspension Bridge Park (see Figure 15). It illustrates that structures can be successfully constructed to serve a purpose that goes above and beyond the utilitarian nature of most modern bridges. The project also serves to reinforce that teamwork on infrastructure projects is the best foundation for success, as this project was truly a collaborative effort from start to finish by all parties involved. Opened on June 3, 2011 the Cliffwalk has been received with many accolades.
