A Case Study on the Performance of High Load Polystyrene as Roadway Insulation in Edmonton, Alberta, Canada

Paper prepared for presentation at the
“Soils and Materials - Successful Mitigation of Frost Heave” Session
of the 2011 Annual Conference of the
Transportation Association of Canada
Edmonton, Alberta

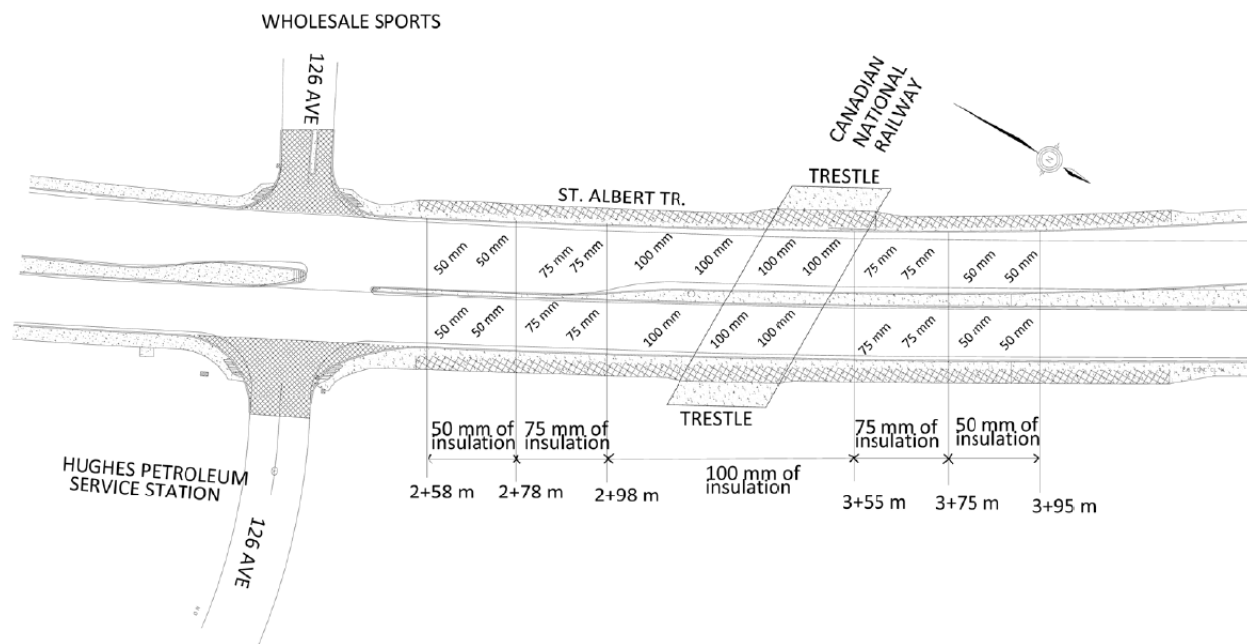
Various thicknesses of Styrofoam were installed along a section of St. Albert Trail, where it passes beneath a CNR trestle. The thickest cross section of insulation was 100mm. It was installed in one long run of approximately 50 metres in length, centered beneath the CNR trestle. The insulation thickness was then stepped down to 75mm and then 50mm, installed in approximately 20 metre runs both northwards and southwards from the 100mm section. A plan of the insulation layout is shown below in Figure 2.

Figure 2. Insulation Layout

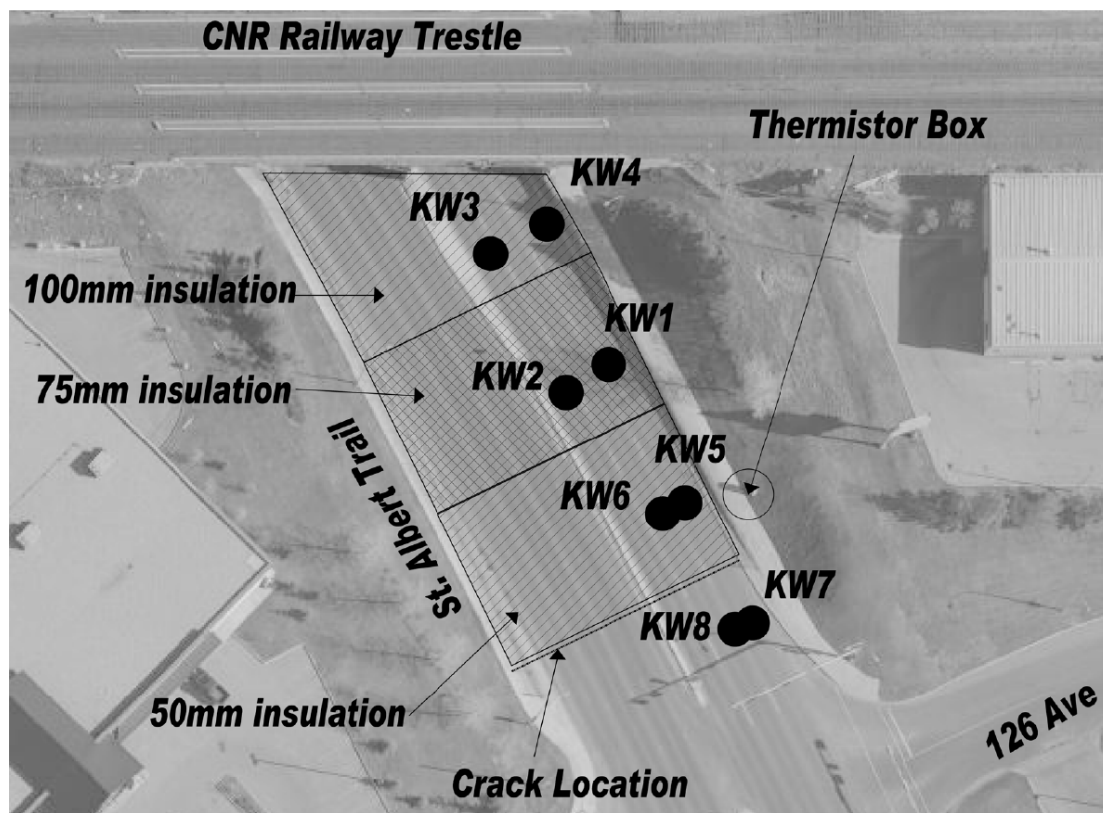
The thermistors were installed in the northbound lanes of St. Albert Trail, north from the intersection at 126 Avenue to the railway trestle. A total of eight thermistor strings were installed; two beneath each roadway cross section. The duplication of thermistor strings was for redundancy purposes in the event that a primary string was ever damaged. Since we had two additional data loggers available at this time, six of the eight thermistor strings were actually monitored, but thermistor strings KW2 & KW4 were not monitored. The thickness of insulation, the locations of each of the thermistor strings and the location of a crack corresponding to the edge of the insulation is shown in Figure 3.

Figure 3. Thermistor, Insulation and Frost Heave Crack Locations

transverse crack formed across all of the northbound and southbound lanes, south of the railway trestle. A vertical displacement of approximately 5mm was noted on the northbound lanes, with the higher side being the uninsulated road section. The heaving of the uninsulated side was due to the penetration of frost into the subgrade surface, which would have still been present in the subgrade soils during the field observation in April, 2011. A much smaller transverse crack was also noted at the end of the insulated section of roadway north of the trestle, but only in the southbound lanes. The location of the large crack on the south side of the CNR trestle, in relation to the thermistor locations and the insulation limits is shown on Figure 3. Figure 9 shows a photo of the crack located along the south edge of the insulated section.

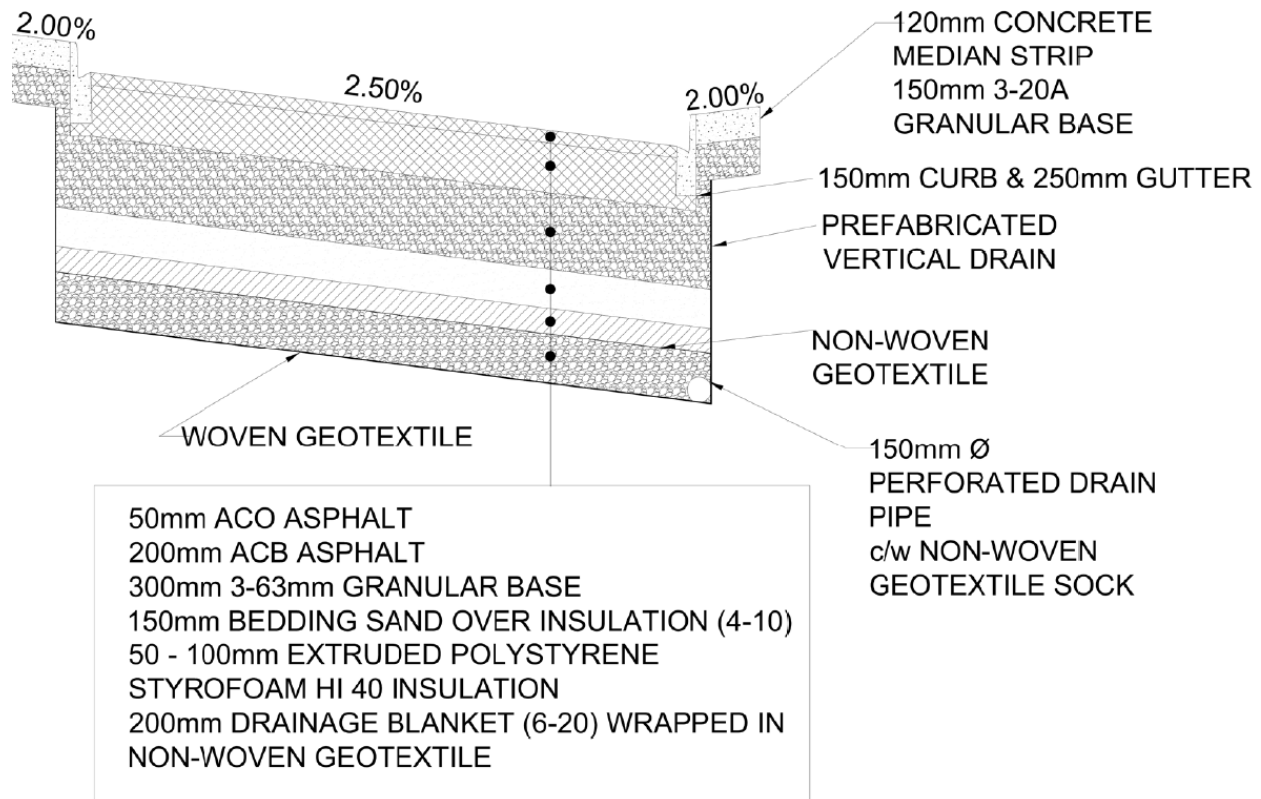
backfilled holes were hand tamped using a long rod to ensure the soil around the thermistor beads was compacted and no voids existed. Figure 4 shows a typical cross section of the roadway that was constructed.

Figure 4. Typical Roadway Cross Section (Northbound Lane)

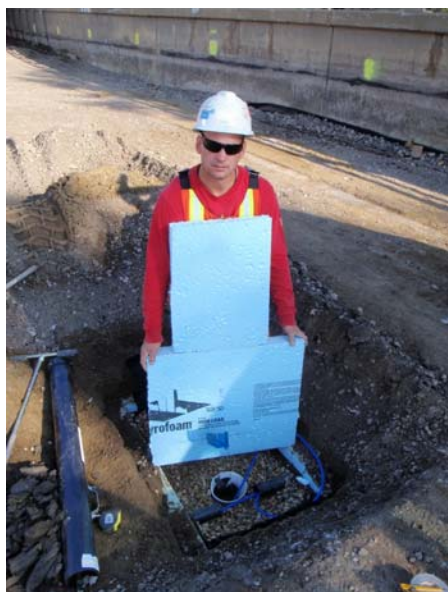
After the placement of the thermistors, the run out portion of each thermistor string was pulled out and the cut out portion of insulation was replaced with one thermistor bead placed on top of the insulation. The PVC pipe and the run out portion of the thermistor strings were then buried with medium grained bedding sand to provide protection for the thermistor strings during and after the completion of construction and to maintain homogeneity within the pavement structure. Typical photos of the installation are shown in Figures 5 & 6.

Figure 5. Thermistor Installation

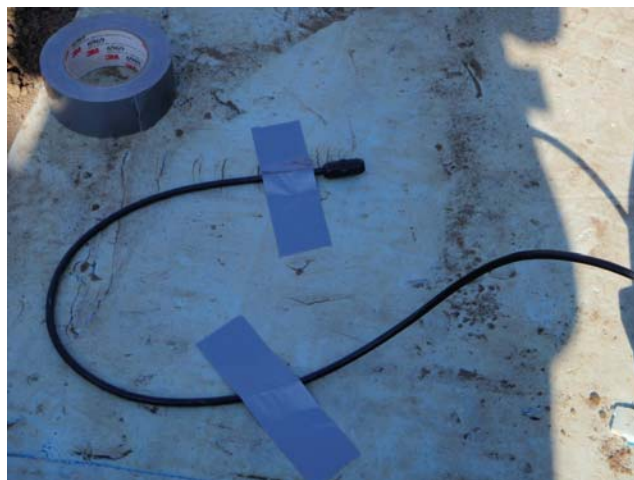
Figure 6. Fly out Thermistor Bead

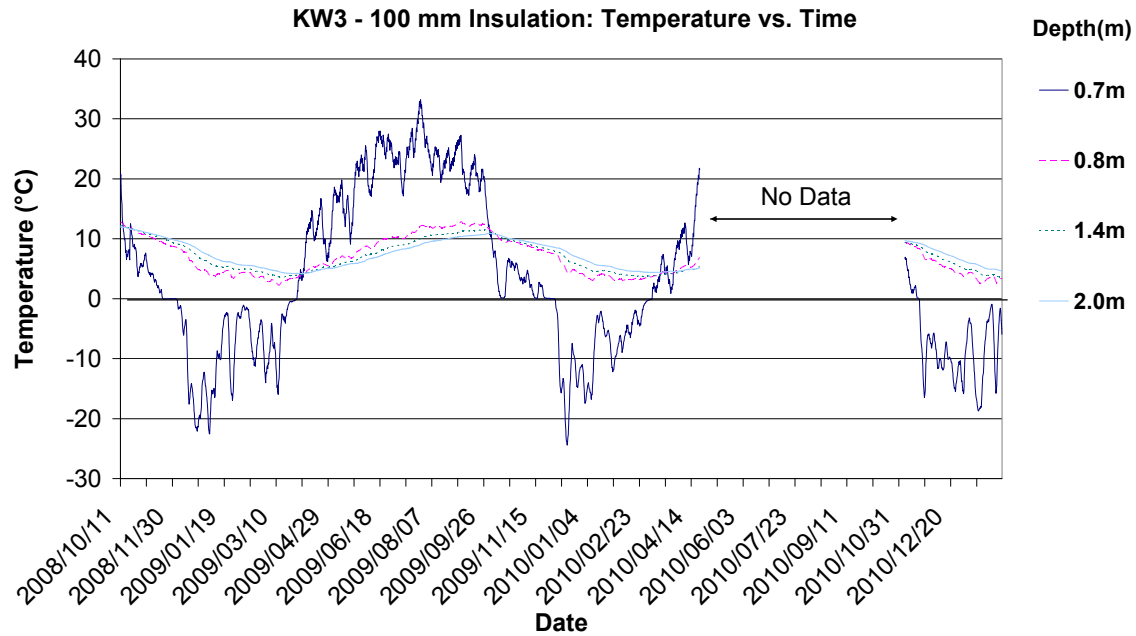
The recorded temperature data showed that 100mm and even 75mm of insulation was more than adequate to prevent frost penetration into the subgrade soils. In the section where 50mm of insulation was installed, frost just penetrated through the insulation. The coldest temperature recorded immediately below the 50mm of insulation in thermistor KW5 was -1.5°C, but the frost penetrated less than 10cm below the 50mm of insulation.

Figure 7. 100 mm Insulation: Temperature vs. Time

Within the project area where no insulation was present, frost penetrated to a depth of approximately 1.6m below the pavement surface during the winter of 2008/2009 and approximately 1.5m below the pavement surface during the winter of 2009/2010. Figures 4 through 7 show a condensed data set collected from the thermistor strings with 0mm, 50mm, 75mm and 100mm of insulation. The dark line at a depth of 0.7m shows the temperature just above the insulation while the other three lines show the temperature data directly below the insulation and at two deeper depths.

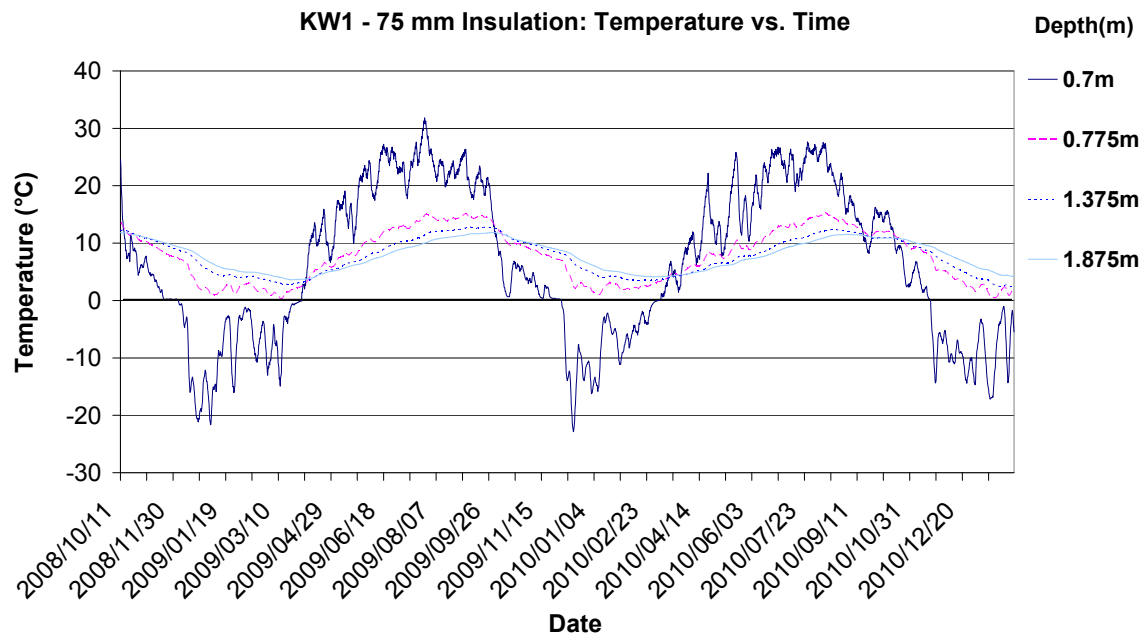
Figure 8. 75 mm Insulation: Temperature vs. Time

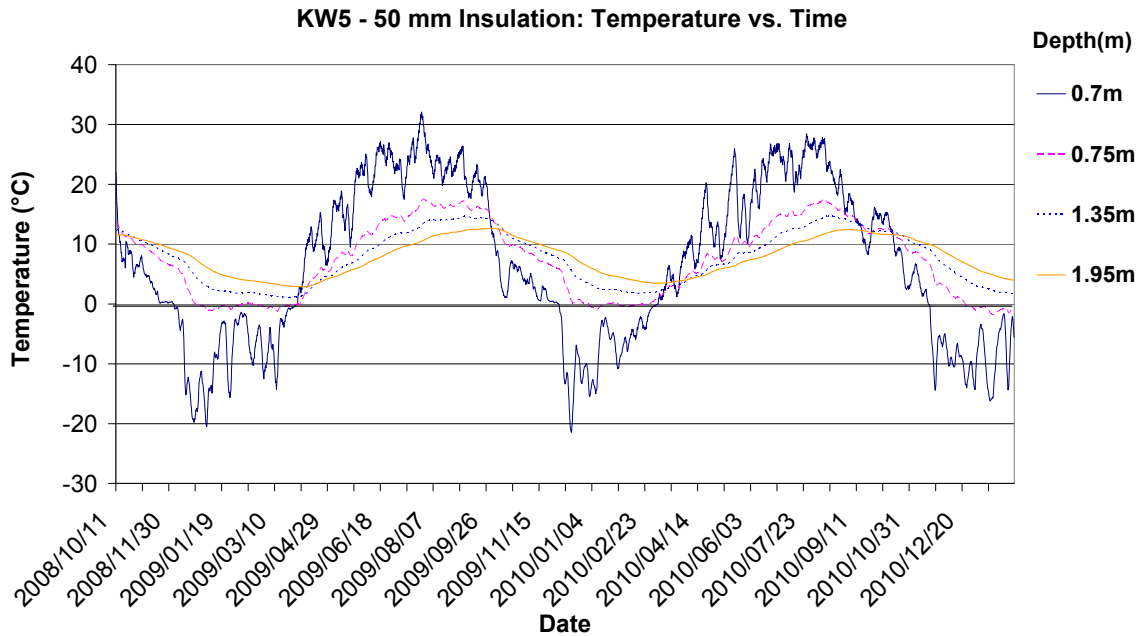
Figure 9. 50 mm Insulation: Temperature vs. Time

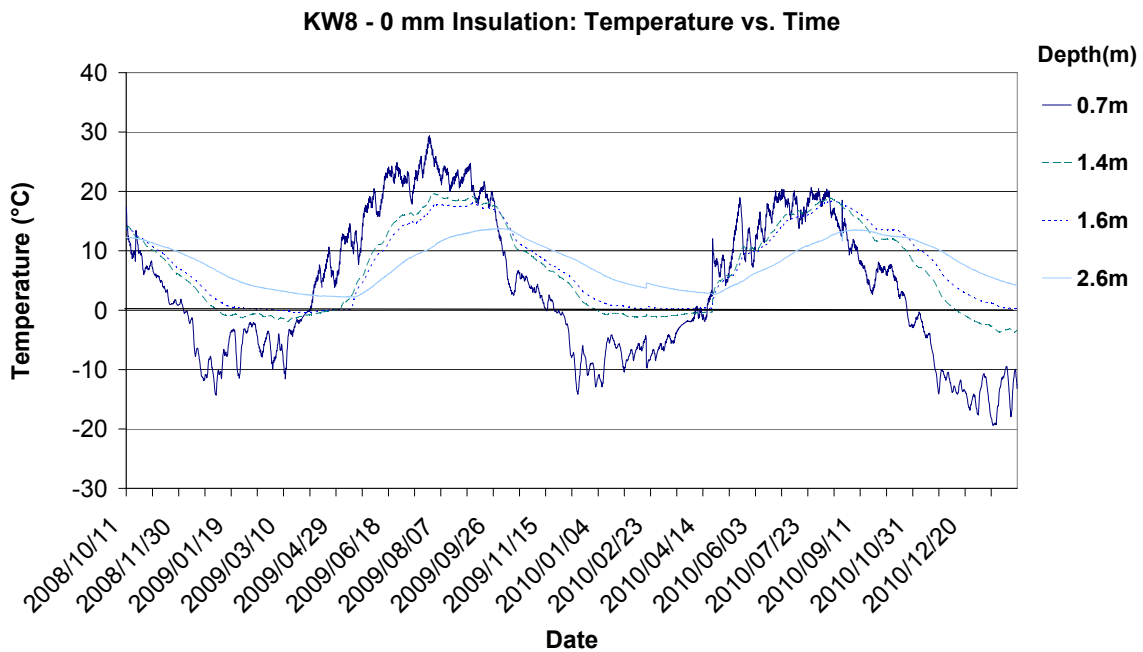
Figure 10. No Insulation: Temperature vs. Time

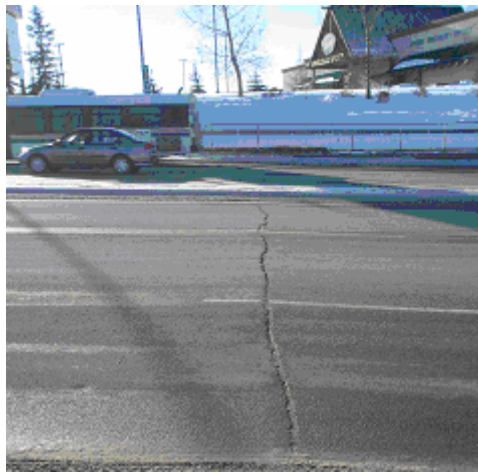
Figure 11. Crack due to Frost Heave

During the course of this program, problems with differential icing were not observed between the insulated and uninsulated portions of the roadway. This may be due in part to an aggressive sanding and salting program on this major urban arterial roadway. The transverse cracking of the asphalt encountered at the transition between the insulated and uninsulated portions of the roadway does suggest that additional experimentation is required to develop a transition design which minimizes or eliminates this problem. Past experience has shown that creating a gradual transition zone where the insulation thickness is decreased by smaller, 25 mm increments may be helpful in mitigating the cracking due to frost heave near the insulation limits.

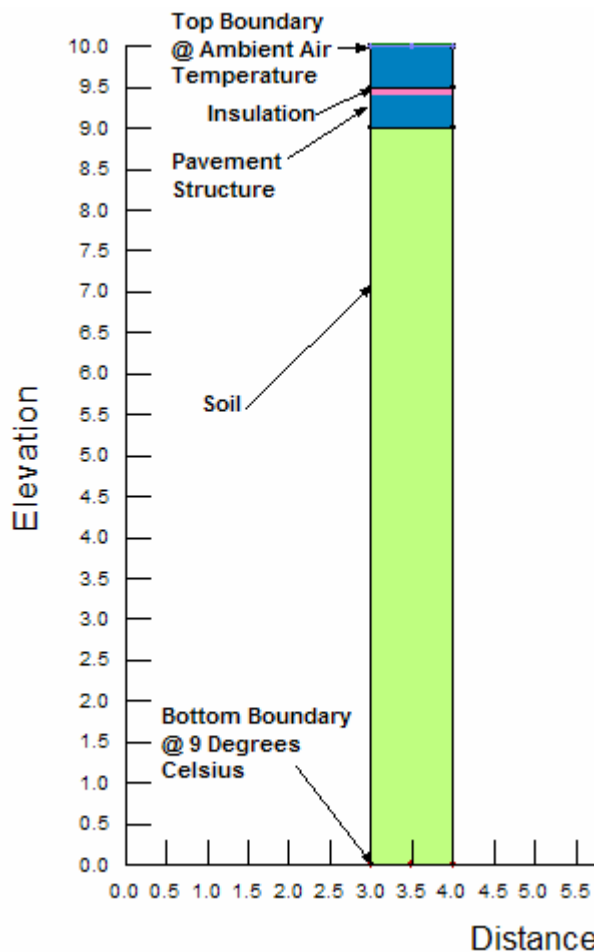
represent the insulation in the model. An interface material is drawn as a line and the thickness cannot be dictated. Therefore the thermal conductivity of the insulation was decreased for the 100mm of insulation, to simulate the increased thickness and higher insulative properties of the thicker insulation layer. Table 3 below shows the material parameters used in the analysis and Figure 11 shows the schematic of the computer analysis.

Figure 12. Geothermal Model

In order to simplify the model, the entire pavement structure was combined into one region. The total pavement structure was made to be 1 metre in thickness, including the drainage blanket. The insulation was placed within the centre of the pavement structure region. In order to obtain an accurate temperature profile, the soil region was extended to a depth of 10m below the ground surface. At this depth the temperature is reasonably consistent throughout the year, and by extrapolating from the thermistor readings obtained with depth, a temperature of 9°C was chosen for the bottom temperature boundary condition at a depth of 10m.

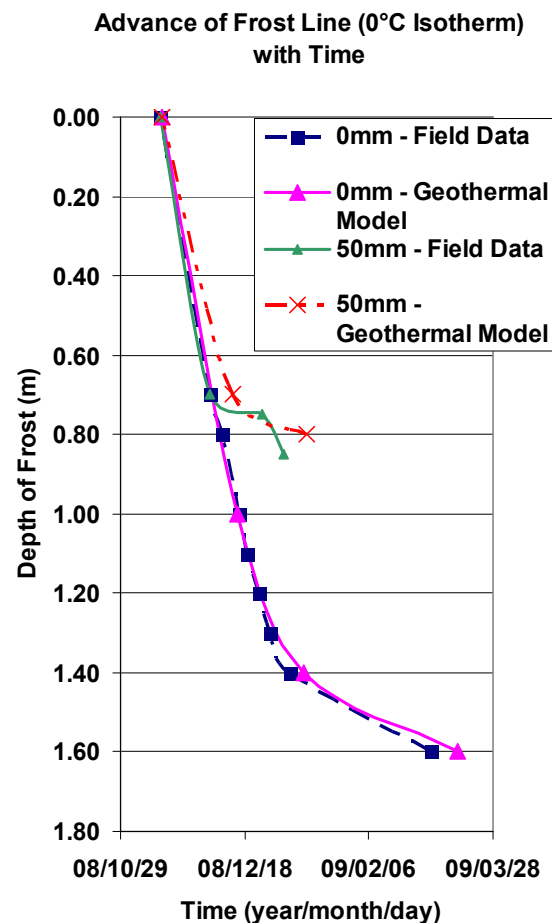
Figure 13 shows the advance of the frost line within the subgrade soils with time. The data shown again demonstrates that the Temp/W model corresponded well with the actual data obtained from the thermistors.

Figure 13. Advance of Frost Line with Time
