Pavement Rehabilitation Design for City of Ottawa OR-174 Composite Pavement Section

Tim Smith, MSc Eng., PEng
Stantec Consulting Ltd.

Paper prepared for presentation at the
Advancement in Pavement Evaluation and Instrumentation Session
of the 2012 Conference of the Transportation Association of Canada
Fredericton, New Brunswick

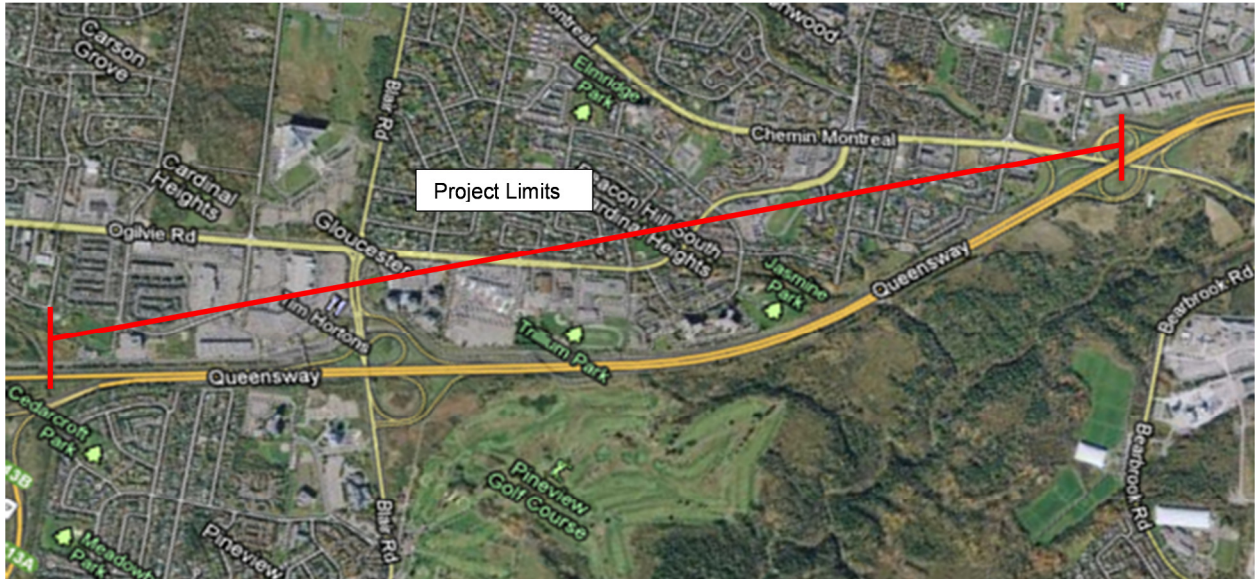
Figure 1.1: Project Limits

Stantec Consulting Ltd. (Stantec) was retained by the City of Ottawa to develop pavement rehabilitation strategies for composite pavement section of the OR-174 between Highway 417 (City Limit) and Montreal Road / St. Joseph Boulevard. This section of OR-174 is functionally classified as a City Freeway and is approximately 3.9 km in length with the inside two lanes in each direction being concrete pavement with asphalt overlay. The project limits are presented below in Figure 1.1.

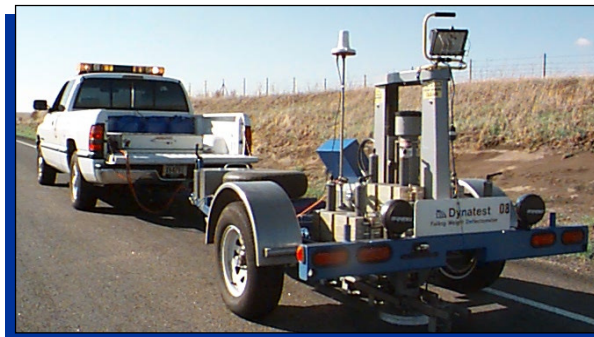
The deflection testing was completed using a Stantec LTPP-SHRP calibrated Dynatest FWD equipped with a differential GPS. It passed calibration (load cell and geophones) at the Harrisburg, Pennsylvania SHRP FWD Calibration Center in February, 2010. A relative sensor calibration was completed in late October 2010 prior to the start of testing. The FWD unit is equipped with thermo sensors that automatically monitor air and pavement surface temperature at each test location and store them in the FWD data file. It is also equipped with a Trimble satellite receiver that is linked to the FWDwin software.

In general, FWD testing was completed in the outer right wheel path at an approximate 100 m interval in each lane and was referenced linearly to an initial starting point on the highway using a DMI and spatially with GPS coordinates. A nine-sensor configuration was used to record the pavement deflections. The FWD sensor configuration used is presented in Table 2.1. The loading sequence consists of a seating drop followed by

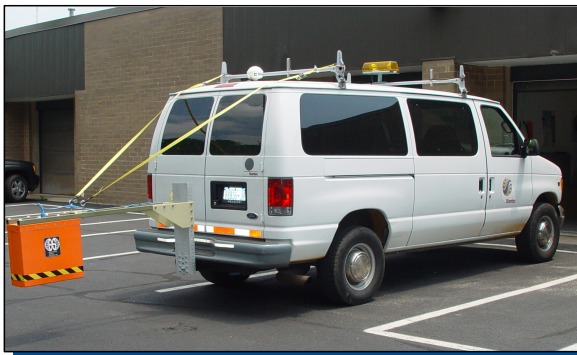
Ground penetrating radar (GPR) data was collected continuously in each lane and direction of OR-174 within the project limits. The GPR system was manufactured by Geophysical Survey Systems Inc. (GSSI). It consists of a SIR-20 data acquisition, a model 4105 2.0-GHz air coupled horn antenna, wheel-mounted distance measuring instrument (DMI). The GPR vehicle is equipped with a Trimble GPS system that will simultaneously collect GPS coordinates along the road sections. The quality of the GPS data depends on the satellite coverage within the area.

In order to collect high resolution GPR data for the asphalt concrete, concrete and granular layers, the antenna was set to collect at 15 nanoseconds. The transmission rate for the GPR data collection was set to 100 kHz. Data was collected at a scan rate of 6 scans per metre. The collected GPR data was saved to the laptop and backed up on an external drive.
