Heritage Aspects of Bridge Engineering

John Lucas, P.Eng., Manager, Transportation Planning and Design, City of London

Paper prepared for presentation
at the _____ Session
of the 2012 Conference of the
Transportation Association of Canada
Fredericton, New Brunswick

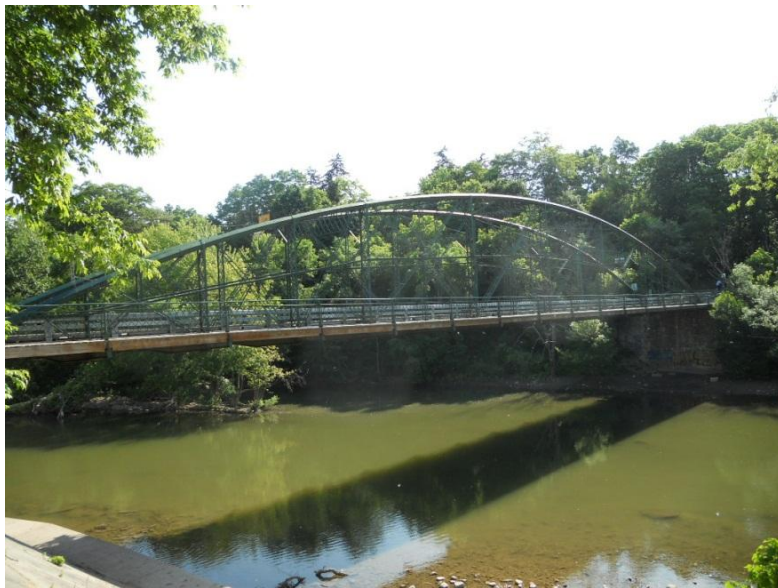
Figure 1 – Blackfriars Bridge (1875)

of wrought iron in 1875 (Figure 1), is still in service; a testament to the durability of the material and design of the day.

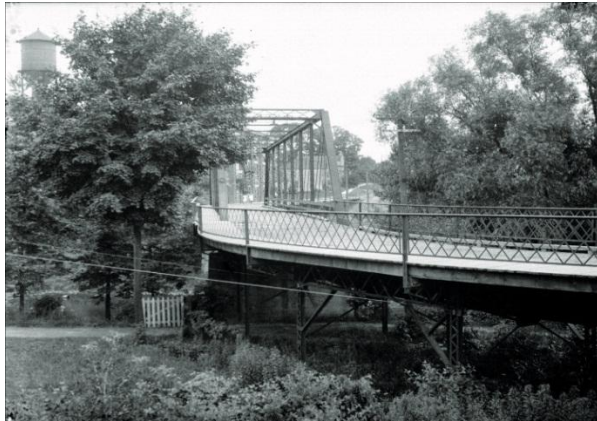
Figure 5 (top left) – Original view

The research yielded pictures showing original bridge features that no longer existed but were related to the pending work program. Most prominent of these were the approaches, deck and handrail. The differences in these items can be seen in the comparative views in Figures 5 to 7.

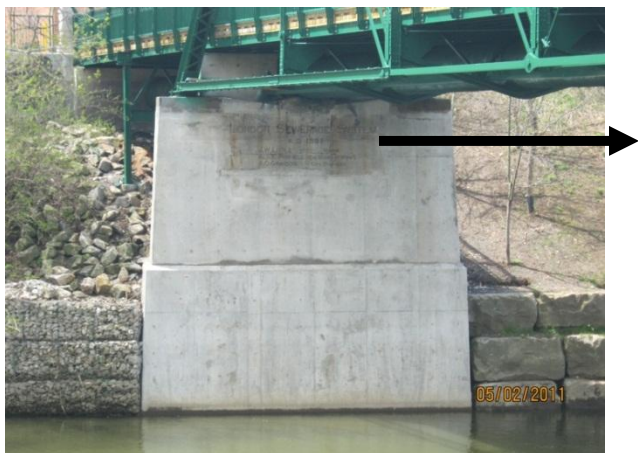
Figure 8 – Abutment Restoration

- Repairs to the concrete barriers, piers and abutments;
- Replacement of the longitudinal steel stringers and connections;
- Coating of the structural steel;
- Reinstatement of the timber deck;
- Replacement of the railing system on the bridge and approaches
- Installation of new wiring, ducts and lighting across the bridge.

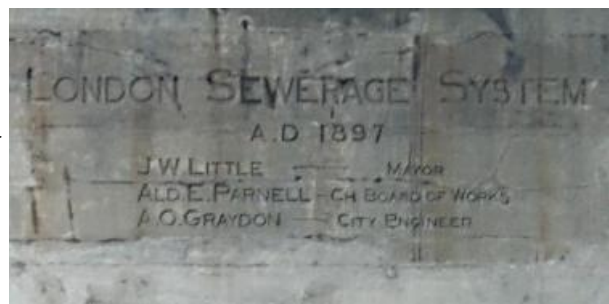
Figure 9 -- Retained Abutment Inscription

Further respect for the historical aspects of this structure included protecting the existing inscription from 1897 on the west abutment (Figure 9) and remounting the existing commemorative plaques, in addition to reinstating some of the original design features noted above (full width deck and railing system). Incorporating these features was intended to bring this structure back to its vintage appearance, while meeting current structural design requirements.

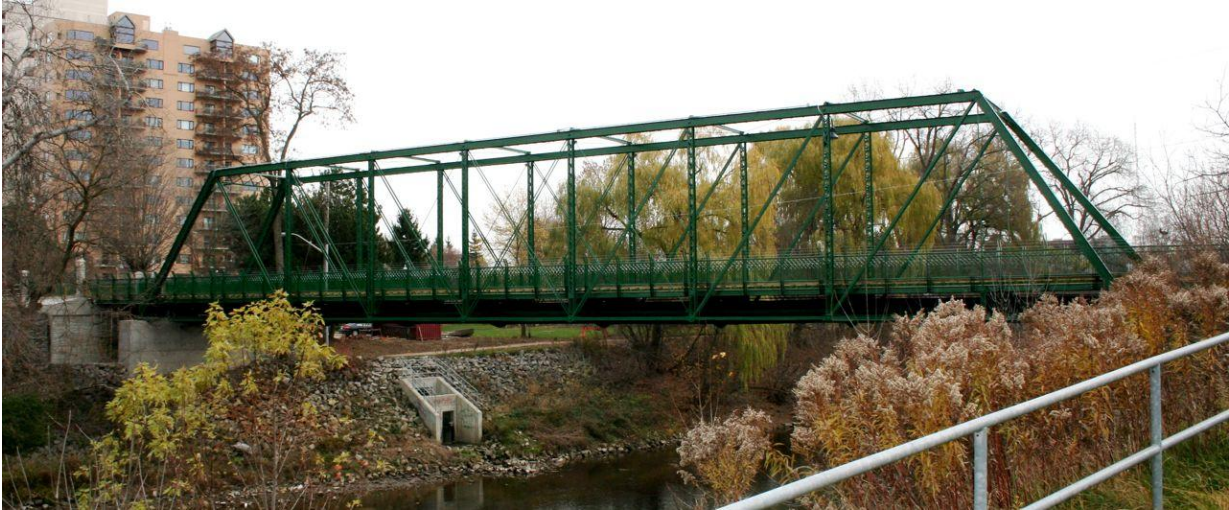
Figure 10 -- Elevation

This 163 foot span Pratt truss bridge on concrete abutments was built in 1897. It served two functions: a transportation connection; and, a support structure for a trunk sanitary sewer which carried effluent to filter beds 2 km downstream. The bridge approaches and sewer were supported by trestles approximately 156 feet long under the west approach and 300 feet long under the east approach across low-lying floodplain. These have since been buried/backfilled with remnants recently unearthed by construction activity.

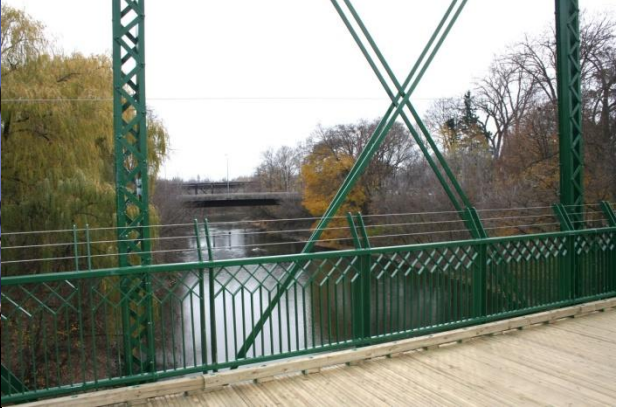
Figure 12 – Handrail and Deck Details

Of particular note were the design details of the deck and handrail. The original full width deck covered an unsightly sewer. Why it was divided to either side of the sewer is not known, but it is speculated to have been to separate pedestrian bridge traffic and / or to allow for easier visual inspection of the sewer. With the sewer having been structurally relined recently and applying present day concepts for Crime Prevention Through Environmental Design, reverting to the original full width deck made sense.

The original handrail design was found to be a metal lattice of insufficient height to meet present day criteria. Added height to a new, similar lattice handrail was achieved with three cable strands that perform the necessary function but are visually discrete enough to leave the original lattice appearance (Figure 12).

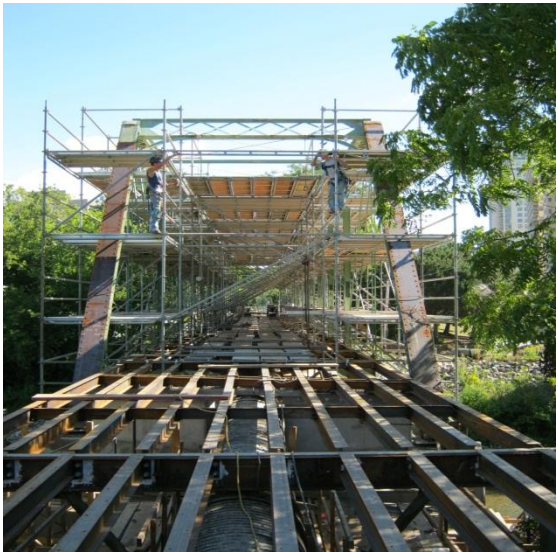
Figure 13 – Portal View During Construction

A fully enclosed negative air system was required to complete the re-coating of the structural steel. The nature of the repair works and recoating of the structural steel required that the bridge be closed to all pedestrian and cyclist traffic for the duration of the project. Total construction cost was \$1.4 million. Figures 8 to 13 provide various views of the project.

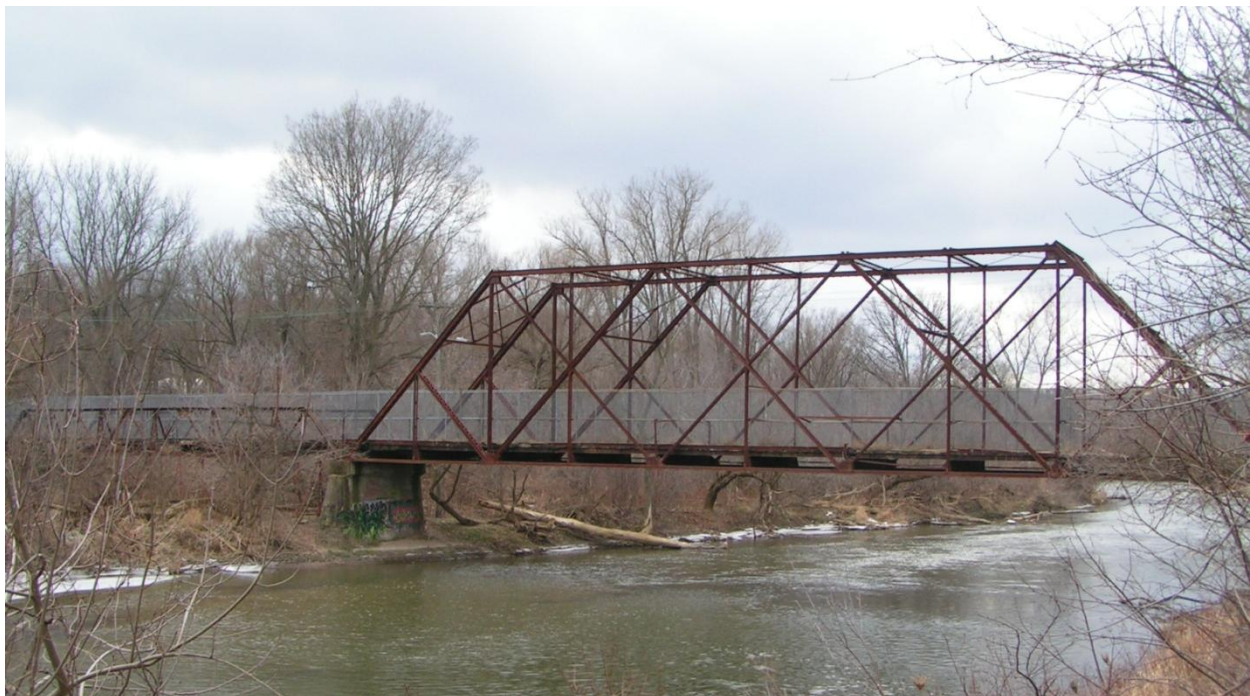
Figures 14 – Elevation

Meadowlily Bridge is a structure of growing heritage interest in the City of London. Erected in 1910/11, the multi-span steel structure consists of three spans over the south branch of the Thames River: two pony trusses of 26.2 and 22m over the floodplain, and a 42.3m Double-Intersection Warren truss spanning the main river channel. Originally designed to carry vehicular traffic, it has been reduced to pedestrian-only traffic confined to the centre 1.5m of the bridge. Regular inspections have reported the superstructure to be in fair to poor condition with some truss members and particularly the floorbeams having large sectional corrosion loss. In 2008 it underwent emergency measures to support the two pony trusses due to floorbeam deficiencies. Steel bents on concrete footings were constructed to prevent potential failure of the deteriorated floorbeam webs and gusset-plate connections.

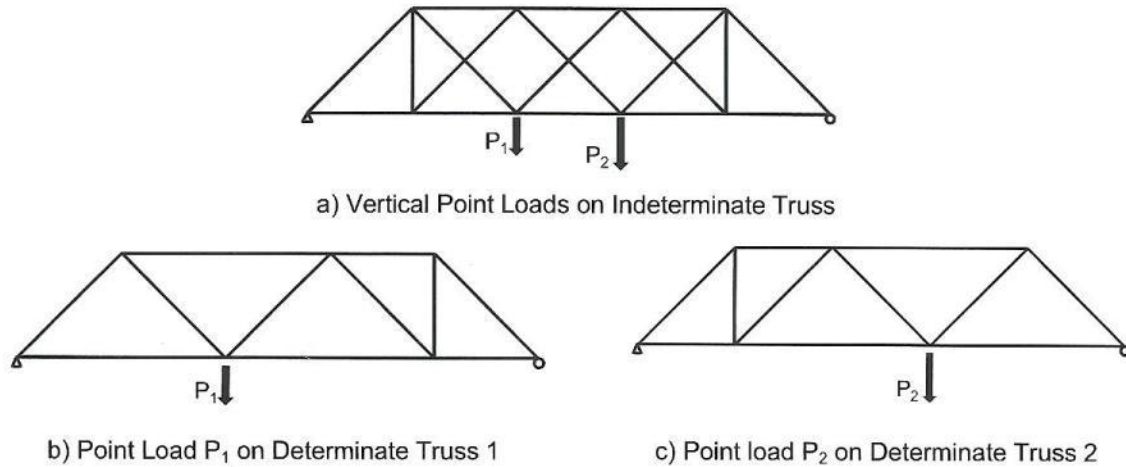
Figure 16 – Analysis of Double-Intersection Warren Trusses (2)

Bartlett and Scott (2) documented the engineering heritage of the bridge with a focus on how engineers over 100 years ago were able to analyze the statically indeterminate Double-Intersection Warren Truss. The graphical methods at that time used superposition to simplify the analysis. Engineers considered the structure as two statically determinate trusses as shown in Figure 16, with loads acting independently at panel points. Chord forces were determined by

adding the results from each truss. They compared historical method results to modern computations with a structural analysis computer program and found results quite comparable. Double intersections were introduced into the Warren truss to increase the number of joints along the bottom chord, effectively reducing the loading and size of stringers and floorbeams. At that time, steel as a fabricated material was more expensive than the labour cost to fabricate and erect it -- and the weight of the stringers and floorbeams often approximately equalled the weight of the trusses.

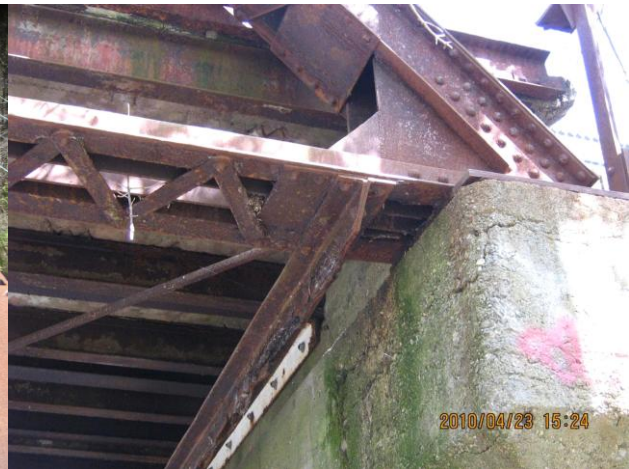
Figure 18 – Bearing

It was concluded that the Warren truss main span could be rehabilitated to support pedestrian loads subject to: bearings being replaced; replacement or strengthening of localized members; and, coating of the steel.

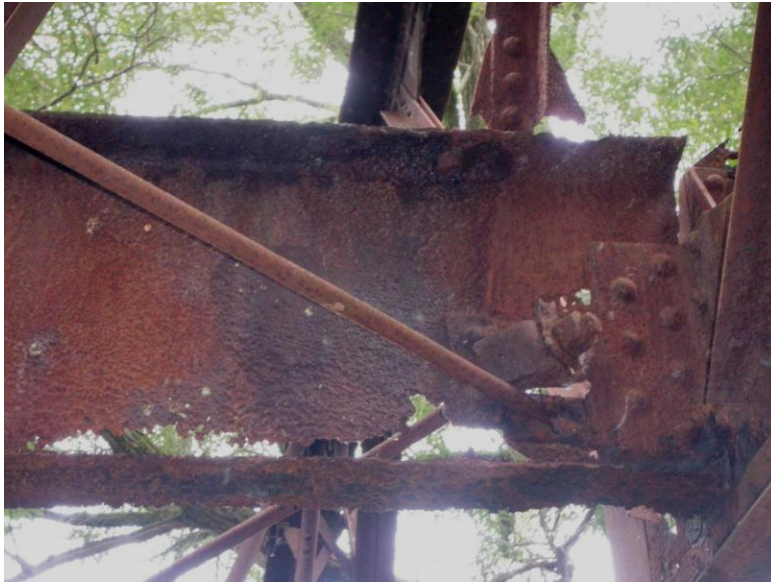
Figure 19 – Pony Truss Floor Beam Connection

The two pony trusses were in severe condition, leaving alternatives of rehabilitation or replacement both open for further consideration. If rehabilitation was to be considered, then a significant program was needed: replace floor beams and connections; replace bearings; replacement or strengthening of localized members; temporary support; and, coating of the steel.

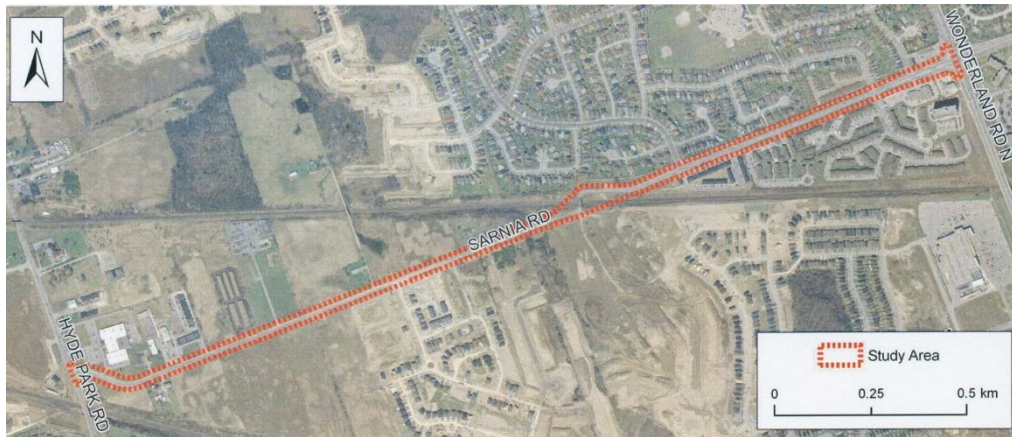
Figure 20 – Study Site (4)

Significant growth in northwest London was driving the need for transportation capacity improvements. Sarnia Road was a two-lane arterial road that could provide east – west capacity, but was constrained by a single lane bridge over Canadian Pacific Railway (CPR).

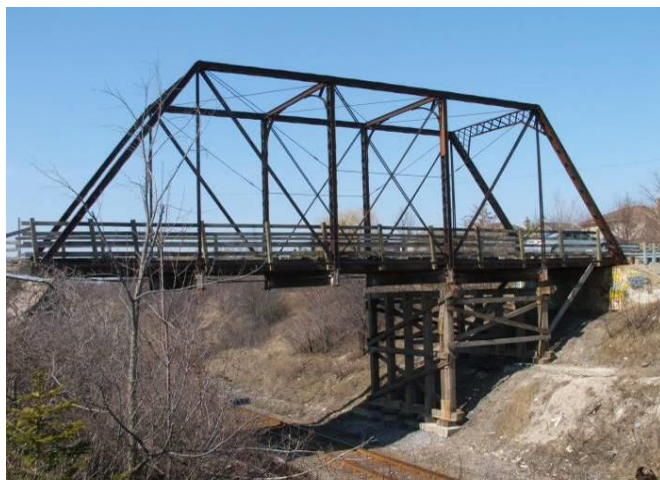
Figure 21 – Elevation

The road existed before CPR constructed their track in 1889; under a Board Order, they had been 100% responsible for maintaining the crossing. Their bridge (Figure 21) had constrained road capacity to less than 7,000 vehicles per day. However, the City required a 9,500 vehicle per day capacity by 2017 and further increases after that.

CPR believed that their overhead structure was approaching the end of its useful life. It had required ongoing investment to repair its deck, and the sharp approaches (Figure 22) and single lane width (Figure 23) had led to two commercial vehicle collisions with the bridge that closed the road for a total of five months. Permanent shoring, clearly visible in Figure 21, was installed.

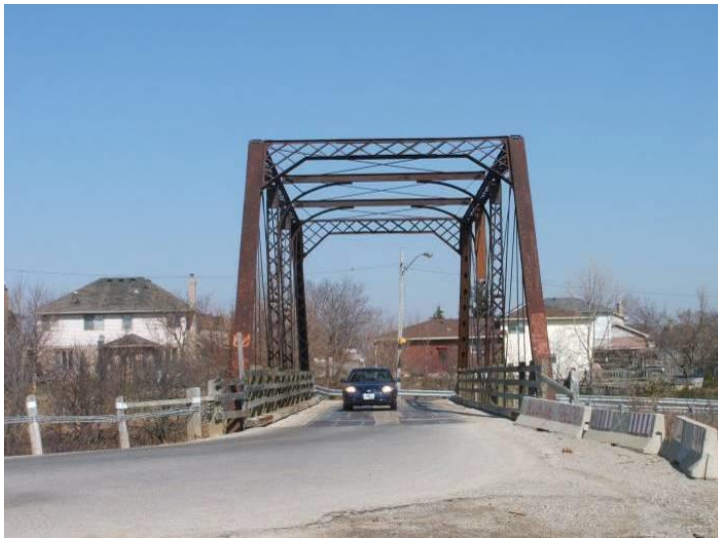
Figure 23 – Single Lane Operation

The rail line was constructed in a deep cut by the Ontario Quebec Railroad Company in 1889. The first bridge on the site accommodated the high skew angle of the road to rail alignments with a 296 foot timber structure. It was replaced in 1909 with a 90 foot steel, pin connected Pratt truss that had seen previous service as a rail bridge in St. James, Manitoba (5). The conversion to road use involved numerous structural modifications to increase the portal to 20 feet. Close inspection and structural drawings (Figure 24) revealed splices and re-use of materials. The crossing span length was significantly reduced by re-aligning the road approaches to allow for a 90 degree crossing. As noted above and shown in Figure 23, this led to one lane operations and presented a collision hazard.

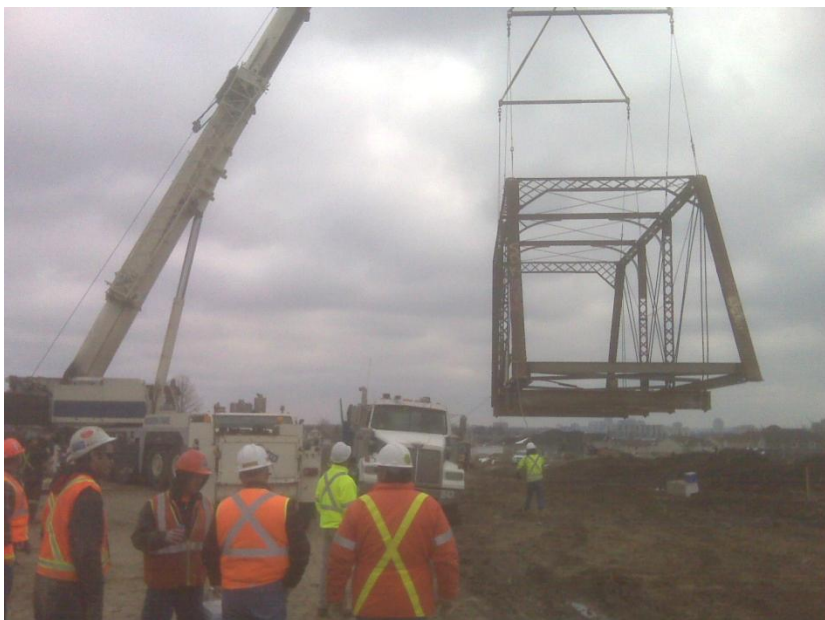
Figure 25 -- Truss Bridge Crane Lift

This option comprised lifting the truss bridge off its abutments (Figure 25) and placing on a lay-down area for documentation and disassembly, with subsequent storage of bridge members for an as yet unknown purpose. This was the most economical option at \$150,000, and least risky. Heritage conservation was conducted following the mitigation measures outlined in the EA Heritage Evaluation, including incorporation of sympathetic design elements into the replacement structure, full documentation of the steel truss structure prior to removal and erection of a plaque. The crossing replacement project is further shown in Figures 26 to 30.

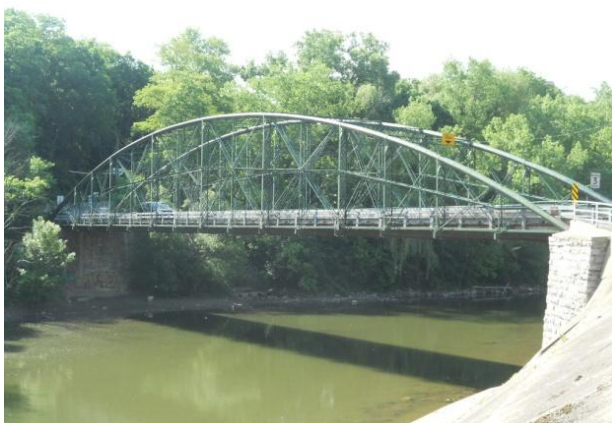
Figure 34 – Elevation

Records of bridge maintenance date back to 1948. It was load restricted to 5 tons in 1949 and further reduced to 3 tonnes in 1986. Significant work to strengthen truss members and reduce vibration was completed in 1951/52. The most effort since then has been on repairs to the wood deck. To maintain a low dead load, a 2x4 nail laminated deck has been used, but is subject to rot, localized failure and frequent maintenance.
