ROAD SAFETY AUDITS: LESSONS LEARNED FROM THE PRE-OPENING STAGE

Eric Hildebrand, John Morrall, Gerry Forbes, Frank Wilson

Paper prepared for presentation
at the _____ Session
of the 2012 Conference of the
Transportation Association of Canada
Fredericton, New Brunswick

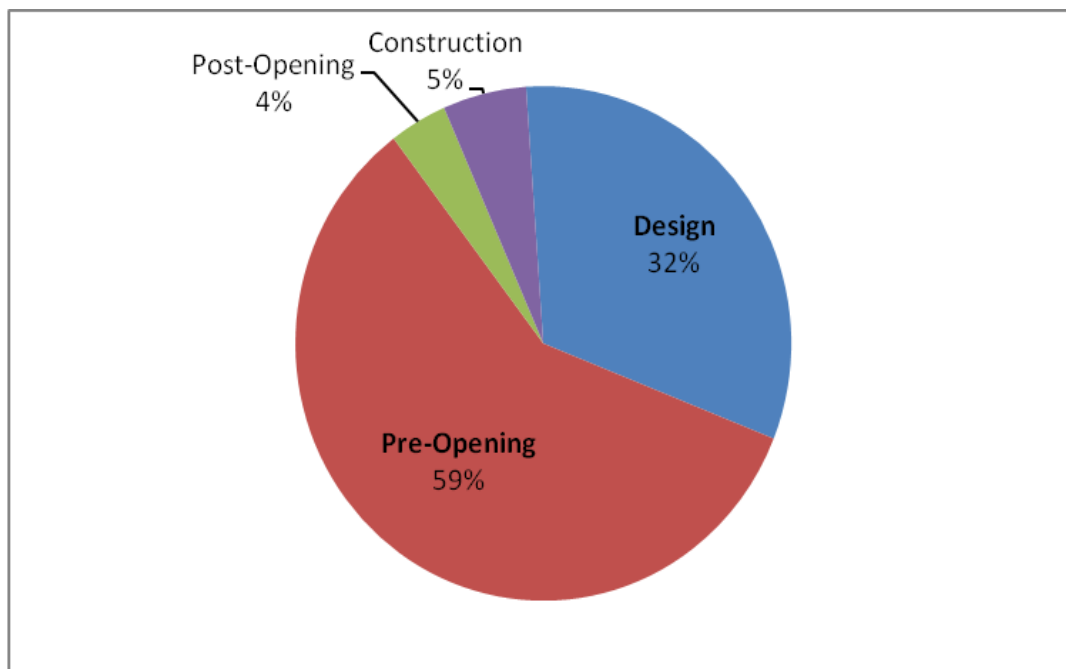
At the onset it should be noted that from a frequency perspective, the majority of audit findings are generated during the Pre-Opening stage. The data in Figure 1 represent the relative frequency of audit issues raised at the various stages that Road Safety Audits are undertaken throughout project development [18]. This is somewhat offset by the common recognition that the more profound changes generated through the RSA process tend to be made earlier in the design stages rather than later as the project nears completion.

Figure 1: Audit Findings by Stage

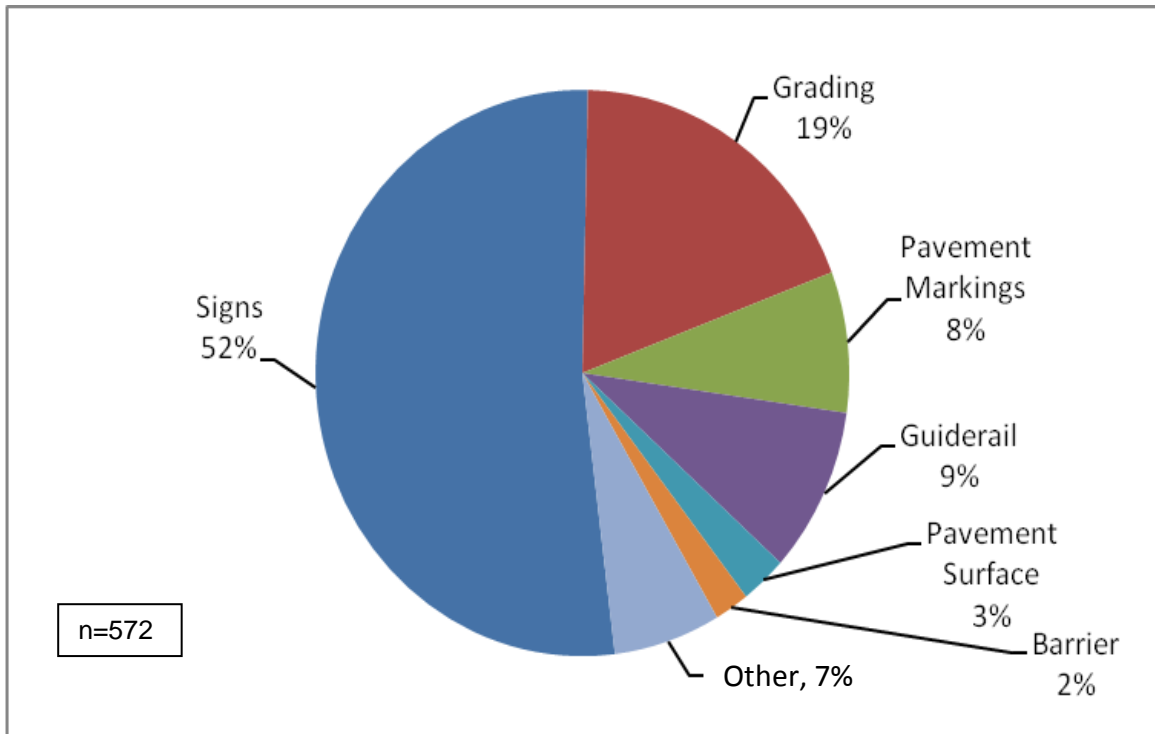
The data in Table 3 provide a synthesis of the types of pre-opening audit issues that were raised for the four projects under study. It is noted that a total of 572 safety-related issues were identified in the audit reports produced for these four projects. The majority of pre-opening audit issues are related to signing problems, while grading, pavement markings, and guiderail deficiencies are the next most frequent concerns noted in rank order. Figure 2 depicts these data to illustrate each category’s relative weight at this audit stage.

The *Other* category in Figure 2 is a catchall that includes items such as fencing, curbing, bridge joints, rumble strips, lighting, drainage structures and others.

Figure 2: Pre-Opening Audit Issues

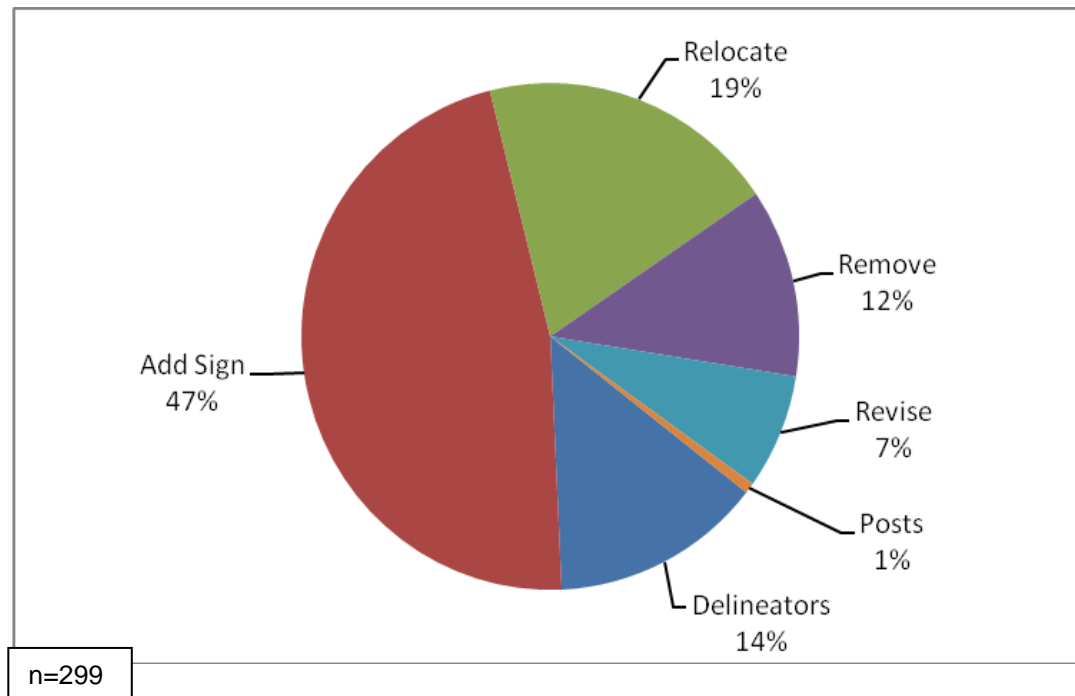
It was previously noted that 299 signing-related issues were identified during the pre-opening stage among the four projects being reviewed. A breakout of the specific types of signing issues is depicted by the data in Figure 3. The *Add Sign* category represents instances where a sign was recommended by the audit team to be installed to supplement the inventory already in the field. The additional sign may have been an oversight by the designers or an additional sign recommended by the audit team on the basis that it would enhance the level of safety afforded motorists at a particular location. For example, a request by the audit team to double-post¹ a Stop sign would fall under this category. This category represented nearly half of all sign issues.

Figure 3: Categories of Signing Issues

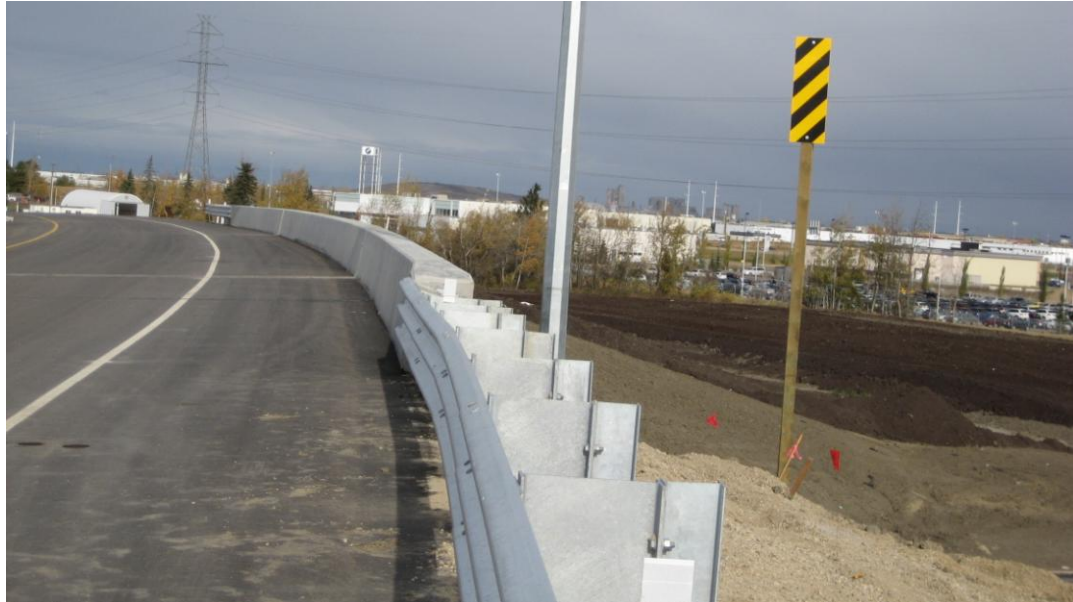
The signing category *Relocate* is the next most frequent issue raised and is a direct reflection of the inexperience often associated with field-fitting traffic signs to accommodate peculiarities found in the field that could not be anticipated during design. Typical issues raised under this category were to move signs longitudinally along the roadway in order to provide proper spacing between successive signs, or to locate the sign a proper distance in advance of the associated hazard. Another common issue was the lateral placement of signs – either too close to the travel lanes or too far out on the shoulder (Figure 4). Finally, signs were sometimes installed at locations where sightlines were obscured and drivers are not afforded sufficient preview time (Figure 5).

Figure 4: Example of a sign with too much lateral offset

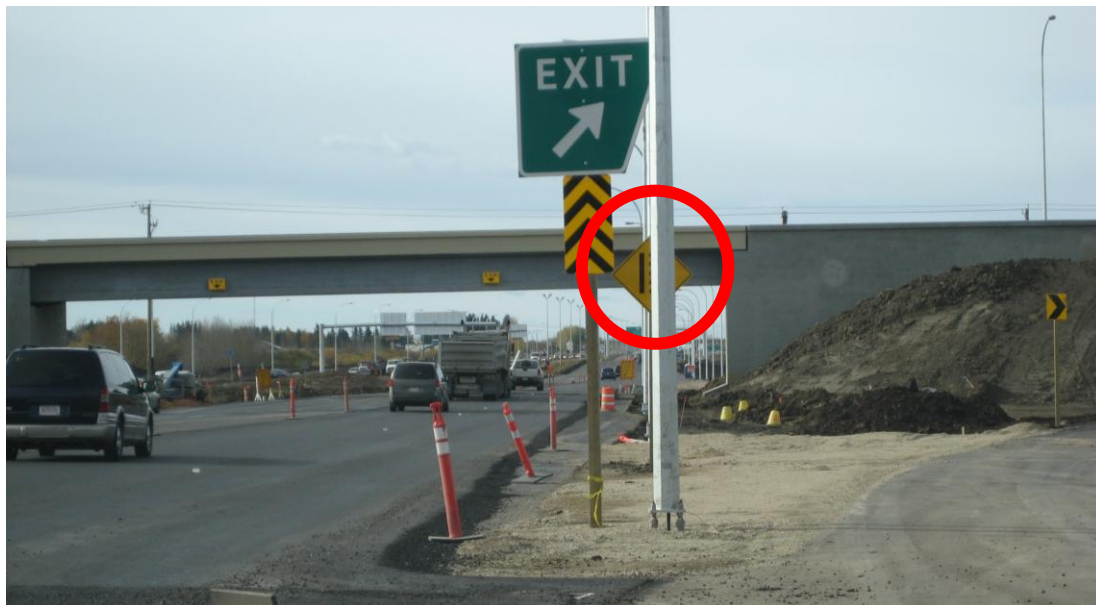
Figure 5: Example of poor field-fitting of signs (obscured Lane Ends sign)

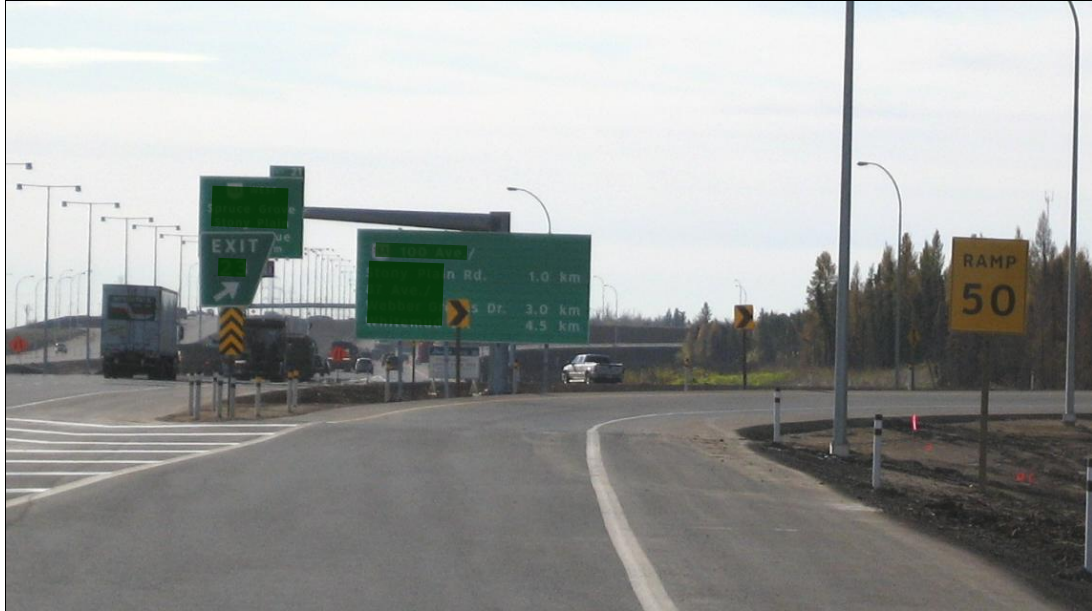
Interestingly, 12% of signing issues called for the removal of signs. Good signing practice avoids over-signing any location to optimize safety. There were a total of 58 instances where the audit team called for the removal of a traffic sign because either it was not warranted, was an incorrect application, or resulted in visual clutter (Figure 6).

Figure 6: Too many signs resulting in visual clutter

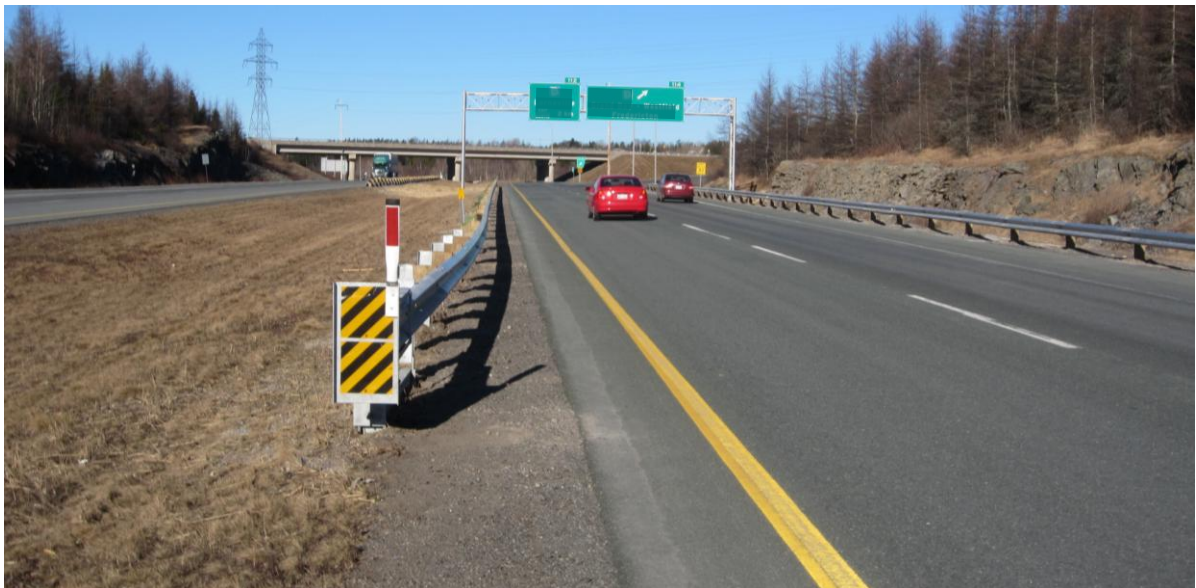
The signing category listed as *Revise*, incorporates all of those instances where the sign that was placed in the field was either incorrect or misleading and needed to be modified or replaced with a different sign. Figure 7 shows an Object Marker installed with the wrong orientation on the guiderail end terminal.

Figure 7: Improper orientation of Object Marker on a guiderail end terminal

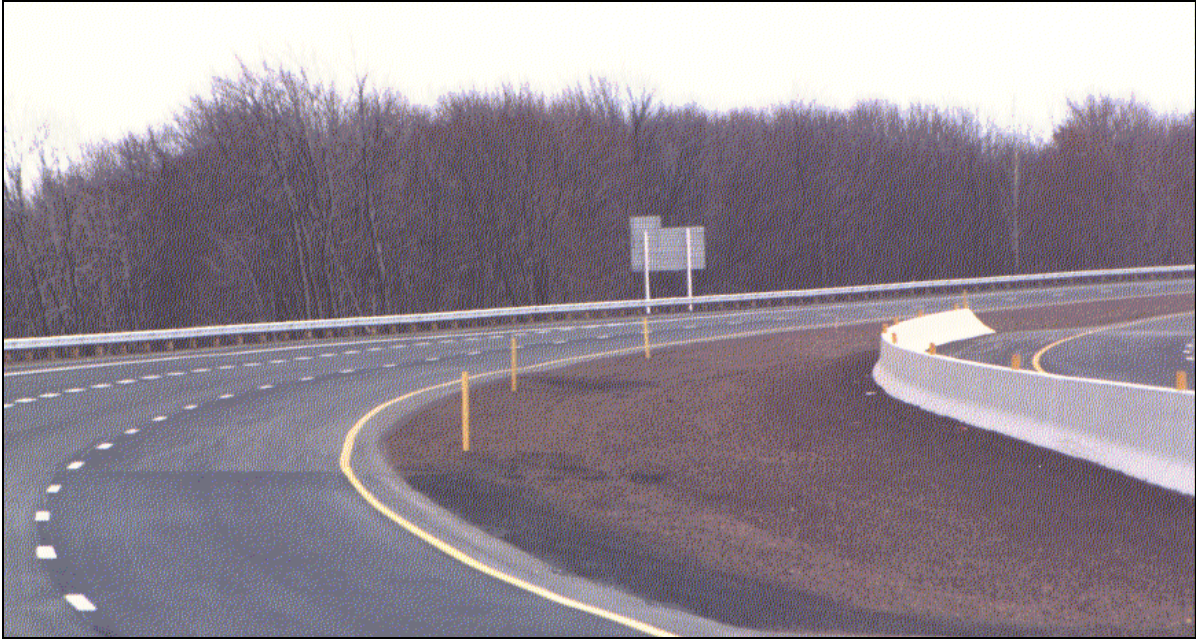
The category *Delineator* refers to instances where the audit team felt that a segment of the road project would benefit from the installation of delineators to provide better positive guidance to the driver. Most instances involved a horizontal curve where the alignment change may not be readily apparent to the driver under reduced visibility conditions. Recommended treatments included post-mounted delineators, delineator tabs installed on guiderail or bridge rails, chevron alignment signs, or linear delineation systems for the vertical face of barriers.

Figure 8: Delineation treatment along shoulder and on concrete barrier

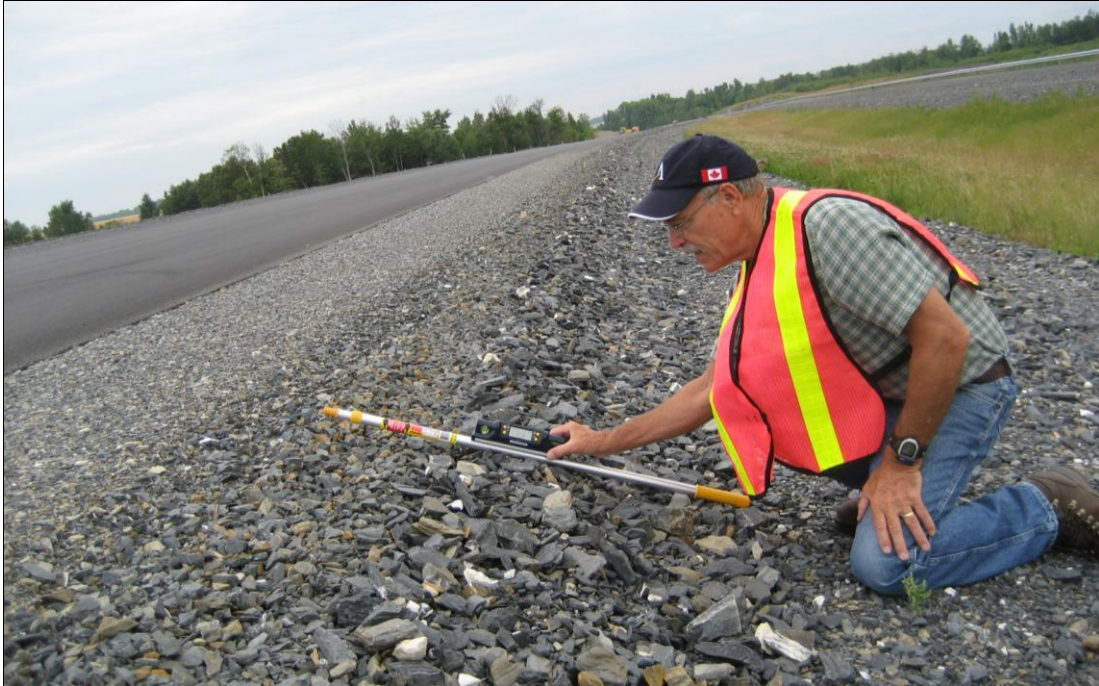
- foreslopes or backslopes that were not sufficiently smooth and traversable to permit an errant vehicle to safely recover.
- foreslopes or backslopes that did not conform to design standards (Figure 9).
- presence of ditch blocks that had not been removed prior to opening.
- foreslopes that had not been properly compacted.
- grading and mounding of materials around bridge piers or light standards on the median.
- Insufficient grading of material around concrete footings for poles with frangible bases (Figure 10).

Figure 9: Improper grading resulting in non-recoverable foreslope

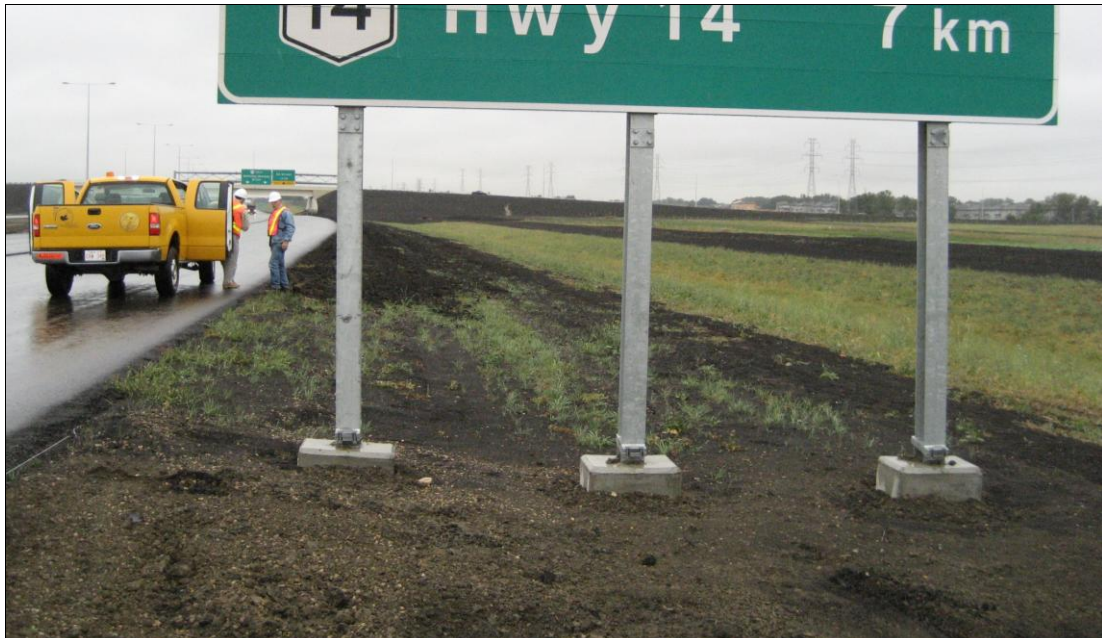
Figure 10: Over exposure of concrete footings

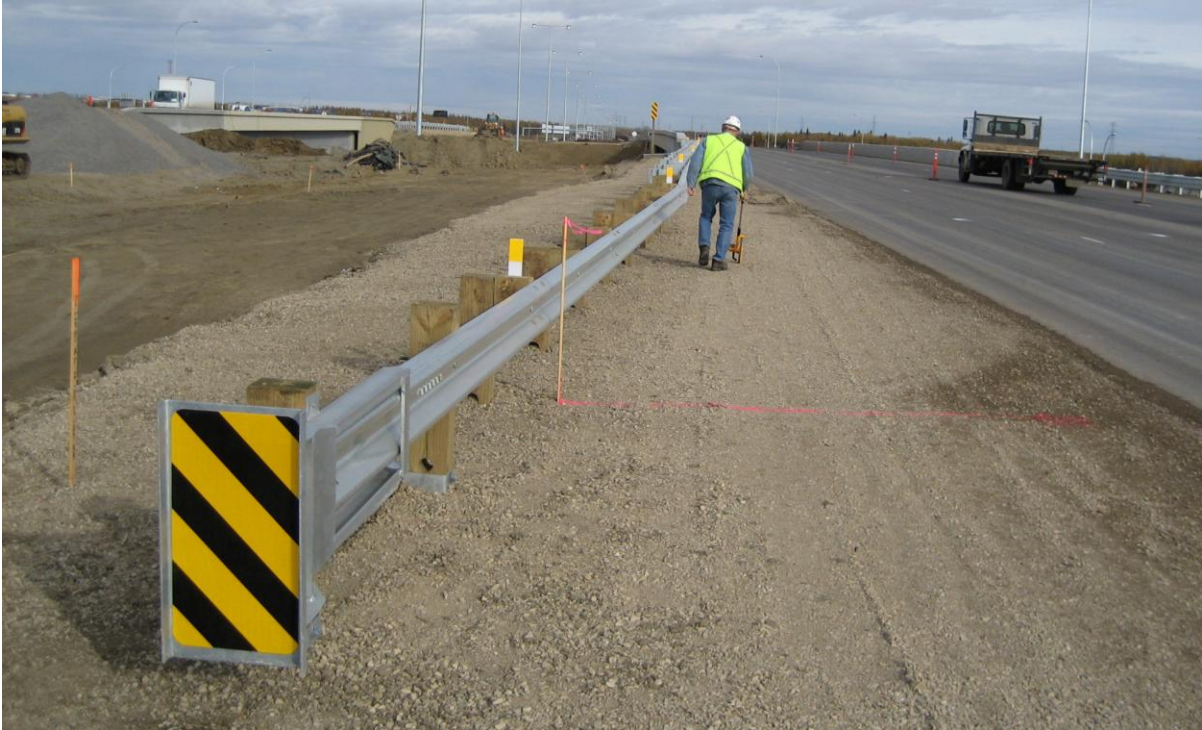
Figure 12 provides an example of an energy-absorbing guiderail terminal (EAGRT) installation where the installed flare rate of 10:1 exceeded manufacturer specifications of a maximum of 25:1. Consequently, the extrusion process would not likely function properly in the event of an impact.

Figure 12: EAGRT installed with excessive flare
