Long Term Performance of Full Depth Reclamation with Expanded Asphalt on the Trans-Canada Highway near Wawa, Ontario

ABSTRACT

In 2001, the Ministry of Transportation Ontario (MTO) constructed its first full depth reclamation with expanded asphalt stabilization project on the Trans Canada Highway, between Sault Sainte Marie and Wawa, in Northern Ontario. The project incorporated three different expanded asphalt mix designs and a control section of full depth reclamation with hot mix overlay. The project has been monitored annually over the past 10 years using the Ministry's Automated Road Analyser (ARAN), which measures International Roughness Index (IRI) and rutting. Roughness data indicates a significant difference between the expanded asphalt stabilized base test sections and the control section. The expanded asphalt stabilization has delivered superior performance over the conventional full depth reclamation with hot mix overlay. Performance curves for the different treatments are compared to the ministry's average performance curve for full depth reclamation projects, and to the performance of treatments on adjacent projects. This project demonstrates the exceptional performa

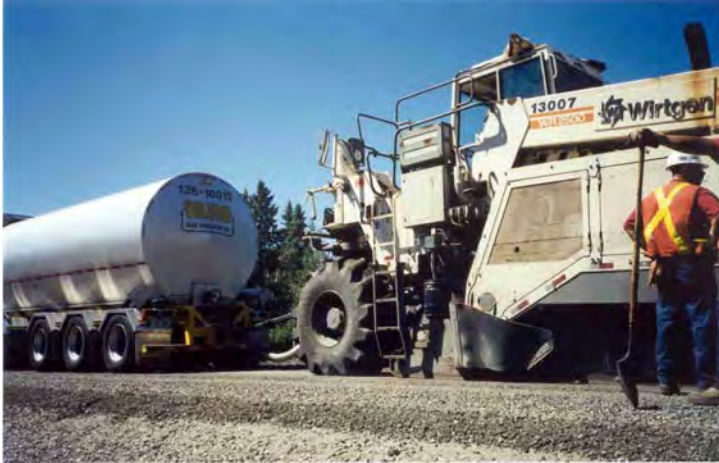
FIGURE 2 The reclaimer/stabilizer attached to a tanker of hot asphalt cement.

Expanded asphalt was injected into the reclaimed material through nozzles on the reclaimer/stabilizer, attached to a tanker of hot asphalt cement (Figure 2). A single steel drum 20 tonne roller was used as a breakdown roller behind the reclaimer/stabilizer. A grader followed behind, grading the mix to final grade (Figure 3). Compaction was carried out with a 21 tonne steel drum vibratory roller. Watering in combination with use of a vibratory roller brought the fines to the surface to give the mat a tight, sealed appearance. A rubber tire roller was used as the finishing roller. The freshly stabilized base resembled a damp granular base material (Figure 4).

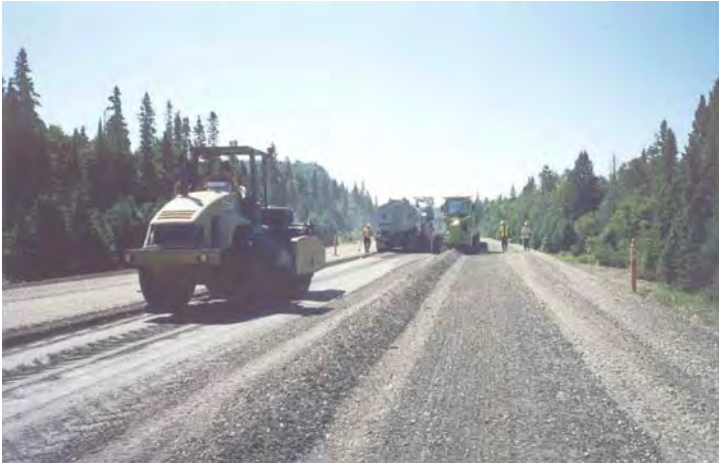
FIGURE 3 The grading and compacting operation following behind the EAS.

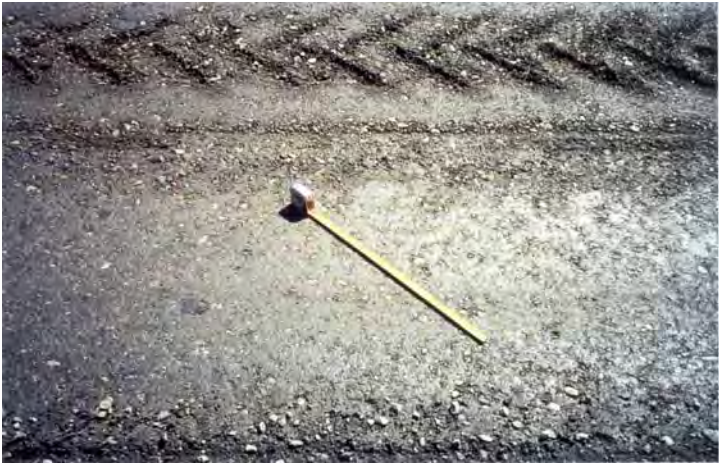
FIGURE 4 The expanded asphalt mat following initial pass of the breakdown roller.

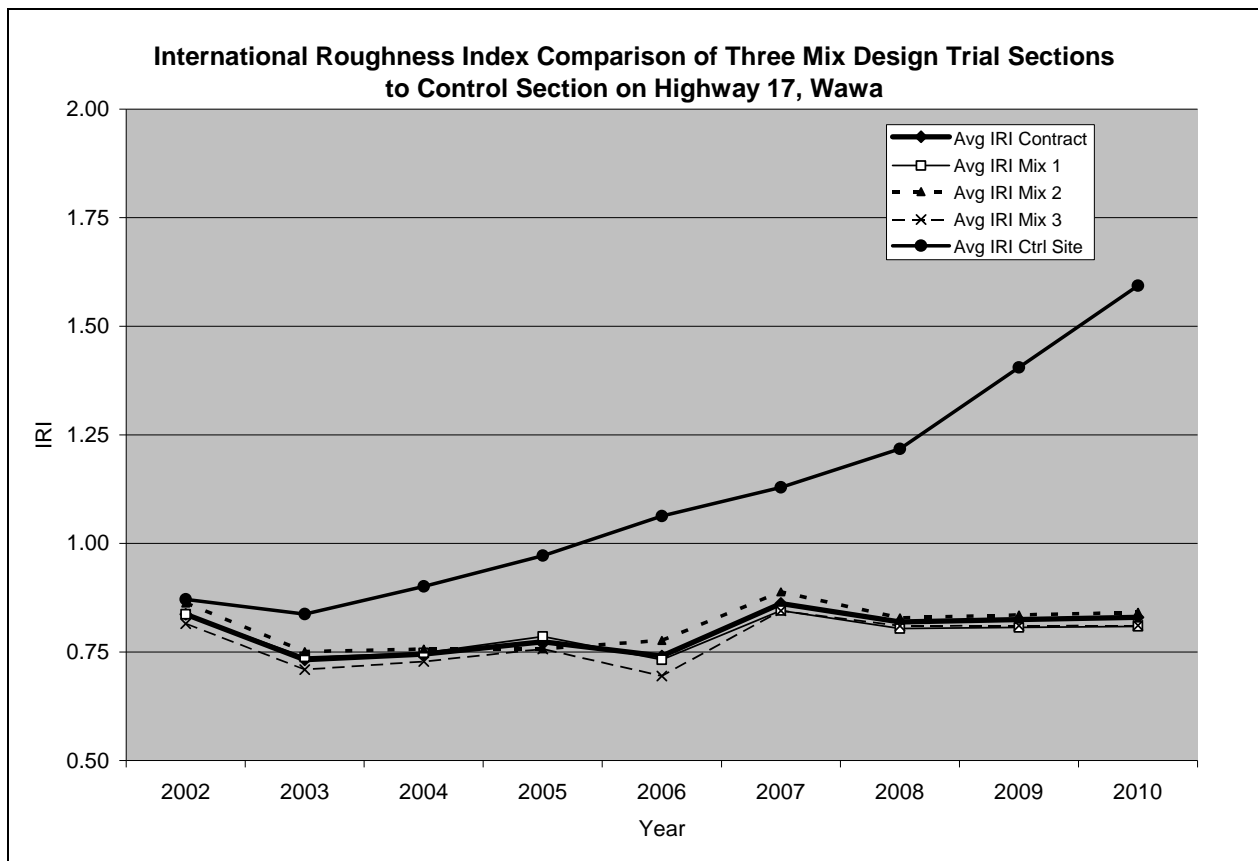
FIGURE 5 International Roughness Index comparison of the average IRI for the FDR with EA contract, to each of the three mix designs and the control section.

In the 10 years following construction of the expanded asphalt stabilization project, the Ministry carried out ARAN surveys of the highway to determine the International Roughness Index (IRI) and pavement distress surveys to determine the Pavement Condition Index (PCI). Results of 10 years of performance monitoring show that the expanded asphalt project is performing extremely well. Figure 5 shows the average IRI performance for the contract, which has remained below 1 (IRI=0.83), indicating a smooth pavement over the course of 10 years. Also illustrated is the performance of the three different mix designs, one without corrective aggregate (mix 1) and two with different sources of corrective aggregate (mixes 2 and 3). These three mixes perform in a similar fashion.

Of note is the 304 m control section of FDR with 80 mm HMA overlay (no expanded asphalt stabilization), placed in the centre of the project. This treatment started out with similar IRI performance but unlike the FDR with EAS, showed noticeable deterioration over the 10 years.

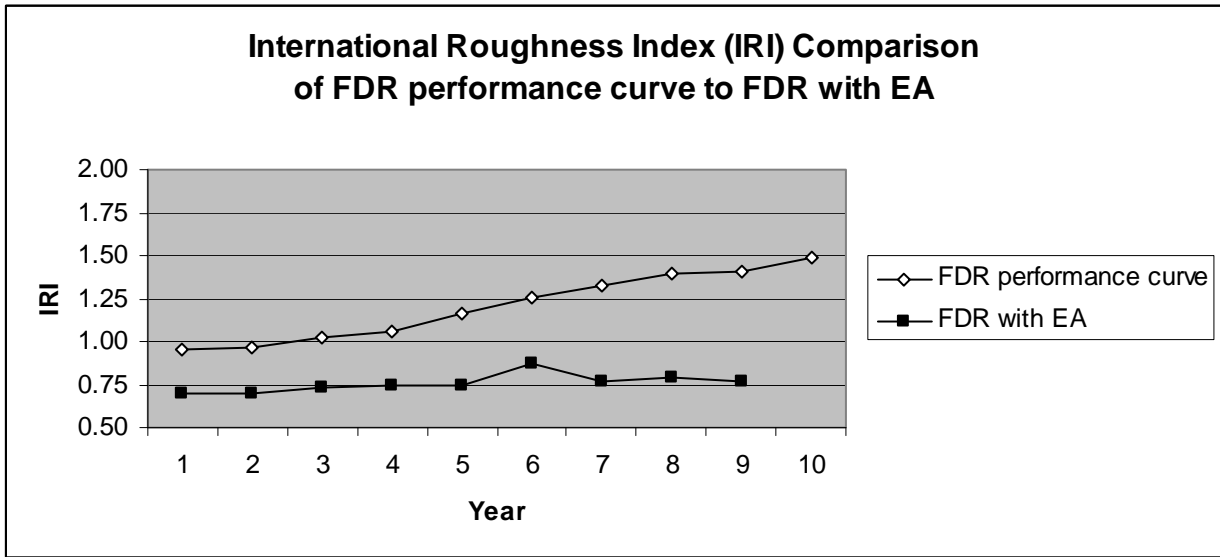
FIGURE 8 International Roughness Index comparison of FDR with EA on Hwy 17 to MTO’s performance Curve for FDR with HMA overlay based on 100 contracts.

MTO has also developed a performance curve for full depth reclamation projects based on a data set of 100 of these projects on 2-lane rural highways. Figures 8 and 9 compare the performance of the expanded asphalt stabilization project to the ministry's IRI and PCI performance curves for FDR with HMA overlay, considered to be one of the most effective reconstruction techniques. It can be seen from these graphs that as a reconstruction treatment, the FDR with EAS is outperforming the average FDR project both in terms of roughness (IRI) and pavement condition (PCI).

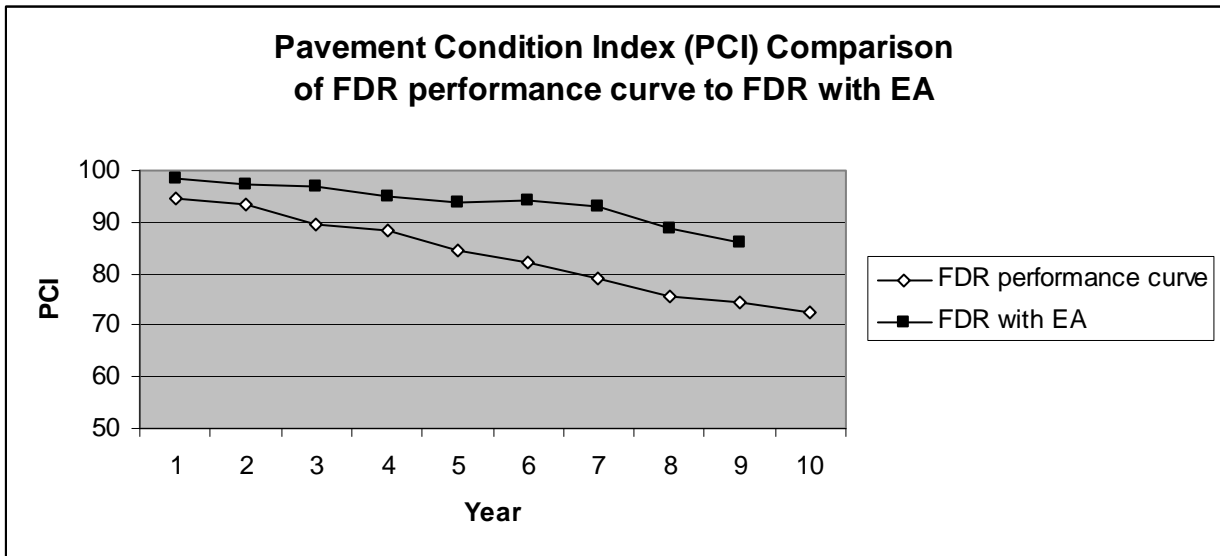
FIGURE 9 Pavement Condition Index comparison of FDR with EA on Hwy 17 to MTO’s performance Curve for FDR with HMA overlay based on 100 contracts.
