Post-Tensioning Corrosion Evaluation and Mitigation

Mr. Liao Haixue, P.Eng., NACE Cathodic Protection Specialist, David Whitmore, P.Eng., NACE Cathodic Protection Specialist
 Vector Corrosion Technologies Ltd., Winnipeg, Manitoba Vector Corrosion Technologies, Inc., Tampa, Florida

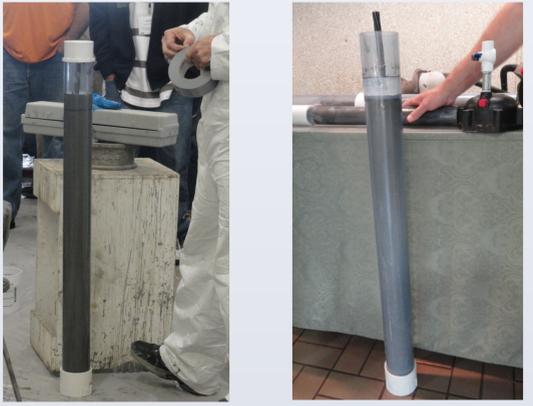
Wick-induced bleed test by American Segmental Bridge Institute in April 2012 showing portland cement grout with about 4% bleeding after 24 hours of grouting operation.

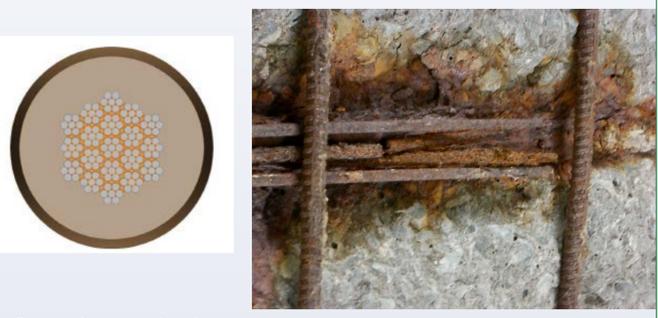
Inner wire corrosion due to the presence of voids and moisture
 Wire corrosion from inside-out caused by water penetration, resulting in wire break and concrete spalling

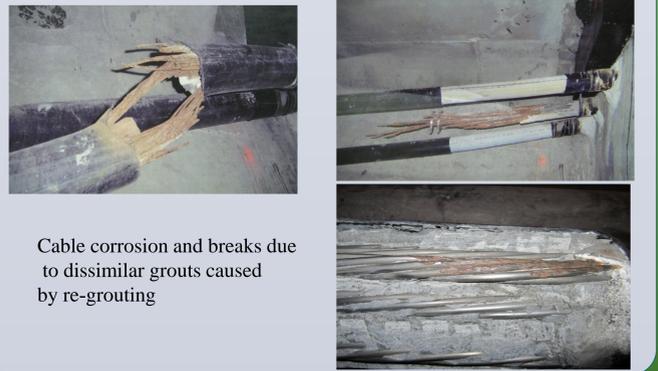
Cable corrosion and breaks due to dissimilar grouts caused by re-grouting

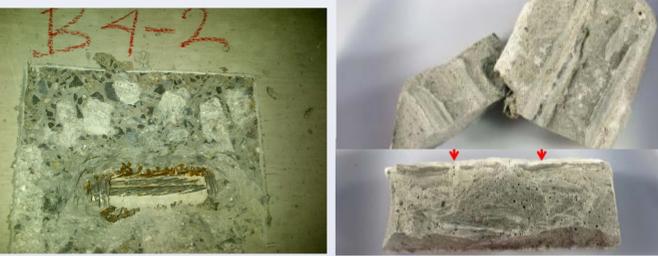
Make exploratory opening to inspect the conditions of the grout and wires
 Take grout samples for lab tests
 White and chalky grouts, grout pores are common

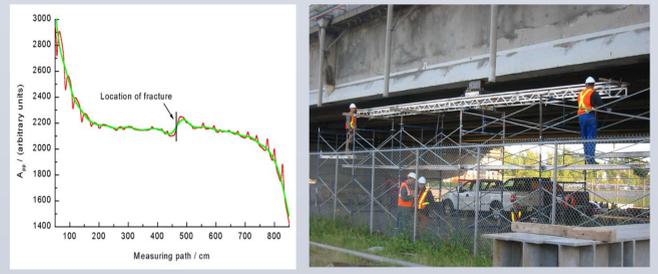
Conduct Remnant Magnetism testing to identify strand/wire fractures or breaks

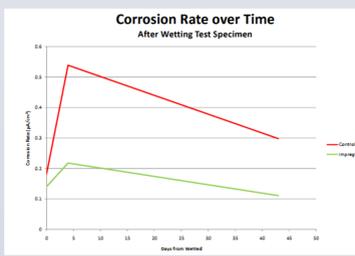
Impregnate the tendon/grout to fill the interstitial space between wires/strands and also the grout Pores to control corrosion

Corrosion Present Throughout the Tendon Tendon Surface Cleaned Corrosion Still Present in the Interior Wires Anode Galvanically Protects the Tendon
