1 Integrated Road Research Facility (IRRF): An Albertan Research Initiative

Paper prepared for presentation at the
Innovation in the Use of Instrumentation in Transportation Infrastructure Design and
Construction
Session of the 2013 Conference of the
Transportation Association of Canada
Winnipeg, Manitoba

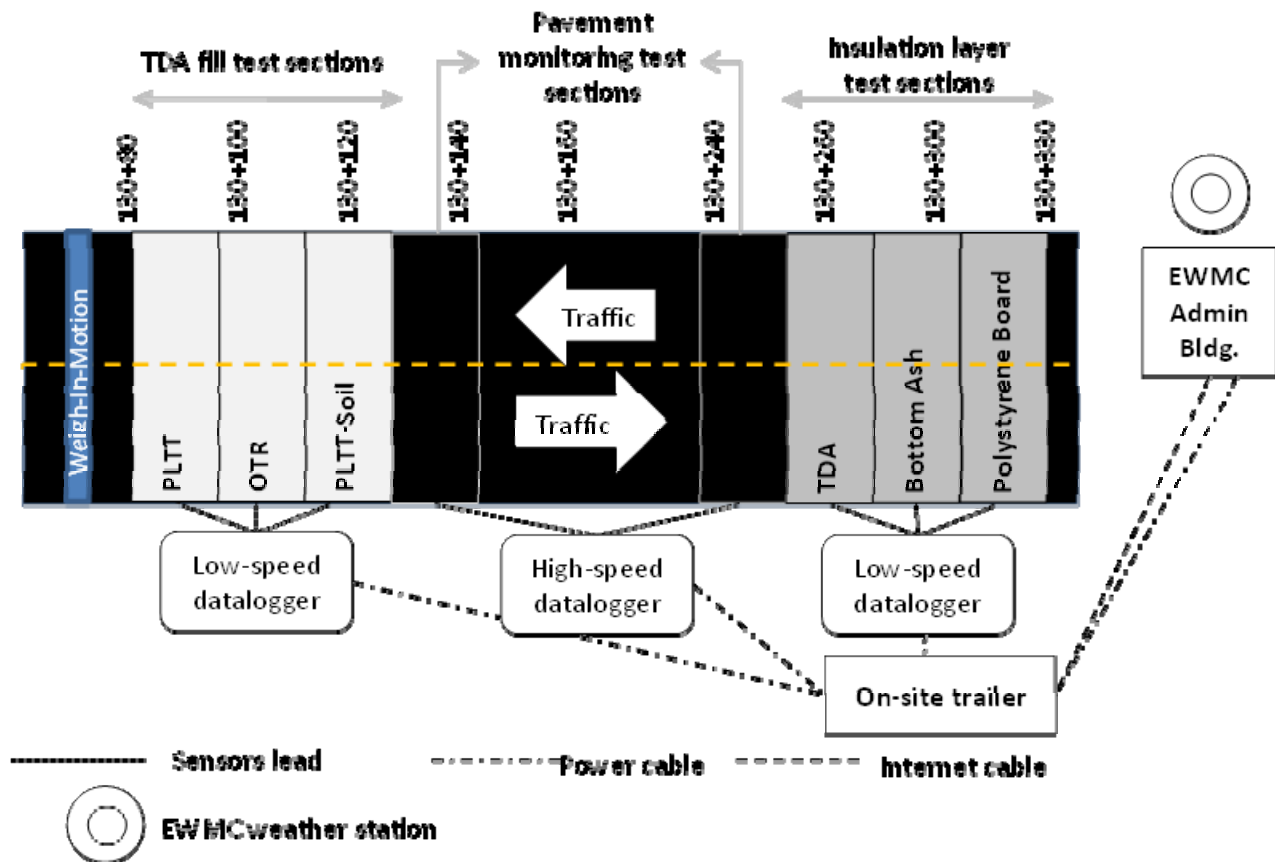
11 Figure 1. Schematic layout of the test road including the three test sections: 1) TDA fill
 12 embankment, 2) pavement monitoring and 3) insulated sections.

24
 25 As illustrated schematically in Figure 1, the test road includes three main test sections.
 26 The three test sections include: 1) TDA fill embankment; 2) pavement monitoring; and 3)
 27 insulated sections. The TDA fill embankment test section starts at Stationing 130 + 80 and ends
 28 at Stationing 130 + 140 and comprises three 20-m test sections: 1) PLTT is the southern section,
 29 stretching from 130 + 80 to +100; 2) OTR is the second section, from Stationing 130 + 100 to +
 30 120; and 3) PLTT-Soil mixture is the last section, from Stationing 130 + 120 to + 140.

13 All three main test sections were instrumented with a variety of environmental,
 14 geotechnical and pavement sensors. The TDA fill embankment test sections were instrumented
 15 during construction with environmental and geotechnical instrumentation. As demonstrated in
 16 Figure 1, all the sensors within the TDA embankment fill were wired to low-speed datalogger
 17 No. 1, located approximately at Stationing 130 + 110. This datalogger is a CR1000 from
 18 Campbell Scientific Corp. (CSC), programmed to collect the data from all the sensors at 15
 19 minute intervals.

13 The insulation layer sections were instrumented with environmental sensors across the
 14 pavement structure's depth. Datalogger No. 2 (another CR1000 datalogger) was used to
 15 continuously collect the data for the insulation test section. A trailer was provided by the
 16 EWMC and was positioned at the side of the test road in the northern section (Figure 1) to
 17 facilitate the data collection process and supply power to the three dataloggers. Power and fiber
 18 optic internet cables were conveyed to the trailer from the EWMC Administration Building
 19 through underground directional drilling. Individual power cables were carried to each
 20 datalogger from the trailer through cables as presented schematically in Figure 1.

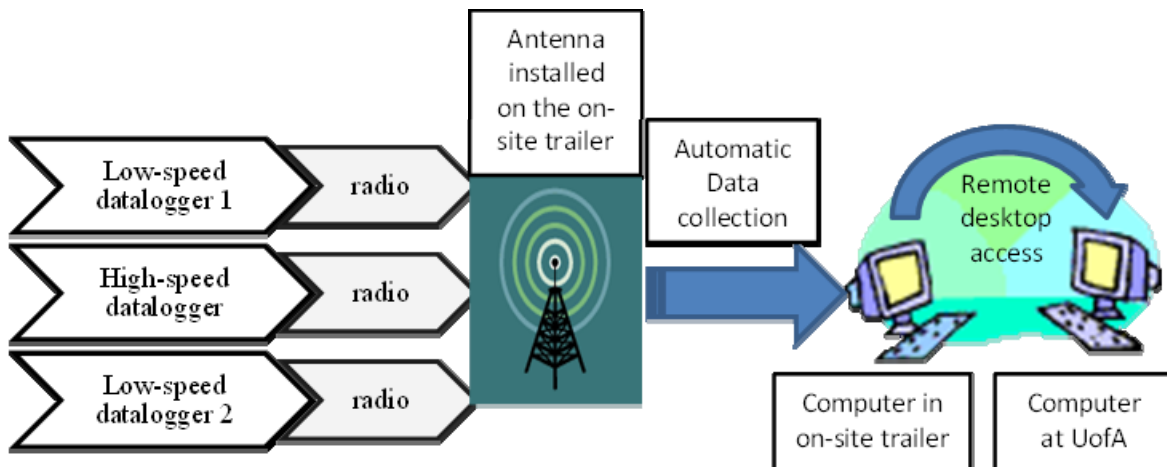
Figure 2. Schematic presentation of remote-access data collection.

21 The data collection and data transfer system from the IRRF's test road to the University
 22 of Alberta is presented schematically in Figure 2. An antenna Model L14221 from Campbell
 23 Scientific was installed on top of the on-site trailer. Each of the three dataloggers is equipped
 24 with a spread spectrum Model RF401 radio to communicate with the antenna on the trailer. The
 25 antenna is connected to a desktop computer in the trailer, which is programmed to automatically
 26 collect the data from each datalogger every day. The data from the on-site computer is then
 27 retrieved at the University of Alberta through remote desktop access.

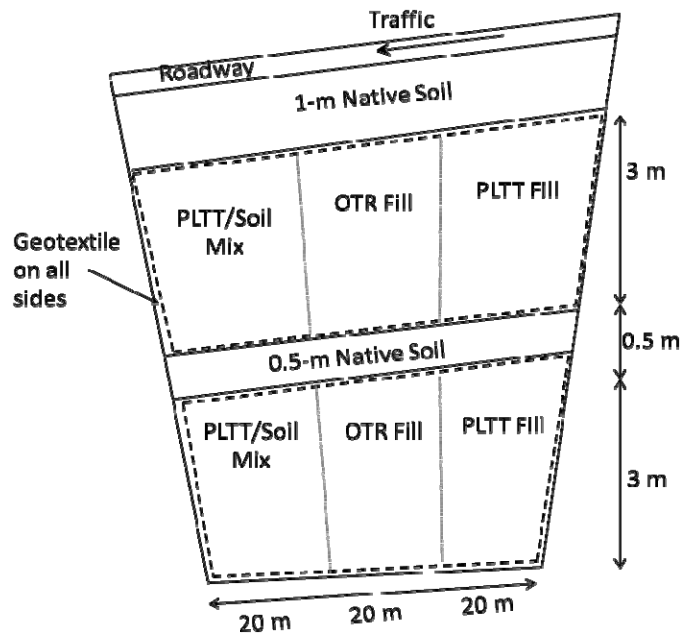
20 Figure 3. Longitudinal cross section of the three successive TDA fill embankment test sections.

9 Figure 3 shows a schematic longitudinal cross-section of the three successive TDA fill
 10 sections. Each test section includes two upper and lower 3-m thick TDA layers, which are
 11 separated with an intermediate 0.5-m mineral soil layer. The intermediate soil cap prevents
 12 internal heating and potential combustion of the TDA according to ASTM D 6270-08 (3). Each
 13 of the upper and lower TDA layers was wrapped in geotextile to avoid mixing with natural soil
 14 (Figure 4).

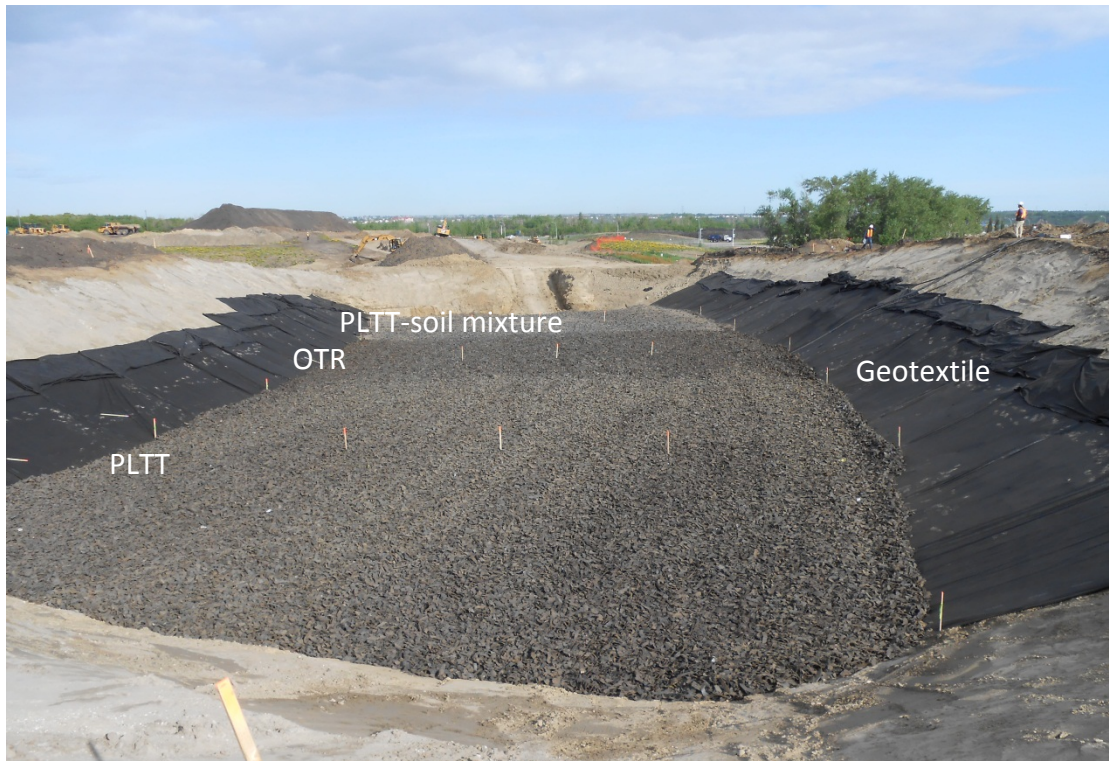
1
2 Figure 4. The embankment pit, half filled with PLTT, OTR and PLTT-soil mixture.
3

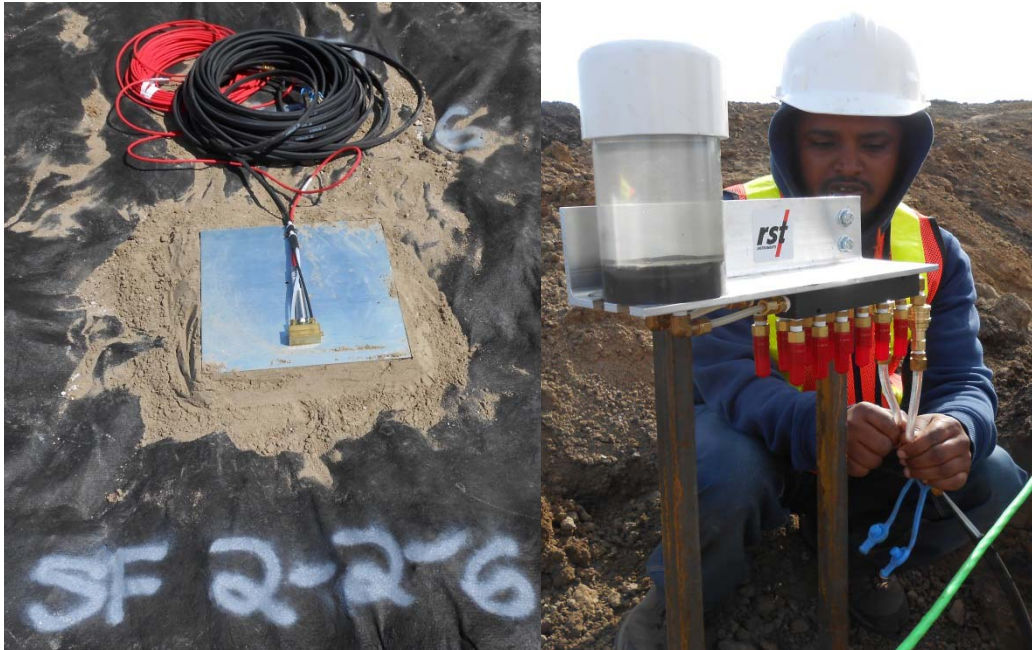
Figure 6. Left: picture of a settlement plate installation and Right: picture of a reservoir for settlement plates in one section.

An encapsulation of fine sand was used to protect the settlement plates from the steel wires of the TDA. Each settlement plate has a lead-out wire connected to datalogger No. 1 and a liquid-filled tube. The liquid-filled tube was connected to a reservoir filled with glycol and installed outside the embankment on stable ground. The right picture in Figure 6 shows a reservoir installation. All the settlement plates in one test section, together with that section's reference plate, were connected to one reservoir. The hydraulic head between the sensor and the reservoir produces a frequency change in the VW transducer. The tube and the wire from each settlement plate were carefully conveyed to the datalogger and corresponding reservoir, respectively through separate flexible conduits. The conduits protected the instrumentation leads from the steel wires protruding from the TDA. Figure 7 shows the complexity of the instrumentation wires and tubes to be connected to the datalogger and reservoirs on ground level.

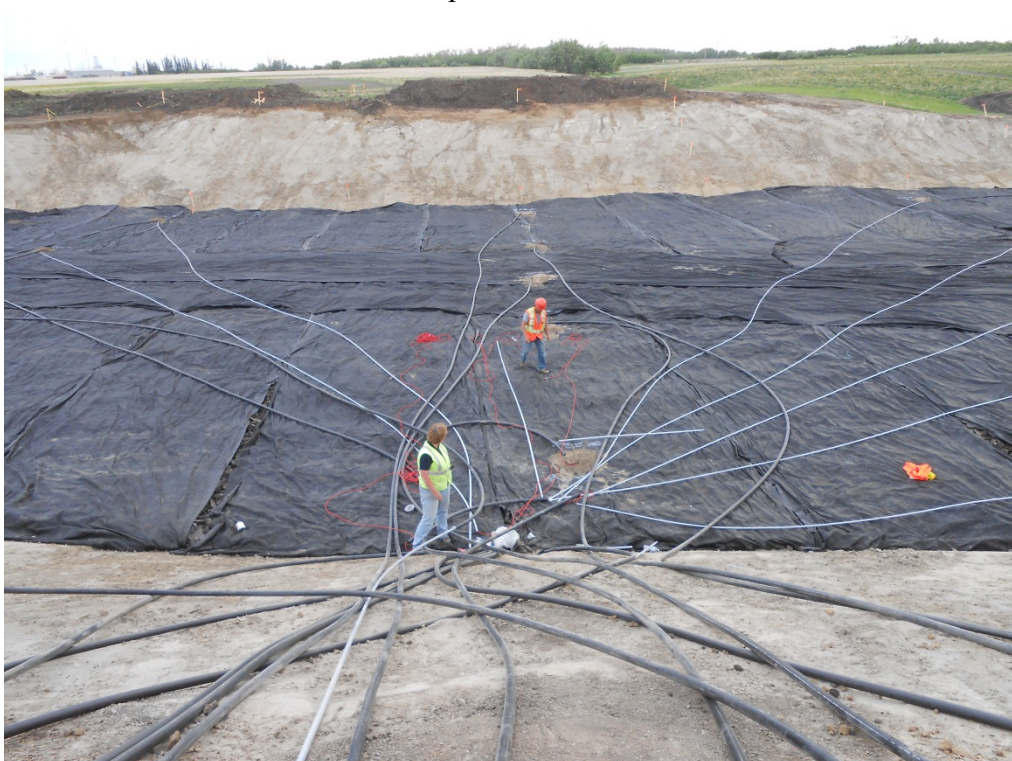
Figure 7. Installation of settlement plates in the three TDA fill embankment test sections.

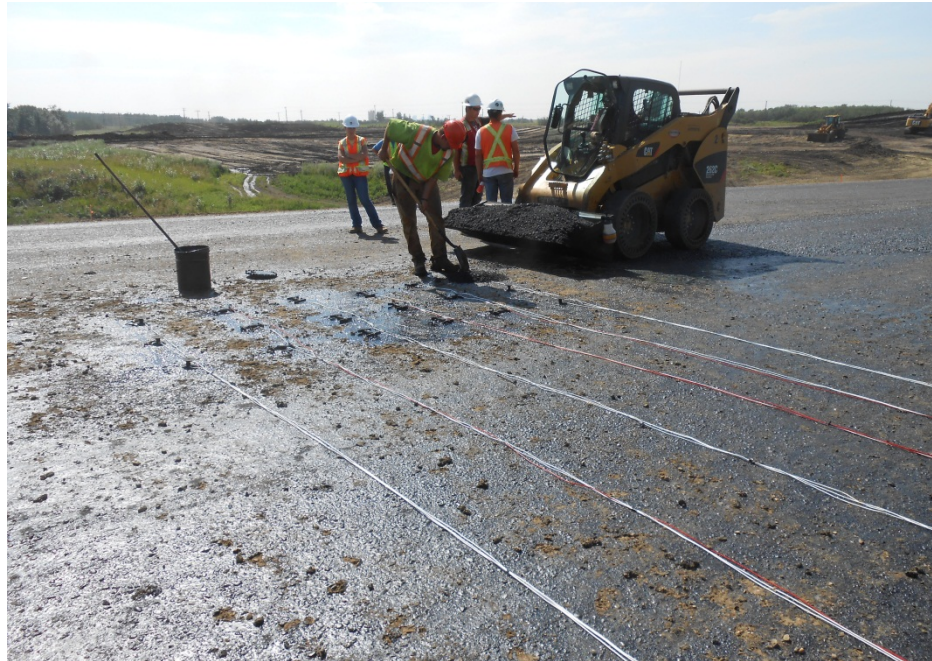
5
6 Figure 9. Asphalt strain gage installation process.

21 The instrumentation was installed one day before paving. Each gage was located through
22 surveying and was identified by wood sticks. The GBC surface was covered with prime coat and
23 gages were placed on the prime coat. When installation was complete, the sensors were covered
24 with another layer of prime coat to secure the instrumentation in place. The gages' wires were
25 laid on the shoulder and down the side slope and connected to the high-speed datalogger to take

1 the initial reading (Figure 9). To protect the sensors and their wires from the paver track and the
2 asphalt truck wheels 50 mm of the HMA mixture was placed over the gages and lightly packed
3 by foot. To provide further protection another 50-mm layer of HMA was placed on top of the
4 gages right before paving.

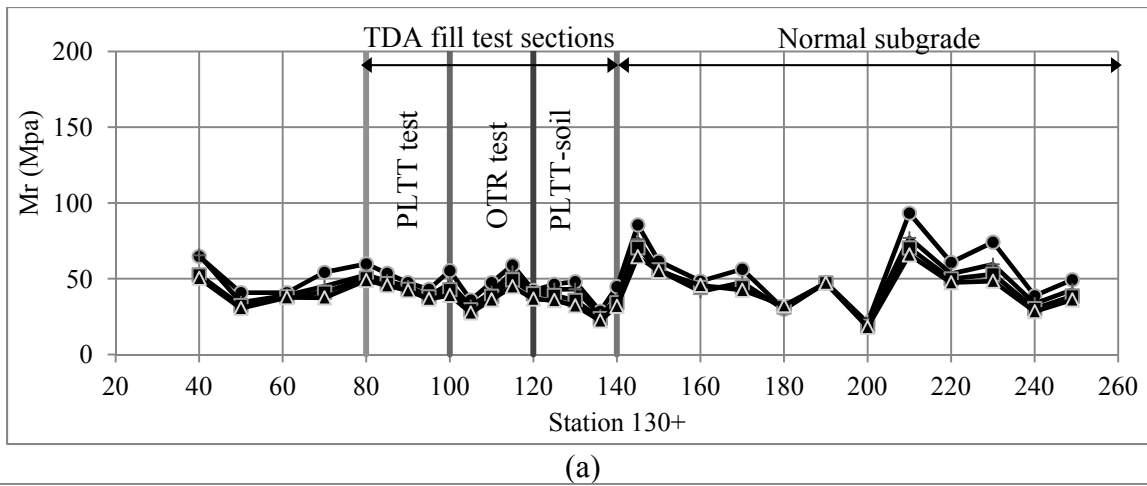
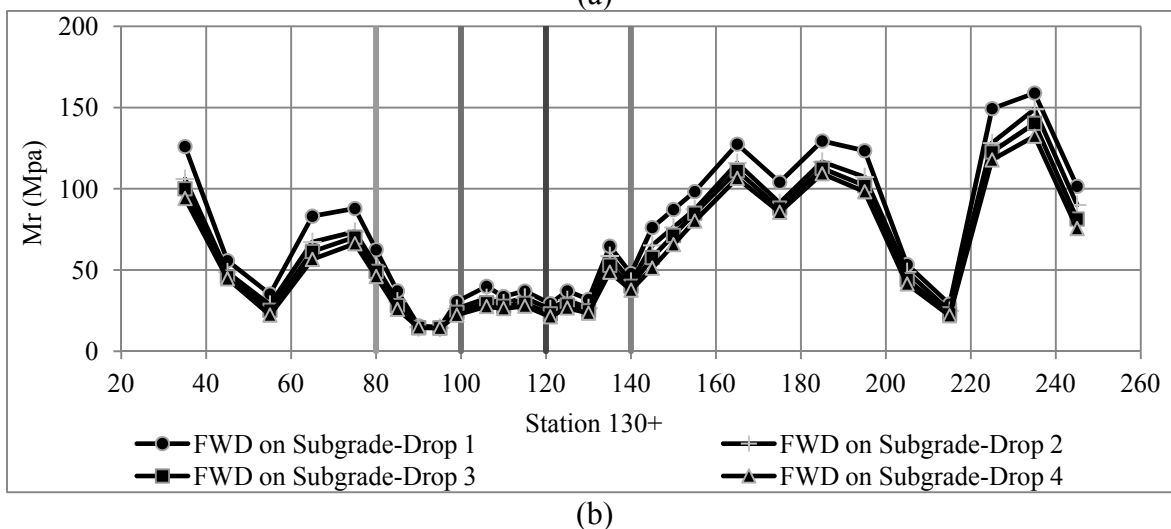
5 Figure 11. Subgrade Mr, backcalculated from FWD tests performed directly on the subgrade,
6 along the (a) wheelpath and (b) centerline.

15 The backcalculated modulus for the four FWD drops at each location along the centerline
 16 and the outer wheelpath are presented in Figure 11 (a) & (b), respectively. According to Figure
 17 11 (a), the subgrade Mr along the outer wheelpath is relatively consistent with average values of
 18 60, 53, 49 and 47 for Drops 1 through 4, respectively. Subgrade Mr shows an abrupt increase to
 19 86 Mpa at Stationing 130 + 145. This point is the end of the TDA fill test sections and the start
 20 of the normal existing ground. Beyond the transition point at Stationing 130 + 150, the modulus
 21 tapers gradually to a minimum value of 47 Mpa at Stationing 130 + 190. Another sudden
 22 increase is evident at Stationing 130 + 220. A possible explanation for the variation is the
 23 change in the natural soil profile at this station.

7 Figure 11 (b) presents the FWD backcalculated subgrade Mr along the centerline. The
8 average Mr along the centerline is 70, 61, 58 and 54 Mpa for Drops 1 through 4, respectively.
9 These average values are consistently higher than those obtained for the tests performed in the
10 outer wheelpath, as discussed previously. The backcalculated Mr at the start point (Stationing
11 130 + 40) drops from a maximum of 107 Mpa to a minimum of 28 Mpa at Stationing 130 + 55
12 and then picks up to a maximum value of 74 Mpa. This variation may be due to localized
13 moisture, note that no variation is evident in Figure 11 (a) for the same section. The modulus
14 significantly drops at the edge of the tire fill embankment (Stationing 130 + 80) and remains as
15 low as 32 Mpa over the fill sections. Backcalculated modulus starts to increase at the end of the
16 fill sections at Stationing 130 + 140 and continues to ascend until Stationing 130 + 170. A

17 sudden drop is seen at Stationing 175, which may be due to such reasons as localized moisture.
18 A sudden drop is noted at Stationing 130 + 190, where the terrain changes. Significant
19 variability existed in the uniformity and quality of compaction of the subgrade along the
20 centerline. It is evident that special care is required during compaction, especially at the
21 transition zones from fill or cut sections to normal ground.
