DESIGN AND CONSTRUCTION OF ACROW PANEL BRIDGES IN NORTHERN MANITOBA

Graeme Loeppky, P.Eng., Associate, Dillon Consulting Limited

Prepared for presentation at the

of the 2013 Conference of the Transportation Association of Canada

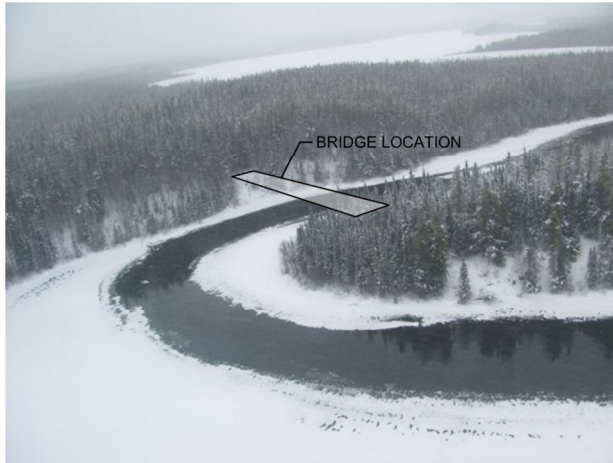
Figure 2: Mainland River Bridge Location

In order to clear span the Mainland River, a location approximately 1 km from the winter road lake crossing was proposed for the new bridge location. Due to the profile of the riverbanks at this location, a three span bridge was proposed with the main span clear spanning the river. The proposed location for the Pelican Rapids crossing was approximately 300 m upstream of a pre-existing winter road crossing over the Stevenson Lake. A bridge constructed with timber cribbing had been installed by the Red Sucker Lake First Nation many years ago at the mouth of the Red Sucker River. Over time this bridge had deteriorated and become unusable for vehicle or pedestrian use. The new crossing location over the Red Sucker River was approximately 100 m downstream of the existing bridge.

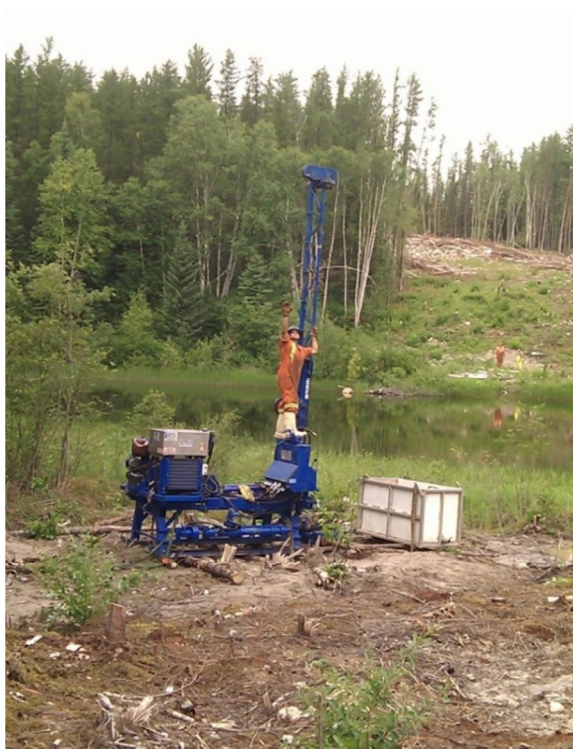
Figure 5: Drill Rig Assembly at Mainland River

Due to the lack of drill rig availability during the 2011 winter road season and construction planning to start during the 2012 winter road season, the drilling program occurred during July and August 2012. The remoteness of the three bridge sites required the drill rig to be transported by both plane and helicopter. One challenge that was overcome during the drilling program was to ensure that each of the airports had equipment that was suitable to load the drill rig into the plane as well as unload the drill rig from the plane. The drill rig used for this project was a ACKER SSII portable drill rig equipped with 125 mm diameter solid stem augers and HQ rock core barrel. The drill rig was transported from the airport to site via a Astar 305 B2 helicopter. Other helicopters considered for the drilling program included the Bell 206B Jet ranger and the Bell 205 A1. Although the Astar 350B2 helicopter did not have the highest capacity for hauling equipment, it was the most economical helicopter for transporting both the drill rig and personnel to the sites. The drill was transported to the site and assembled at the test hole location. Following the drilling of each test hole the drill was disassembled into approximately five components and transported to the next test hole where it was reassembled. Relocation of the drill rig required eight to nine return helicopter trips to transport the 12,600 lb drill rig, equipment, and personnel. The drilling at the three bridge sites was completed in 14 days between July 24 and August 8, 2011.

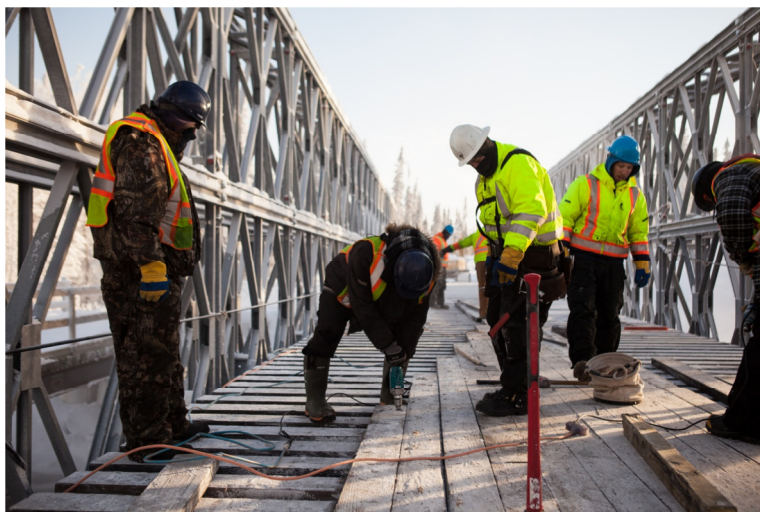
Figure 7: Timber Deck Assembly at Red Sucker

The preferred superstructure alternative was the ACROW 700XS steel truss (Acrow). The Acrow superstructure was selected due to the long clear span lengths and that it could be launched into place resulting in no in water works. Although the Acrow superstructures have a deep cross section, this superstructure has a relatively low structure depth below the top of the bridge deck of approximately 900 mm. The main advantage to the ACROW trusses is the fact that the trusses are constructed of modular steel components that are shipped by truck to the site, and do not require any specialized shipping vehicles or trailers, which is ideal for the limited accessibility of the bridge locations along the winter road system. The trusses are then assembled on the approach embankment by bolting the components together and the bridge is then launched into place. The ACROW bridge also includes a timber deck curb and steel W-beam guardrail that are all connected to the trusses. The assembly and installation of the bridge and deck aligns with ESRA's overall vision to provide opportunities for training local labourers and economic development.

- Once the bridge is fastened to the abutment via welding the bearings to the base plates, the installation of the stringers and timber decking is completed. The side curbs and guardrails are also installed. A timber backwall is installed on top of the abutment, behind the bridge, and provides a retention mechanism for the roadway structure.

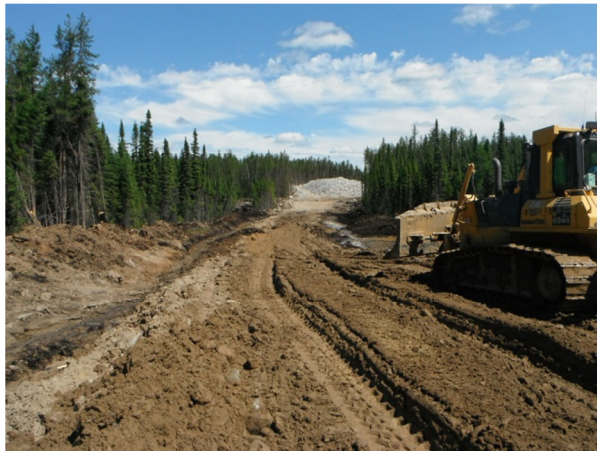
Figure 5: Typical Soil Conditions at Mainland

Prior to the start of construction, site preparation and equipment mobilization began in February 2011 at all three sites in preparation of the bridge and roadway construction. The typical soil conditions at the sites consisted of silty sand and bedrock outcrops, overlain with peat and organic material. The poor soil conditions made the construction of the laydown and temporary site roads especially challenging. For example, at the Mainland River bridge site, the contractor spent two months removing the peat layers, draining the site, and creating access roads.

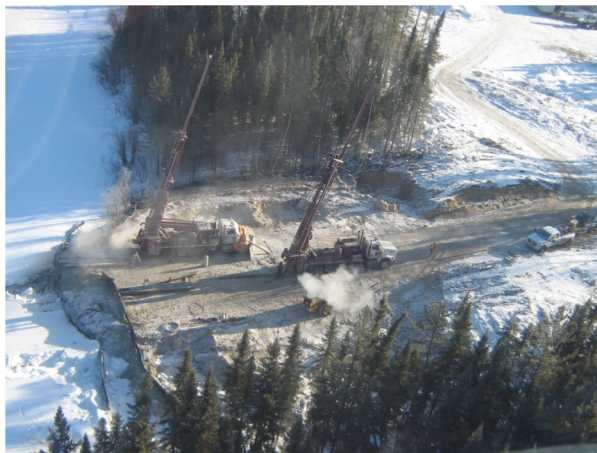
Figure 7: Drill Rigs at Mainland

Specialized drilling equipment for the installation of the steel pipe piles into the underlying bedrock was transported to the site immediately following the January 20, 2012 opening of the winter road. As it would be prohibitively costly to leave the equipment on site for the entire year, it was necessary for multiple drilling rigs to be mobilized to complete the drilling. The drilling operations were maintained 24 hours a day for both drill rigs, which necessitated around the clock geotechnical inspection. Due to unseasonably warm weather and rainfall, the winter roads were closed less than four weeks earlier on March 13, 2012. Despite the additional efforts employed for the drilling works, it was not possible to complete the piling in the shortened winter road season.

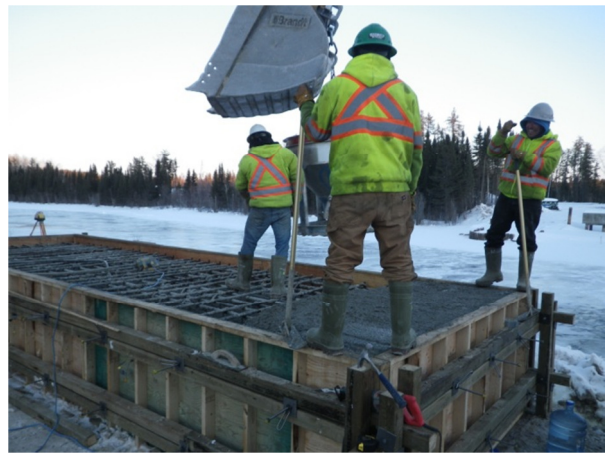
Figure 8: Concrete Placement at Mainland

Fortunately over half of the piles were completed and the south abutment and pier were able to be constructed throughout the summer of 2012. Due to lessons learned from the 2012 winter road season, road improvements and advanced snow packing and flooding on the lake crossings were completed by January 2013. These efforts were a major contributing factor in the winter road opening ahead of schedule. On February 5, 2013 drilling operations resumed with the completion of the north abutment and pier pile installation completed before the end of the month. The construction of the remaining substructure was completed immediately after piling finished allowing the concrete batching equipment to be transferred to the Feather Rapids site for concrete production on that site.

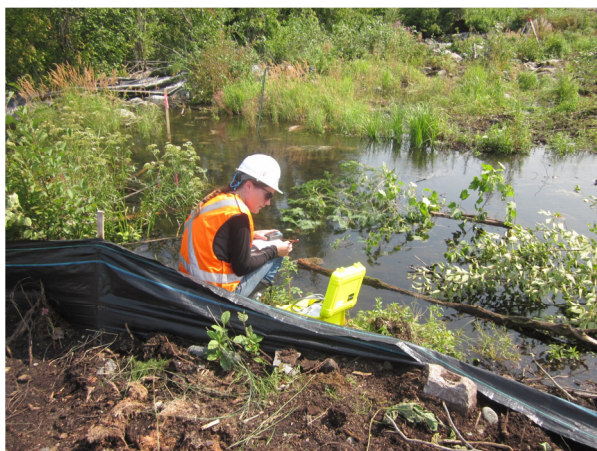
Figure 9: Turbidly Monitoring at Red Sucker

While the overland flooding primarily occurred within a 20m band of the boulder field to the west of the river, it was possible to identify channels of water within the flooding area. It was determined these channels could be intercepted approximately 15m north of the west abutment and be rerouted back to the primary river channel. On August 11, 2012 the channel re-routing was completed protecting the west abutment area from overland flooding. To mitigate the loss of fish habitat developed due to the overland flooding and control the sediment released during construction, an extensive protection and recovery program was instated for the construction of the west diversion channel. This included the use of turbidity monitoring and fish salvages.

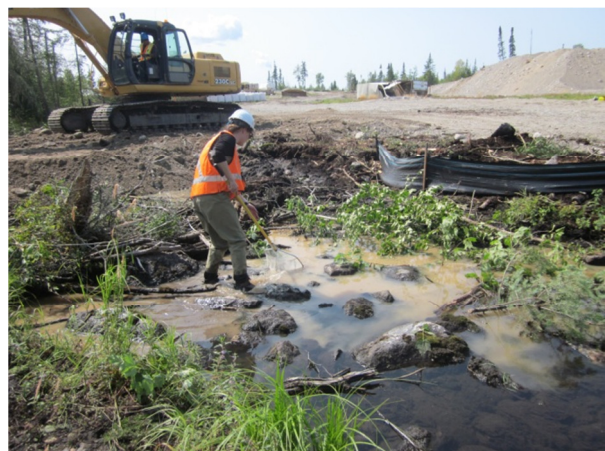
Figure 10: Fish Salvage at Red Sucker

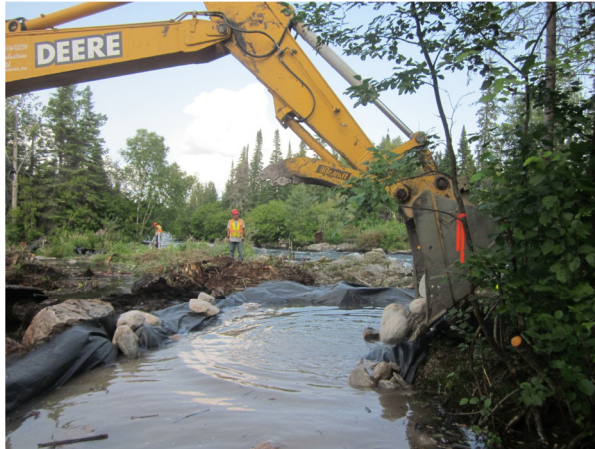
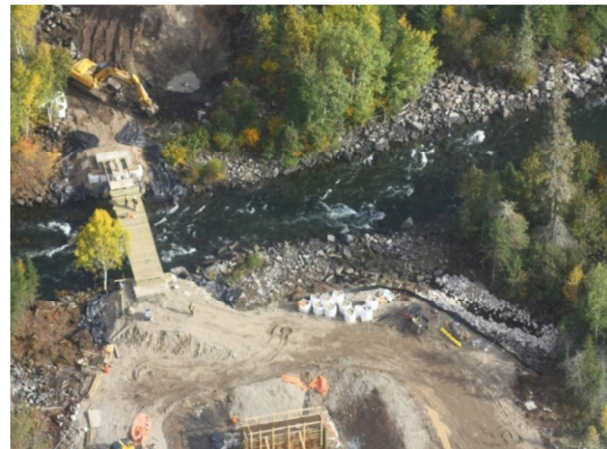
Figure 11: Channel Re-Route at Red Sucker

After the channel diversion had been installed and the overland flooding was addressed, the excavation for the substructures commenced. Ground seepage was a constant issue and despite the installation of clay plugs to limit seepage, several submersible pumps were utilized to maintain a dry excavation. As there was significant laydown area available around the abutments and the excavation depths were less than 5m, open-cut excavation was utilized, although shallow slopes were required due to the seepage issues.

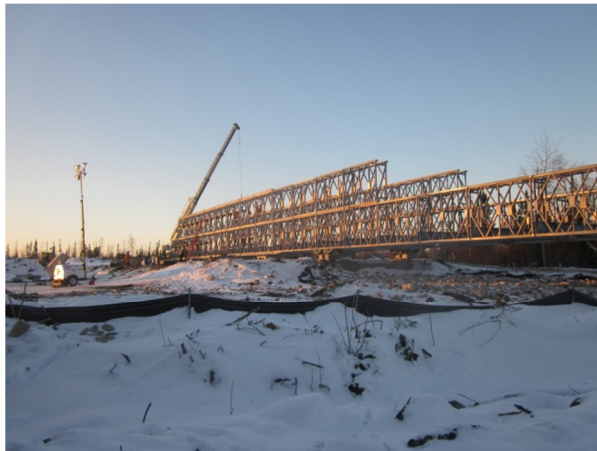
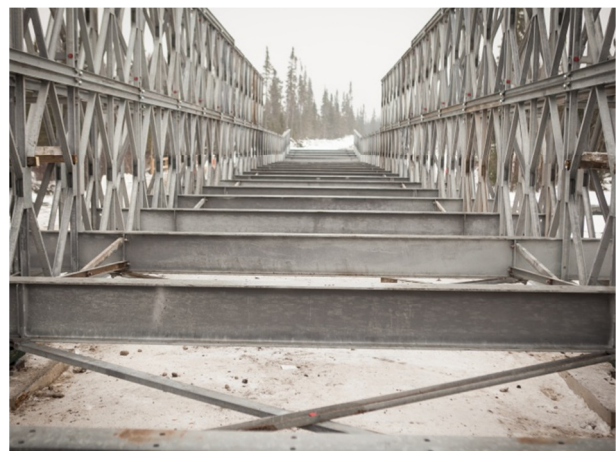
Figure 13: Acrow Construction at Red Sucker

As discussed above, the superstructure for the three bridges was an Acrow panel bridge system. This Acrow system consists of assembling pre-fabricated steel panels which act as the girders, together with transoms which act as diaphragms and supports for the stringers which provide support for the timber decking. A portion of the Acrow parts were transported to the site during the initial mobilization of equipment in 2011, and when the design for the bridges was finalized, an additional shipment of parts had to be sent to site to accommodate the finalized span lengths.

In general, Acrow panel bridges are typically assembled and launched into place. This consists of assembling the bridge on rollers and then incrementally pushing the bridge across the river to the foundation on the other side of the river. A pre-cambered launching nose is attached to the front of the bridge to account for the deflection that occurs in the bridge during launching. The detailed sequence of the assembly and launching as follows:

- Following the backfill of the abutments, the launching and receiving pads behind the abutments were constructed using either crushed blast rock or granular material.

- The part lists are verified on site and the parts are organized in piles that are readily accessible.
- Cast in place concrete blocks are installed on the launching side at a spacing of 7.6m and align directly below where the vertical panels will sit. After the elevation of the concrete blocks has been achieved through grinding or shimming, the rollers are installed on each of the blocks and assembly can commence. A set of rollers is also installed on the receiving abutment and this is where the launching assembly will touch down when the bridge is pushed across the river. While the assembly and launching of the Acrow panel system is relatively simple, it is imperative the initial layout of the rollers is accurate horizontally to ensure the launch will reach the rollers on the side and vertically to limit the differential stresses in the parts. To achieve smooth rolling and assembly as well as directional launching, a tolerance of no more than 5mm was instated for both horizontal and vertical layout.

- Assembly was completed with a crane and loader on the launching side and an excavator on the receiving side. A diligent process of steel assembly and torqueing operations must be observed to ensure the bridge is not assembled too far in advance of bolt tightening and verification.

- Launching of the bridge occurred simultaneously with the assembly. As the bridge gains sufficient length and the center of gravity is shifted away from the leading roller, which is located at the launching abutment, the bridge is pushed forward and begins to cantilever out towards the receiving abutment. Once the bridge is fully constructed, additional counterweight is installed on the back of the bridge to offset the weight of the launching nose and shift the center of gravity further back and allow the nose to touch down on the receiving abutment. After the bridge is received on the far abutment, the launching nose is removed and the bridge is jacked up to remove the rollers at the abutments, and then jacked down to its final location on the bearing plates.

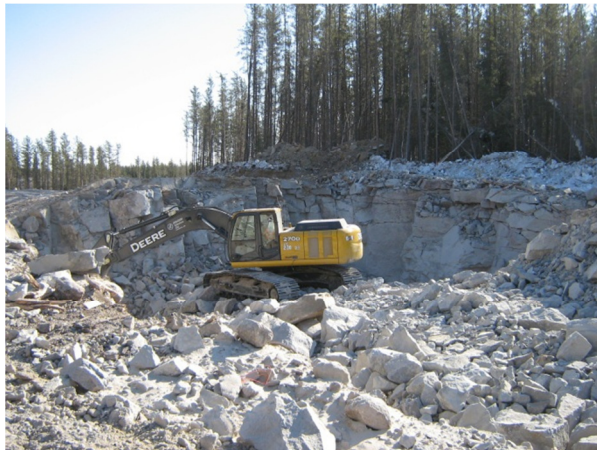
Figure 16: Blasting Area During Excavation at Mainland

Several key considerations were factored in selecting the suitable bridge and roadway location for each site. The selection of the Mainland bridge was approximately 1 km from the winter road lake crossing, which was selected for ideal span lengths and crossing location. However, north of the north abutment there was a large bedrock outcrop. Blasting was required to meet the necessary roadway grades and width requirements. The blasted granite shot rock was hauled to an area northwest of the project site, at a clearing along the winter road alignment. In the clearing, a crushing spread was set up to crush the blast rock and provide the 150mm sub-base and 19mm base course, as well as the class 350 rip-rap. Due to the capacity of the crushing spread, it was difficult to produce the rip-rap, and to compensate the contractor mobilized a skeleton bucket which sorted the unprocessed blast rock into the necessary gradation. Although the sorting process was cumbersome, the jagged blast rock provided ideal rip-rap material with maximum erosion control capacity.

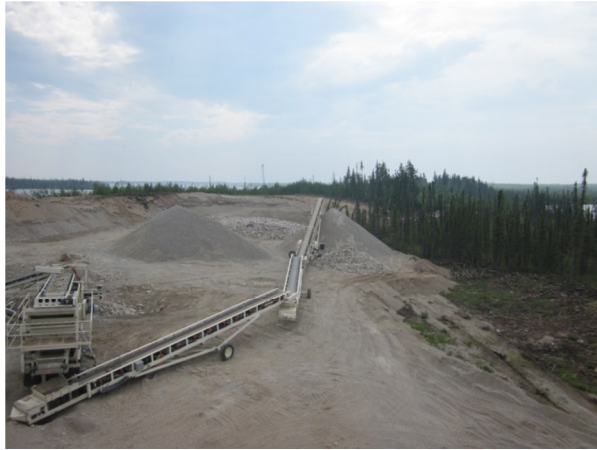
Figure 18: Crushed Rock from Quarry at Red Sucker

The Red Sucker roadways were originally designed to be completed after the bridge was assembled and launched to take advantage of the large excavation volumes on the east side. However, during bridge construction, it was determined that considerable schedule acceleration could occur if a borrow source could be found on the west side. As there is an open quarry approximately 1 km to the west of the site, the roadway was filled to sub-grade elevations with unprocessed granular material (pit run). A large crushing spread was set up at the quarry and the crushed granular and rip-rap was also sourced from this quarry.

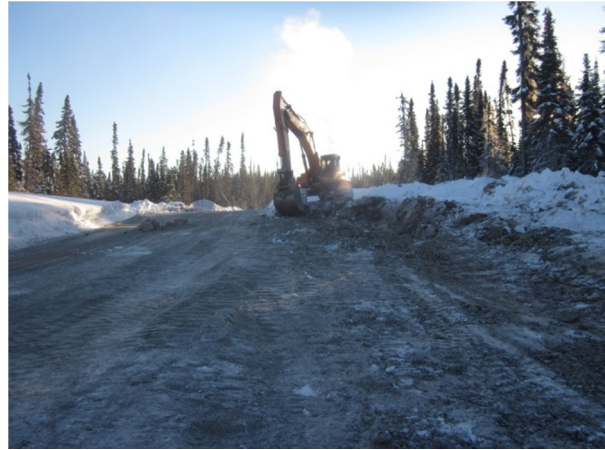
Figure 19: Road Upgrades at Red Sucker

The approach roadway on the west side was originally designed to fall within the existing clearing limits to minimize impact to the site, which necessitated a very tight turning radius. After discussion with MIT, and RSLFN it was determined that the safety enhancements at this location from decreasing the approach angle would justify some additional clearing. The roadway design was altered and the road was constructed providing longer sight lines and accommodated higher approach speeds, with an overall increase in roadway safety at the west approach.

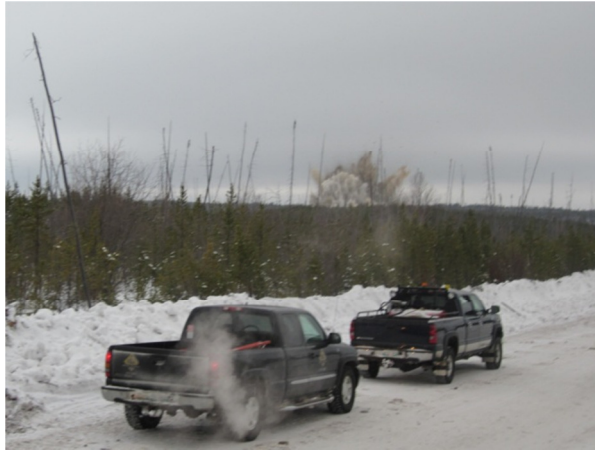
Figure 20: Blasting at the Quarry at Feather Rapids

Blasting was also completed in a rocky outcropping further away from the river as blast rock was required for laydown areas and access roadways. As the outcropping (quarry) area was sufficiently far away from the river, a much larger blast was possible.

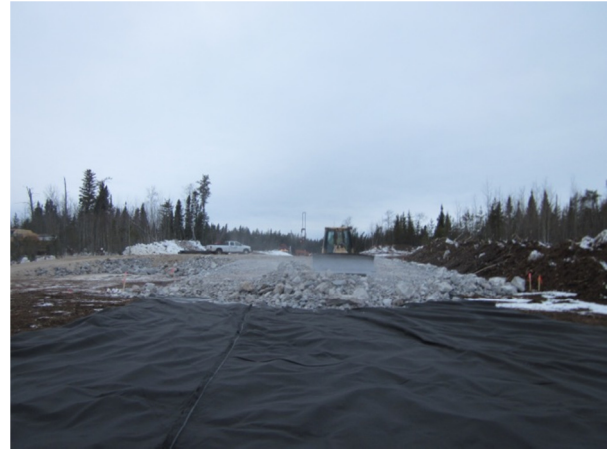
Figure 21: Sewn Geosynthetic at Feather Rapids

On the east side of the bridge, a large swamp is present only 70m away from the abutment. During the winter, this swamp will provide ideal winter road conditions. However during the summer, there were concerns that the roadway could potentially fall apart from below unless an extensive segregation layer was provided. By providing a heavy duty geosynthetic layer, sewn at the edges for a continuous piece along the entire width, the degradation concerns were addressed. Due to the use of a heavy duty geosynthetic, specialized sewing facilities had to be sourced and were eventually completed in Georgia, USA.
