**Challenges, Risks and Successes
in the Construction of the
Lake St. Martin Emergency Channel**

Ron Weatherburn, Executive Director for Construction and Maintenance,
Manitoba Infrastructure and Transportation
Eric-L. Blais, Golder and Associates

Paper prepared for presentation
at the Maintenance and Construction Session
of the 2013 Conference of the
Transportation Association of Canada
Winnipeg, Manitoba

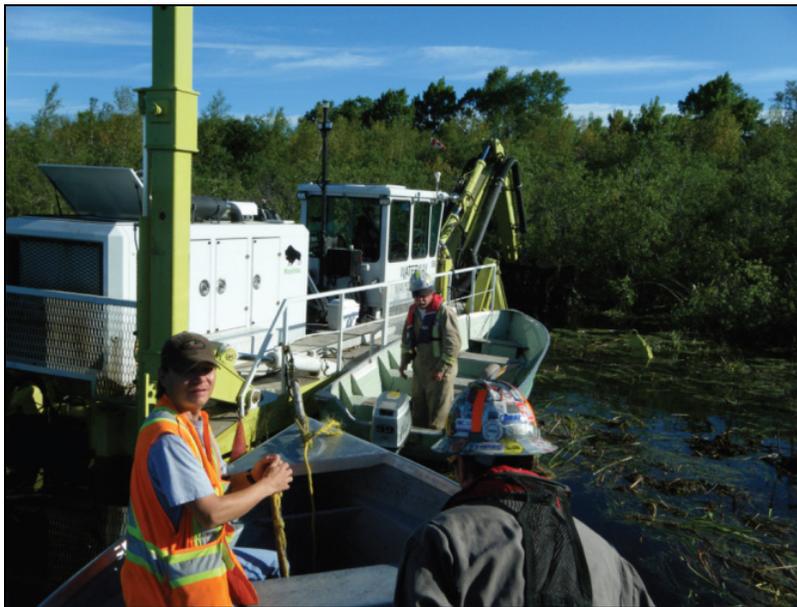
Figure 4 – Attempting to Cut Access Channel

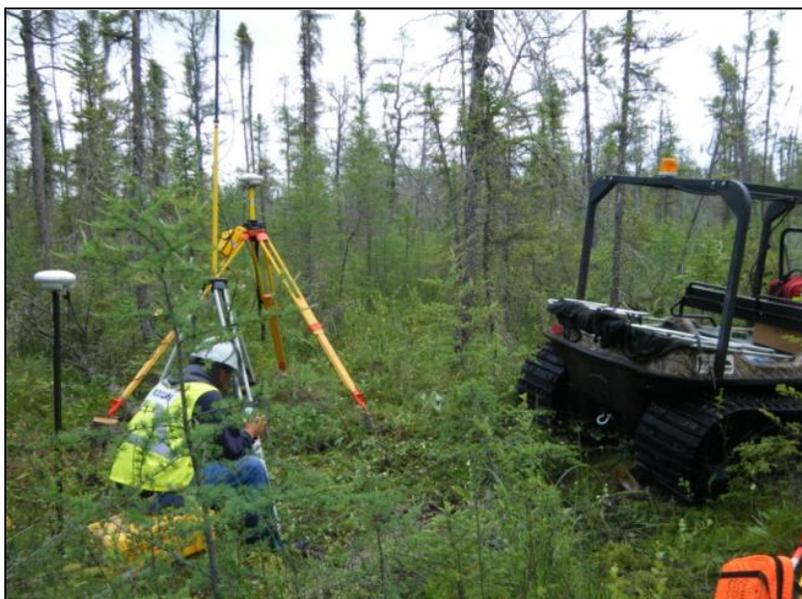
Figure 5 – Survey Crew Setting Alignment

Line clearing crews were deployed to cut narrow paths to facilitate GPS alignment survey. This led to the collection of topographic data necessary to estimate earthwork quantities and support engineering estimates of total construction cost. Additional line cutting crews cleared helicopter access pads, while surveyors installed local control points as temporary benchmarks at helipad locations.

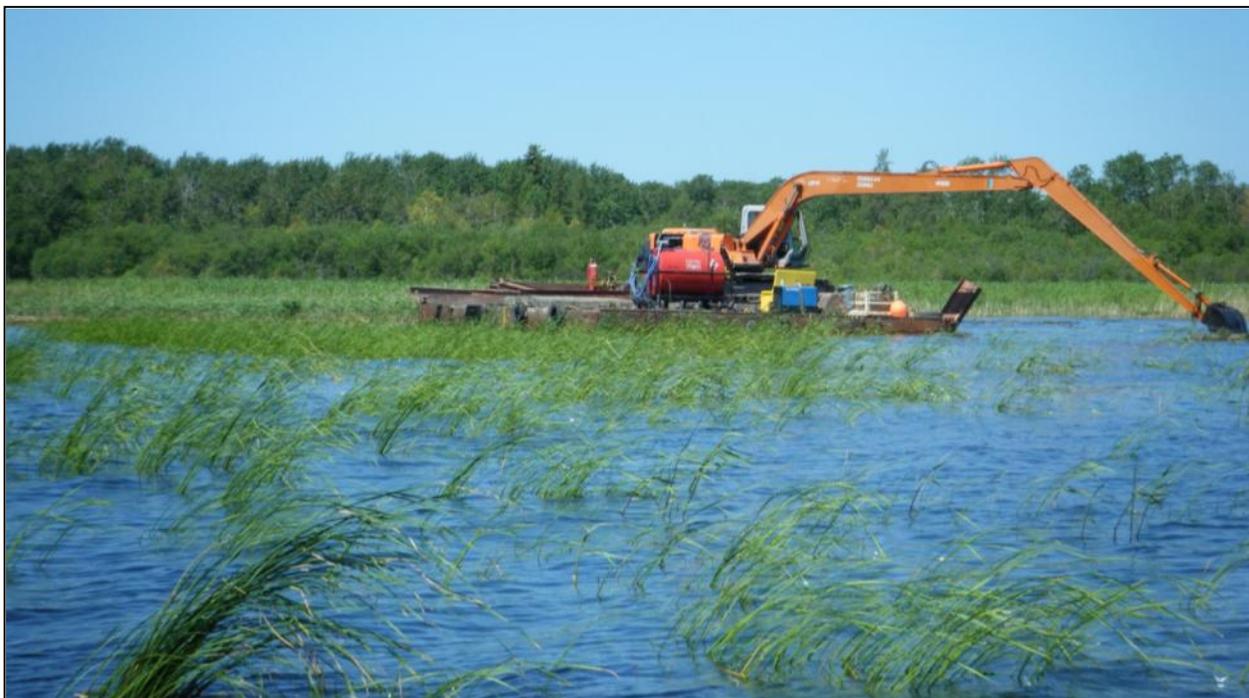
Figure 6 – Access Channel Construction Using Barge Mounted Excavator

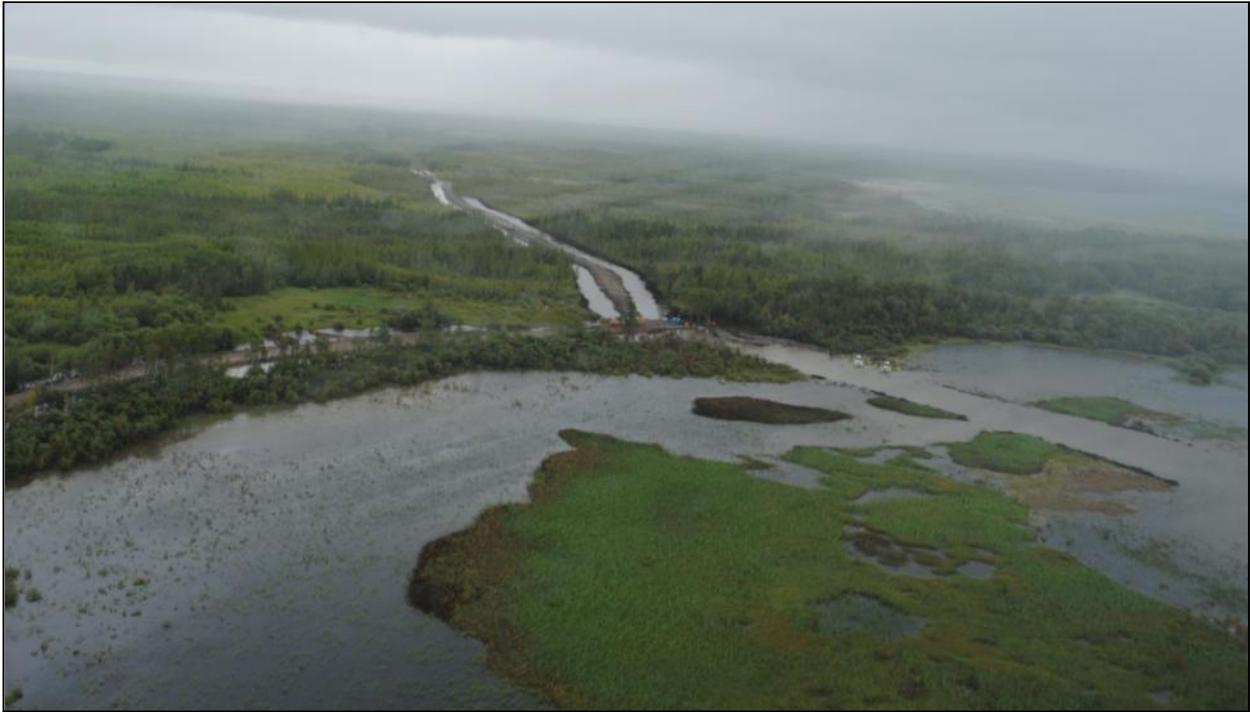
Figure 7 – Barge Channel and Drainage Development

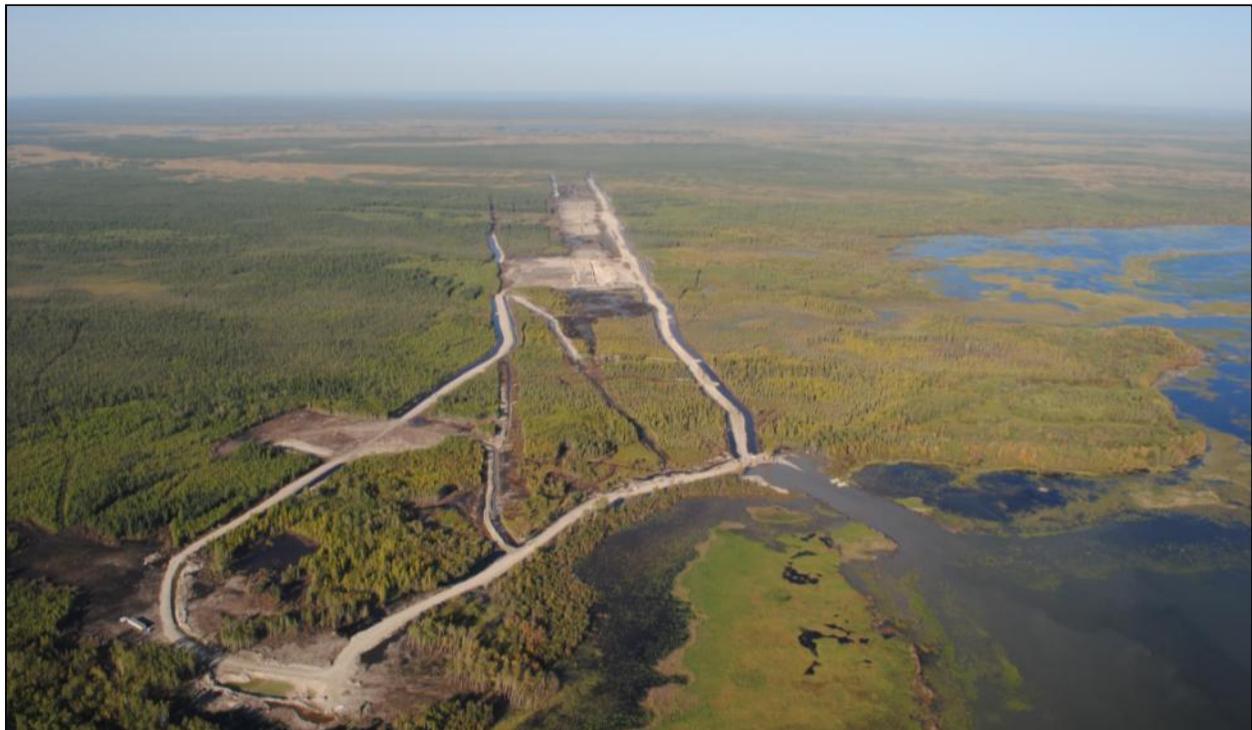
Figure 9 - Progress by September 9

As in August, progress was difficult to quantify initially. A suggestion was made to survey the excavated parts of the channel and perform volume calculations to determine progress. As this process proved too onerous and labour intensive, the site inspectors resorted to estimating progress throughout the site by recording the estimated cut remaining at various stations. This information was entered into a spreadsheet of estimated daily cumulative progress. The method did not provide the level of accuracy as one would have with surveyed cross-sections, but it was considered adequate given the conditions and constraints of the project.

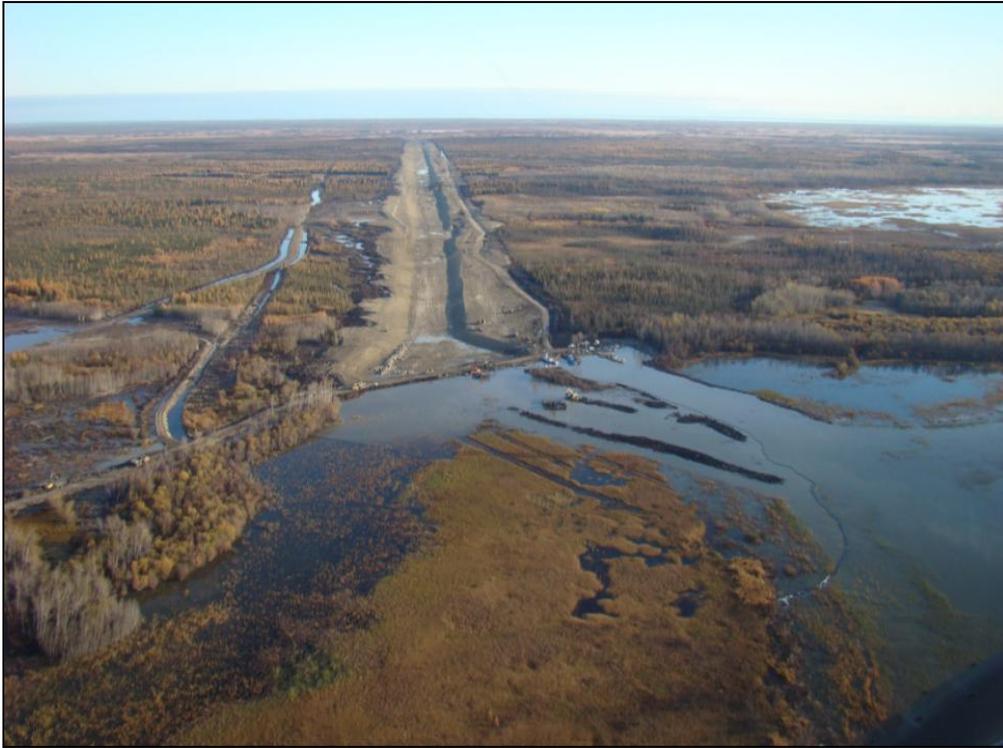
Figure 10 - Channel Progress by October 2

At the start of October, till excavation was approximately 35% complete. Progress was steady for the first two weeks of the month averaging about 22,320 m³ per day. Excavation rates increased to 31,620 m³ as the deadline approached. By October 31, 2011, excavation of the channel was complete.

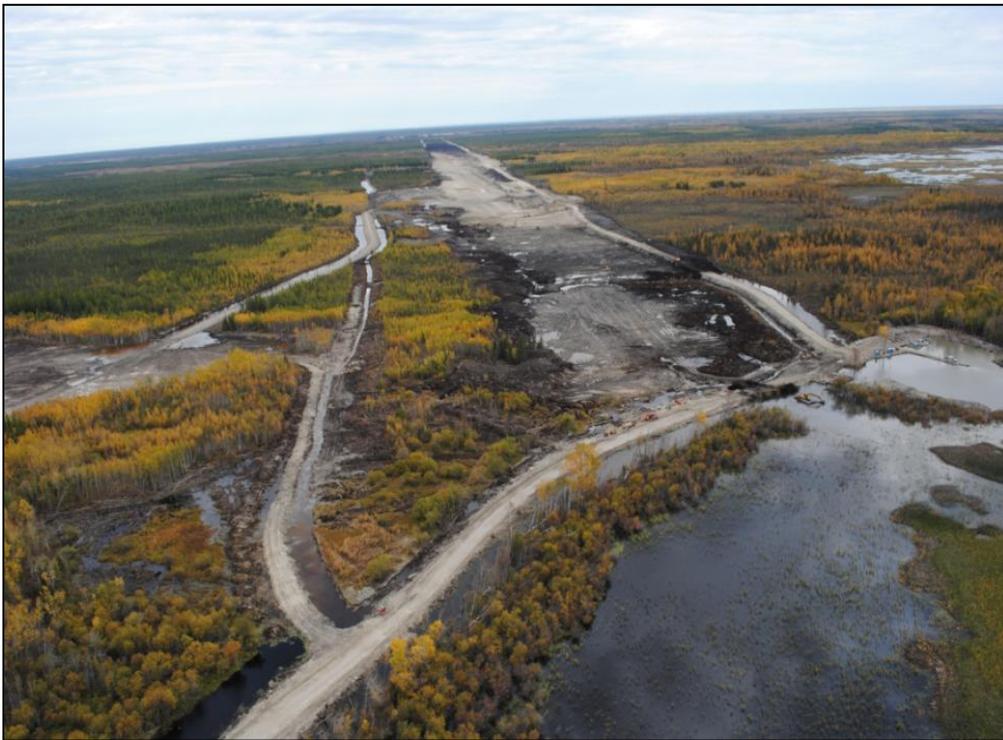
Figure 11- Channel nearing Completion - October 25

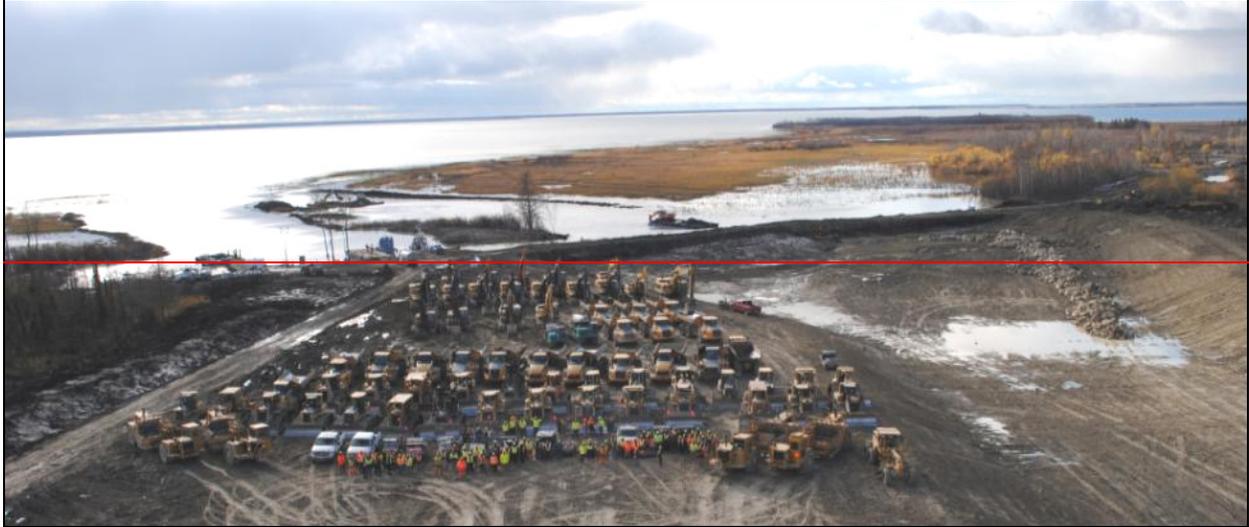
Figure 12 - Construction Equipment on Site

August saw the first major influx of earth moving equipment to the construction site, increasing from 10 to 43 units including 19 dozers, 17 excavators and 7 rock trucks.

The amount of earth moving equipment nearly doubled in September, reaching 82 units from the 43 units at the end of August. The equipment roster was comprised as follows:

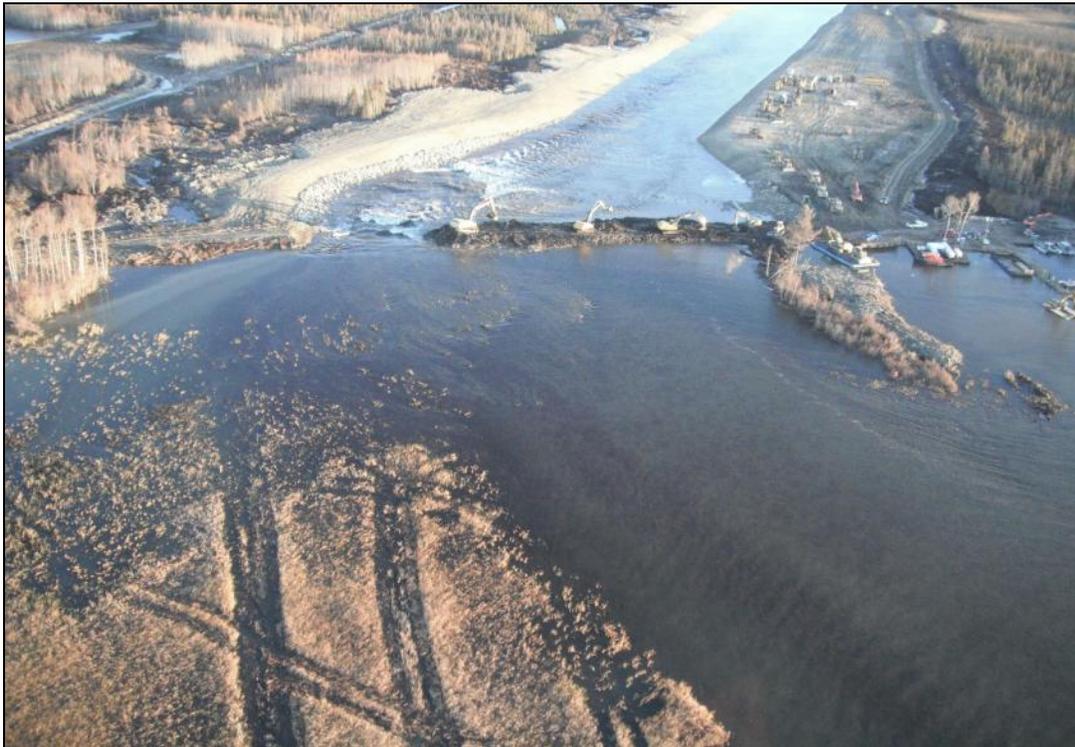
Figure 13 –Channel Opening November 1, 2011

Excavation of the south dike, which separated Lake St. Martin from the channel, was initiated around noon on November 1st using six (6) excavators along the length of the dike. The excavation started from the west end working eastward. The western most excavator cut into the dike and the material was pitched back to the successive excavators behind. Excavation of the dike continued the following day, but was suspended due to an incident where one of the tugs and a barge were swept into the channel by strong cross-channel currents.

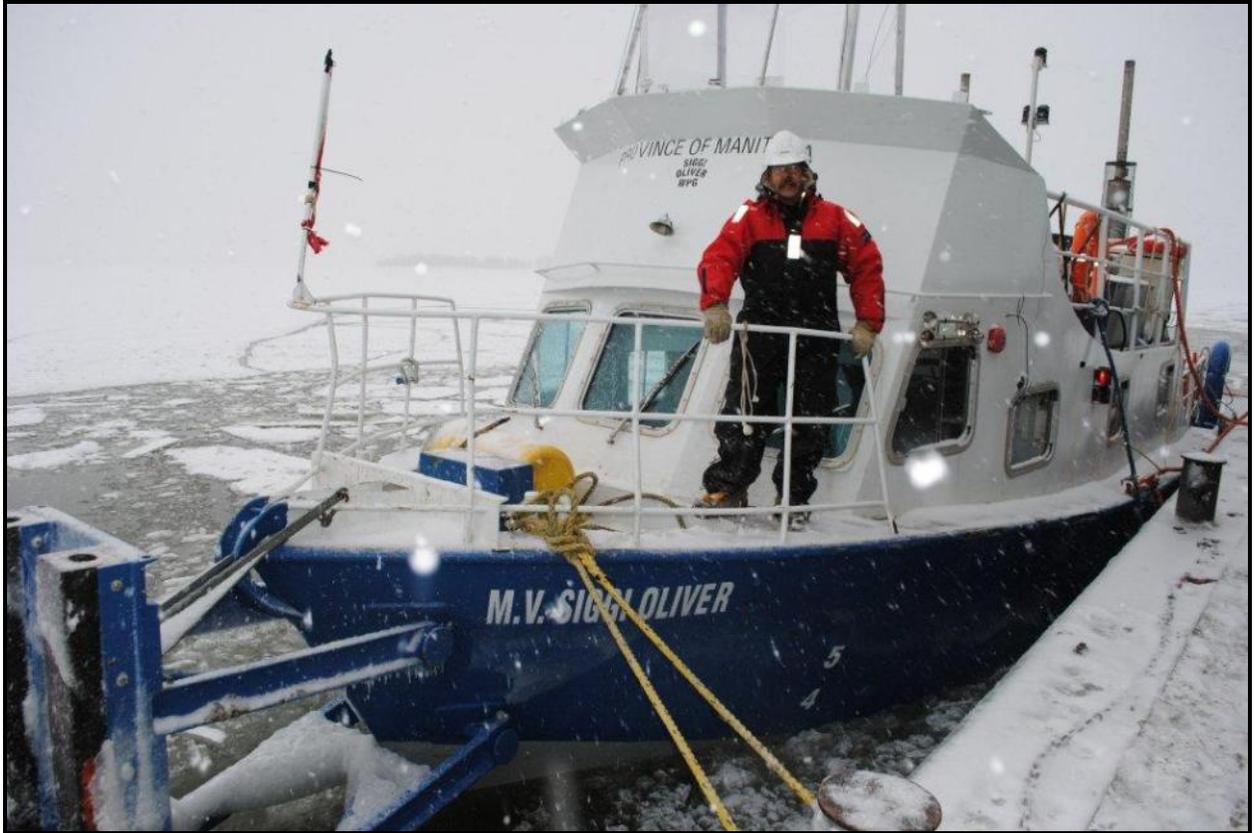
Figure 14 - Final Day of Barge Operations – November 19, 2011

The contract was also silent on demobilization of equipment at the end of the project. It would have been preferable to state exactly what costs would and would not be covered to demobilize under different scenarios. The vast majority of the equipment was removed by barge back to the mainland once it was no longer required. However, a small amount of equipment was still at the site when the lake froze over and halted any further barging. This equipment needed to be walked out once a winter road was in place.
