The Puvirnituk airstrip pilot project; results from the first three monitoring years

Félix Gravel Gaumond ^{1,2}, ing. jr
Guy Doré ^{1,2}, ing. PhD., professor
Chantal Lemieux ^{1,2}, research coordinator ARQULUK
Anick Guimond ³

Paper prepared for presentation

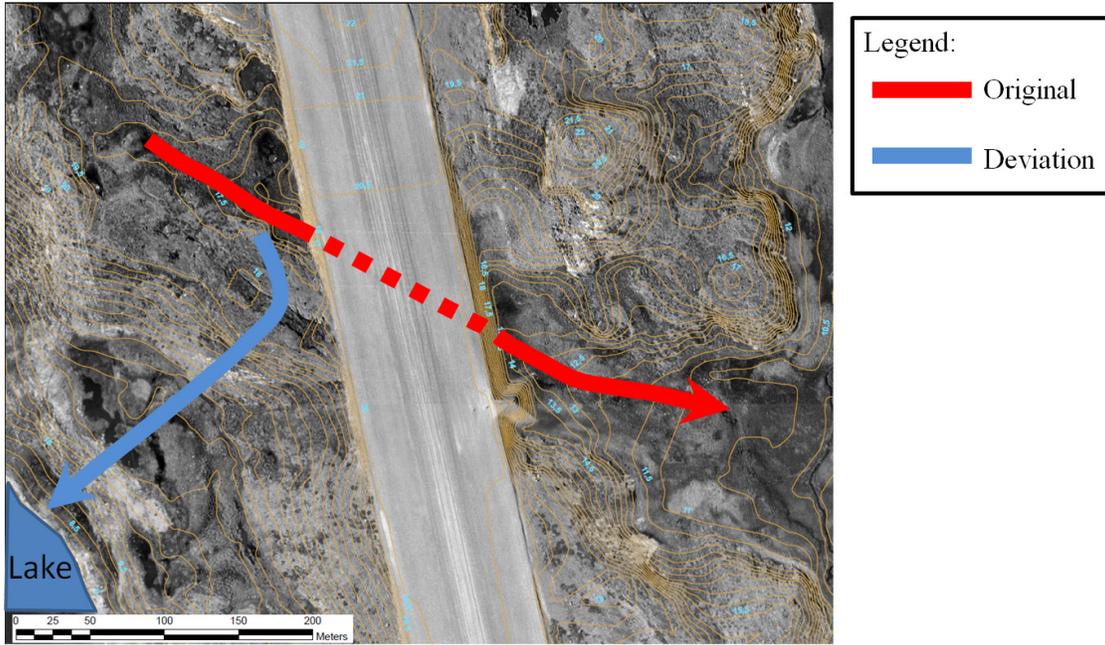
Figure 1: Water source deviation

The Puvirnituk airstrip has been extended and upgraded in order to allow landing of a Boeing 737. In this context, thermal and mechanical stabilization of the embankment was needed. Stabilization measures were taken during the construction work in 2009. These measures include the deviation of the water source upstream (west side of the airstrip) and the construction of convective embankments and berm. The convective embankment allows the extraction of heat and the berm allows the mechanical stabilization. The berm is made with the same convective material as the embankment. It is important to mention that the water source deviation has been completed at the end of summer 2010, see details on Figure 1. Thus, only the second monitoring year takes into account this corrective measure. The time allowed to proceed with the construction work was unfortunately not long enough to allow optimization of the thermal design of the mitigation method. The mitigation method was first study in the context of other research projects (Beaulac, 2006; Voyer, 2009). The convective embankment and berm design constructed on the Puvirnituk airstrip is shown on Figure 2. The ventilation system added to the convective embankment allows open convective movement.

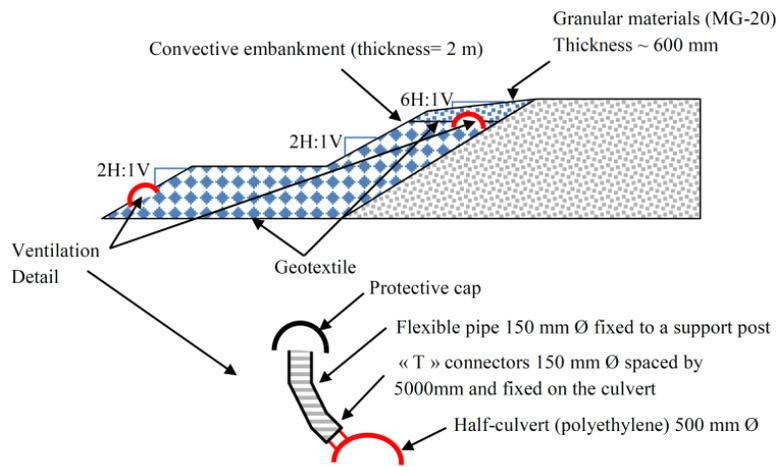
Figure 2: Convective embankment and berm design (modified from Verreault 2010)

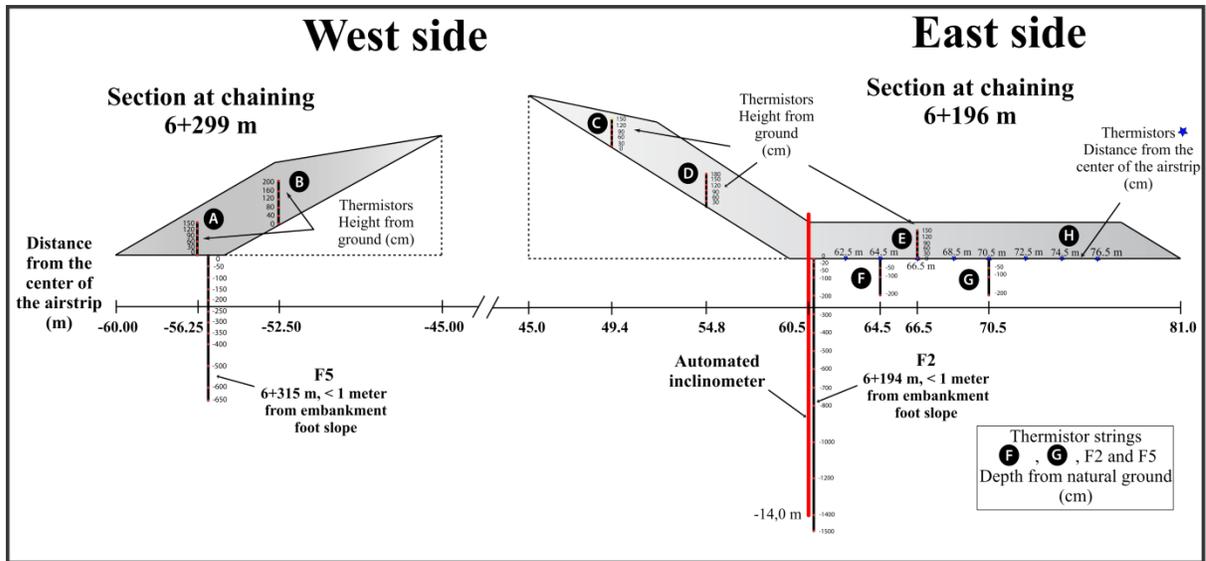
Figure 3: Measuring instruments installed on the west and the east sides of the Puvirnituk airstrip

likely to occur. The inclinometer is composed of 32 segments of 500 mm each, for a total length of 16.0 m. It reached a depth of 14.0 m, and 2.0 m are installed in the convective embankment. Figure 3 shows the location of the instruments placed on the west and the east sides of the Puvirnituk airstrip.

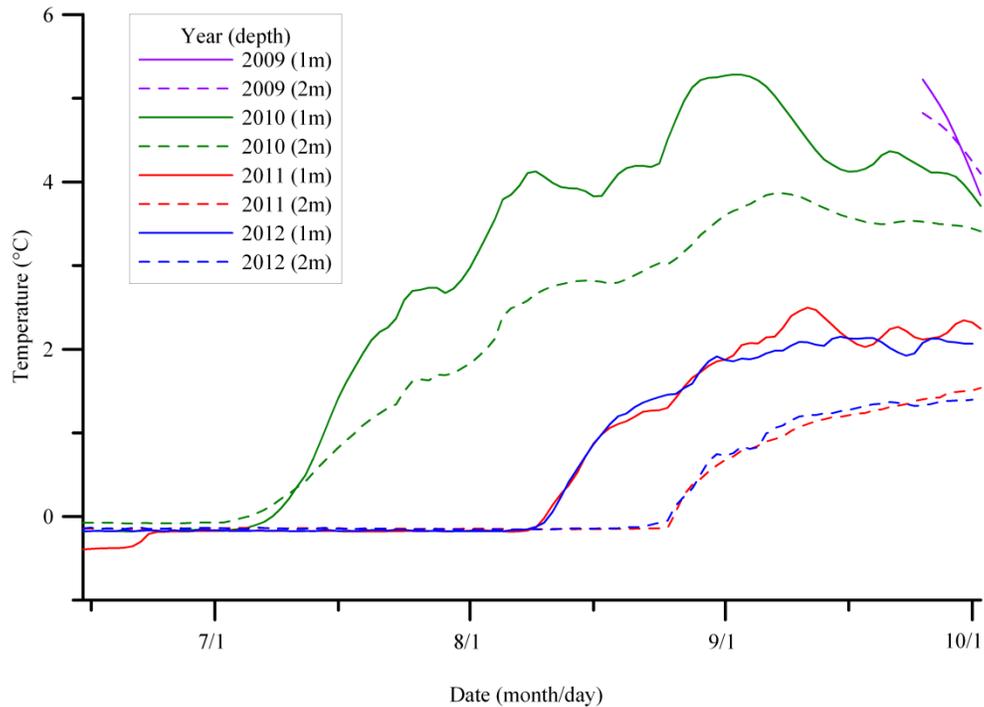
Figure 4 shows the evolution of soil temperature at 1 m and 2 m for the thermistors string F5 (upstream side), between June 15 and October 2 for years 2009 to 2012. Thermistors at 100 cm and 200 cm show significantly different behavior between summers. In summer 2010, ground at 200 cm had reached a temperature above $0\text{ }^{\circ}\text{C}$ three days before the ground at 100 cm, respectively on July 6 and July 9. This behavior is quite different in summer 2011. The ground at 100 cm reaches a temperature above $0\text{ }^{\circ}\text{C}$ on August 11 2011 while the ground at 200 cm temperature reaches this temperature on August 26 2011. There is therefore a time offset of soil warming, which suggests that the heat intake is significantly lower. It is possible to believe that the predominant heat transfer mode between the two summers is different. The difference in maximum temperatures reached during summers 2010 and 2011 also give indications in this regard. The evolution and the maximum temperature reached after the deviation are similar for summers 2011 and 2012. Finally, few values from summer 2009 provide the indication that the maximum temperatures reached at 1 and 2 meters were even higher than those reached in summer 2010.

Figure 4- Evolution of soil temperature at 1 m and 2 m for the thermistors string F5 (upstream side), between June 15 and October 2 for years 2009 to 2012

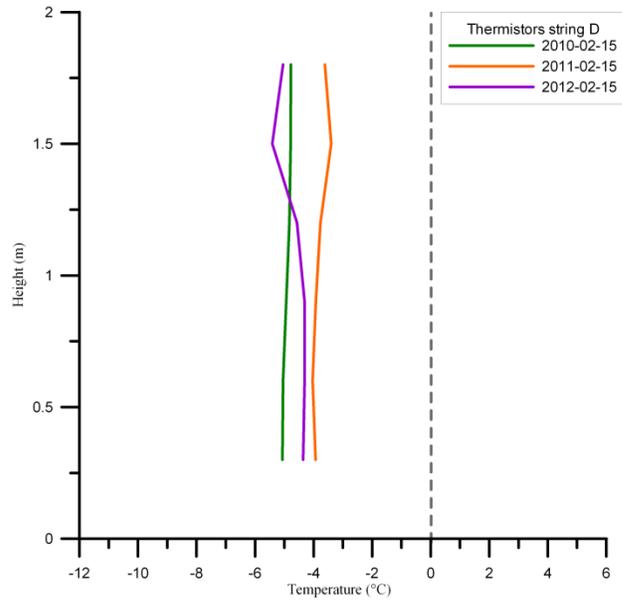
Thermistors string D, the one located at half height of the convective embankment, shows an interesting behavior in winter. In winter, the normal behavior consists in having colder temperatures in the upper part of the embankment and warmer temperatures in the lower part of the embankment. This situation is caused by the fact that the heat extracted from the natural ground warms the bottom of the embankment while the temperature at the top of the embankment is influenced by the air temperature. This situation is observable for the different thermistors strings except for thermistors string D, where the temperature is constant through the entire embankment, see Figure 7. This situation can be explained by convection cells, which make the temperature uniform in the convective embankment.

Figure 7: Temperature profiles for thermistors string D

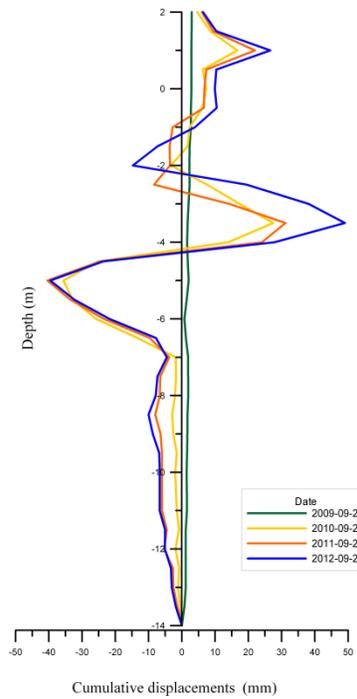
Cumulative displacements as functions of depth are shown in Figure 8 for September 26 2009, September 26 2010, September 25 2011 and September 26 2012. This figure shows that the main movements occur principally at three depths; in the middle of the convective embankment (1.0 m), between 2.5 and 4.0 m depth and between 4.5 and 6.5 m depth. These cumulative displacements are respectively 27 mm, 49 mm and 39 mm. It should be noted that the two movements occurring in the natural ground are in opposite directions.

Figure 8 : Cumulative displacement as functions of depth for September 26 2009, September 26 2010, September 25 2011 and September 26 2012

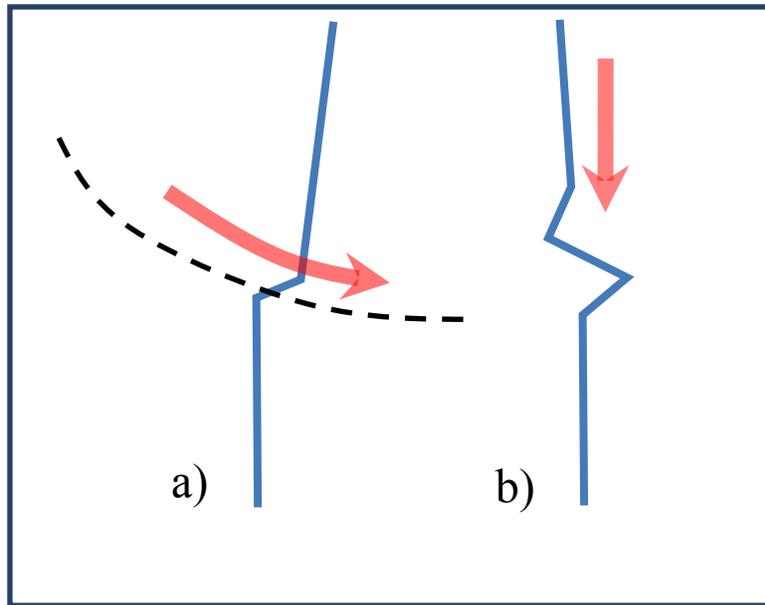
The general trend observed during the three monitoring years is not related to a failure movement of the embankment as schematize by Figure 9 a), but is more likely related to a vertical compression movement as schematize Figure 9 b). Consolidation of the silty-clay layer seems to occur, resulting from the vertical stress induced by the convective embankment construction built over the instrumentation.

Figure 9: a) Related displacement associated with failure movement and b) vertical compression movement

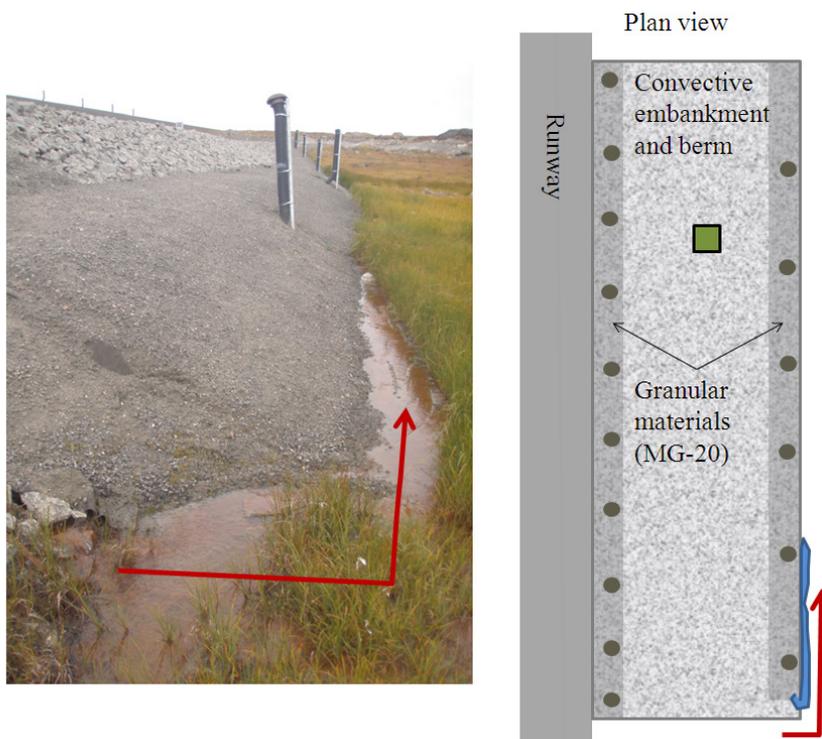
Water seepage has been observed at the south-east end of the convective embankment, at the limit between the granular materials (MG-20) and the convective materials, see Figure 10. This water likely comes from intense precipitations that occurred in the hours before the visit. All the water that has fallen on the convective embankment must have seeped freely to the east end where compacted granular materials cover the ventilation systems. The water then flows to the south end of the embankment and finally returns to the center of the valley.

Figure 10: Water seepage observed at the south-east end of the convective embankment, at the limit between the granular materials (MG-20) and the convective materials

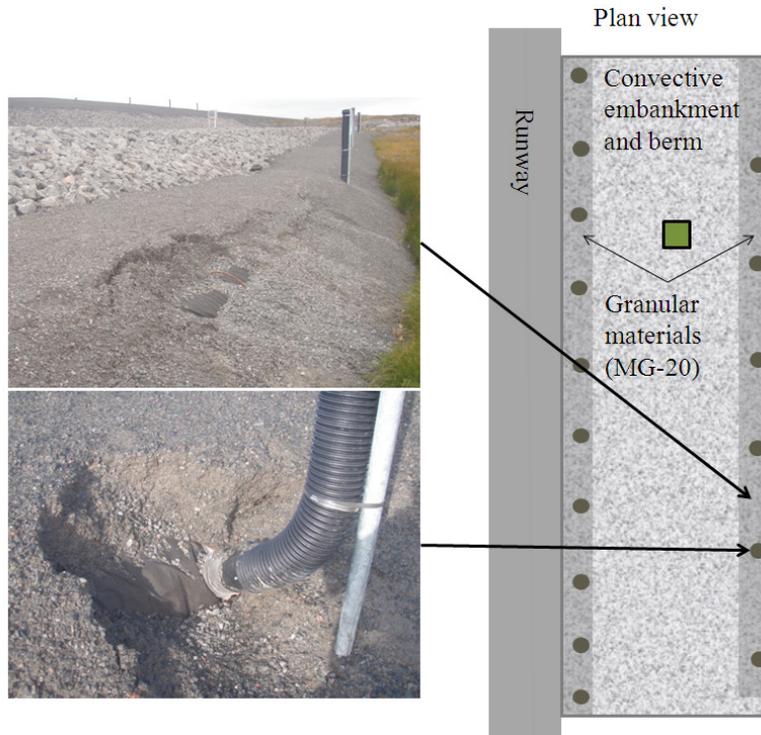
Some deteriorations have been observed three years after the convective embankment construction. Granular materials adjacent to the convective berm slipped and exposed the ventilation system. Figure 11 shows the half culvert from the ventilation system at two different places, either at the base of a ventilation pipe and between two pipes.

Figure 11: Ventilation system exposed at two different places from granular materials slipping

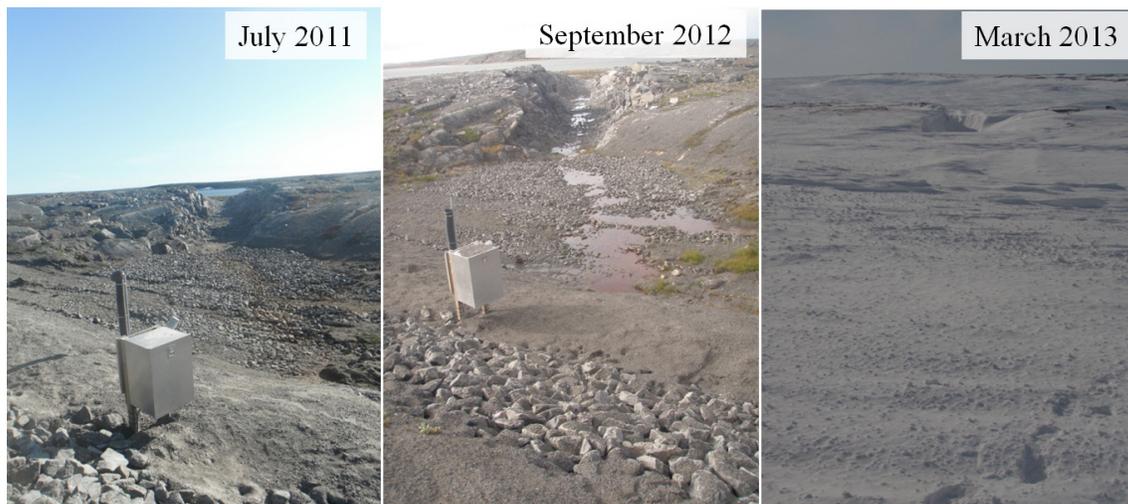
Figure 12 compares the convective embankment on the east side at different times, with a view towards the water deviation channel. It is possible to note that snow covers all ventilation chimneys at the base of the convective embankment are completely covered with snow. The data-acquisition box is also completely covered with snow.

Figure 12: Convective embankment on the east side at different time, with view towards the water deviation channel

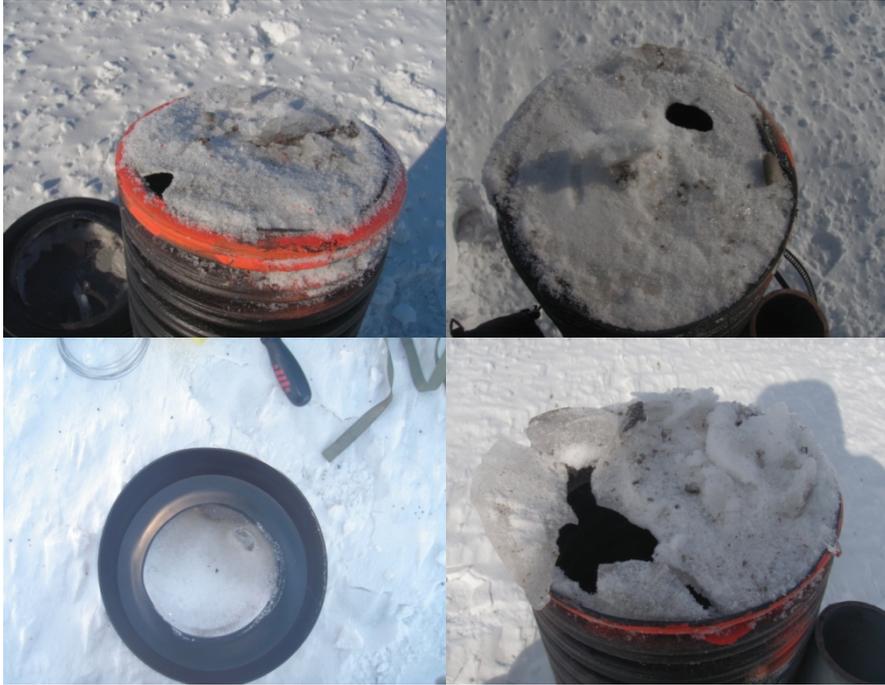
During the March 2013 visit, several ventilation covers were removed to check inside of the ventilation system. Figure 13 shows four cases where chimneys are clogged directly under the cover. This situation has been observed under almost all cover removed. The thickness of the ice covers varies from few millimeters to more than two centimeters. When no ice cover was observed, it is quite possible that it was broken during the ventilation cover removal operation.

Figure 13: Ice covers forming under the ventilation covers

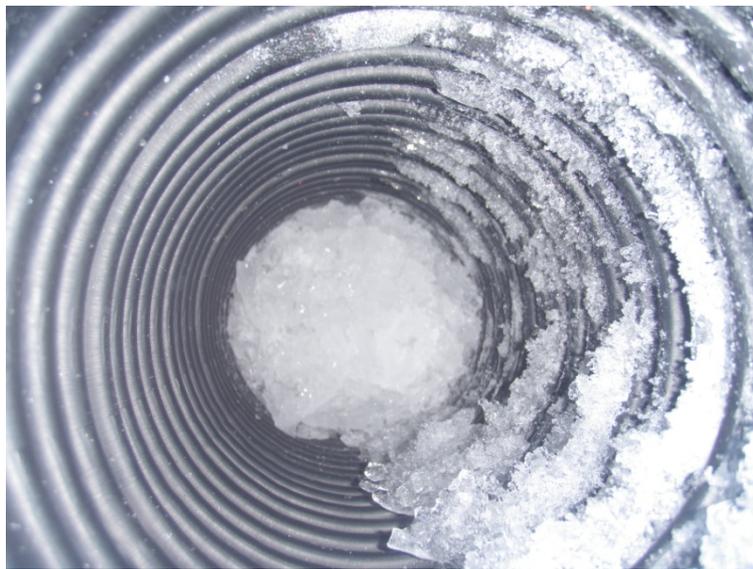
Inside the ventilation chimneys, at a depth corresponding approximately to the snow cover, ice chunks accumulation clogged the chimneys, see Figure 14. These ice chunks accumulations were observed in most ventilation chimneys, including all those located at the top of the convective embankment on the east side. Ice accumulation is also observable on the ventilation chimney walls. Ice chunks details are shown on Figure 15. These ice chunks are likely formed by condensation on chimney walls. These ice chunks falls in the chimneys forming a plug.

Figure 14: Ice chunks accumulation were observed in most ventilation chimneys

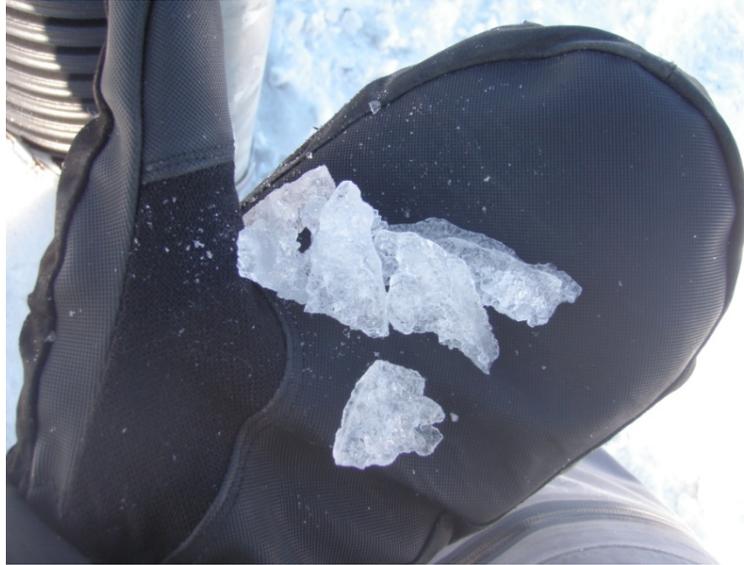
Figure 15: Ice chunks details
