Road Utility Cuts and Repairs – Applying Keyhole Technology

Michael L.J. Maher, Principal, Golder Associates Ltd., Whitby, Ontario

Paper prepared for presentation
at the **Better, Faster, Safer Road Maintenance** Session
of the 2013 Conference of the
Transportation Association of Canada
Winnipeg, Manitoba

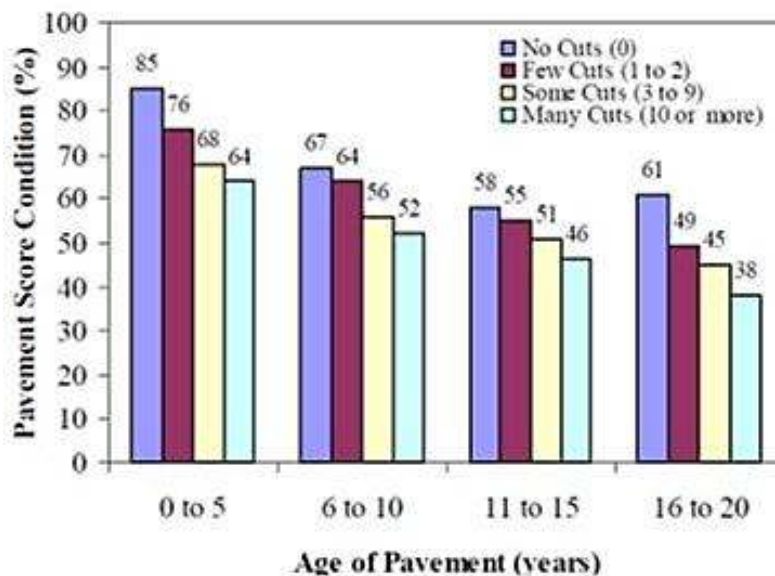
Figure 1 - Utility cut effects on pavement condition [2]

These types of localized pavement distortion can become a traffic hazard, especially for cyclists and requires early maintenance. Frequently, cracks occur around patches thus allowing moisture to infiltrate into a pavement and cause accelerated deterioration. Studies [4] have shown that the effective reduction in pavement life of a repaired utility cut can be up to 50 percent. A study in San Francisco [2] demonstrated that the Pavement Condition Rating (PCR) was reduced from 85 to 64 for pavements less than 5 years old with 10 or more utility cuts (Figure 1).

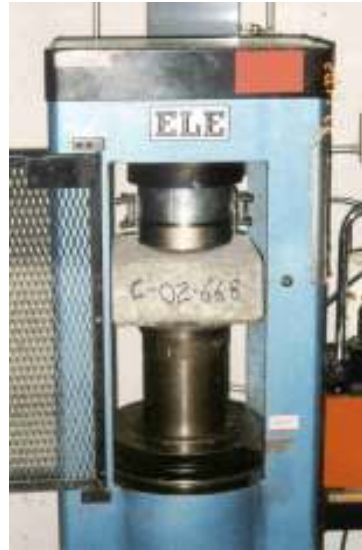
Figure 2 – Test set-up for simulated keyhole testing

Initially, some 15 different commercially available grouts and bonding compounds were evaluated on a preliminary basis. The workability, early strength gain and ease of site mixing were used to shortlist five products for laboratory testing. The bonding compounds were evaluated based on compressive strength at various ages (ASTM C109) and using a specially devised punching shear laboratory test that was designed to simulate to some degree the loading conditions in the field. The test arrangement for this laboratory test is illustrated in Figure 2.

A nominal 100 mm diameter core was cut from concrete slabs 250 mm square by 100 mm thick. The slabs were made from 30 MPa concrete. The cores were bonded back in place using the bonding compound product selected for laboratory testing. The load needed to dislodge the core was measured at various ages. From this study, an epoxy-type bonding compound was initially selected. Based on further discussions with the client, it was decided that this product would be impractical for large-scale use in the field and had some health-related concerns for field crews.

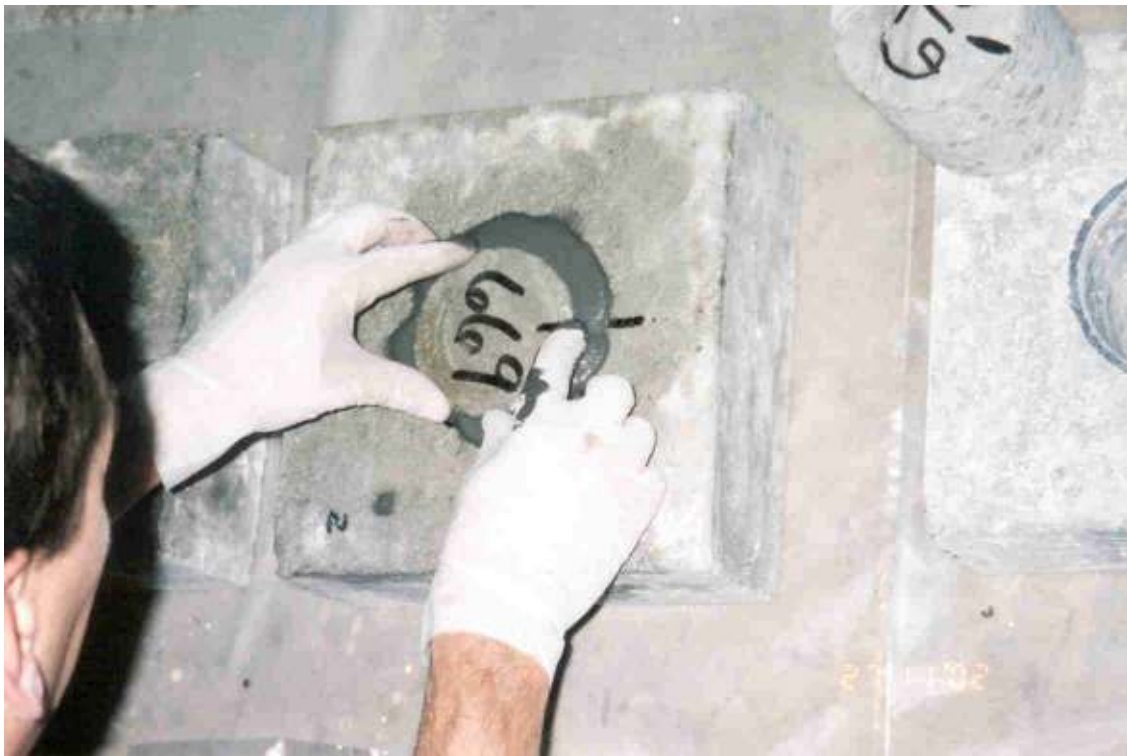
Figure 4 – Core sample being re-instated into slab for push-out testing

As in the previous phases of the laboratory evaluation, the punching shear laboratory tests, or push-out tests, were used to simulate loading conditions in the field. The cores were bonded back in place using the bonding agent being assessed. The test arrangement was designed to determine the load needed to fail the shear bond at the core/core hole interface and dislodge the core. The failure load was recorded over a range of curing times from 1.5 to 48 hours. In many instances, especially at higher failure loads, the concrete test slabs cracked as the core was punched through, indicating that the bond was stronger than the overall concrete substrate.

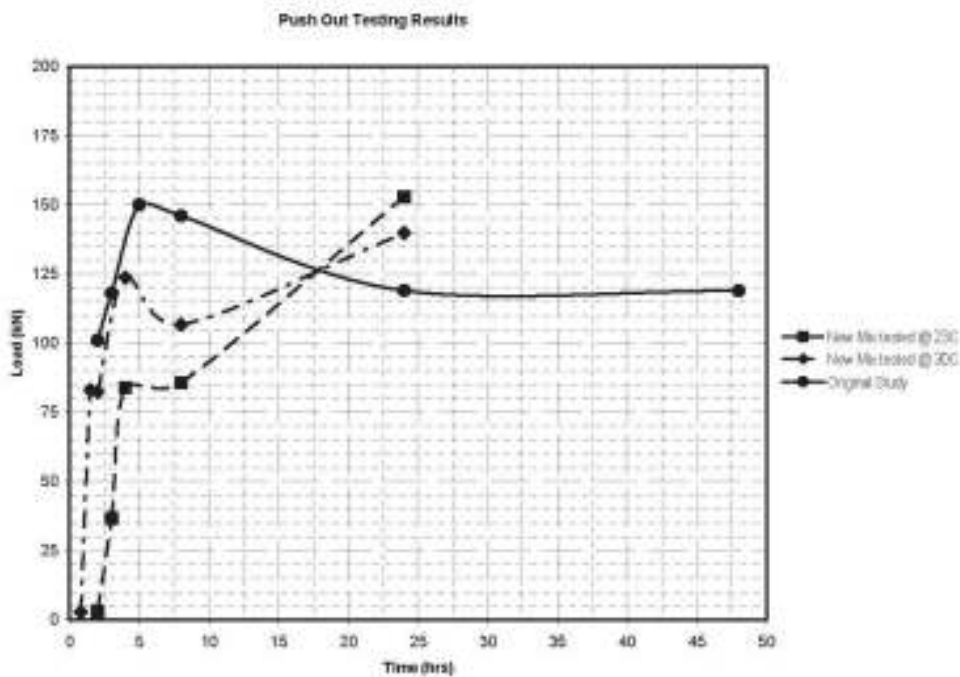
Figure 5 – Results of push-out testing

The failure loads for the Phase 3 testing are shown in Figure 5 and indicates that the Utilibond product reached the necessary load capacity to support traffic within one to two hours depending on temperature. It is interesting to note that the load decreases in the short term which is attributed to the initial high heat of hydration which puts the Utilibond annulus in compression resulting in higher support capacity. It should also be noted that in some instances, when the failure load exceeded 100 kN, the substrate slab fractured before the bond sheared and thus the results plotted do not represent the failure load of the bond, in those instances.

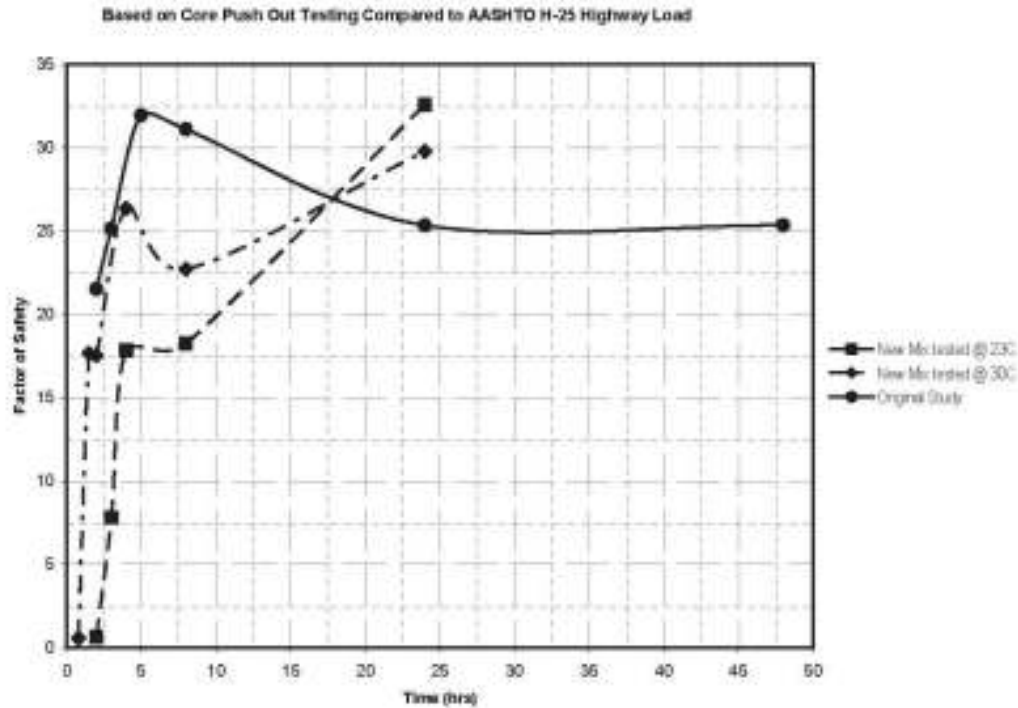
Figure 6 – Factor of Safety vs. AASHTO H-25 Loading

For the purposes of comparison, the loads have been normalized by dividing them by the calculated critical load to determine a factor of safety. The Utilibond achieved a factor of safety of five within 2.5 hours at 23°C and 15 within five hours (Figure 6).

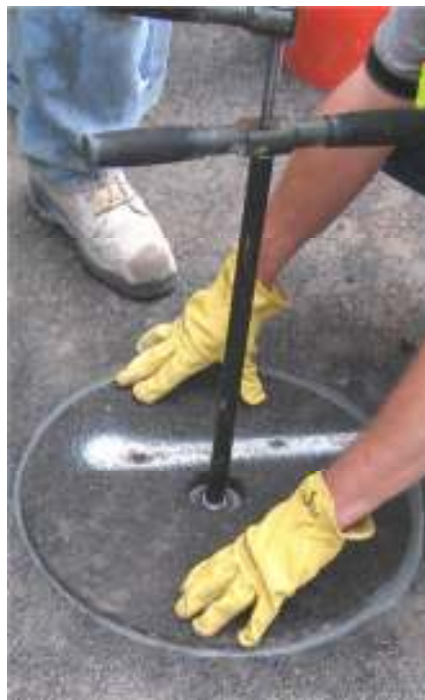
Figure 7 – Final seating of the keyhole core into the pavement

The cold patch was removed from the hole and the sides of the core hole and the pavement core were washed with pressurised water. The core comprised about 100 mm of asphalt overlying about 200 mm of concrete. Material from the bottom of the core hole was removed to a depth of about 325 mm from the pavement surface and all loose soil and ponded water vacuumed from the hole. A layer of pea gravel about 30 mm in thickness was placed at the bottom of the core hole. The composite (concrete and asphalt) pavement core was lifted with the hoist and placed in the core hole on top of the pea gravel. With the hoist still carrying the weight of the core, the core was gently rotated back and forth to seat it well and lightly compact the pea gravel. As the level of the core was beneath that of the pavement surface, the core was lifted and additional pea gravel was added to the bottom of the hole. The seating operation was repeated until the top surface of the core was flush with the surrounding asphalt pavement surface. The formed steel spacers were wedged into the annular space at four locations around the perimeter to maintain a more or less even clearance of 12 to 15 mm between the core and the walls of the core hole. At the completion of the seating operation, the plug lifter was disengaged from the core and the hoist moved away from the repair area.

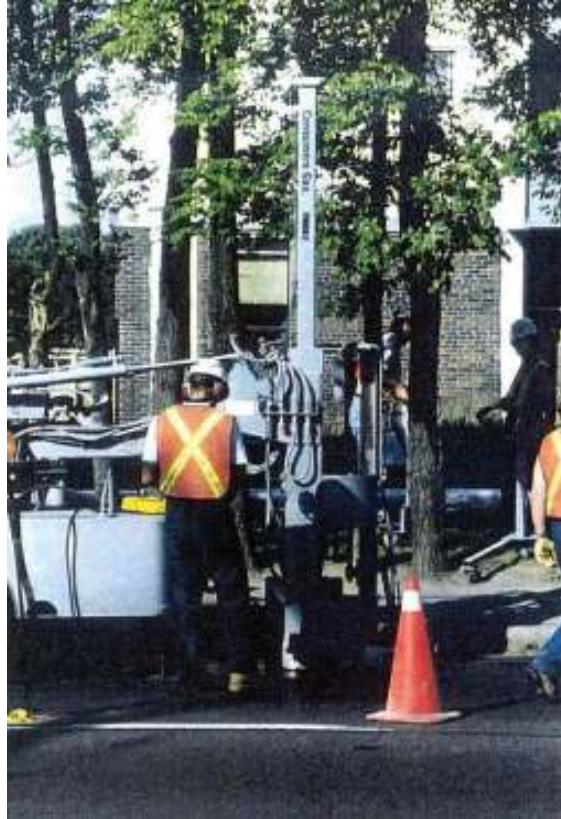
Figure 8 - View of coring rig at 720 Kennedy Road in 1995

One of those bus route locations was at 720 Kennedy Road where an excavation, repair and core reinstatement was undertaken in August 1995. Kennedy Road (Figure 8) is a major arterial road in the City with four lanes of traffic and an AADT in excess of 10,000 vehicles in each direction. It is also a major bus route for the TTC with an average of 380 southbound bus trips per week.

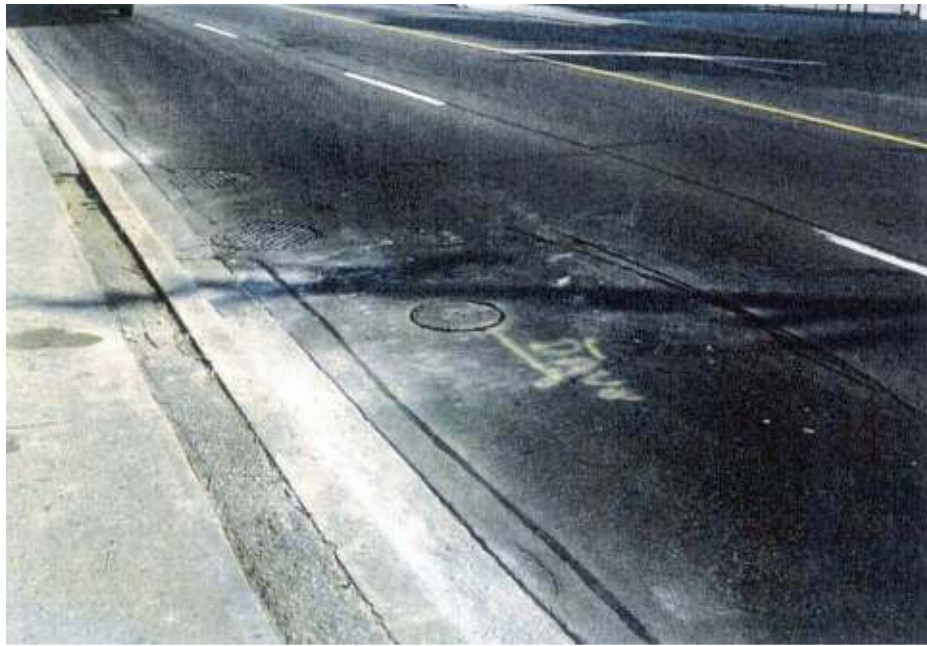
Figure 10 – View of reinstatement two weeks after installation

Two weeks after the reinstatement, the site was revisited and the core restoration inspected. Figure 10 and Figure 11 show the appearance of the core after sustaining two weeks of traffic comprising approximately 70,000 vehicles, including 760 bus passes.

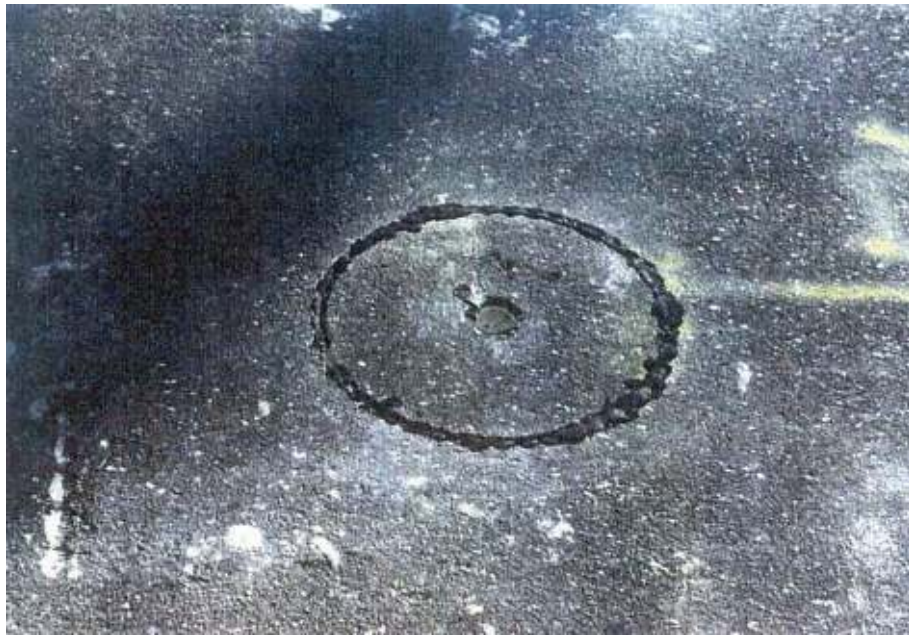
Figure 11 – Close-up view of reinstatement two weeks after installation

Figure 11 also confirms an excellent continuous bond within the asphalt surface layer. Crack sealing compound had been used around the surface joint. What was also encouraging was the complete infilling of the voids in the pea gravel bedding showing complete contact between the base of the core and the supporting stabilized pea gravel.

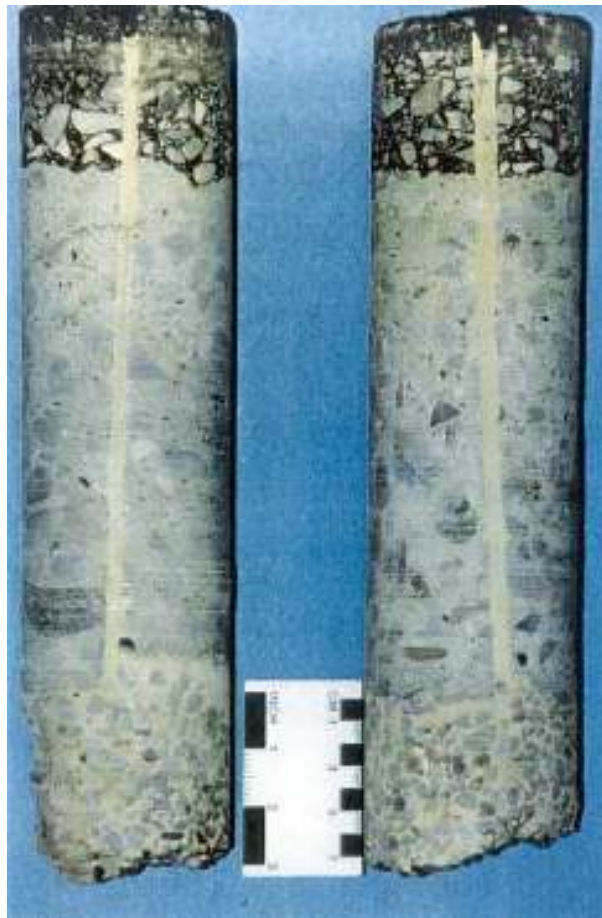
Figure 12 – View of satellite cores taken one month after installation

In September 1995, about one month after the reinstatement, the site was again revisited and two vertical satellite core samples were taken through the repaired joint from opposite sides of the 450 mm diameter core. The photograph of the cores (Figure 12) shows the light grey line representing the bonding agent.

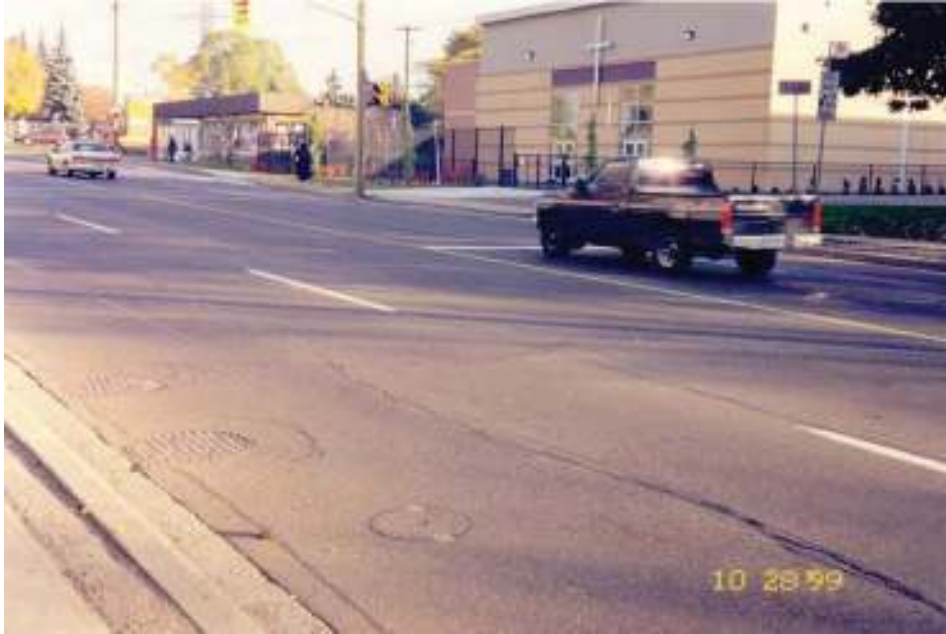
Figure 13 – Kennedy Road four years after reinstatement

Four years later in October 1999, the photographs shown on Figure 13 and Figure 14 were taken and confirmed no displacement of the reinstated core and no associated degradation of the pavement surface.

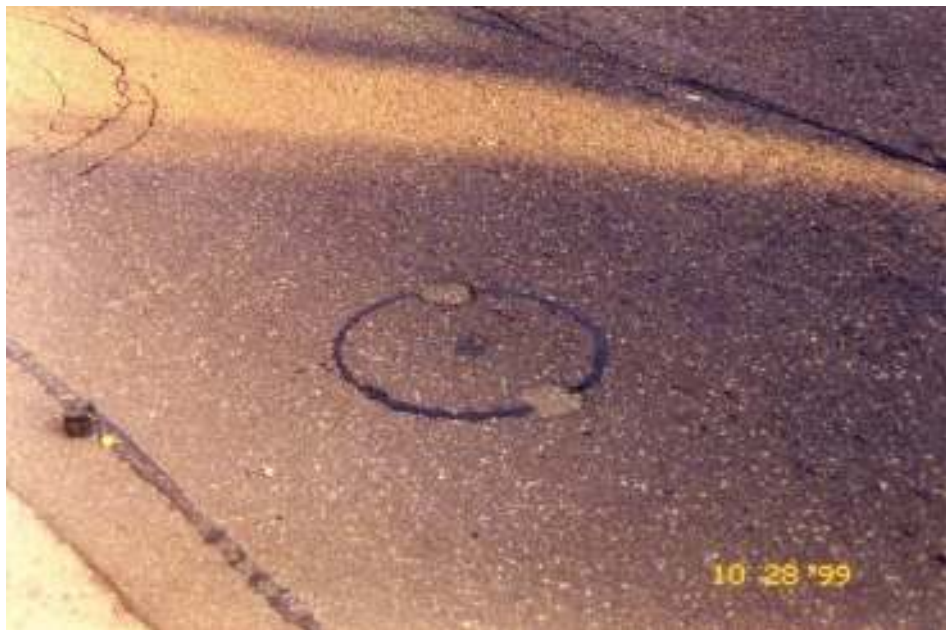
Figure 14 – Close-up view of core on Kennedy Road four years after reinstatement

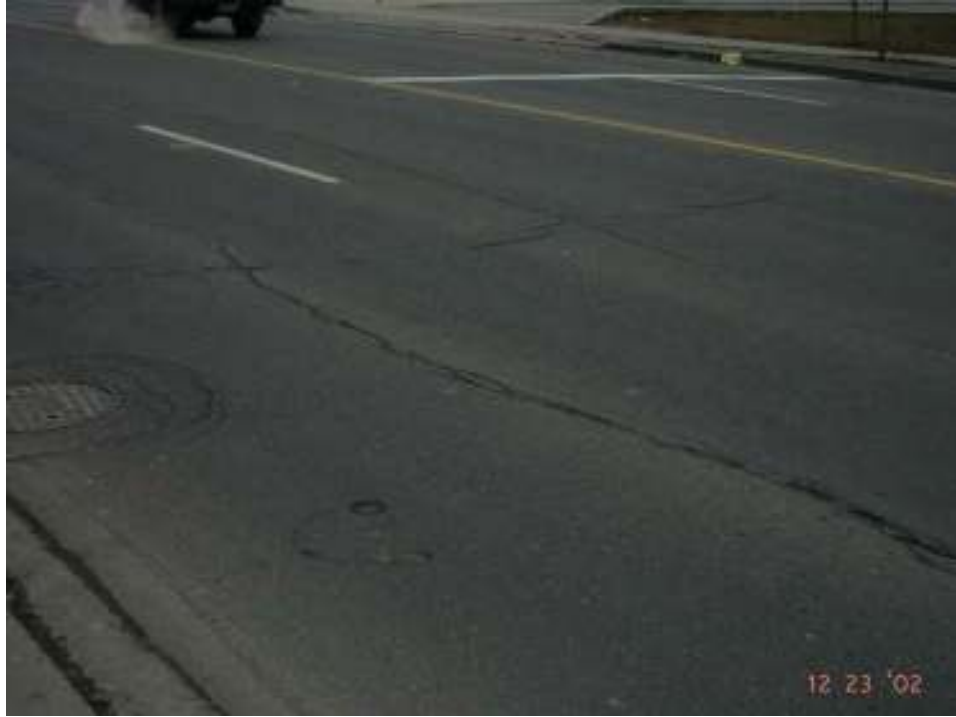
Figure 15 – Kennedy Road Keyhole Core, over seven years after reinstatement (Dec. 2002)

The core reinstatement was again inspected in December 2002, some seven years and four months after the reinstatement.

By December 2002, it was estimated that the reinstated keyhole core had withstood more than 145,000 transit buses and more than 13 million commercial and other vehicle passes.

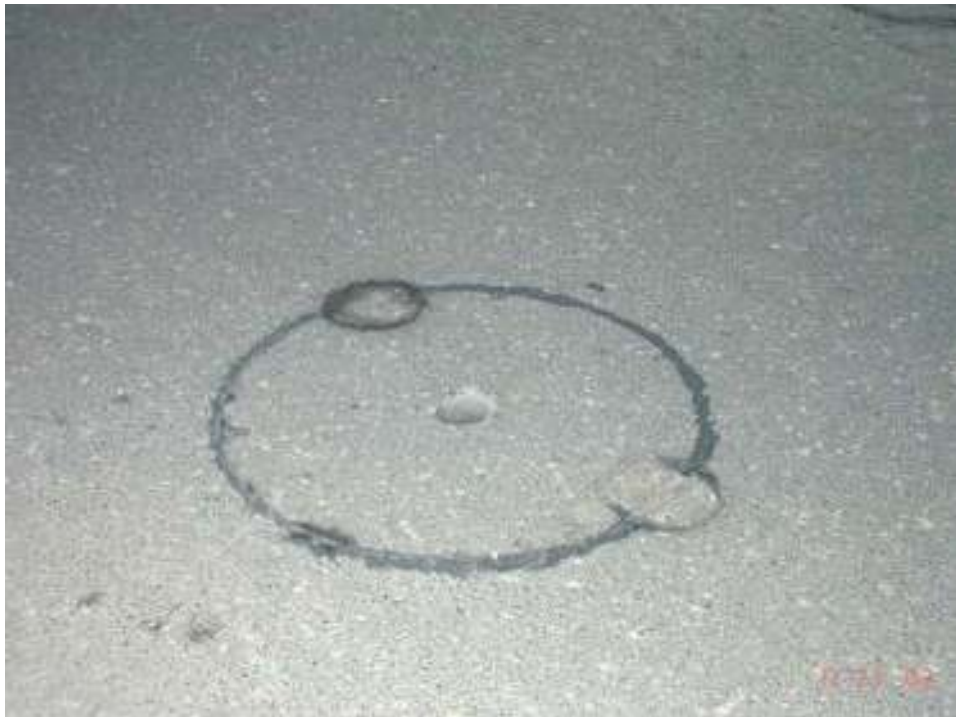
Figure 16 – Close-up view of Kennedy Road test core (Dec. 2002)
