# Why Concrete Intersections Make Good Sense.

## *Mississauga's Courtney Park and Kennedy Rd. Intersection Case Study*

| Paper prepared for presentation at the Urban Pavements – Better, Safer, Faster Session of the 2013 Conference of the Transportation Association of Canada; Winnipeg, Manitoba

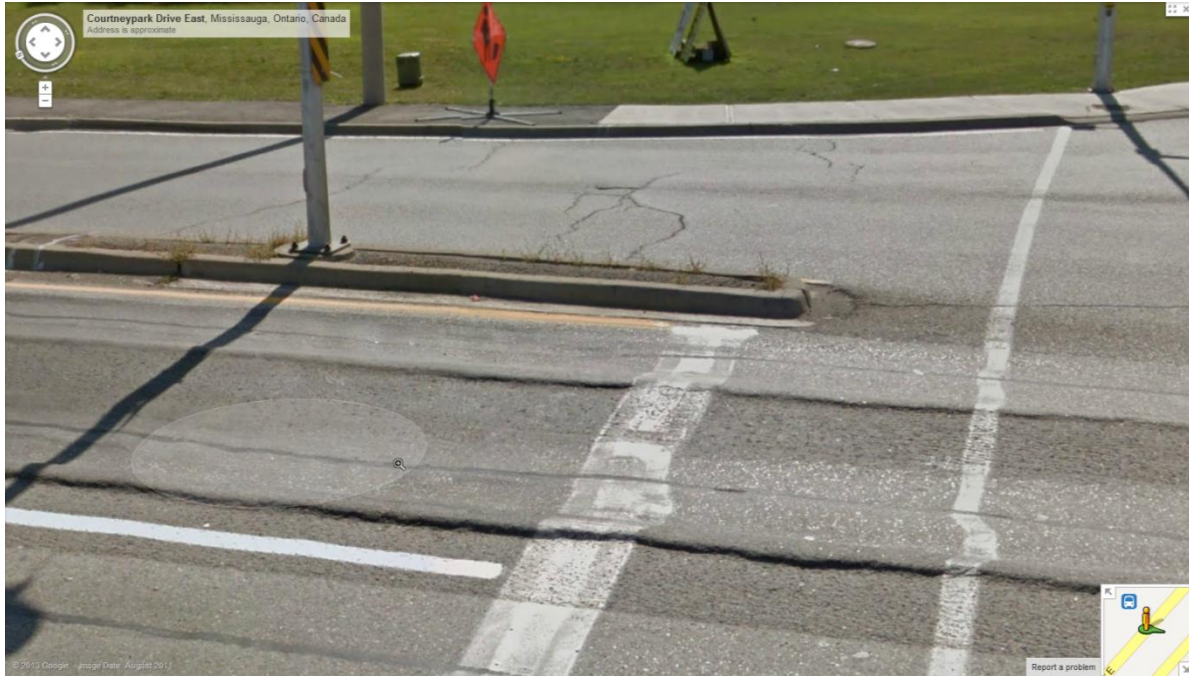
Picture 1: Intersection in August 2011. Source:<http://maps.google.ca>

Based on picture evidence, part of the lane was rout, sealed and overlaid between August 2011 and August 2012. These repairs are not in the database and there are no estimates accounting for them.

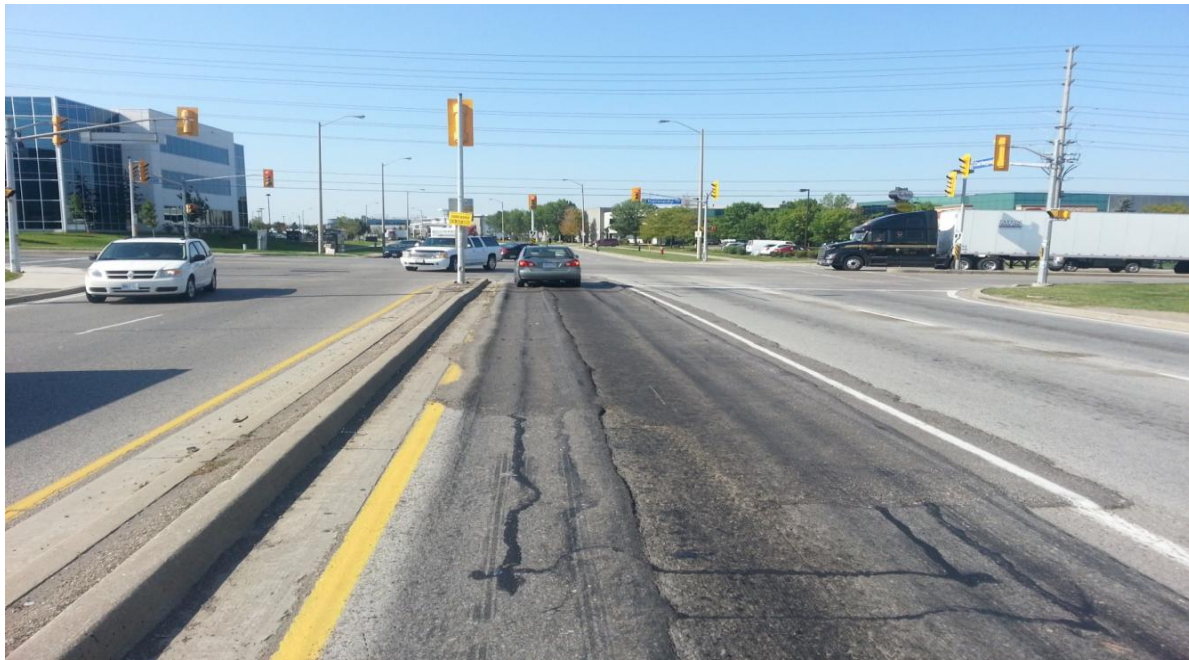
In late August of 2012, during a routine inspection of the Courtney Park Drive and Kennedy Road intersection in Mississauga, the city inspector noted severe rutting in the westbound left turn lane. Rutting depths of up to 100 mm were measured in the lane. The other lanes in the intersection only showed minor rutting, and the city decided to fix them with asphalt using conventional “shave and pave” techniques.

Picture 2: Intersection in August 2012 prior to repair. Source: RMCAO

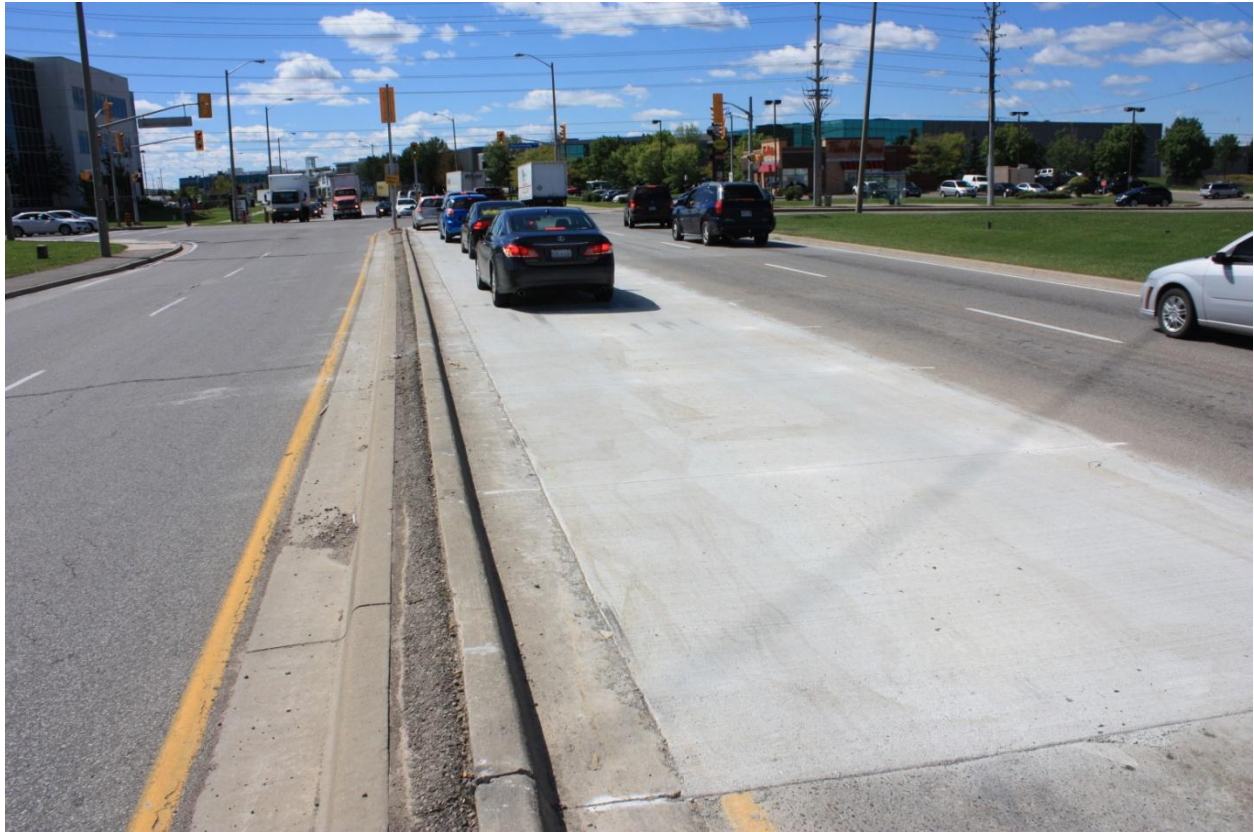
Picture 3: Completed Project September 2012. Source: RMCAO

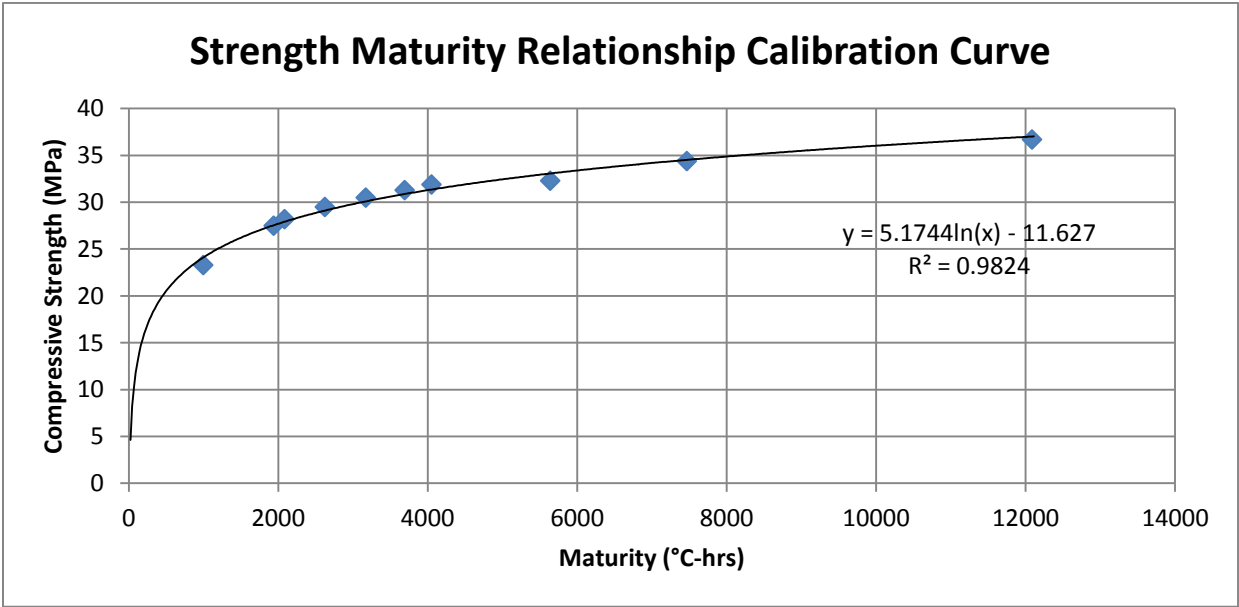
Figure 2: Maturity Calibration curve for 35 MPa High Early Strength Concrete

The City requirement for opening the road to traffic is 72 hours with no provision for minimum concrete strength. Based on concrete compressive strength the lane can be opened much sooner. The concrete cylinders cast were to be broken at 3, 7 and 28 Days. At the recommendation of the Ready Mixed Concrete Association of Ontario, maturity testing was also carried out. While the mix was not calibrated prior to use, the results could be used for future work (Figure 2). At 24 hours, the mix reached 23 MPa and at 10 days, it reached the required strength of 32 MPa for durability. Based on the maturity probes in the pavement, 15 MPa was reached in less than 8 hours and 20 MPa was reached in 13 hours. Typically, the Ministry of Transportation of Ontario specifies 20 MPa for the fast track concrete prior to opening lanes on Highway 401 through Toronto.

The amount of fatigue and erosion damage can be calculated based on the maturity testing, using the strength data. This showed that if the lane was opened to traffic upon achieving 15 MPa, the damage to the pavement until 35 MPa was attained would be less than 1% for both fatigue and erosion (Table 2), with total damage at 25 years being 2.9% for fatigue and 22.0% for erosion.

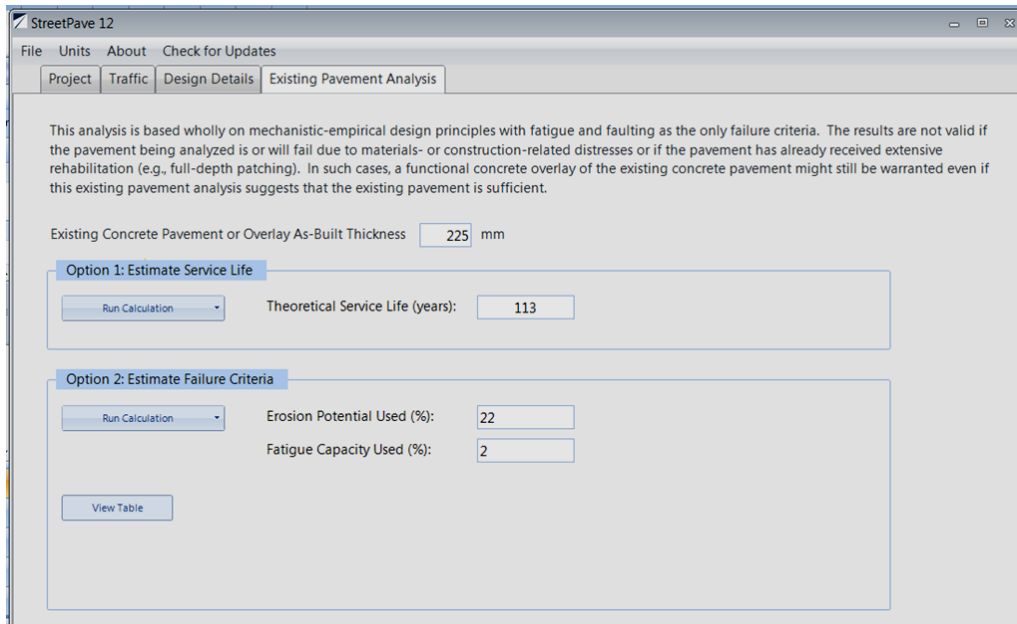
Figure 3 – Fatigue/Erosion for 35 MPa using StreetPave 12 Software from American Concrete Pavement Association

Concrete Pavement Association, the yearly fatigue damage was calculated using compressive strengths ranging from 15 MPa to 32 MPa (Table 1, Figures 3-8).
