Highway 99 Shoulder Bus Lane at BNR Overhead:  
Complex Fast-Tracked Bridge Widening and Seismic Retrofit  
to Provide Streamlined and Sustainable Commuter Option

Caroline Ngan, P.Eng. Project Engineer, MMM Group  
Henry Leung, P.Eng. Senior Project Manager, MMM Group  
Jan Kocaba, P.Eng. Senior Project Manager, MMM Group  
Jianping Jiang, P.Eng. Vice President, MMM Group

Paper prepared for presentation  
at the Technical Paper Session  
of the 2013 Conference of the  
Transportation Association of Canada  
Winnipeg, Manitoba

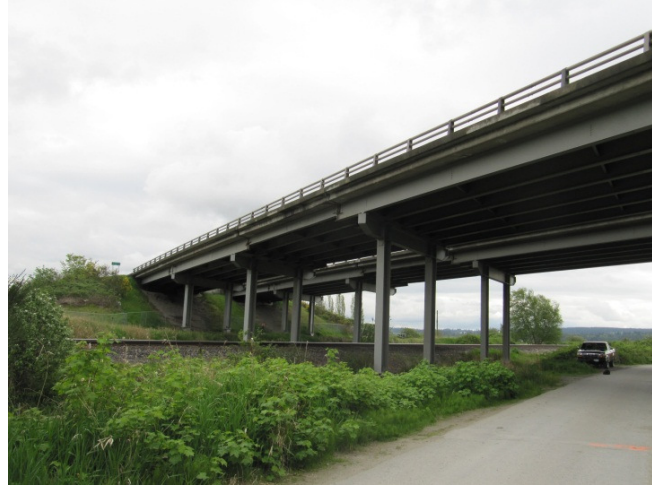
Figure 2 – Existing Bridge Structure

Two parallel, independent structures cross a single railway track at this location, one carrying two lanes for northbound traffic and one carrying two lanes for southbound traffic along Highway 99. The twin bridges are typically about 4 m apart and have a skew angle of about 35°. This project deals with the northbound bridge only. Figure 2 shows a general view of the existing bridges looking northeast.

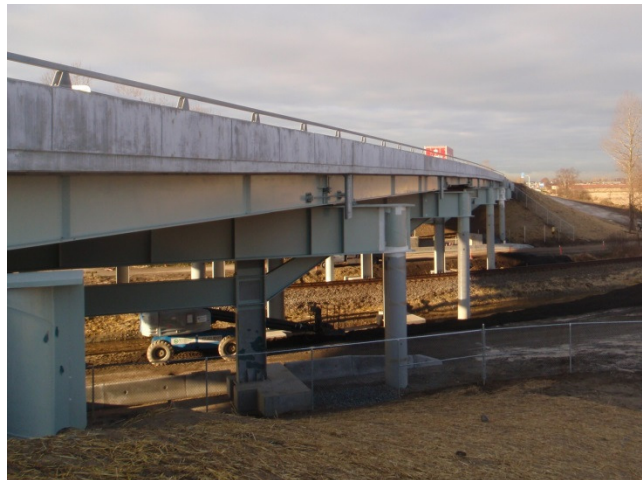
Figure 6 – Photo of the "Catcher" frame system

embankments by earthquakes, a temporary repair or partial re-build will likely be required to provide access for emergency vehicles. Figure 6 is a photo of the completed "catcher" frame system.

The proposed “catcher” beam system was designed to prevent the collapse by providing completely independent supports (“catchers”) to the bridge superstructure in the event that the load bearing capacity of the existing timber piles augmented by new helical piles is lost due to liquefaction of the soil strata underlying the bridge site. The “catcher” beam system uses larger diameter ductile steel pipe piles driven beyond the liquefiable layers to the competent soil strata to form the primary vertical supporting members of the “catcher” frame and a pre-fabricated steel girder under slung below the existing bridge superstructure and structurally connected to the steel pipe piles to become the required “catcher” beam. A nominal gap of 100 mm was provided between the top of the “catcher” beam and the underside of the bridge superstructure such that under normal service conditions, the “catcher” frames have no contact with the superstructure. The “catcher” frames will only be engaged when the superstructure has lost its original supports caused by the design earthquake. Once in contact, the bridge superstructure will be carried by the stiff “catcher” frames, thus preventing the collapse of the structure.

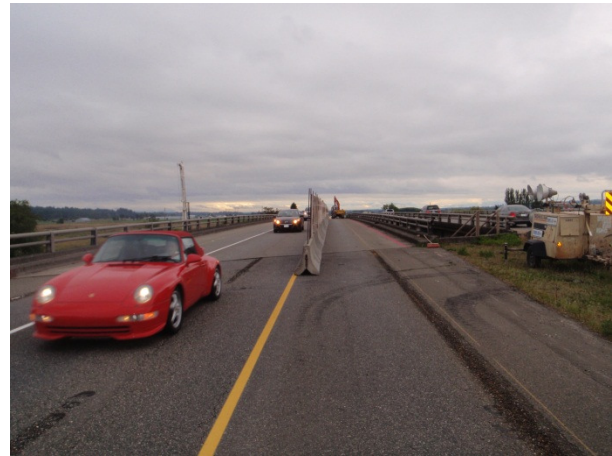
Figure 8 – Traffic Management During Construction

A detailed traffic management plan was developed, and, together with well-staged construction sequences, the widening and seismic retrofit work was accomplished while maintaining an uninterrupted flow of traffic. A two-stage construction approach was used for the widening: with one side of the bridge being worked on behind temporary concrete barriers while maintaining two lanes of traffic with a reduced lane width on the other side of the barriers (see Figure 8). The staged construction was also used for the widening work on the piers and abutments.

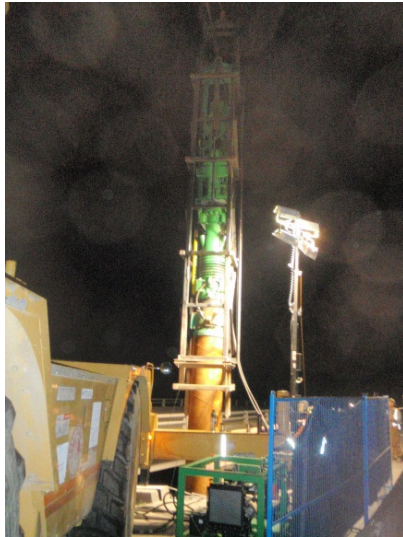
Figure 9 – Pile Driving at Night

**PILE DRIVING:** The “catcher” frames, which are constructed to prevent collapse of the structure under a major earthquake, consist of steel pipe piles and pre-fabricated steel beams. The steel pipe piles are typically located along edges of the deck, and the traditional pile driving method by Diesel hammer was used. However, the access area was limited by the close proximity of the adjacent southbound structure and pile driving was prohibited from the bridge deck. The solution was to install the piles immediately after the demolition of the overhang of the existing deck but prior to the construction of the new widened deck and the new bridge barriers. It was a significant challenge for the Contractor to move the pile driving equipment in position and to drive piles between the northbound and southbound bridges and to keep the operation outside the railway clearance envelope. Figure 9 is a photo showing the pile driving during night time.

Each pile had to be driven in relatively short sections and spliced. This generally suited well to the construction shifts that the pile driving was done during short night time closure window available and splicing the piles done during long day time shift.

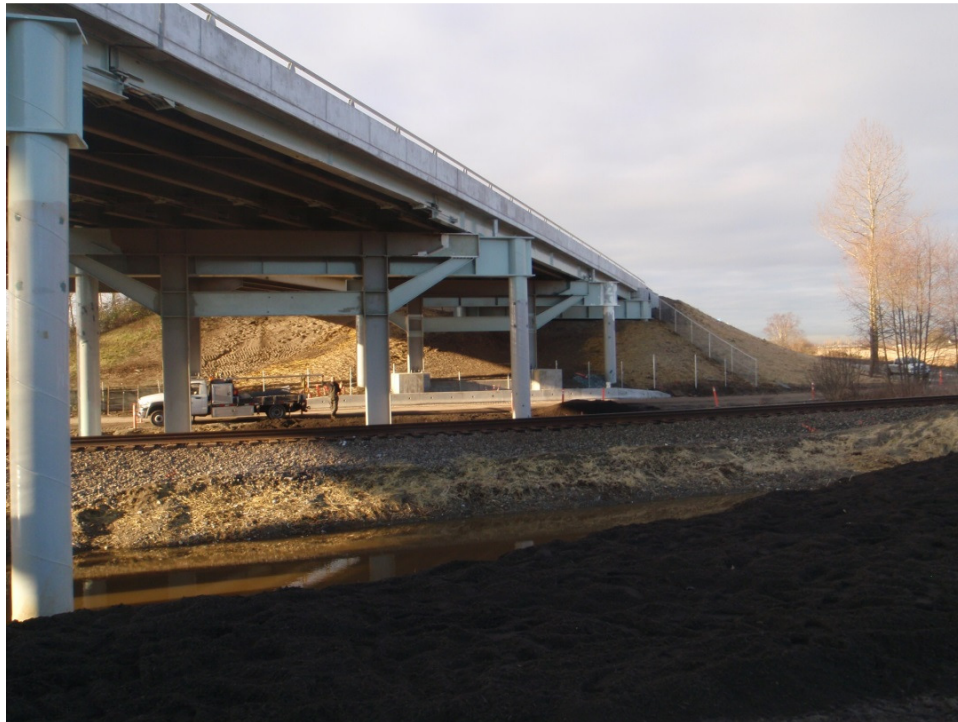
**Figure 11 – Retrofit of Existing Pier Support**

**WIDENING OF THE EXISTING STEEL PIERS:** The widening of the bridge superstructure required widening of the existing piers to support one additional steel girder along each side of the bridge deck. The widening scheme adopted an outrigger strut supporting the lengthened cantilever of the top beam and a spreader beam between vertical legs of the pier frame where the outrigger struts framed into. Figure 11 shows the completed steel pier widening.

Although the structural solution described above is easy to understand and relatively simple to design, the construction proved to be quite challenging. The initial field fit-up, in particular, required more time than expected and the field welding also experienced some difficulties and caused time loss. However, these construction problems were resolved in time to proceed with the widening of the bridge superstructure and the completed pier widening blend well with the existing structural system of this 50-year-old bridge.
