# **Lessons Learned: Terry Fox Drive Wildlife Guide System intended to reduce road kills and aid the conservation of Blanding's Turtle (*Emydoidea blandingii*).**

Proceedings, Transportation Association of Canada, September 2014.

**Shawn R. Taylor<sup>1</sup>, Nicholas Stow<sup>2</sup>, Caleb Hasler<sup>3</sup>, Kevin Robinson<sup>3</sup>.**

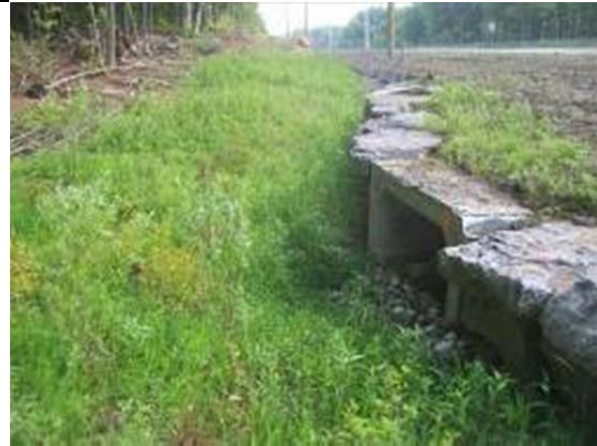
**Plate 1. Box culvert with armour stone guide walls on each side. With 30 cm of substrates covering the bottom, the opening is 60 cm tall X 120 cm wide. The 25 cm overhanging lip is meant to stop animals from scaling the walls.**

Beneath the 5.8 km new section of Terry Fox Drive, four terrestrial (TCV) culverts (Plate 1) were installed along with six hydraulic culverts (CV) carrying watercourses (Figure 1). Concrete box culverts, each 0.9 m tall X 1.8 m wide X 52 m long were installed with the invert at grade. Nine of ten culverts were fitted with three, equally spaced modified catch basins, to provide 'skylights' every 13 m, and reduce the tunnel effects common with small box culverts (Brudin *et al*, 2003; Clavenger and Waltho, 2000). The other was an arch culvert that did not require skylights as it provided a larger opening at either end and retained water throughout the year. Bottom substrates were added to all culverts: cobblestone in the hydraulic culverts, ¾" clear gravel in two of the terrestrial culverts, and organic soil and logs in the other

two terrestrial culverts. To assist with directing animals into the culverts, 907 m of armour stone guide walls flank the culverts through the wetlands and bottomlands (Plate 1), averaging 45 m per side. A gap between the fencing and treeline is intentional, and meant to be maintained free of woody vegetation while shrubs planted at each open end, are meant to provide cover for moving animals and attract them to the openings.

The guide walls on this project were specified as armour stone blocks, with an 800 mm exposed face height. The 600 mm wide and 200 mm thick cap stones provide a 250 mm overhanging lip. The gneiss blocks were very rough and did not fit tightly together with gap tolerances of 5 mm as specified. Filter fabric was used behind the blocks, to line the excavation and resist movement of fines out of the gravity structure. Flexible drainage pipe (100 mm Big-O) installed behind the walls minimizes lateral water pressure and ice expansion. Crushed gravel (Granular B) was backfilled behind the walls to assist drainage and enhance bedding of the armour stone. Similar guide wall systems elsewhere have used tightly fitting armour stone, formed concrete blocks, steel piling and poured concrete. In this location, several walls would need to be built through the wetlands, so stability, constructability and frost heave was a concern as well as cost; however, there are early signs that the walls may not be as sustainable as desired. Theft seems to be an issue, as new homeowners take the rock for their property landscape.

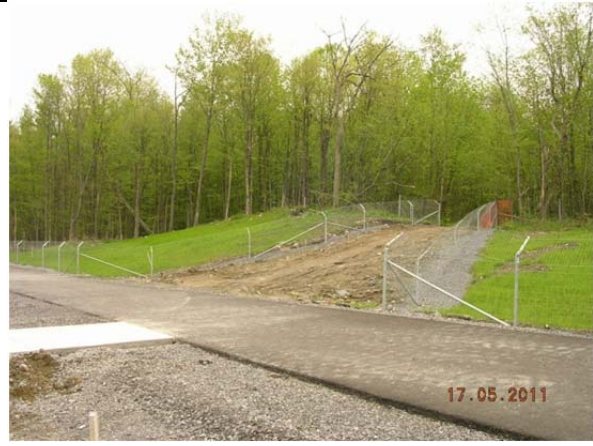
**Plate 2. Terminal ends of the fencing at a bike trail opening were wrapped backwards to avoid escapes. Top panels were angled back 45° as some turtles can scale fences using their beak and claws.**

In addition to the armour stone walls, galvanized, welded wire fencing, with the top 40 cm angled towards the habitat (Plate 2), and the bottom 40 cm entrenched, extends for 2.1 km on either side of the road throughout the forested areas of the Terry Fox Drive Right of Way. The fence fabric provides vertical openings 50 mm wide X 100 mm tall, sized to inhibit all turtles larger than new hatchlings from passing, yet open enough to pass wind and snow loads. Finer mesh, with 10 mm hexagonal openings, was applied to the bottom 300 mm of the fence through the most exposed wetlands. Fence terminal ends wrap back on themselves (Plate 2), encouraging the animals to turn back and cross at the culverts. An at-grade level crossing of the Nepean-Arnprior rail line caused a 15 m wide gap in the fencing system, but otherwise the fence and guide walls encloses the road on both sides of the four-lane arterial through all of the forested section.

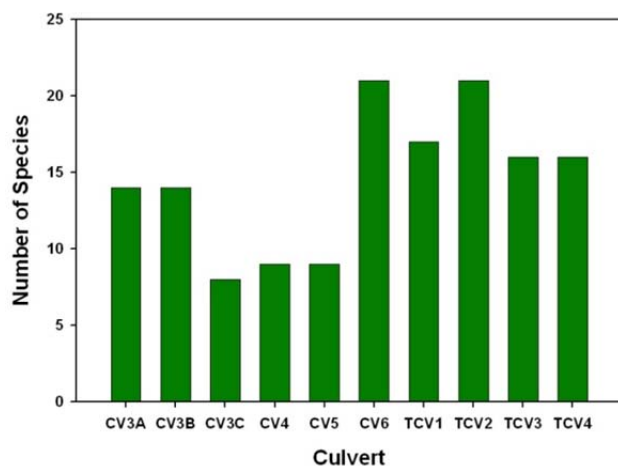
**Figure 2. Three year comparison of culvert preference by species.**

The TCV series of culverts that were installed specifically for wildlife passage, consistently saw the highest number of species movements (Figure 2), peaking with TCV2, a semi-wet culvert that saw 20 species. Comparable to this was CV6, a hydraulic culvert on East Shirley's Brook, which also saw 20 species moving along the natural stream corridor. Surprisingly, CV5, the large arch culvert on West Shirley's Brook had one of the lowest species counts, but considering that water fills the culvert throughout most of the year, which may have deterred some land

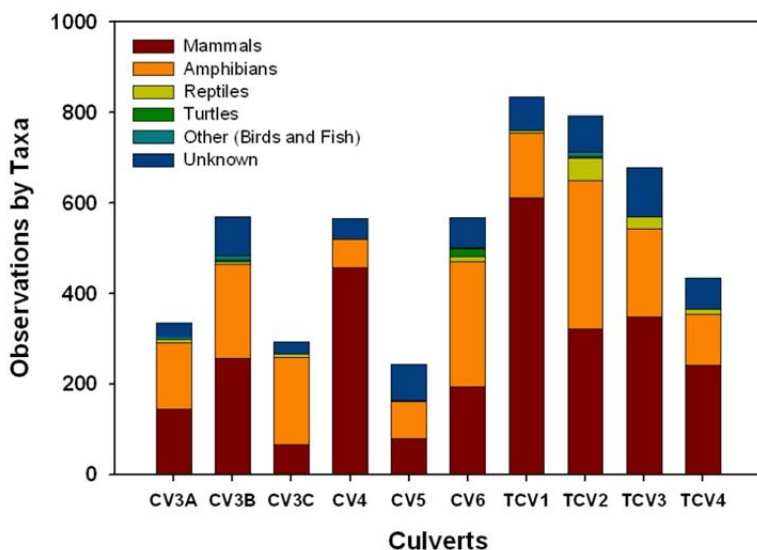
**Figure 3. Three year comparison of culvert preference by taxonomic group.**

Figure 3 represents culvert preferences by taxonomic group based on the total number of observations for each group. Culvert CV4 is a relatively dry tributary set at the edge of the forest and was heavily used by mammals but few amphibians and no reptiles were observed here. There are few desirable wet habitats on the downstream side of culvert CV4, so there would be no need for semi-aquatic animals to use this corridor.

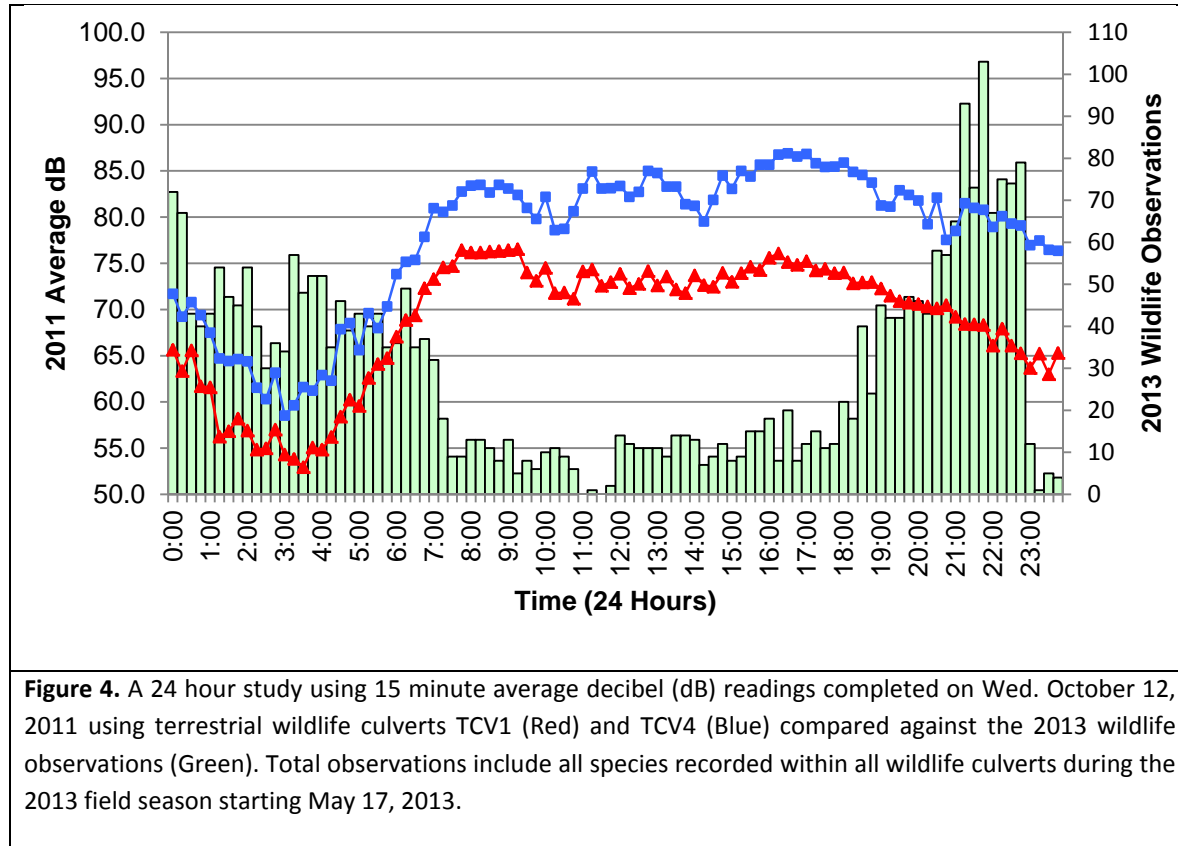
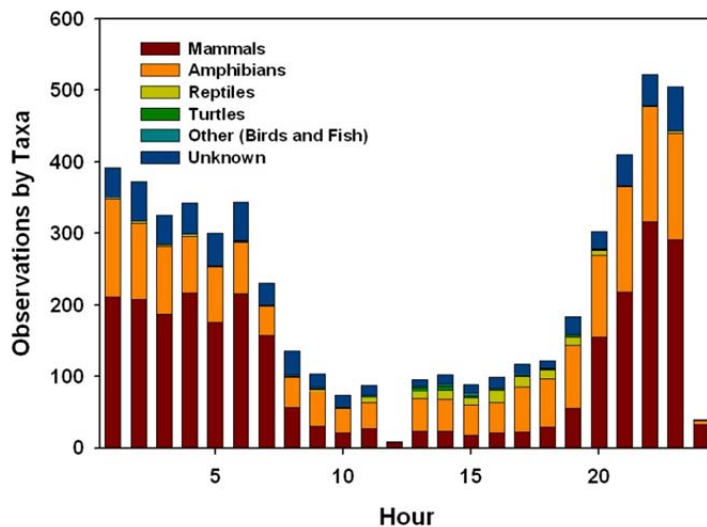
Figure 5 represents the number of movements by taxonomic group by time of day (diel), where zero hour is 12:00 midnight. Mammals clearly move more during the night time hours, when traffic movements are minimal.

This study has also analyzed time of travel, to determine if the noise and vibration related to the daily fluctuation in traffic patterns influenced animal passaged in the WGS. Figure 4 represents the time of travel data for all observations per hour during 2013. Several observations record movements during the daylight hours, but overall, it is apparent from the data that early morning evening, and late night

are the primary movement periods. These periods offset the noise profiles, suggesting that the normal periods of movement avoid the peak travel periods.
