***‘SAFETY EDGE’* for Improved Road Safety and Pavement Performance**

**Raymond Lau, CET, rcca, Project Manager, Transportation Design and Construction,
Regional Municipality of Halton**

**Paper prepared for presentation
at the Infrastructure Safety Measures Session**

**of the 2014 Conference of the
Transportation Association of Canada
Montreal, Quebec**

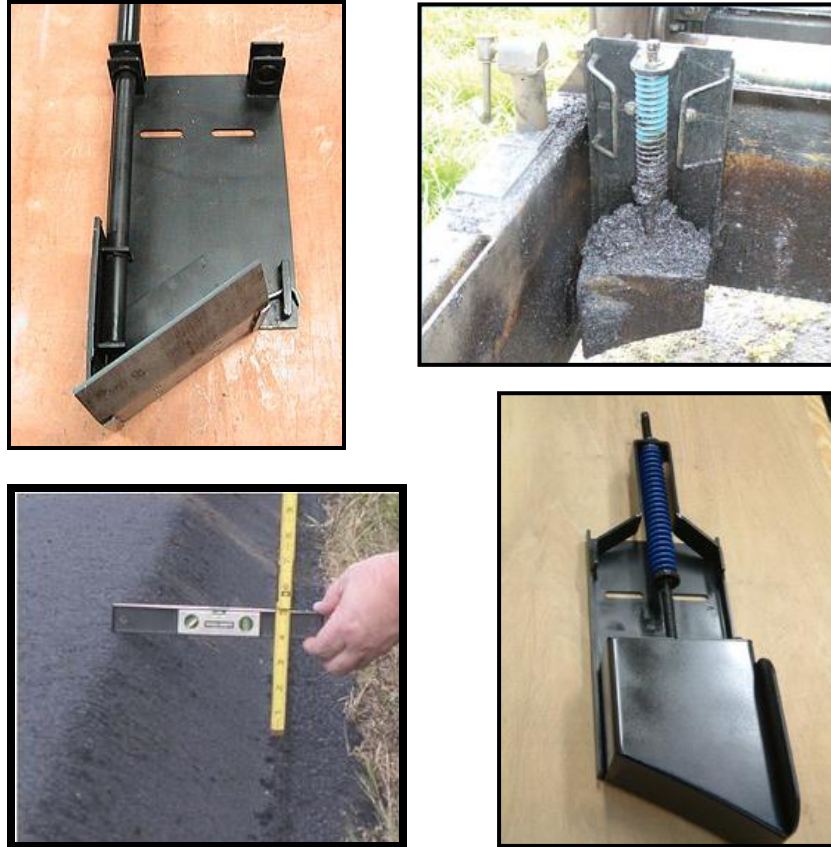
Figure 2: FHWA approved 'Safety Edge' sample devices (Picture credit to FHWA and Carlson Paving)

This simple attachment as shown in Figure 2 is a low-cost adjustment (less than one-tenth of percent increase in asphalt tonnage to the construction of the asphalt edge) that has been documented to reduce the number of vehicle crashes by allowing drivers to safely recover should they drift off of the paved surface. Of course, data may not always record the occurrences where no property damage results such as 'near misses' or unreported events, which may be attributed to the effectiveness of Safety Edge. Although noted to be effective for all rural types of roadway, the use of a Safety Edge is particularly found to be useful on rural two lane roadways with minimum shoulders.

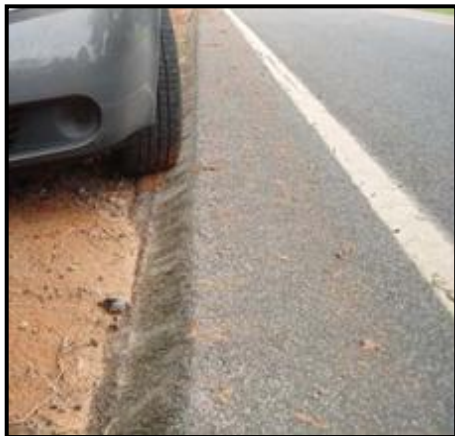
Figure 3: one of MTO pilot road sections

As illustrated in Figure 3, gravel shouldering should be maintained to the top level of the pavement grade, to help with vehicle recovery along this area, as well, as to preserve the integrity of the pavement edge from such vehicle movements. Gravel shouldering was subsequently placed in this MTO example.

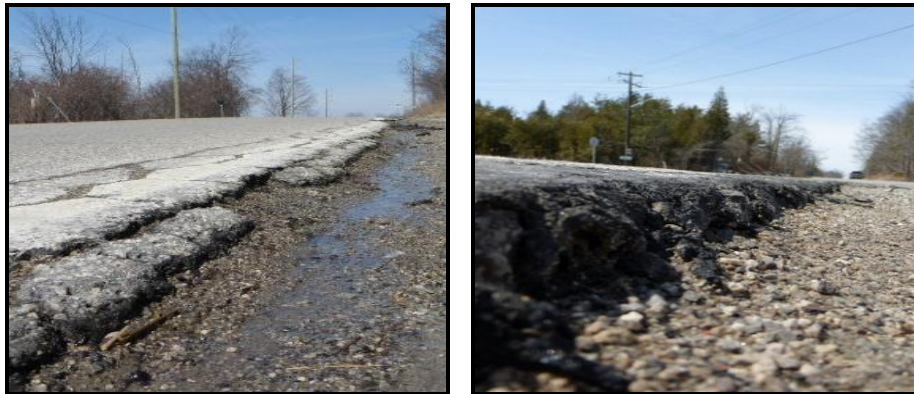
Figure 4: 20 Sideroad typical edges, curve and linear sections

Edge drop-off and loss of material, as seen in Figure 4, at the edge of the pavement was prominent throughout the project. The most severe of the edges were as expected nearest the two curves, Figures 5 and 6, and two intersections within the limits.
