## **Terry Fox Drive, March Road to Kanata Avenue**

**Environmental Achievement Award  
Submission**

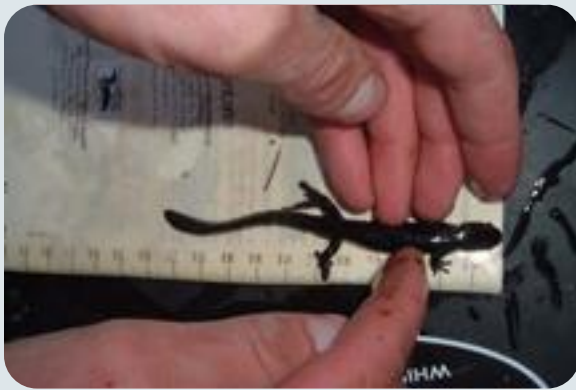
**PHOTO 3:**  
Blue Spotted Salamander

To meet the vertical profile through a rock cut, blasting was required around sensitive wetlands and vernal pools that supports habitat of Western Chorus Frog and Blue Spotted Salamander (*Photo 3*). Dillon wrote in reduced blasting specifications to protect certain areas from subterranean rock fracture which may have caused water loss and collapse of important ecosystem features; only 40 m away. To offset floodplain impacts to the Carp River by the new roadbed, a large grading cut was finished off as 8 ha of constructed wetlands (*Photo 4*), that indirectly also offset the loss of 1 ha of PSW. Built as a series of unconnected swamps, they targeted frogs and turtles, some of the most vulnerable species in Ontario. It is anticipated as they mature, that aquatic birds will use them regularly. Adjacent to the watercourse on otherwise vacant land, a 2.5 ha plot was reforested with over 6,000 trees to compensate for the loss of forest land (*Photo 5*). These trees will serve as a windbreak to reduce snow loads, a future recreational area, a wildlife migration corridor, and as carbon sink offsets.

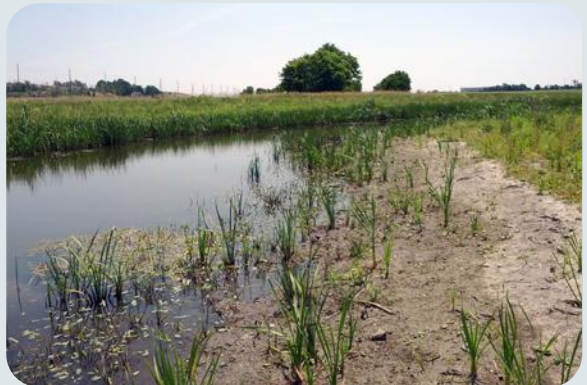
**PHOTO 4:**  
Constructed Wetland

Where possible, changes made to support the environment have been multi-use. The floodplain cuts were necessary compensation to avoid flooding impacts, but the constructed wetlands used to finish them were also used by animals as refuge and habitat. They ameliorated water quality in the Carp River by creating deposition zones, and over the long-term, will be part of a larger meta-corridor along the River. Following the concepts of reduce, reuse and recycle, all materials used in the constructed wetlands (e.g., boulders, roots, organic soils, seed bank) came from the roadway clearing. No imported building materials were necessary for their construction other than new shrubs and aquatic plants.

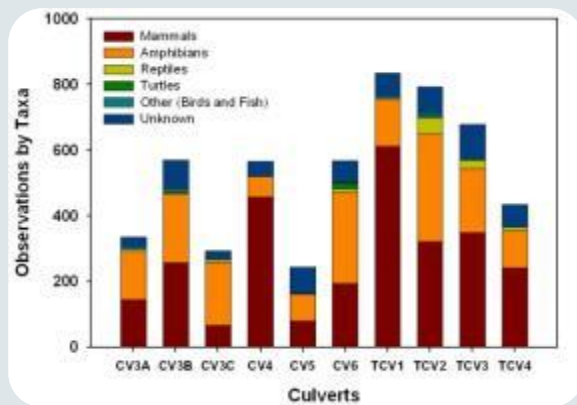
**CHART 1:**  
Observations by Taxa for each wildlife guide culvert

The observations have been linked to time-of-day travel to understand the movement patterns of the various wildlife groups and which culverts performed the best so we can learn from and disseminate the lessons' learned to other road ecology practitioners (*Chart 1*). Dillon has proven that given the right configuration and little choice, many species of wildlife will use the 1.8 metre wide by 0.9 metre high box culverts, and that the ecological impacts of roads need not be significant with forethought, innovative planning and engineering. After these three years of monitoring, the overall wildlife statistics see significantly decreased mortalities compared with nearby roads.

Following the opening of the road in July 2011, the effectiveness of the impact reduction strategies was monitored to address a number of science-based questions. Infrared trail cameras mounted in the ten culverts for three years have captured 6,033 images of 24 species of animals (e.g., frogs, snakes, fishers, porcupines, beavers and Blanding's turtle) moving through the passages, proving the effectiveness of the wildlife guide system at protecting migrating animals (*Table 1*).

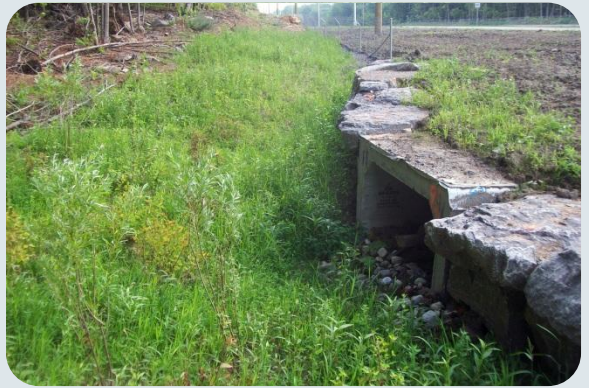
**PHOTO 9:**  
Wildlife Guide System Culvert

As a separate, yet integrated piece of the environmental infrastructure, a three-part wildlife guide system ensures animals can still migrate between habitats without the risk of being killed on the road. In addition to the six culverts passing creeks; four purpose-built dry terrestrial culverts were installed beneath the roadway, with flanking guide walls and custom fencing covering both sides of the 2.4 km roadway section through the forests and wetlands. The fence and walls direct wildlife to the culverts, which are lined with stone, topsoil and logs to provide cover from predators. Three modified catchbasins, sitting above each culvert, act as skylights, to stimulate passage and avoid the tunnel effects of small passages.

The additional four culverts, wildlife guide walls and 4.8 km of fencing cost \$978,000, saving the lives of countless animals, yet requiring periodic maintenance by City staff to ensure its integrity is not compromised. However, the wildlife guide system is an unqualified success and represents a significant achievement in road ecology.
