## **A Cost-Effective Maintenance Treatment for Improving Airfield Pavement Friction**

Paper prepared for presentation  
at the Winter Road Maintenance Session  
of the 2014 Conference of the  
Transportation Association of Canada  
Montreal, Quebec

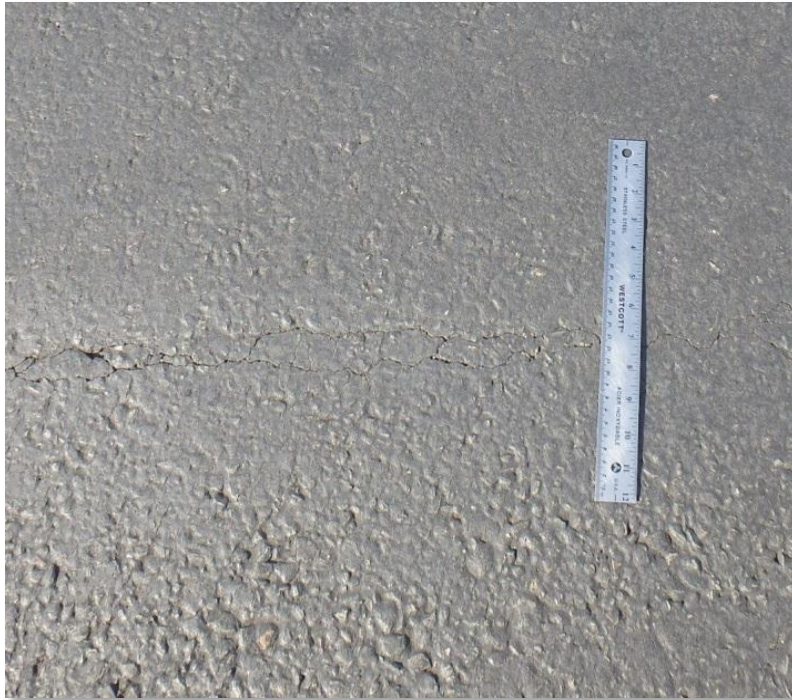
Low severity linear cracking was observed on the asphalt surfaced pavements at seven terminal gates. Low severity fatigue cracking was observed on the asphalt surfaced pavements at only two terminal gates. Photos of the observed characteristic low severity linear and fatigue cracking are presented below in Figures 1 to 4.

**Figure 1: Low Severity Linear Crack and Asphalt Sealant**

In order to restore skid resistance to the asphalt pavements surrounding the gates at the terminal, it is recommended that the bituminous sealant be removed by shot or water blasting. This treatment will

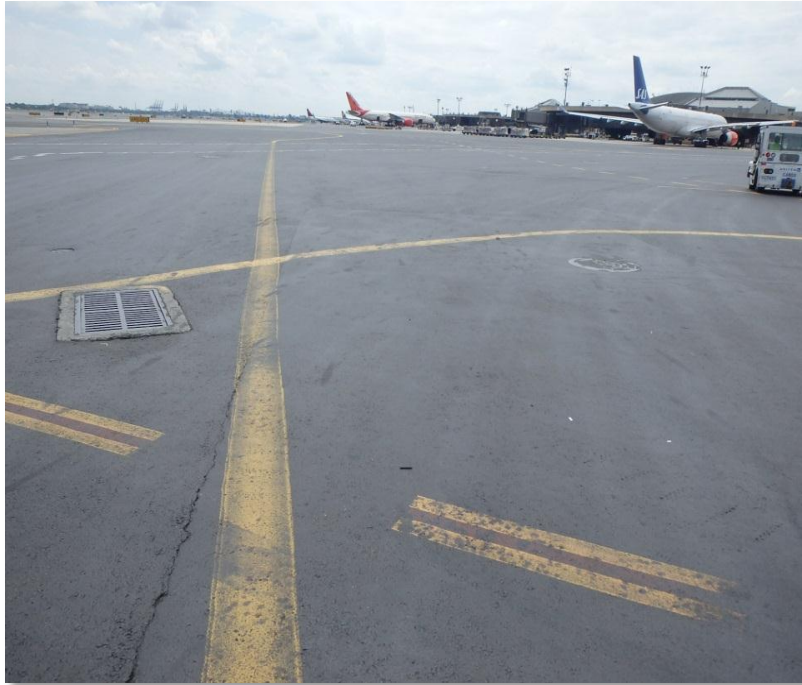
**Figure 2: Low Severity Linear Crack**

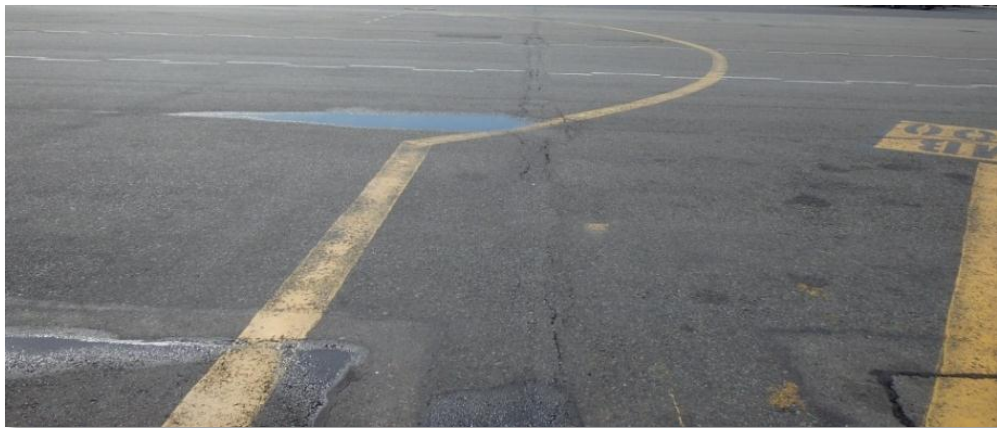
**Figure 3: Low Severity Fatigue Cracking**

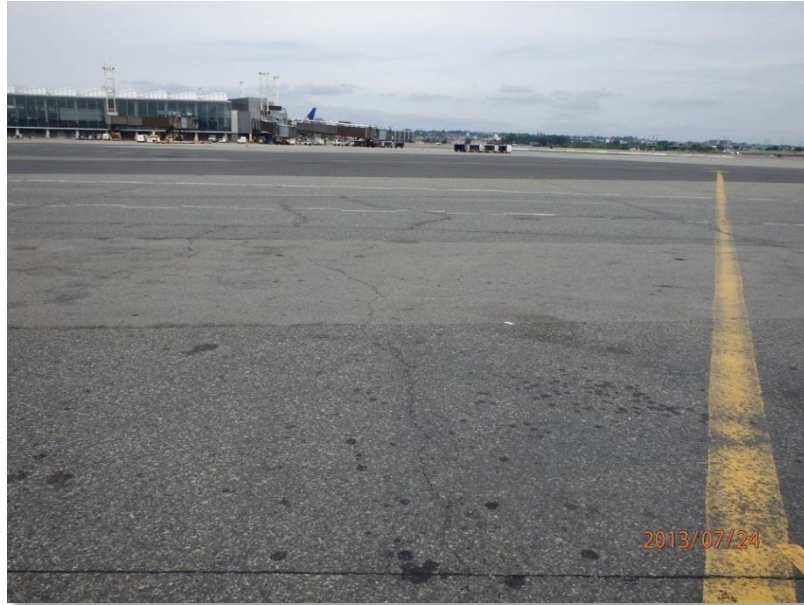
**Figure 4: Low Severity Linear Crack**

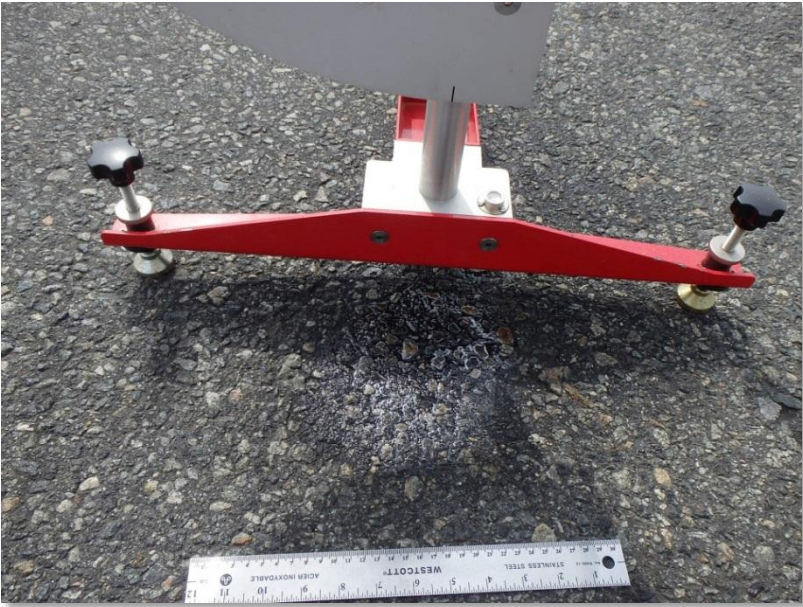
During the field investigation, it was noted that there was a visible difference between the micro- and macrotextures of the sealed and unsealed asphalt pavements in the recently rehabilitated area. The roughness of the aggregates and pavement surface in general was observed to be “less rough” in the areas where the sealant had been applied. The visual difference is evident and is illustrated below in Figures 6 and 7.

**Figure 6: Unsealed Asphalt Pavement**

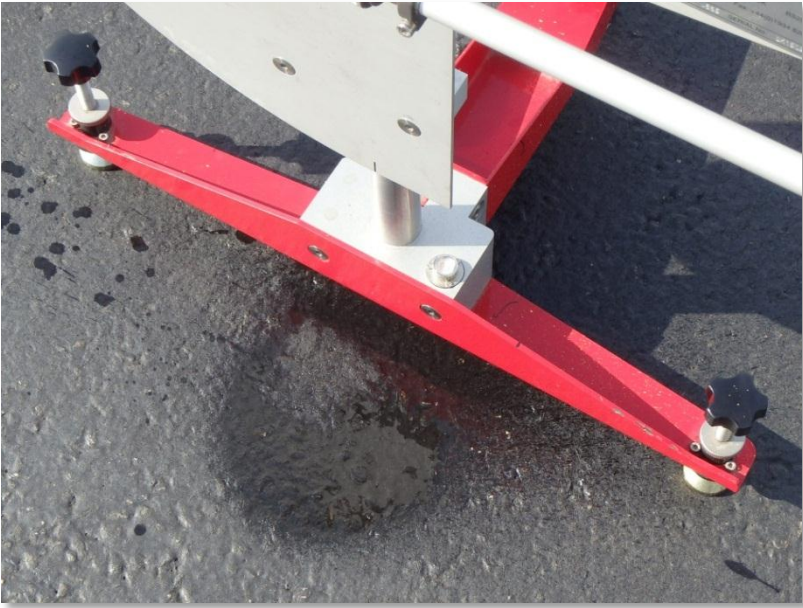
**Figure 7: Sealed Asphalt Pavement**

remove the thin film of the bituminous sealant and restore the macro- and microtexture of the pavements.

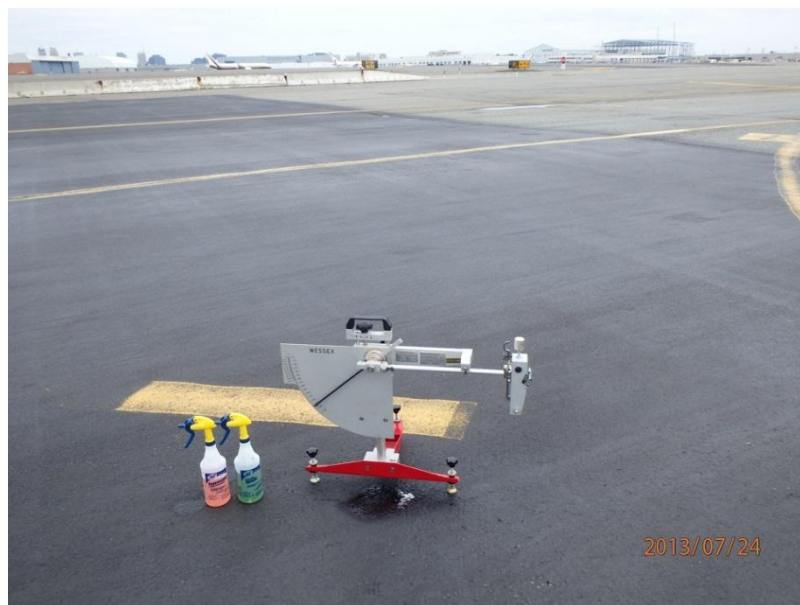
The British Pendulum Tester (BPT) is a dynamic pendulum impact-type tester used to measure the energy loss when a rubber slider edge is propelled over a test surface. The BPT was chosen to quantify the frictional properties of the asphalt pavement surrounding the ramp alley area due to its portability and relatively quick testing time. These attributes made it an effective method of testing skid resistance in a high traffic area.

The BPT uses a pendulum equipped with a standard rubber pad to determine the frictional properties of a test surface. The frictional properties are measured in units of British Pendulum Number (BPN). At each test location, the BPT is leveled and calibrated to the pavement surface by adjusting several leveling screws and an adapter nut to ensure accurate readings. The test surface is cleaned from debris using a small brush and wetted using water prior to testing. The pendulum is then raised to a locked position and then released allowing the slider to make contact with the test surface. A drag pointer on a scale indicates the BPN. A larger BPN measurement is the result of a more retarded swing, therefore greater friction between the rubber pad and the pavement surface. The lower the BPN number, the lower the amount of friction between the rubber pad and the pavement surface. Five tests were performed at each specific test location and an average was taken as being a representative BPN test result. A photo of the BPT equipment is presented below in Figure 8.

**Figure 8: BPT Equipment on Sealed Asphalt Pavement**

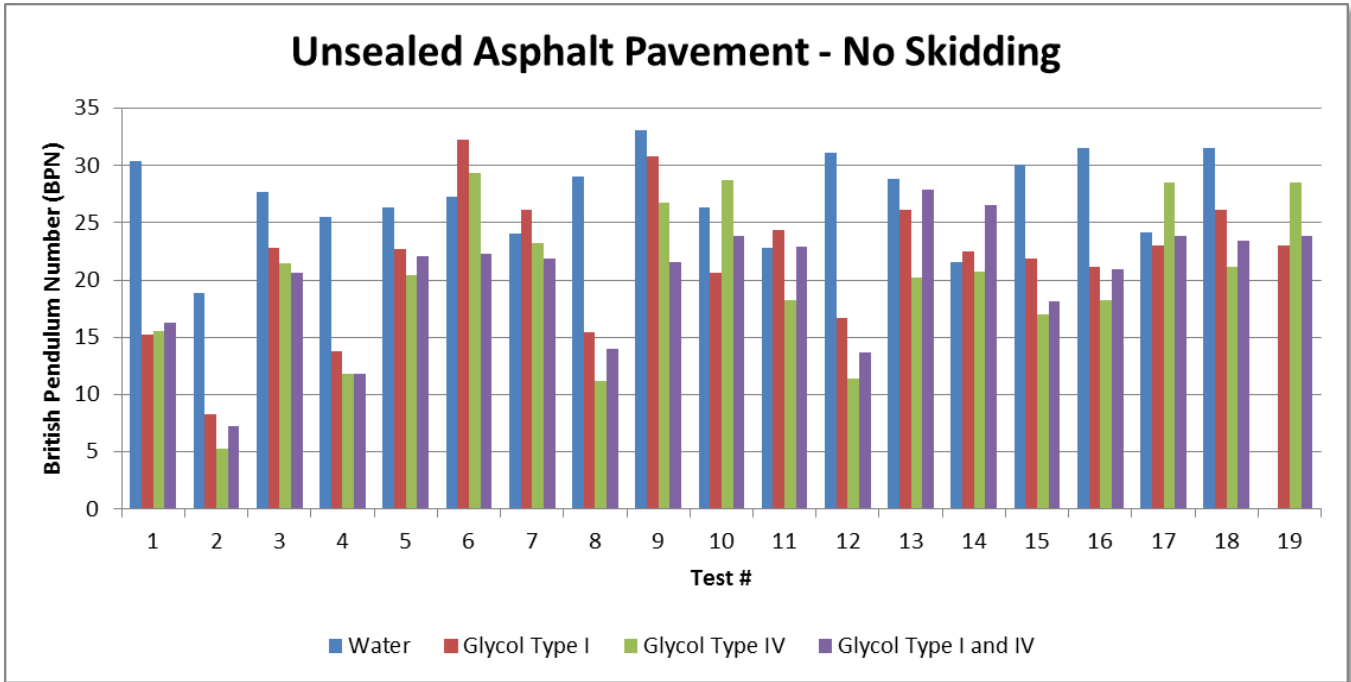
As shown in the tables above, the test results show there is a difference in BPN between the glycol solutions and water. However, there was not a significant difference between the BPN on the sealed and unsealed asphalt pavements using water as the wetting solution. The BPN measurements taken at each test location are illustrated below in Figures 9 and 10 for unsealed and sealed asphalt pavements, respectively.

Figure 9: BPN Measurements on Unsealed Asphalt Pavements

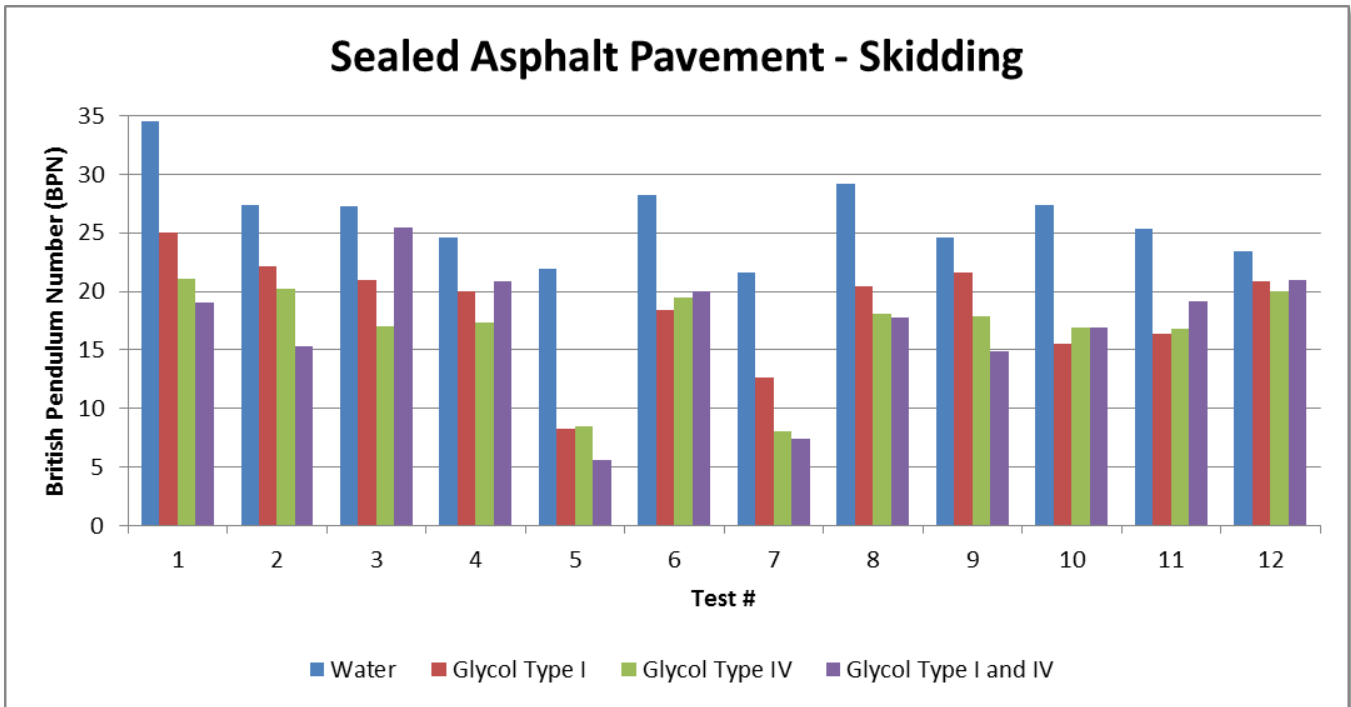
Figure 10: BPN Measurements on Sealed Asphalt Pavements

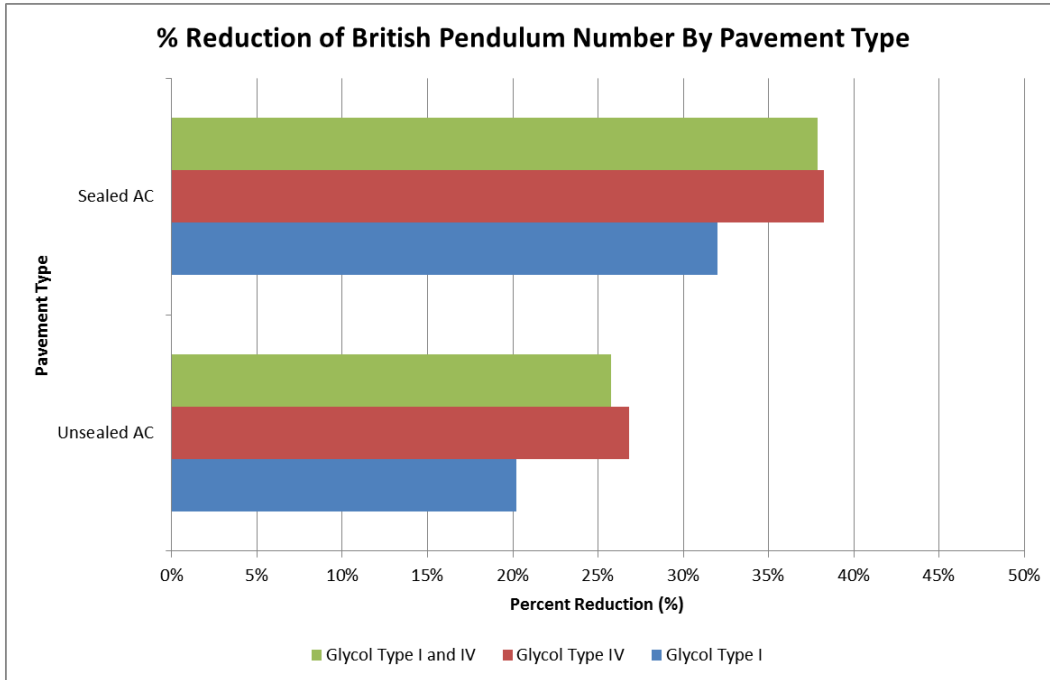
Also shown in the tables above, are the percent reduction in BPN, thus skid resistance in general, categorized by the type of wetting solution used. It is evident that there was a higher loss in skid resistance when performing the BPT measurements on the sealed asphalt pavements. There is an approximately 11% to 12% reduction in BPN when using the glycol solutions on the sealed asphalt pavements. This relationship is illustrated below in Figures 11 and 12 and categorized by both pavement and glycol type respectively.

**Figure 11: % Reduction in Skid Resistance by Pavement Type**

Since the testing was done on both the unsealed and sealed pavements with all other variables being equal, the 11% to 12% additional reduction in BPN caused by the bituminous sealant in combination with the 20% to 27% reduction from the glycol solutions appears to be causing the aircraft tire slippage on the sealed asphalt pavements surrounding the gates at the terminal.
