Cold 2014 Winter and Early Asphalt Pavement Cracking Observed in Ontario

Ludomir Uzarowski, Ph.D., P.Eng., Golder Associates Ltd., Ontario
Gary MacDonald, P.Eng., Region of Waterloo, Ontario
John Rizzo, CET, Region of Niagara, Ontario
Gary Moore, P.Eng., City of Hamilton, Ontario
Vimy Henderson, Ph.D., P.Eng., Golder Associates Ltd., Ontario

Soils and Materials: Climate Change Considerations for Geotechnical and Materials Engineering Session

of the 2015 Annual Conference of the
Transportation Association of Canada
Charlottetown, PEI

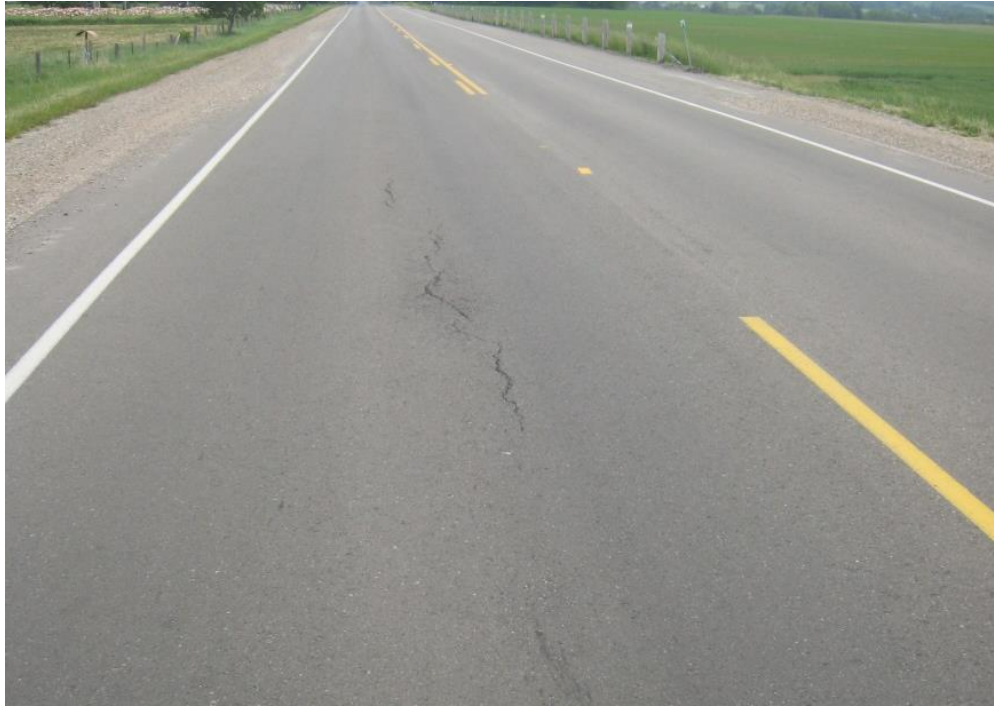
Photograph 1 Midlane cracking of a 6 months old pavement on Bleams Road constructed in 2009 [LU, 2010]

Premature asphalt pavement cracking starting with a midlane crack was for the first time observed in the Region of Waterloo in 2010. Photograph 1 shows the centerline cracking observed on Bleams Road after only about 6 months after construction (one winter). Since that time this type of failure was still unique it was not clear how to investigate the failures and to determine the causes of the failure, and develop recommendations for failure prevention.

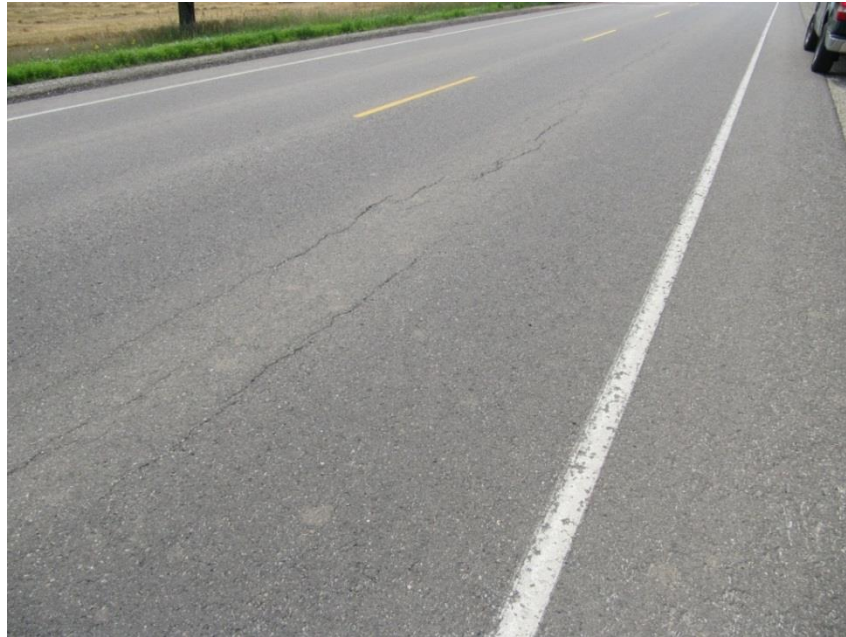
Photograph 2 Multiple midlane cracks on Katherine Street [VH, 2014]

Photographs 2 to 7 show examples of premature cracking on Katherine Street, Trussler Road, Swan Street and Moser Young Road in Region of Waterloo. Photographs 8 and 9 are from Portage Road in Region of Niagara. The similarity in the cracking pattern is obvious. The most visible is the medium

severity midlane cracking. Low severity random cracking was also observed. Careful pavement inspection also revealed extensive pavement microcracking.

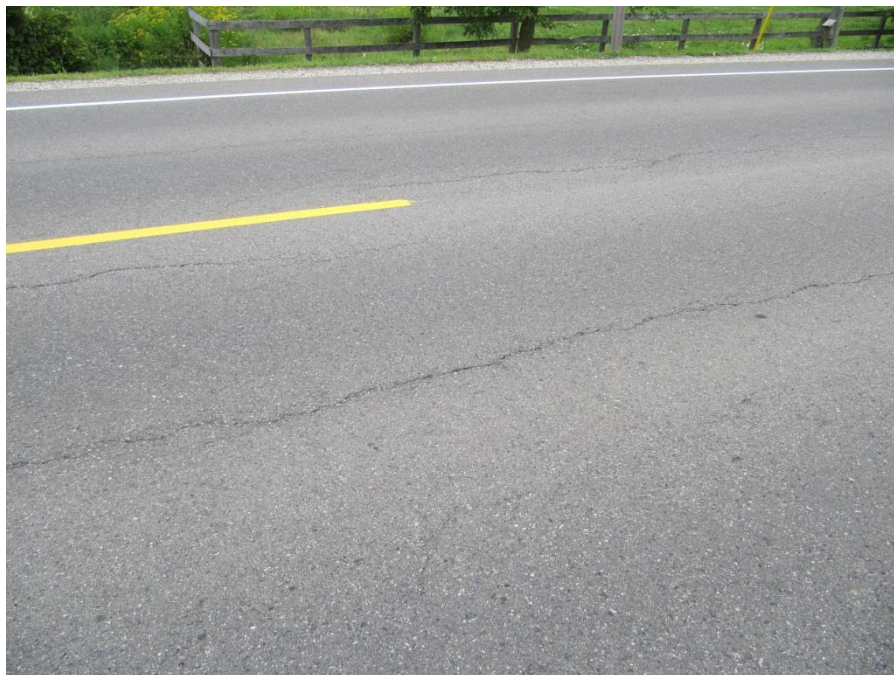
Photograph 3 Midlane and longitudinal cracking on Katherine Street [VH, 2014]

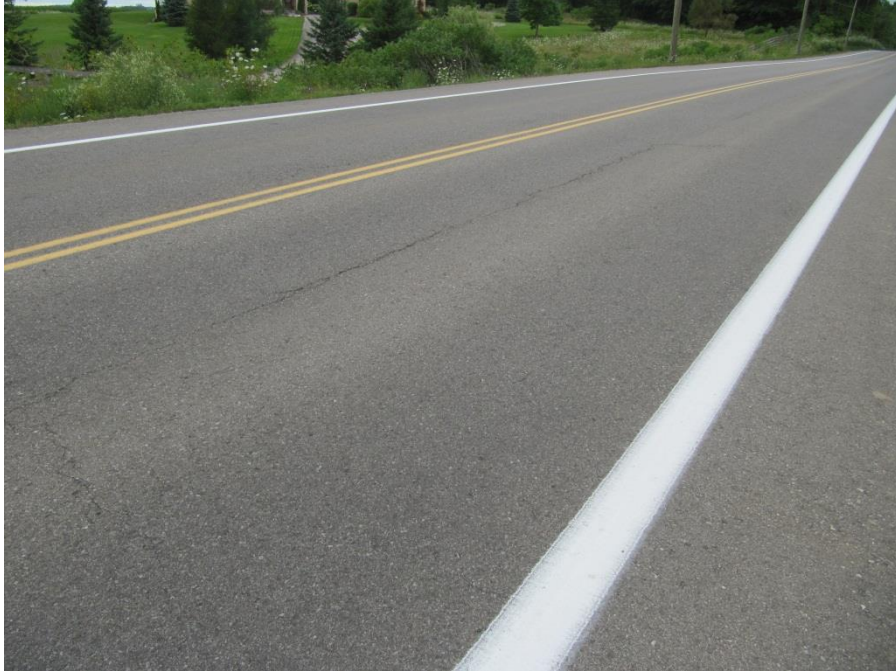
Photograph 4 Midlane cracking on Trussler Road [VH, 2014]

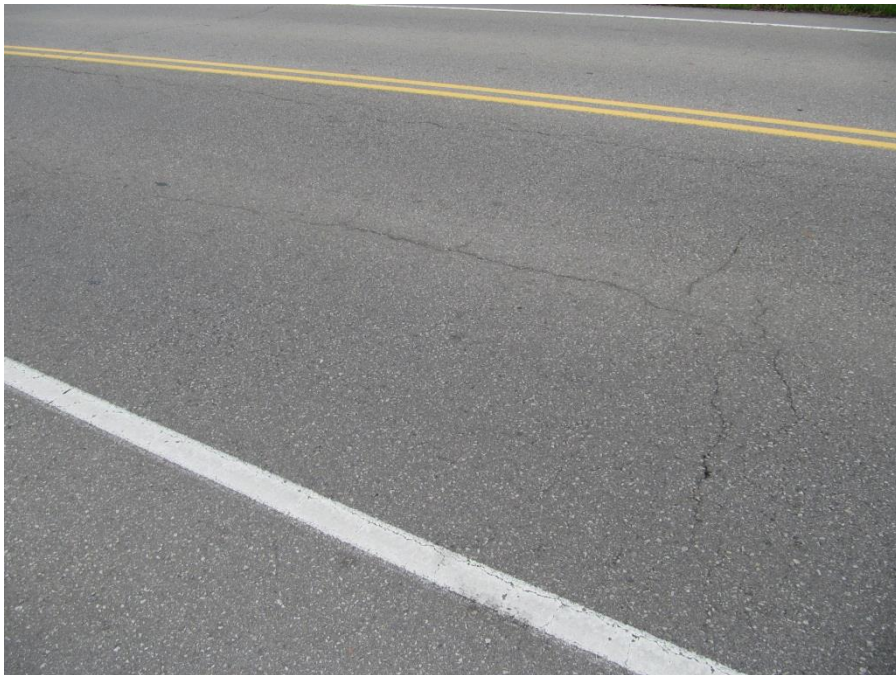
Photograph 5 Midlane, longitudinal and check cracking on Swan Street [VH, 2014]

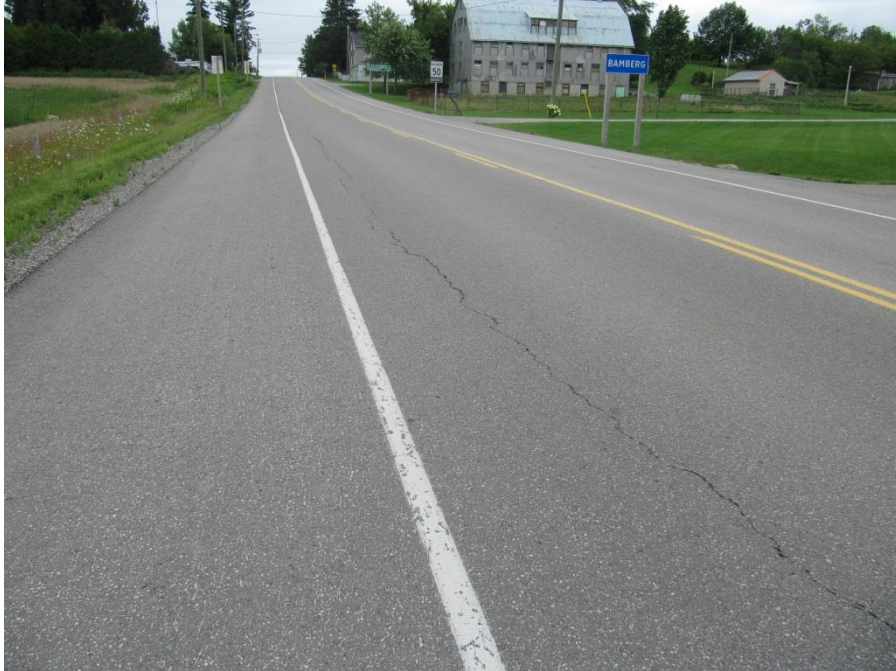
Photograph 6 Midlane cracking on Moser Young Road [VH, 2014]

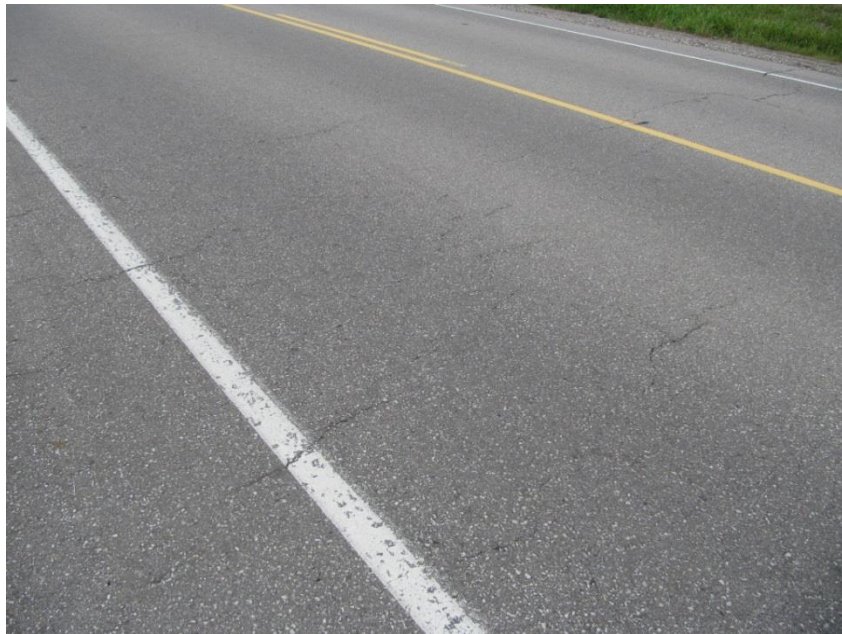
Photograph 7 Check cracking on Moser Young Road [VH, 2014]

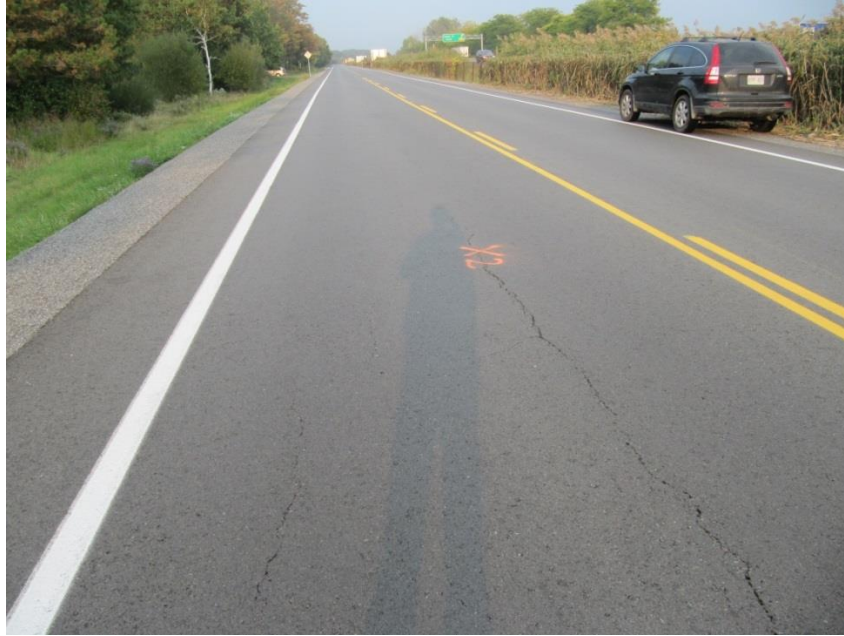
Photograph 8 Cracking on Portage Road constructed in 2013 [VH, 2014]

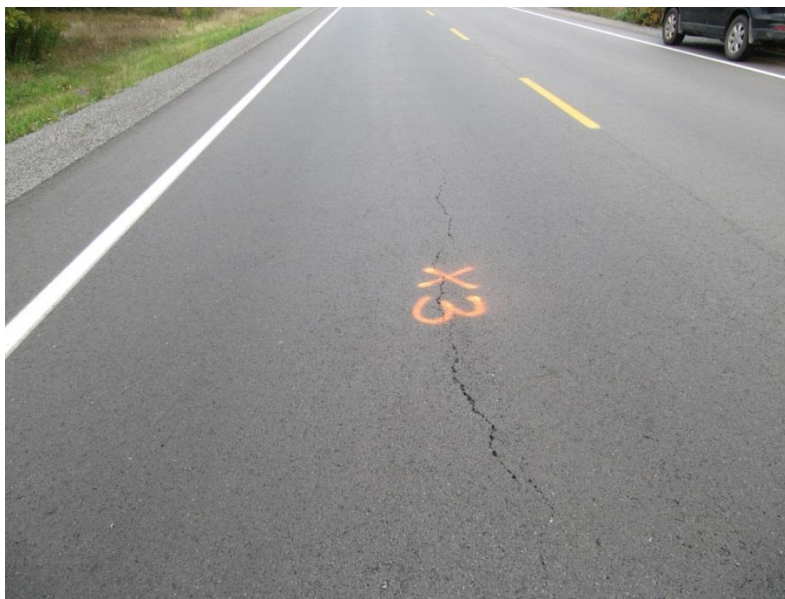
Photograph 9 Cracking on Portage Road constructed in 2013 [VH, 2014]

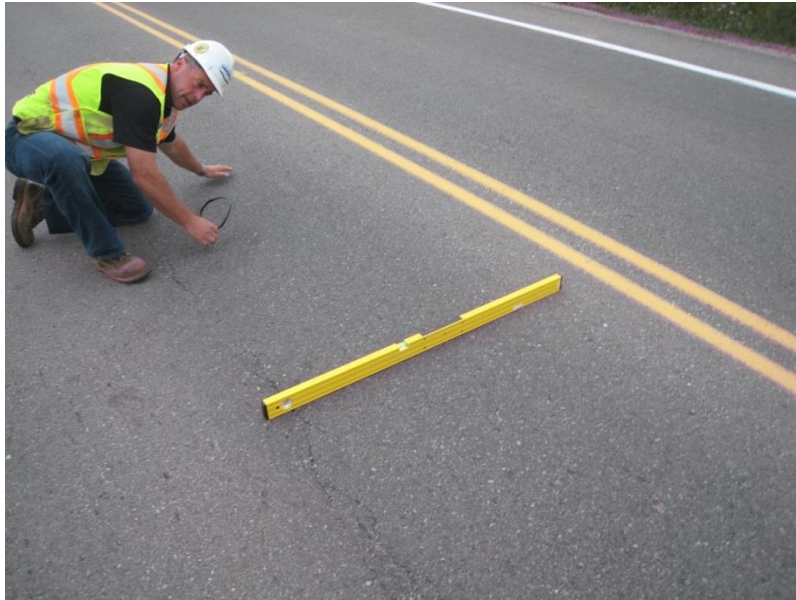
Photographs 10 to 13 were taken during the investigation of a pavement in Region of Waterloo. None of the failed pavement exhibited permanent deformation (Photograph 10). Asphalt layers cuts were typically carried out across medium severity cracks (Photograph 11). One cut was done at a good location (with no cracks) for comparison purposes. The premature cracks in the investigated pavements were mainly observed only in the surface course. The underlying binder course was intact (Photograph 12). This clearly indicated that the cracks were not of the fatigue bottom up type. Photograph 13 shows the reinstatement of the granular base after checking its quality of obtaining granular material samples for laboratory testing. On all investigated pavements the quality of the granular layers was good to very good. The granular material was dry and met the specified requirements.

Photograph 10 No rutting was observed on the 2 years old cracked pavement [LU, 2014]

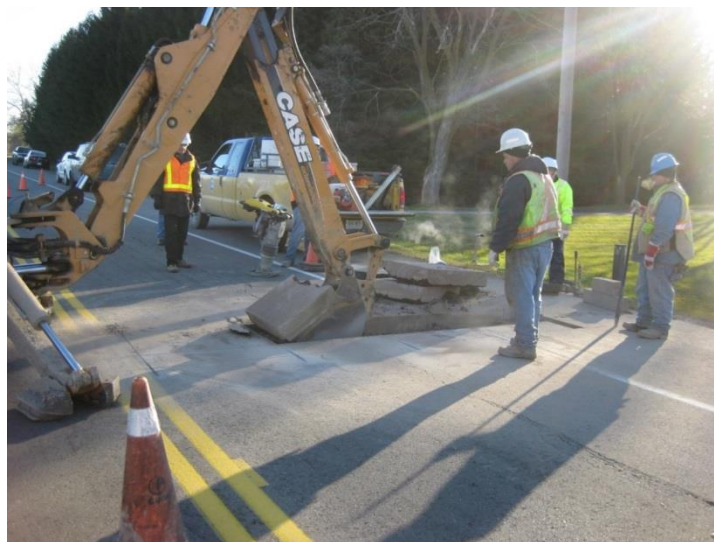
Photograph 11 Cutting asphalt slab as part of the failure investigation on 2 year old pavement [LU, 2014]

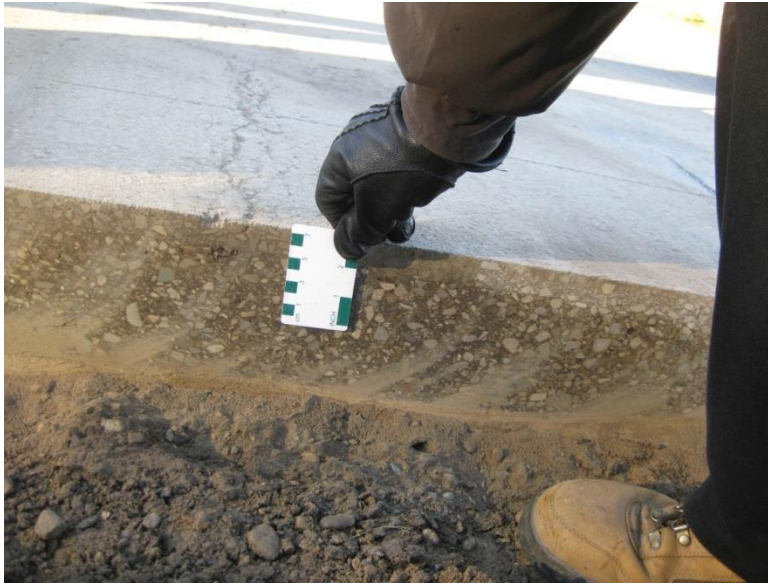
Photograph12 The crack in the investigated pavement was observed only in the surface course [LU, 2014]

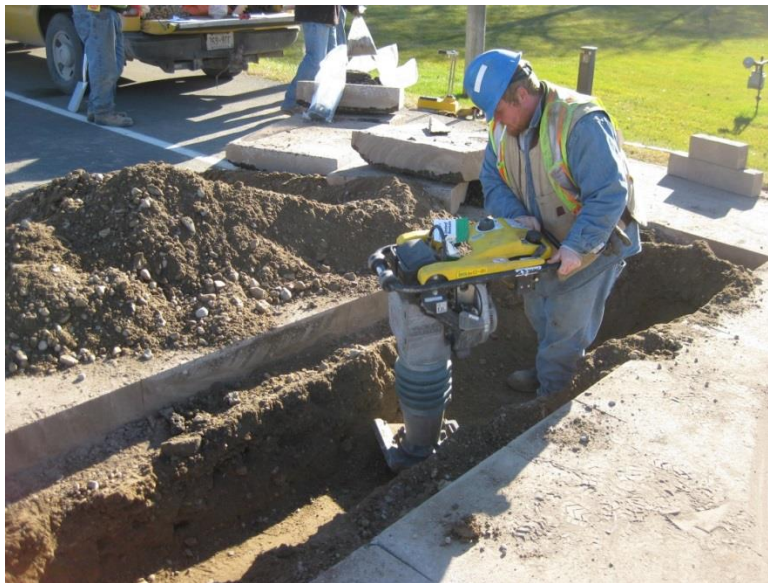
Photograph 13 Reinstatement of the granular base layer after checking its quality and obtaining samples for laboratory testing [LU, 2014]
