Design Consistency and Multi-modal Safety in Urban Areas

Mitchell Jacobson, M.Sc., PEng., Transportation Engineer, Boulevard Transportation
Tom Baumgartner, M.Sc., PEng., Transportation Engineer, Boulevard Transportation

Paper prepared for presentation at the Geometric Design - Lessons Learned: Linkages Between
Design Standards and Road Safety Session

of the 2015 Conference of the
Transportation Association of Canada
Charlottetown, PEI

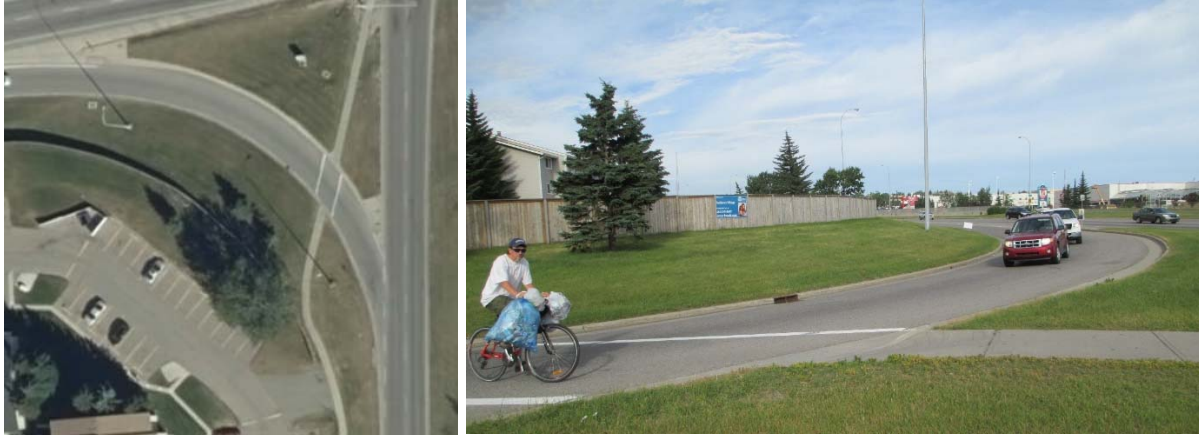
An example of this situation is shown in Figure 1, from the intersection of Memorial Boulevard and 36 Street NE in Calgary.

Figure 1: Large Radius Right Turn Channelization with Yield Control

In this particular situation, the departure roadway has a posted speed limit of 80 km/h (although the intersection transitions to 50 km/h immediately past the intersection), and the turn radius of 49m equates to a design speed of 40 km/h. This is a relatively fast approach speed where abrupt braking for the yield condition may occur, which can result in rear end collisions. Note also that pedestrians on the outside corner of the intersection have only a minimum of visibility to approach vehicles, and even then, approach vehicles often are looking to their left for oncoming vehicles (to merge with or yield to) rather than to the right towards pedestrians.

Figure 6: Mitigation Option (for Figure 1 scenario) – Smart Right Turn Channelization, and Separate Bus Bay

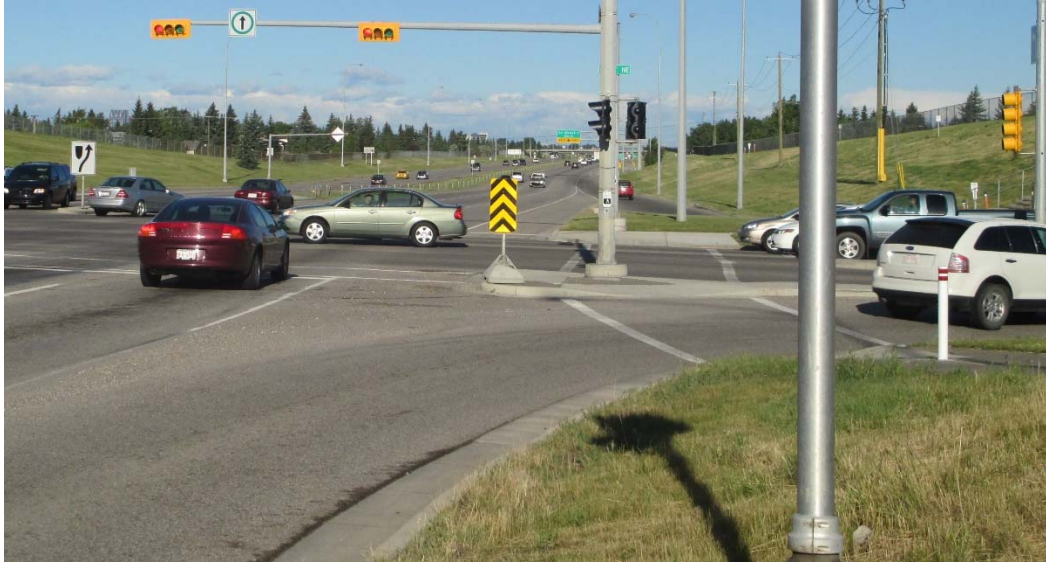
The example in Figure 2 shows the westbound right turn movement at 16 Avenue and 68 Street NE in Calgary. This location has a right turn lane with a small radius right turn, leading into an added lane (for a free right turn scenario). Despite this, numerous drivers were observed to brake and yield. It should be noted that there is in fact no Added Lane signage or Merge signage present, but nonetheless there is a long added lane downstream (and there is no immediate left turn opportunity downstream for which a turning driver might wait in order to make an immediate lane change). In this particular case there are utility constraints and a retaining wall that prevent the easy construction of a larger right turn radius. The inclusion of primary and secondary Added Lane signs would however help address this issue.

Figure 2: Small Radius Right Turn Island, with Added Lane

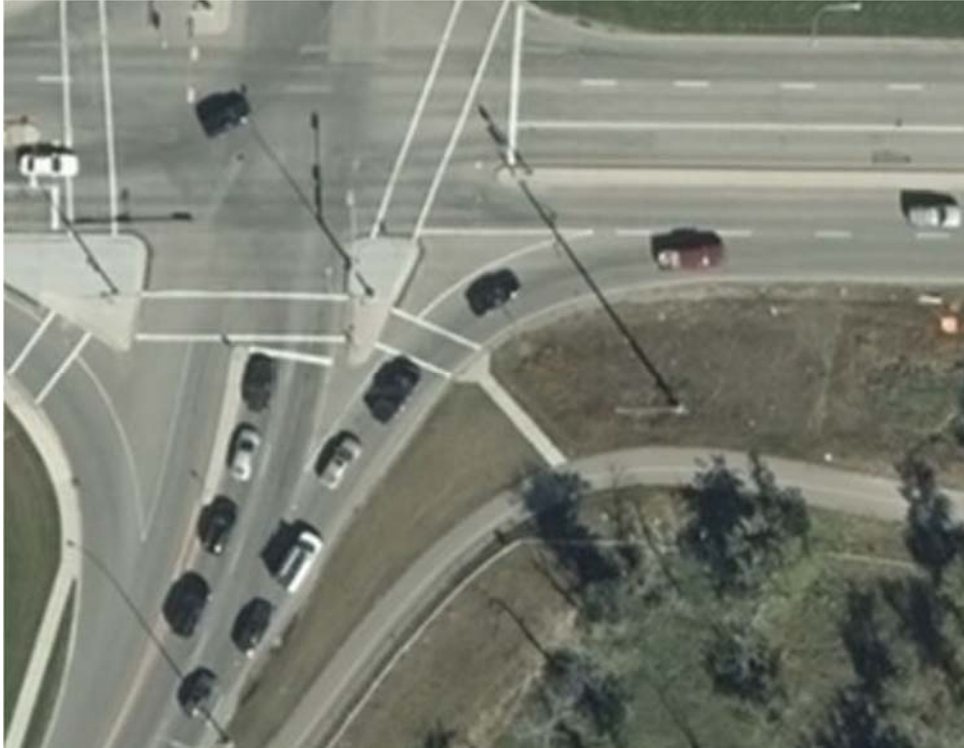
Figure 3 shows this situation at the intersection of Heritage Drive and Glendeer Circle in Calgary. In this example, there was a relatively recent change in traffic control (September 2013) from yield control to an added-lane (for a free right turn), which was done to accommodate the heavy right turn movement (the dominant movement at the intersection). This was done by eliminating one lane in the eastbound movement (left-to-right in the figure), as this is a comparatively low volume movement that does not need two lanes to meet capacity requirements. The geometry of the island, however, is still similar to a yield design, as it effectively just extends the existing yield-style island out further, without adding curvature that would indicate to drivers that they are protected from oncoming traffic. Approximately one in three drivers were observed to yield at the added lane approach, and frequent honking from trailing vehicles was noted. Although the paint markings do clearly show the intended path, and Added Lane signage is used on the outside corner, they do not in this case provide the physical and psychological reinforcement that it is truly a free right turn movement.

Figure 3: No Deflection on Right Turn Island (centre of photo), with Added Lane

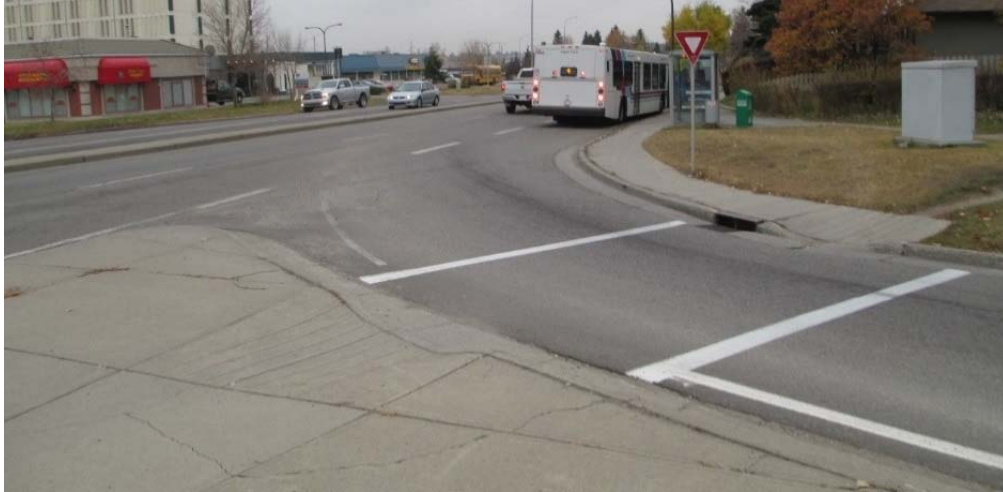
A challenging scenario can be where there is a right turn island with yield control, but also a bus bay immediately upstream of the entry point onto the intersecting road. In this case, the bus bay may be misconstrued as a merge lane, and conflicts can arise since there is not sufficient acceleration length. This scenario can result in inconsistent driver behaviour, from drivers properly yielding (but with some trailing drivers being annoyed, as they perceive it to be an added lane or merge lane situation), drivers merging at speed (and conflicting with intersecting traffic), or drivers entering the bus lane, realizing there are not sufficient gaps, and stopping in the bus stop area (and potentially conflicting with buses, and even being overtaken by trailing right turn vehicles that drive straight into the main lane). See Figure 4 for an example, from the intersection of McKnight Boulevard and Edmonton Trail in Calgary.

Figure 4: Bus Bay at End of Right Turn Channelization with Yield Control

In some cases marking improvements can have some benefits, and highlight the correct intent. For example, where a bus bay begins immediately past a right turn yield channelization island, the bus bay can be bounded by dashed bus bay lines, with a reserved diamond lane stencil added to the bus bay (see Figure 5, for a mitigation option for the situation in Figure 4). Additional emphasis of the bus bay can be given by colouring the bus bay red.

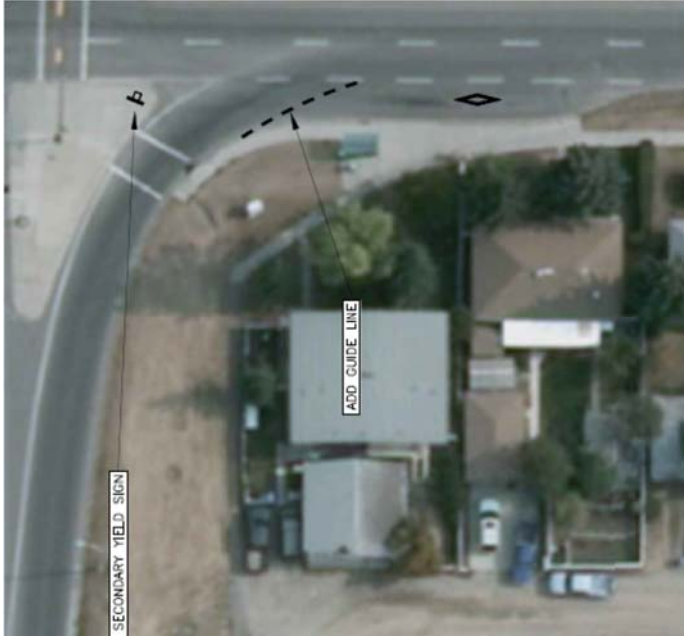
Figure 5: Mitigation Option (for Figure 4 scenario) - Guide Lines and Bus Bay Diamond

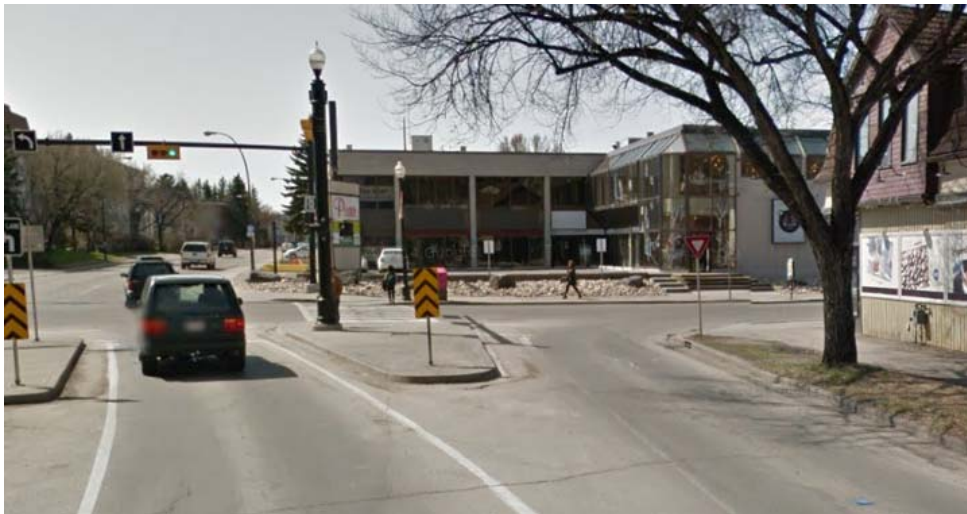
Signage and markings, however, are ultimately passive measures only that can be ignored or missed by drivers. Geometric changes are a stronger measure as they physically require driver action (lest the driver collide with the edge of the road). One geometric measure that can have a strong safety benefit for not only drivers but pedestrians as well is smart right turn channelization. This type of design results in a sharper angle approach, that allows for better driver visibility of pedestrians (either on the raised island or outside of the intersection) as well as yield signage, and more of a geometrically-inherent need to yield at the intersection, since the turning radius is greatly reduced. An example of how the situation depicted in Figure 1 could be mitigated with a smart right turn channel is shown in Figure 6, and an in-field example is shown in Figure 7.

Figure 7: Example of Smart Right Turn Channelization (5 St and 17 Ave SW, Calgary)

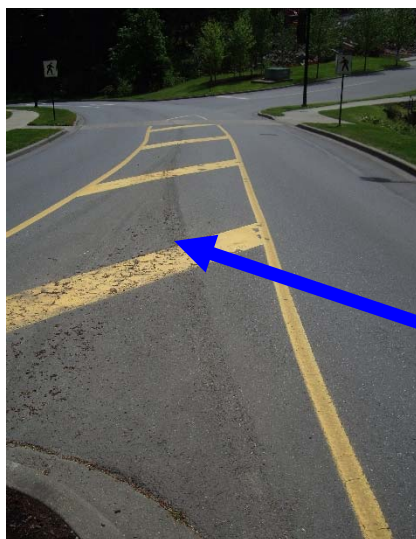
Additional features that may contribute to the safety risk include median areas on curves demarcated by paint markings only, as many downhill drivers were observed to travel over the painted area in order to maintain as much speed as possible. Also, the existing Curve warning signage did not fully convey the extent of the safety risk (and the chevron signs were not as conspicuous as they could be due to inherent lighting and visual backdrop conditions), see Figures 8 and 9.

Original (eradicaded) paint markings, but many drivers were observed to follow this path and drive through the oncoming left turn lane, to maintain speed while travelling downhill

Figure 7: Upstream Median Markings

- Roadway crossfall – convert to a reverse crown on curves with poor safety performance or at the bottom of long, steep downhill roadway approaches
- Install raised medians (with curbs) in lieu of painted medians, to force proper positioning in the lane and reinforce the appropriate drive speeds
- Improved signage (increased conspicuity, size, and emphasis)
- Lane narrowing; options include a mountable median (to allow for driveway access while still narrowing the roadway) or curb re-location
- Barrier improvements

Subsequent to the review of Bear Mountain Parkway, the City installed centre line pickets, improved signage, and raised medians (that force proper positioning in the lane) in advance of the area of concern. The measures have thus far had a positive impact, with no reported collisions in the area by Langford staff in the first year.
