## **Improving Safety in Canada's Oil Sands with Temporary Signal Lights**

Erica MacDonald, Civil Engineer-In-Training, Stantec Consulting Ltd.

Paper prepared for presentation  
at the *Intersection Safety through Traffic Control Devices* Session

of the 2015 Conference of the  
Transportation Association of Canada  
Charlottetown, PEI

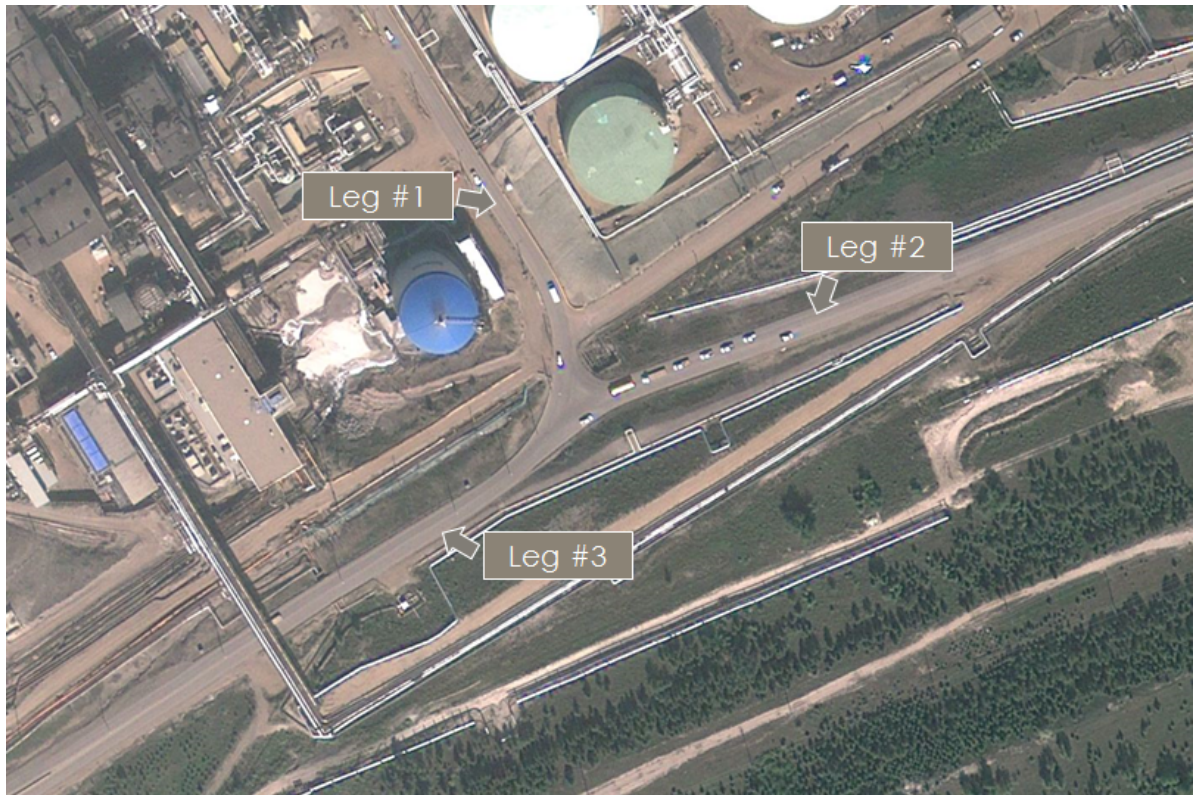
Figure I: Aerial view of the project site

As previously mentioned, this project is a three-leg intersection located on an industrial site near Fort McMurray, Alberta. For the purposes of this report, the connecting roads of this intersection shall be identified as Leg #1, Leg #2, and Leg #3. Figure I displays an aerial photograph of the project site.

Leg #1 – This leg connects on the northwest side of the intersection and approaches the intersection at a slight uphill incline. Leg #1 operates as a through-road to Leg #3 during non-peak hours. This leg also has several access points to facilities near the intersection, as well as another stop controlled intersection approximate 350m north.

Leg #2 – This leg approaches from the northeast side of the intersection and is stop-controlled during non-peak periods. It approaches our site at a slight downhill incline

Leg #3 – The final leg of this intersection approaches from the southwest at a slight downhill incline. As noted, this leg works as a through road to Leg #1 during non-peak hours.

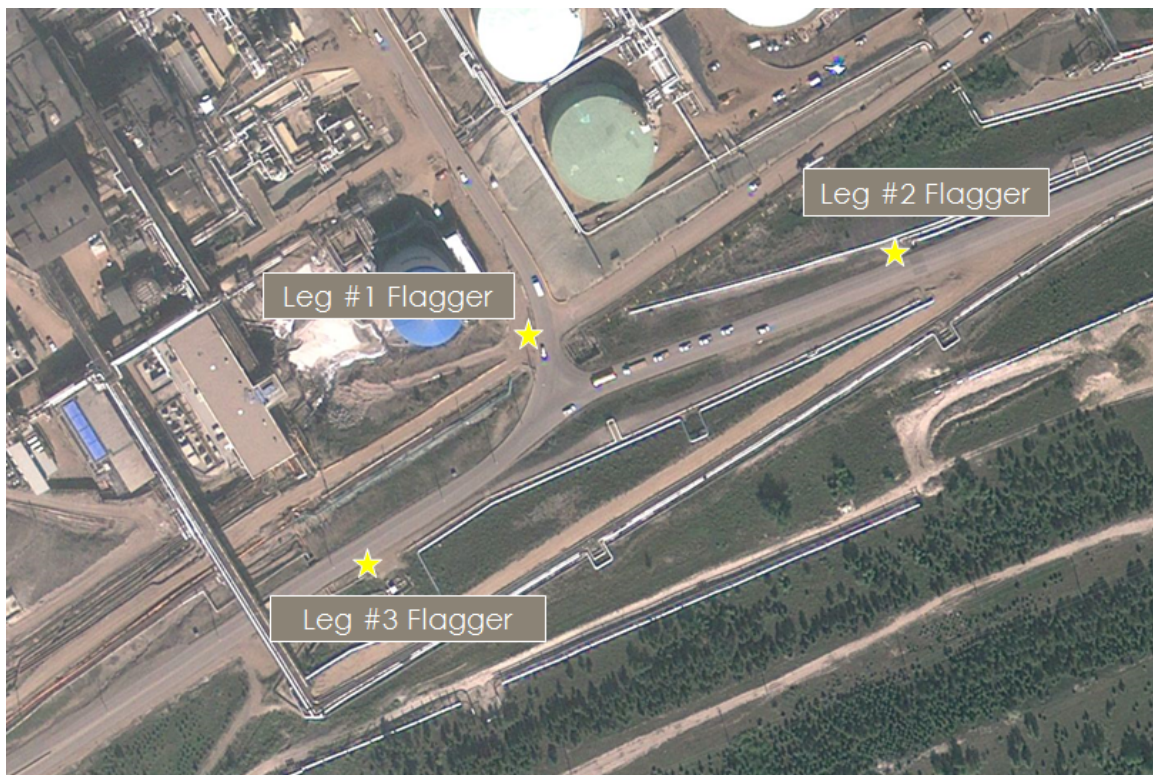
Figure II: Flagging locations during peak hours

- To help ensure their safety, flaggers had to be positioned with an escape route where they could move away from the roadway quickly and easily if required. Due to the amount of utilities located at ground level, flaggers on Legs #2 and #3 had to be positioned approximately 150m and 100m, respectively, away from the intersection. Figure II shows the approximate location of flaggers when directing traffic during peak periods.
- The flaggers directed traffic similarly to a three-phase signal, where only one leg was given right-of-way at a time. When it was safe to do so, flaggers would frequently direct vehicles that were not located in the right-of-way through the intersection, similar to a right-on-red movement. This was mainly apparent for movements coming from Leg #1, due to their relative close proximity to the intersection.

Due to the nature of the industrial facility, a significant amount of infrastructure was located aboveground adjacent to the roadway, thus limiting where the temporary units could be safely positioned. These space limitations resulted in the equipment being positioned in the same locations that the flaggers stood while directing traffic, as shown in Figure II. Although not ideal, permanent signals would have the opportunity to further improve efficiency being placed closer to the intersection.

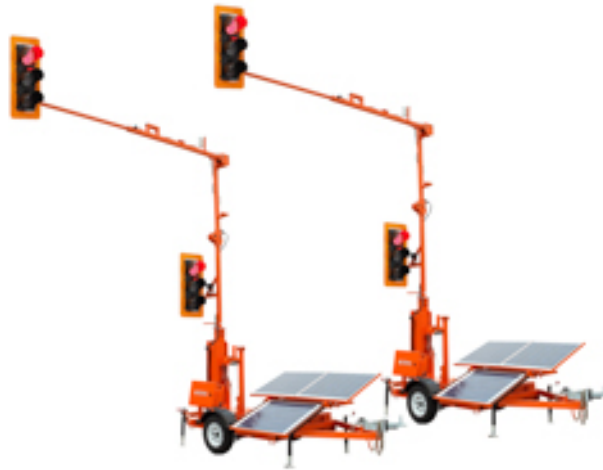
Figure III: TDL-3612 units used on Legs #1 and #3

Ver-Mac temporary traffic lights were obtained for the pilot study for the site. The trial used TDL-3612 units for Legs #1 and #3 and a TDL-2312 unit on Leg #2. TDL-3612 and TDL-2312 units are shown in Figures III and IV, respectively.

Height constraints were quickly identified once the trial commenced. The TDL-3612 units, located on Legs #1 and #3, operate with two signal heads. One signal head is located on the mast to the right of the driving lane, while another is located above the driving lane on the trailer boom. Immediately after the trial commenced, it was apparent that mobile cranes were unable to fit underneath the 6.5m tall trailer boom. The booms on both units were quickly lowered. The remainder of the trial utilized only the signal heads on the mast of these two trailers.

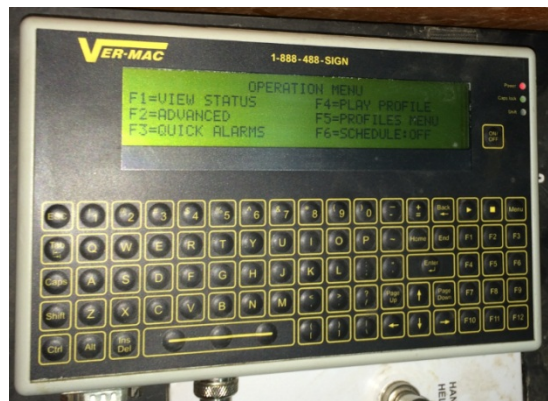
Figure V: Controller box located within the unit on Leg #1

Throughout Weeks 1-6 of the trial, the traffic signals were to be operated manually by the flaggers from the unit located on Leg #1. A manual setting was applied from a controller box also located at the unit on Leg #1. Once the manual setting was applied, control of the light was achieved with the aid of a button attached with a 25ft cable to the unit. This allowed the flagger managing the system to stand away from the road or even sit in a site vehicle during inclement weather while still maintaining control of the signal lights. When set cycle timings were applied, digital timers were used in combination with the manual control to allow some flexibility if necessary. A photo of the controller box is shown in Figure V.

Due to technical issues with the controller box and potential safety issue associated with this, the traffic signals were temporarily shut down for Weeks #3 and #4 until the supplier could return to site to replace the controller and re-program the system.
